10. Security

The Security site visits were performed from February 9 through February 12, 2009 on all floors of the building to include the roof and the parking garage. The security team visually assessed these areas for physical security issues (stand-off and clear zones; accessibility to the site and building; vehicle ram barriers; lighting for security; perimeter barriers to access the buildings and structures; exterior utilities feeds to the structures; bullet resistant protection; internal room and area security; doors and locks; internal administrative controls relating to the foregoing) as well as electronic protection (card access; cameras; electric door strikes; duress or panic buttons; video recording equipment; intercoms; Security control room; head-in/main electronic equipment). A threat and vulnerability assessment for the site and building was conducted. The type of occupancy, its use, the surrounding area and what is there determines the level and type of security needed and what is appropriate. However, what is in place should in all cases be performing at a level as designed by the manufacturer to meet those needs and objectives required for the protection level.

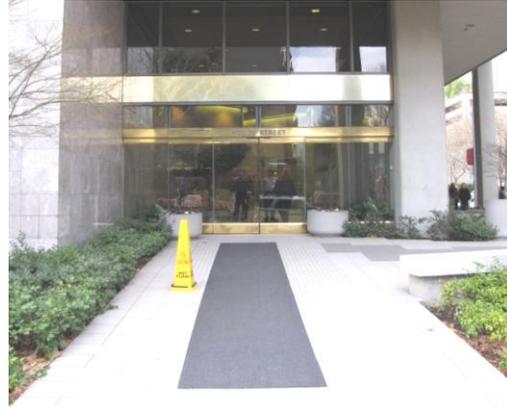
3. At the main entrance on the NE corner, both the “N” Street entrance and the 5th Street entrance have ramps leading up to the primary visitor and employee entry doors and into the lobby. ***This creates an vulnerability in that it allows for the brute force driving of a vehicle into and the follow-up denotation of an explosive device within and under the very confines of the high rise structure itself.***

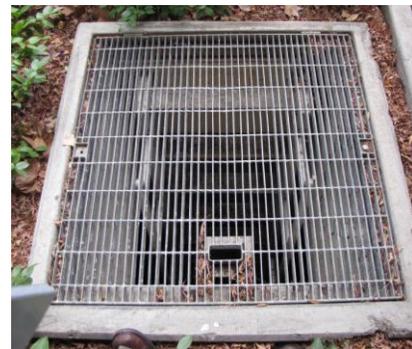
4. Along the East side (5th Street) are Sacramento Municipal Utility District (SMUD) vaults for delivery of service to the building. The open grates are secured with manufacture’s bolt screws; however, one of the two is missing from one of access grates. ***The vulnerability here is that there is no physical security type device on these grates nor was there any electronic intrusion sensor or camera coverage of area. The area allows for concealment of explosives.***

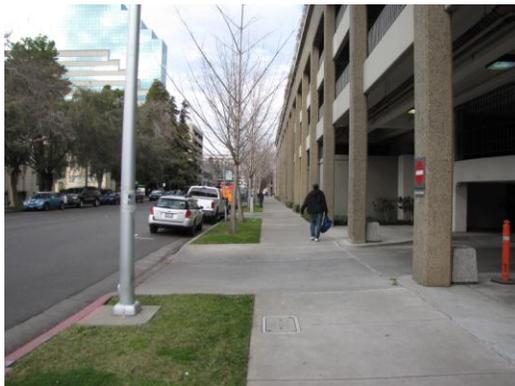
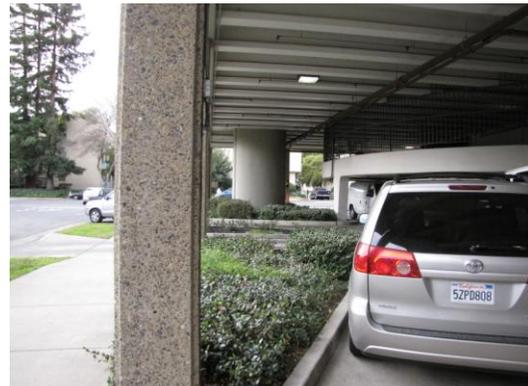
6. The SW corner (“O” Street and 4th Street) of the site has vehicle and pedestrian access to the ground level parking garage and to various points depending on the day of the week and time of day. However, there is always some unlimited access to certain portions of the ground level of the garage at all times.

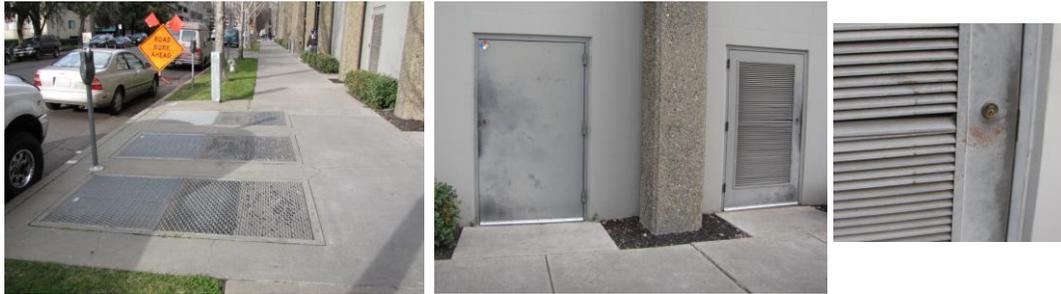
7. The SMUD Vaults for the building's water and electric power vaults are located on the open space between the sidewalks and curb on 4th Street near this intersection. The cover grates are not secured except for the normal privacy bolts to hold them in place. The rooms for the Generator, Diesel fuel, Fire pump, Water distribution are located adjacent these vaults. It appears that the aluminum door vent slats have been forcefully tampered with. The doors to these rooms are metal, with open exterior non-security hinges and no latch protectors. These rooms are not monitored with any electronic intrusion sensors. ***The current security protection for these utilities and activities are extremely vulnerable to unauthorized access and contamination and/or destruction. Direct placement of an explosive device would probably result in the feeder line being severed and will affect the building being occupied for normal business.***

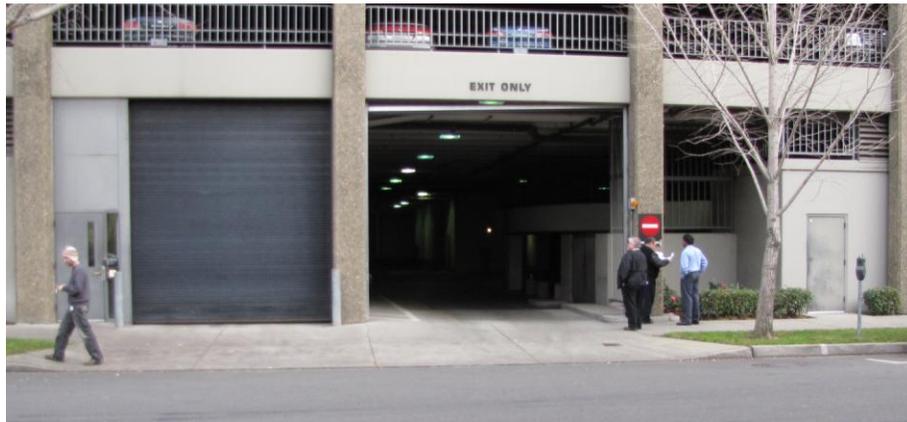
8. An overhead, metal grated door that is approximately 14 feet by 12 feet is utilized for trucks too high to enter through the south side ("O" Street) entrance way going to the loading dock. This door was in the raised position even though no vehicles were at the dock. ***This creates a vulnerability in that free access is granted to either vehicles or pedestrians to the loading dock and upper levels of the garage.***

10. Access into the Loading Dock and Parking Garage from 4th Street is protected by a metal, overhead, roll up/down gate. The speed at which this gate proceeds either upward or downward allows for the piggy-backing of vehicles or pedestrians into the interior of the building. This gate needs to be replaced with a high-speed door and left in the closed position when no vehicle is moving in or out of it (See Appendix 3-E).

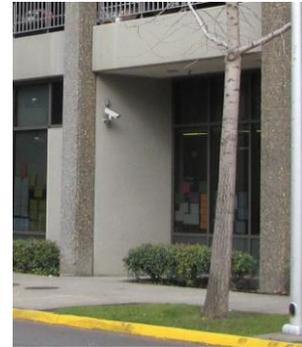
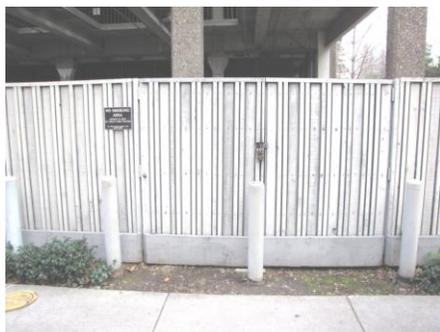
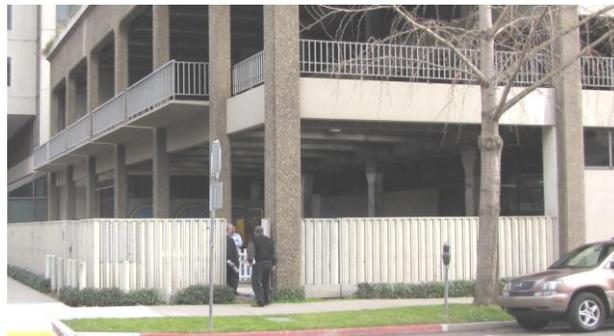
10. The child care center is located on the west side and NW corner of the site. The primary entry door is glass, has a card access door with an electric strike and an intercom. An exterior camera monitors the back of an individual entering the building and front of people exiting the door. The intercom goes to the office area and there is no intercom station at the door itself. The child care center play yard located on the site's extreme NW corner ("N" Street and 4th Street) has a 6 foot, wooden fence that has 6 inch diameter, 3 foot high pipe bollards located on portions of the perimeter. These bollards become climbing aids to jump into the yard. The yard is equipped with 3 external pedestrian gates for emergency egress out of the yard, two of which are located on this corner. These gates allow fast exiting from the yard in the case of a potential spousal or other type kidnapping. Access into the parking garage and positing at its NW corner on floors 2 and 3 allows for discrete viewing of the yard and its activities. ***Vulnerabilities are created in that the door may be opened to hear comments from someone immediately outside the door and access given by force. The fence wall is also too low to keep intruders out and the roof viewing allows for undetected observation of the children.***

4. The existing wall around the child care play yard should be replaced with at least a 10 foot high wall and have no viewing into the yard from ground level.

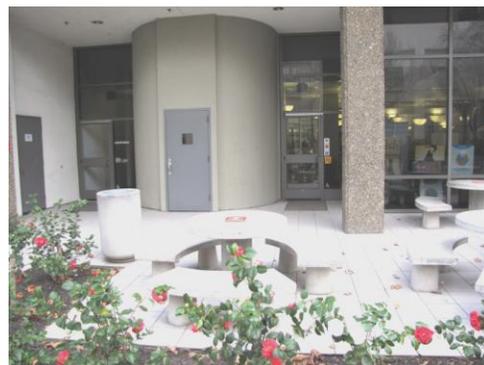
11. Approximately midpoint along the north side ("N" Street) is an open area (approximately 40 feet long by 30 feet wide) next to the building with four pedestrian doorways. These doorways serve primarily as emergency routes for egress from the building. Two of the doors have keyways that allow access from the outside for those having a key. The other two doors lead into the cafeteria and are manually opened and secured for exterior entry when the cafeteria is in operation. There are outside tables located here for use by cafeteria patrons. ***The walkway leading to the exit routes allows for a vehicle to get under the high rise building structure for explosive placement.***

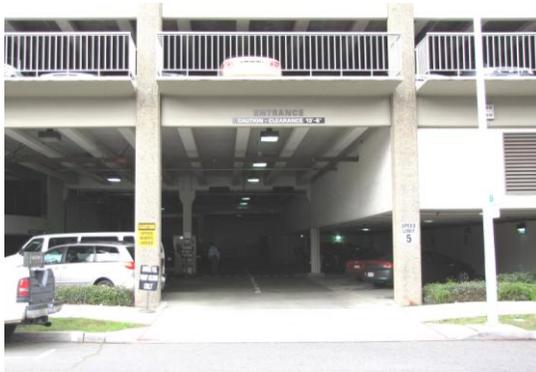
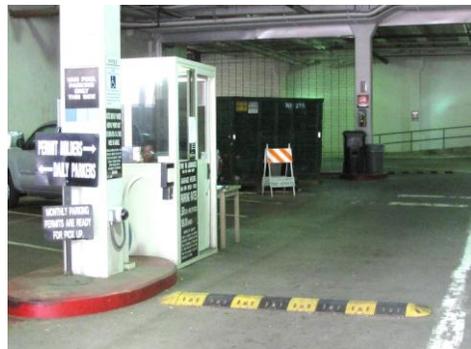
12. The parking garage has a parking attendant present in a booth approximately 50 feet inside the garage to assist vehicles entering from the “O” Street entrance. Parking is available for those who have been authorized to park there and possess an access card to certify that the card is an authorized one. The attendant is also there to assist delivery personnel. Signage is present as well as camera coverage. It is unknown whether the attendant has a duress switch to call for assistance if needed. It is also unknown if there is any validation of the access card to an actual person or if anyone who finds the card can use it to gain parking. The parking attendant booth cannot view the entry/exit drive off of 4th street or any entry/exit of people or vehicles. ***Vulnerabilities are created in not having total knowledge of the identity of those entering and what else is coming into this area. The lack of knowledge can place the complex in a negative position from the standpoint of premise liability avoidance and provides less than reasonable security protection.***

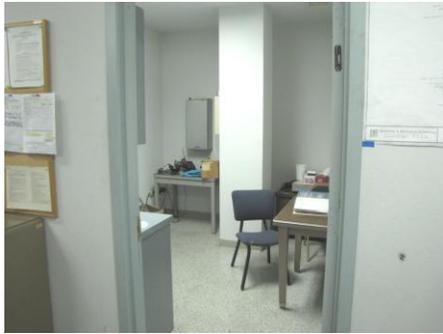
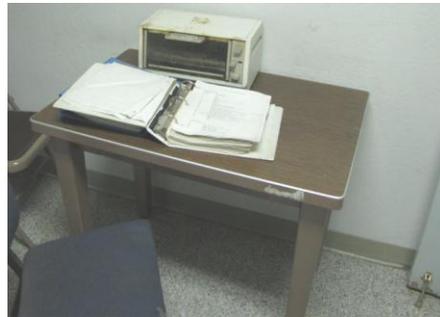
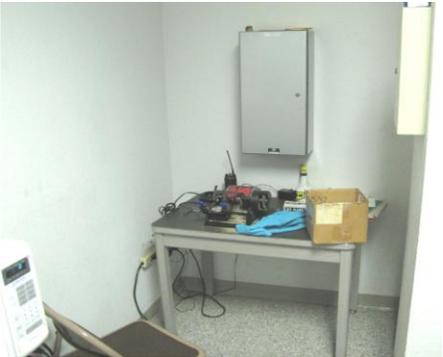
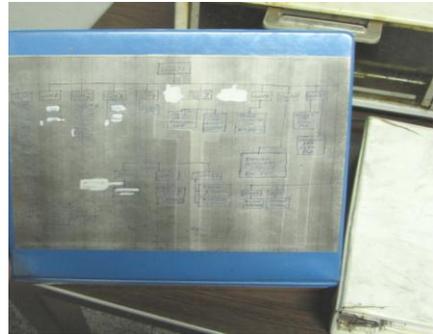
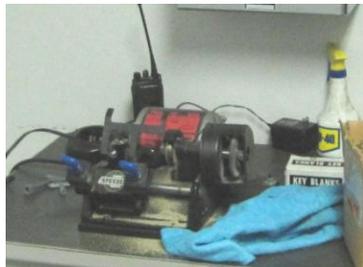
22. There is signage present at the main entrance that states "NO FIREARMS" and the legal reference.
 23. The lock and key system currently being utilized at the BOE Building is manufactured by "Russwin". The system was installed in 1993 and is maintained by the engineering department which is provided by an outsourced firm. The keyway uses a five pin series with keys made by the engineering staff upon notification to provide keys for certain individuals to certain areas. There is no key control software in use to track who has what keys. There are currently three

engineers that may cut keys. It is unknown how many individuals have been cutting keys since the system was established, how many master keys have been issued and to whom. The area where keys are made is an unsecured room on the Penthouse floor that is also utilized as a break room. The manual for the building system plate and key cut codes is lying openly in the room on a coffee table. Wall mounted key boxes with key blanks and sample keys stored in them have only cabinet privacy locks. This system is not a high security system. ***The vulnerability created by this process, the lack of maintenance of the records allows for unknown access that results in the compromised and integrity of the building keying system. Thus, from a security perspective the current key and lock system in use is rendered useless as a security safeguard. This lack of control over the lock and keying system can place the complex in a negative position from the standpoint of premises liability avoidance and provides less than reasonable security protection.***

16. The lock and key system used for the BOE Building that is manufactured by “Russwin” and installed at the time the building was built has been compromised. Identifying who has what keys, where are all the keys, how many master keys have been made are unknown as well as the process/codes to make keys has been stored in an unsecured area. The exterior and interior lock and key system needs to be replaced.

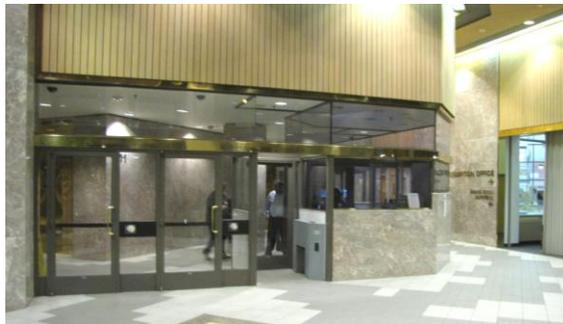
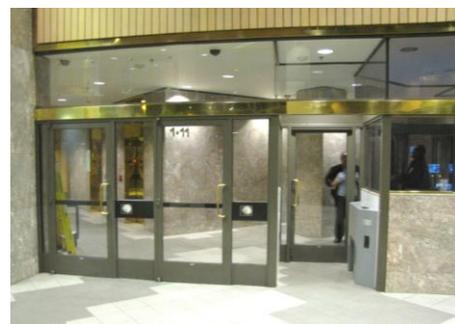
This first floor lobby area was renovated after the 1993 shooting incident. Special attention was given to the main lobby guard station and entry/exit ways into the core high rise elevators leading to the upper floors. Basically, a floor to ceiling barrier was created consisting of bullet resistant glass panes, doors and a marble lower wall around the guard station. The ability to open a door to gain entry is controlled by an electric strike activated by an access card presented at a card reader positioned next to the door. If the card is authorized, by presenting it at the card reader, it will release the latch to the door and allow the holder of the card to enter. The doors also act as exit doors and simply require the pushing of the exit hardware to open the door in order to leave.

The UL classification of the bullet resistant glass is unknown so the determination of the ability to stop the various caliber of firearm is also unknown. It is also unknown if the lower wall around the main lobby guard station has any bullet resistant rating. The guard present in the main lobby guard station has the ability to press a button to release the door's electric strike, which by-passes the card reader, should they have a reason to do so (i.e. an employee has a temporary badge or an authorized card holder they recognize has their hands full). ***Multiple vulnerabilities are created at this point. The bullet resistant glass protects***

primarily against different levels of firearms, so the higher the caliber the higher the cost of the glass and installation. The glass may not provide the intended protection that was originally called for in the installation. It is unknown whether the lower wall around the main lobby guard station is protected in the same manner. The use of doors allows for the “piggy backing” of individuals. Confusion over individuals exiting and individuals waiting to enter allows for someone to use an exiting door for entry. An access card works for whoever has it in their possession, thus allowing for a stolen or found card to be used to gain a fraudulent unauthorized access. The ability for a guard to bypass the system overrides the safeguard that has been put in place.

18. The lobby entryway doors into the secured area (elevator banks and core support offices) needs to be modified. Currently, the use of a door for entry and exiting allows for the “piggy backing”, simply entering a door that an individual has exited through or rushing forcefully through during the entry or exit. These doors on each side of the Main Lobby Guard Station need to be replaced with security revolving turn-stiles equipped with card readers (SEE APPENDIX 3-C).

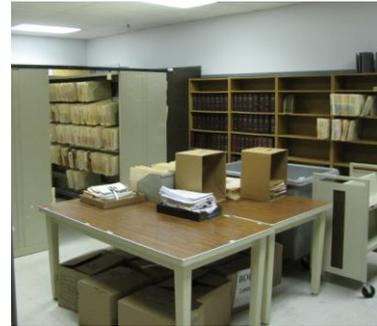
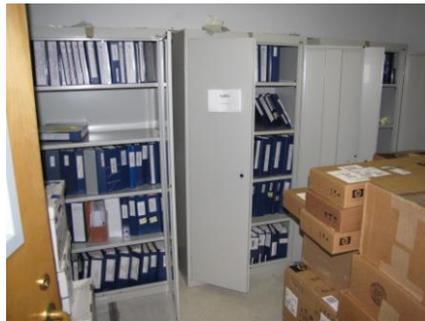
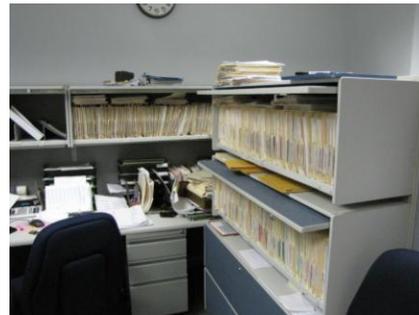
28. Currently several of the floors are identified as “sensitive floors” for the activities being carried out there. Access to these floors is limited and further controls exist on the internal corridors with the use of card reader controlled access. Within these areas, the activities are carried out in a relative “open manner”, files are left open on desks, lateral files and wall cabinets are open and unsecured. Areas include legal department, personnel management, tax payer records, audits, and cashier - mail processing. Cleaning personnel have free access to all materials that were on these sensitive floors. By not securing the cabinets and files, security issues are created in the protection of documents that are created by earthquakes and their reoccurring aftershocks, not to mention the administrative production issues. Some sensitive and secured rooms having card readers have not secured the ceiling. Two rooms were identified that are very sensitive that have no walls above the false ceilings, allowing for surreptitious access into the secured area for whatever reason. The use of cameras and intrusion alarm points are absent from

most of these areas. *Multiple vulnerabilities are present in these areas mentioned above and the opportunity for compromise is readily available.*

Compromise in some of these areas due to lack of physical security protection could result in the ability to prosecute legal cases, personnel actions, and possibly legal proceedings against BOE management for nonfeasance, not to mention the possibility of legislative investigations and loss of public confidence in BOE.

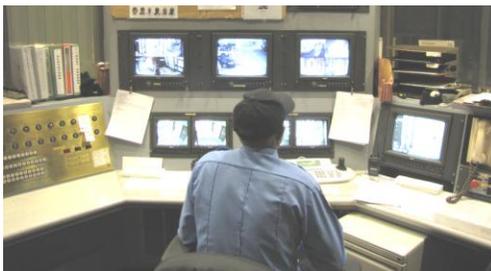
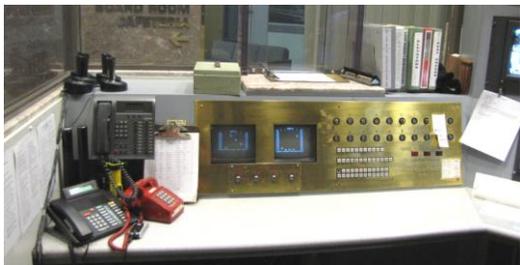
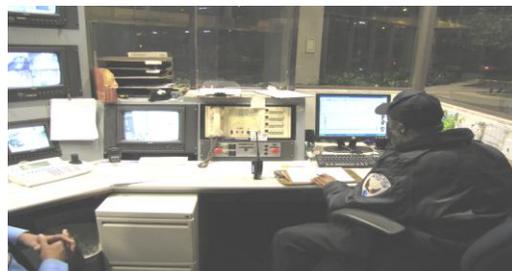
20. Intercom: At various perimeter locations and around the interior of the building there are Intercom door stations installed. These stations report to an Aiphone "NEM" series intercom master located at the Main Lobby Guard Station security console. The door stations are Aiphone LE-D series plastic stations and they are starting to deteriorate and fall apart at some locations.
21. Console: The Main Lobby Guard Station security console is located inside the building lobby. It has bullet resistant windows overlooking the lobby. It also has a transaction window. The console is located between the windows and it is comprised of color video monitors at the top and control equipment such as computers, video matrix joystick, intercom master, telephones, radio equipment and elevator control panel down below.
