Architectural Photographs

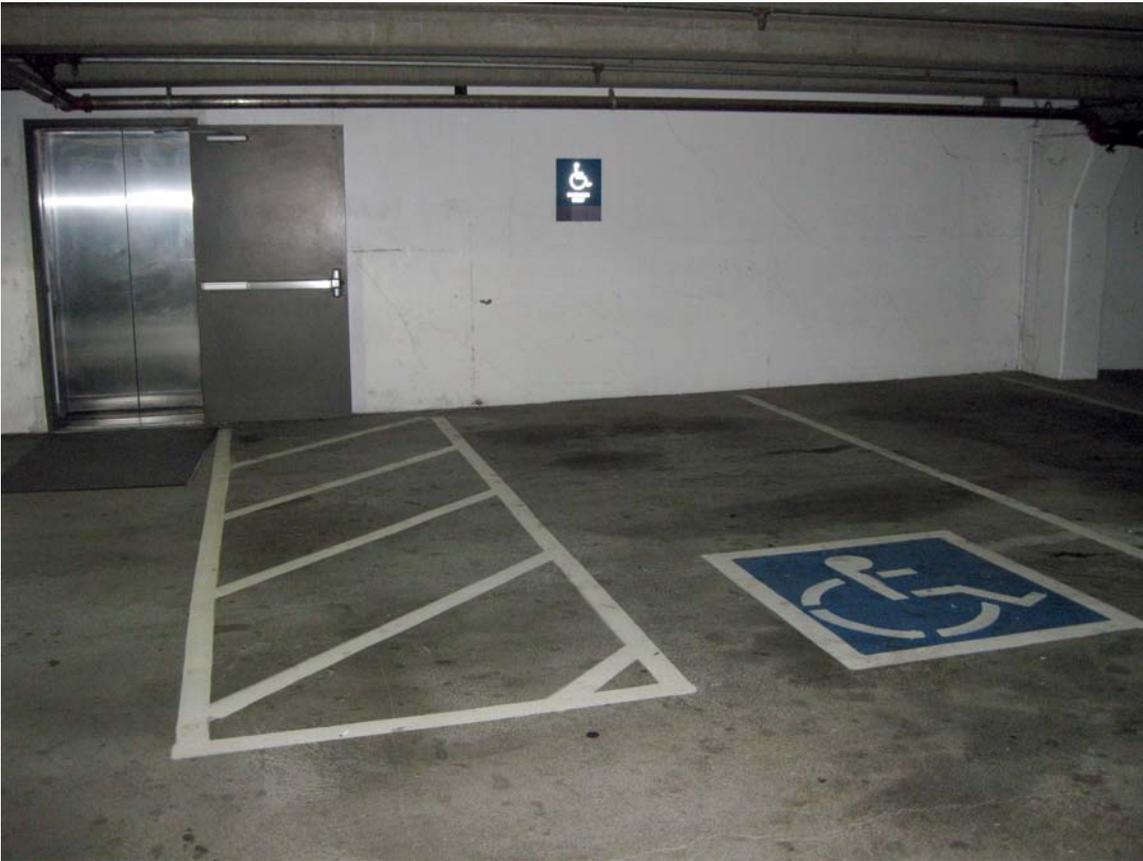
Photo No. 1– Disabled parking space: Note the missing wheel stop and missing “NO PARKING” text in the loading area. Also, the vertical clearance does not comply with ADA requirements.

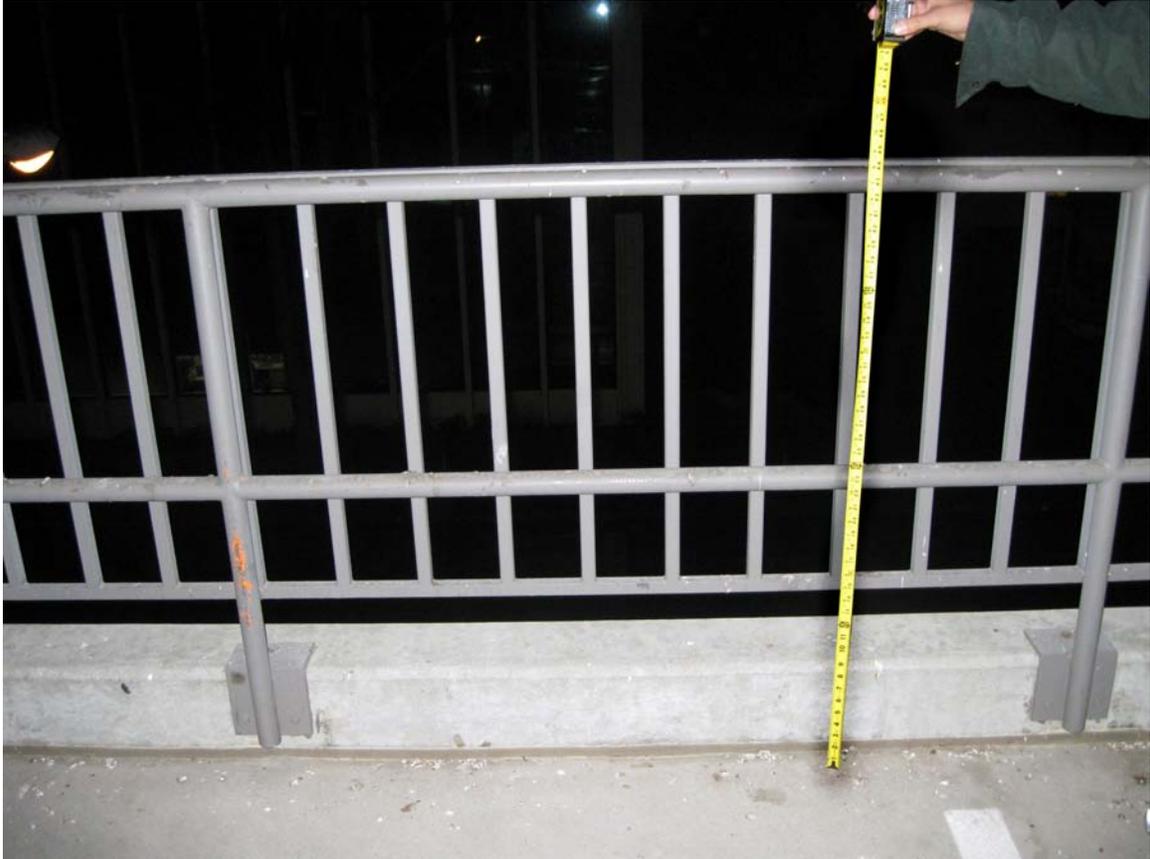
Photo No. 2– Vehicle Barrier: The existing pipe railing cannot withstand a 6000 lb load per 2007 CBC requirements.

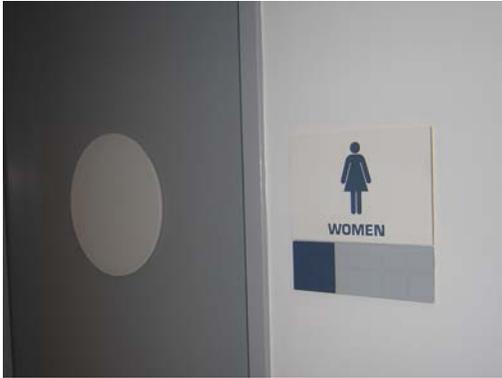
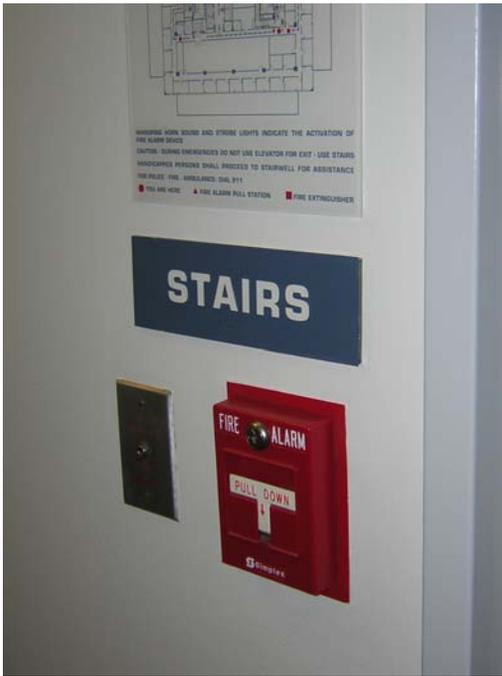
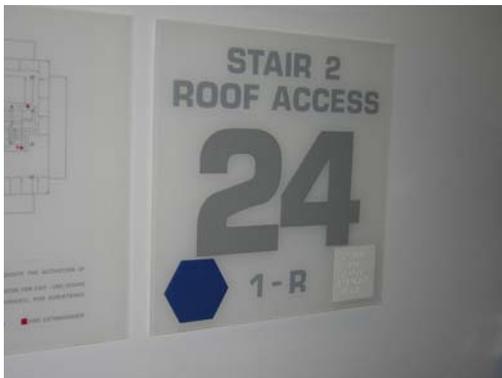
Photo No. 3– Typical Signage: Restroom signage is missing female pictogram (top). Text for stair signage does not comply with 2007 CBC requirements (middle). Stair signage inside the stairwell complies with 2007 CBC requirements (bottom).

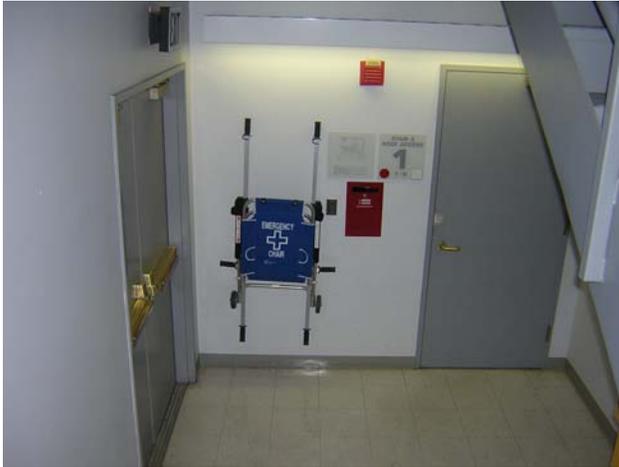
Photo No. 4– Stair 2: This photo shows the door from the corridor on the right and the door to the exit passageway on the left. Stair 2 is acting as an intervening room between the corridor and the exit passageway.

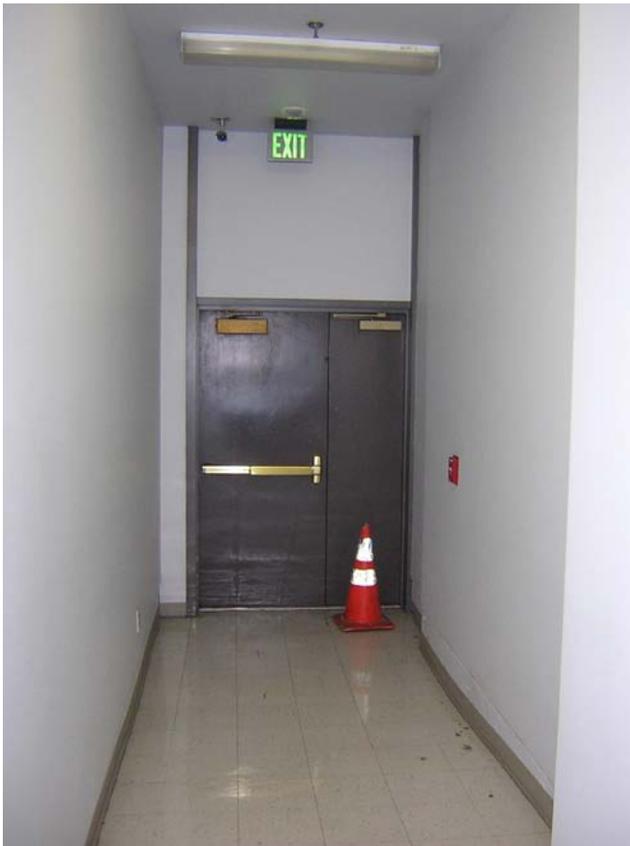
Photo No. 5– Stair 2: View inside the exit passageway from Stair 2.

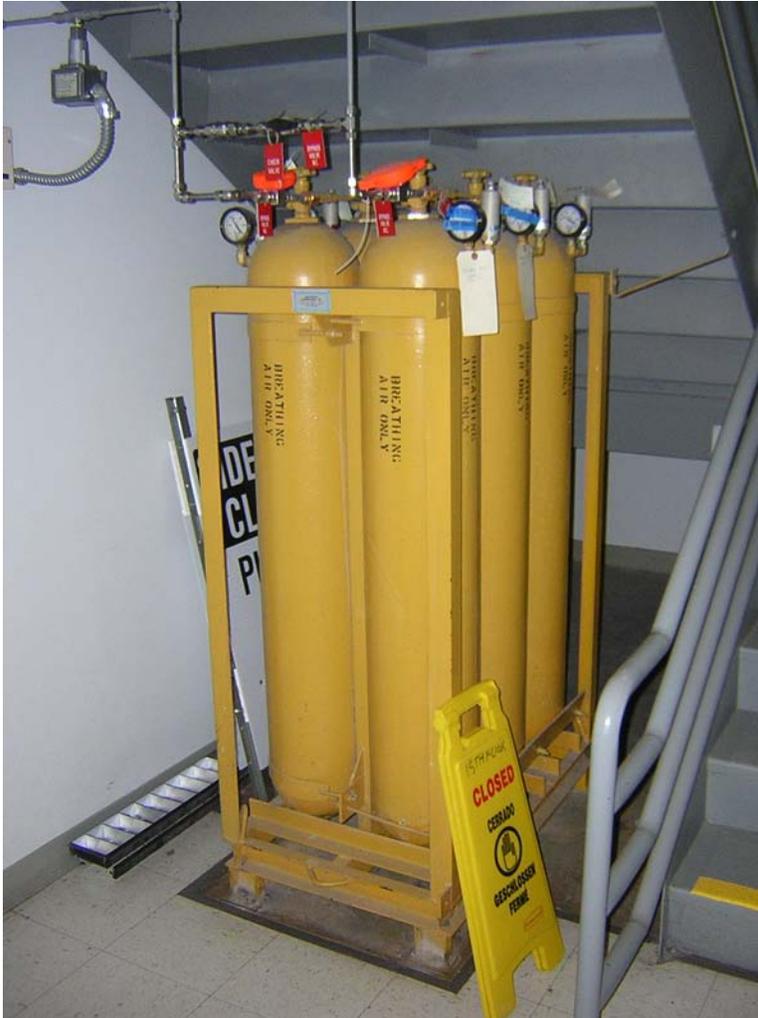
Photo No. 6– Breathing Air Tanks Inside Stair 2: View of existing breathing air tanks located beneath the metal stairs. The pipeline from the tanks runs to the adjacent fire control room.

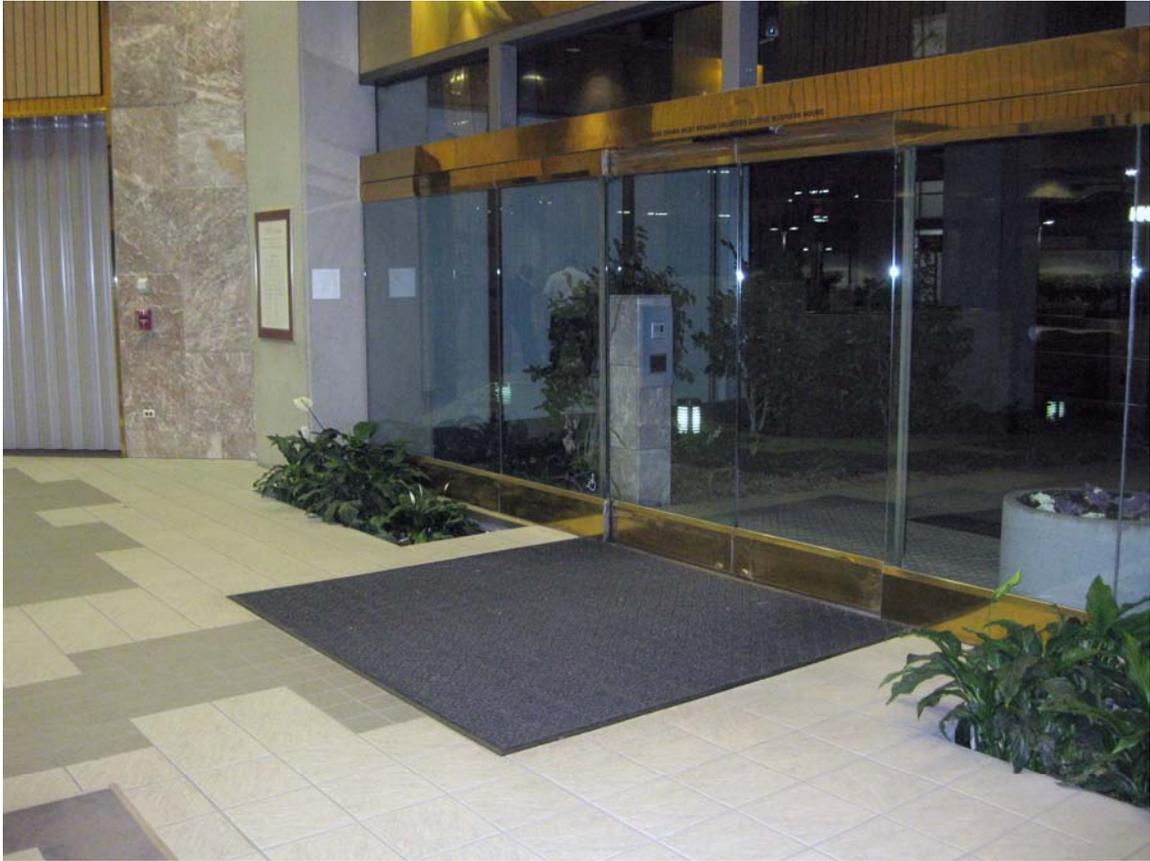
Photo No. 7– Main Lobby: View of the recessed planters which create a drop-off hazard.

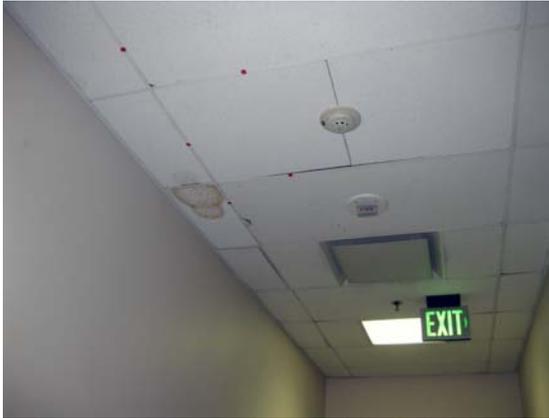
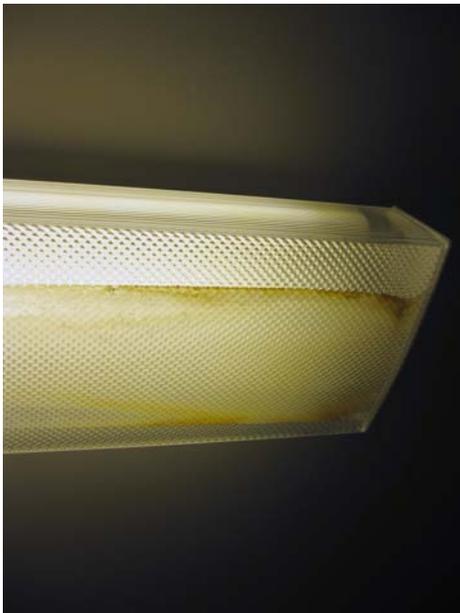
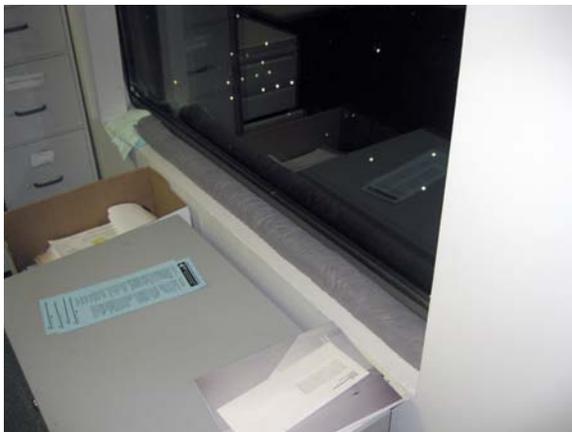
Photo No. 8— Examples of Water Intrusion: View of a water stained ceiling panel beneath a VAV box (top). Close-up view of a water stained light fixture lens (middle). View of an “All-Wik” at a window sill (bottom).
