PROJECT LOCATION  
BOARD OF EQUALIZATION BUILDING  
450 N STREET  
SACRAMENTO, CA. 95814

PROJECT  
STATE OF CALIFORNIA, DGS  
BOE ASSESSMENT  
(LCD NO. 2372-572)

DESCRIPTION  
WATER DAMAGE SURVEY

LOCATION  
GROUND FLOOR

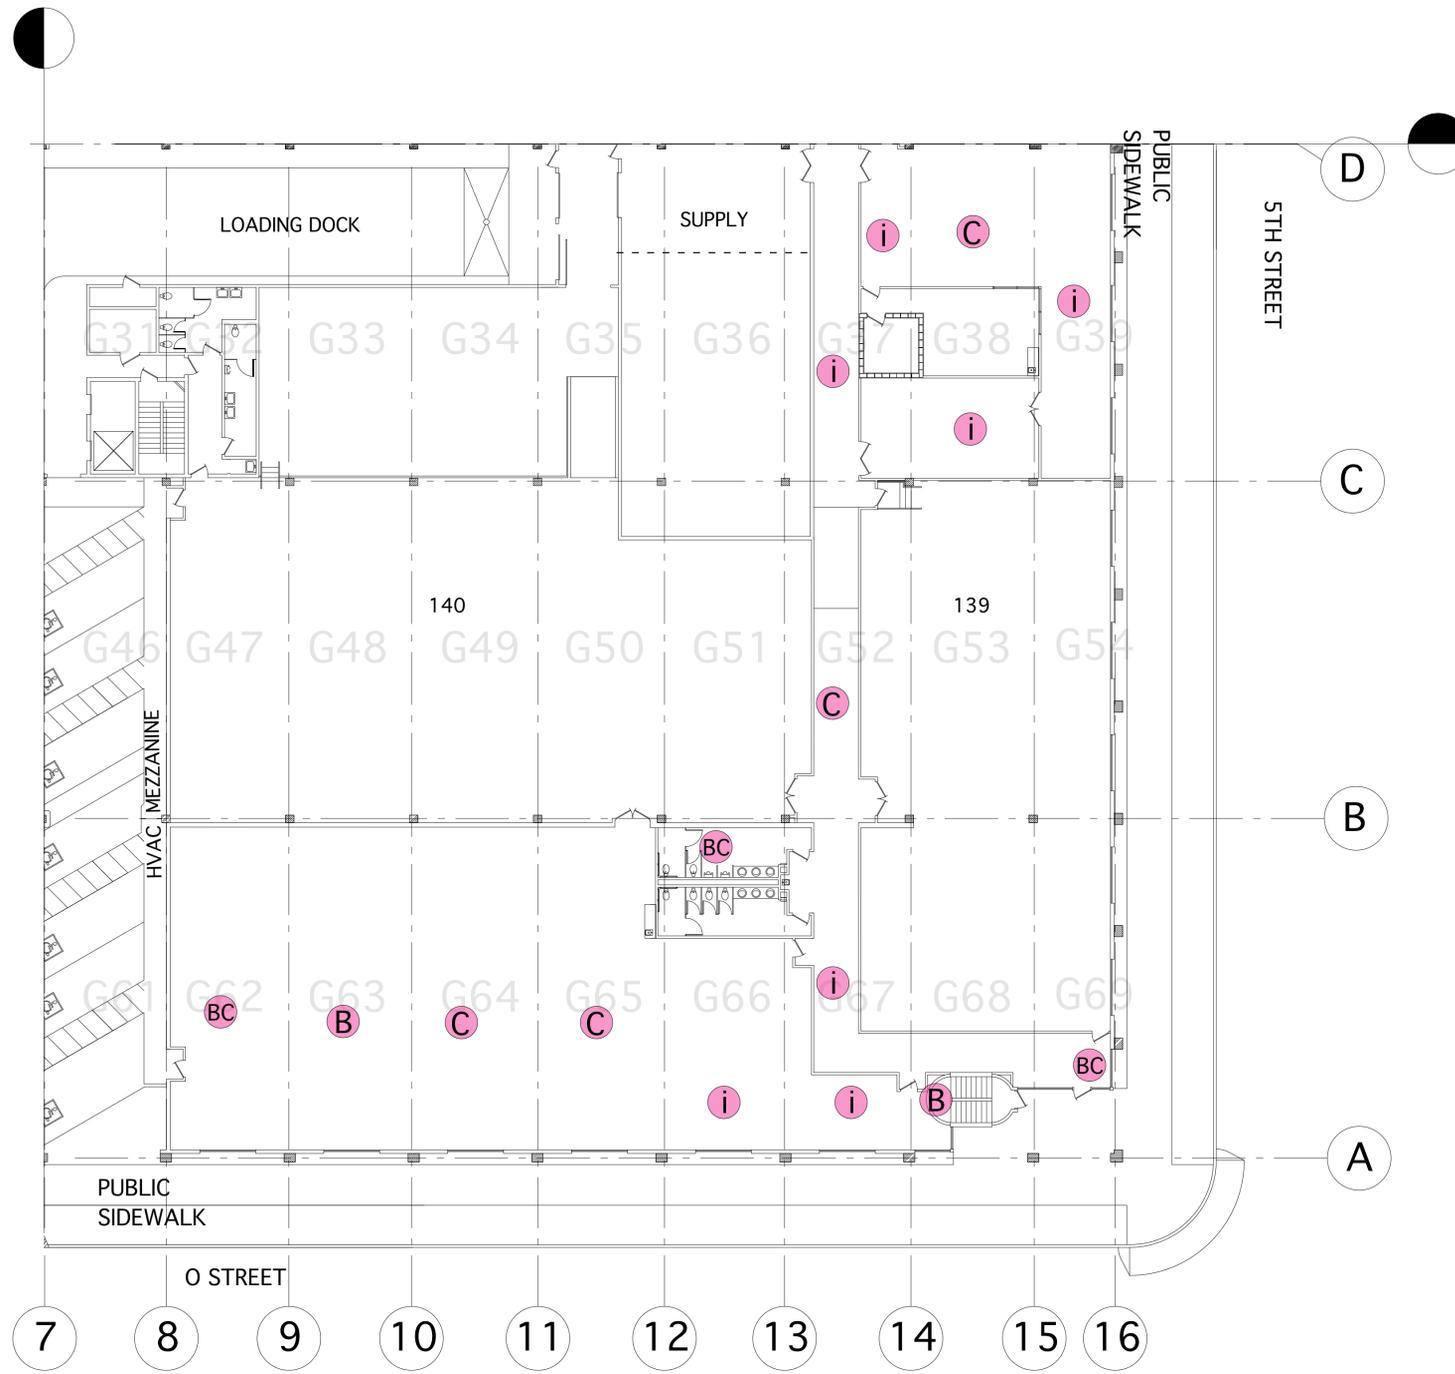
FLOOR PLAN S/E QUADRANT  
SCALE: 1/8" = 1'-0"

D LINE. WATER DAMAGE FROM PARKING GARAGE TO BUILDING FLASHING PROBLEM
