PROJECT LOCATION  
BOARD OF EQUALIZATION BUILDING  
450 N STREET  
SACRAMENTO, CA. 95814

PROJECT  
STATE OF CALIFORNIA, DGS  
BOE ASSESSMENT  
(LCD NO. 2372-572)

DESCRIPTION  
WATER DAMAGE SURVEY

LOCATION  
25TH FLOOR  
PENTHOUSE

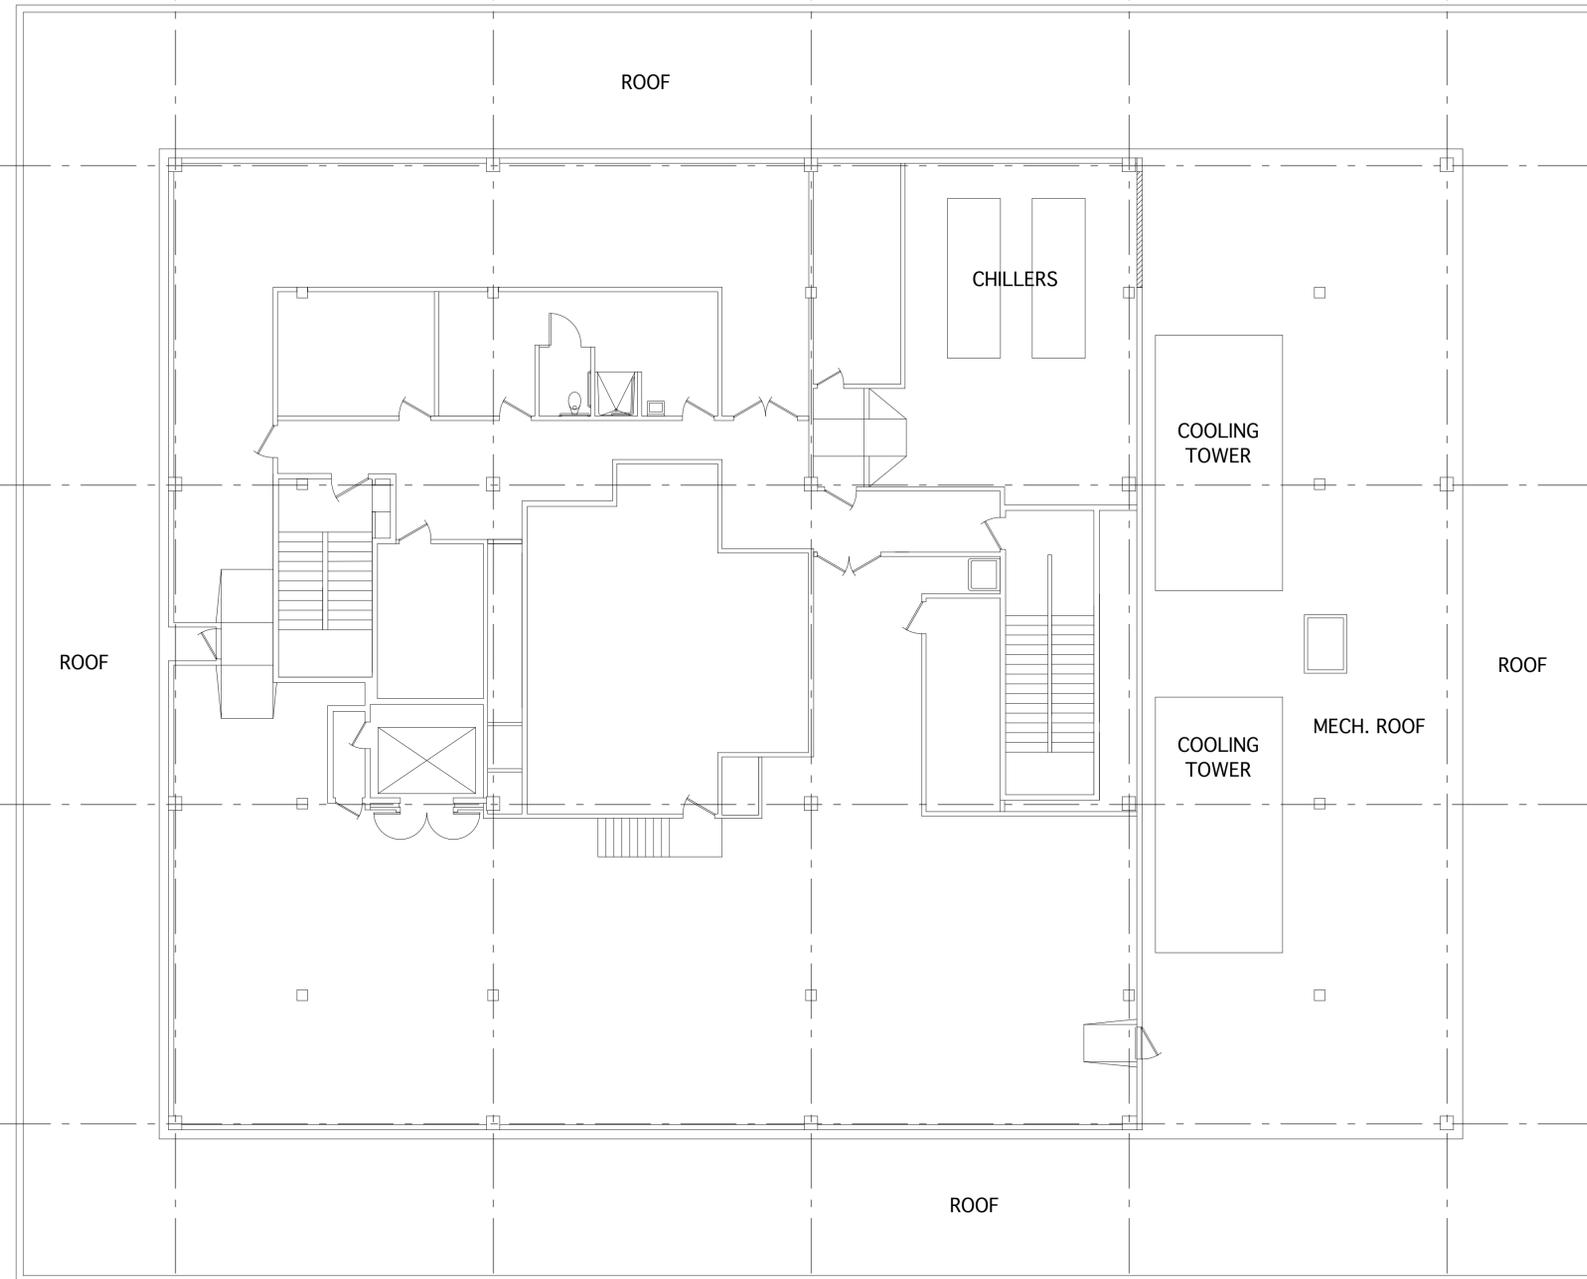
SHT NO.	SHT NAME
25	A25

① PENTHOUSE FLOOR DOES NOT HAVE A SUSPENDED CEILING. FOR GENERAL FINDINGS SEE WDA SUMMARY TABLE.
