December 16<sup>th</sup>, 2008

**Post Mitigation Assessment Report**  
**Department of General Services**  
**Board of Equalization Building, 450 N. Street**  
**Break Room 2014**  
**Sacramento, California**

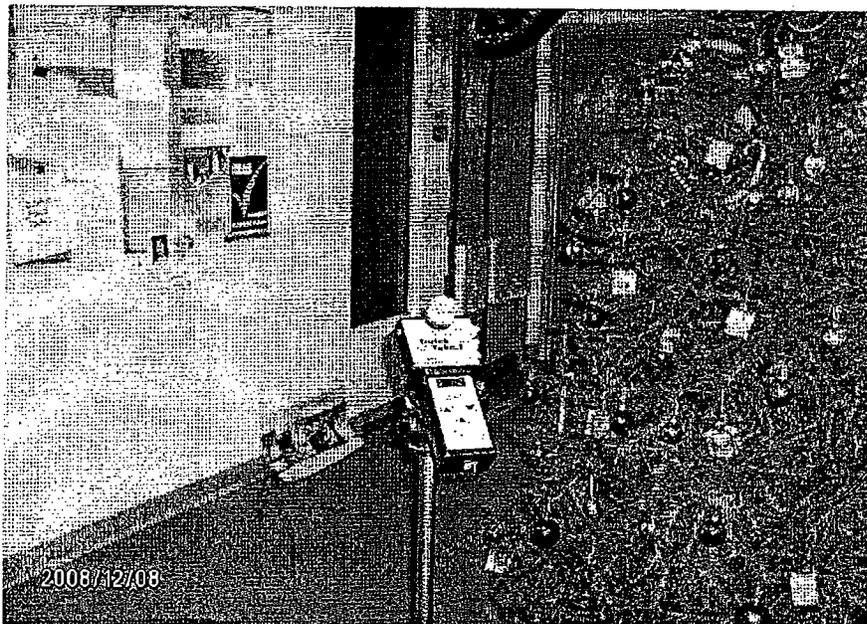
1) Image within tenant occupied hallway working space of 20<sup>th</sup> floor adjacent to 2014 Break Room Area at time of assessment.

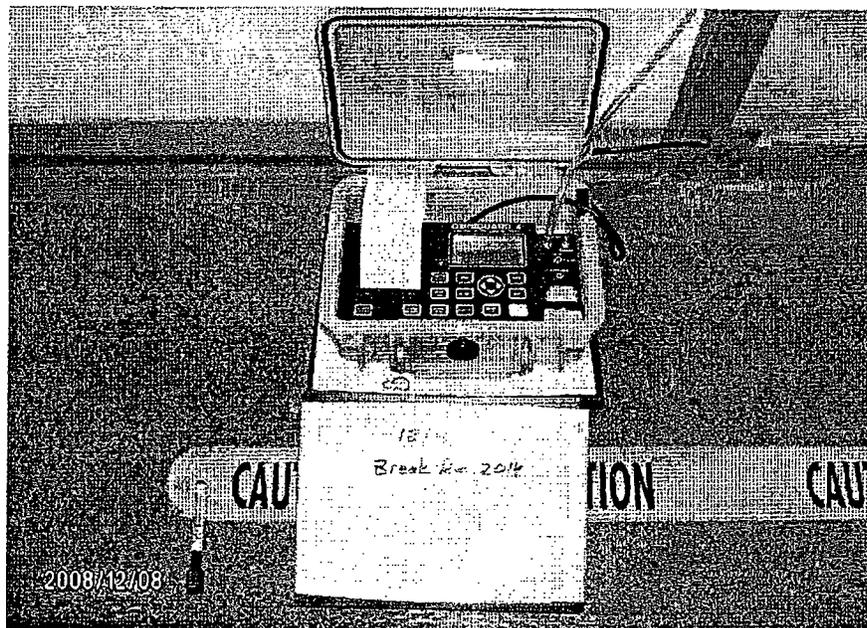
2) Image of Break Room 2014 pressure data logging equipment as viewed from occupied hallway at time of clearance assessment.

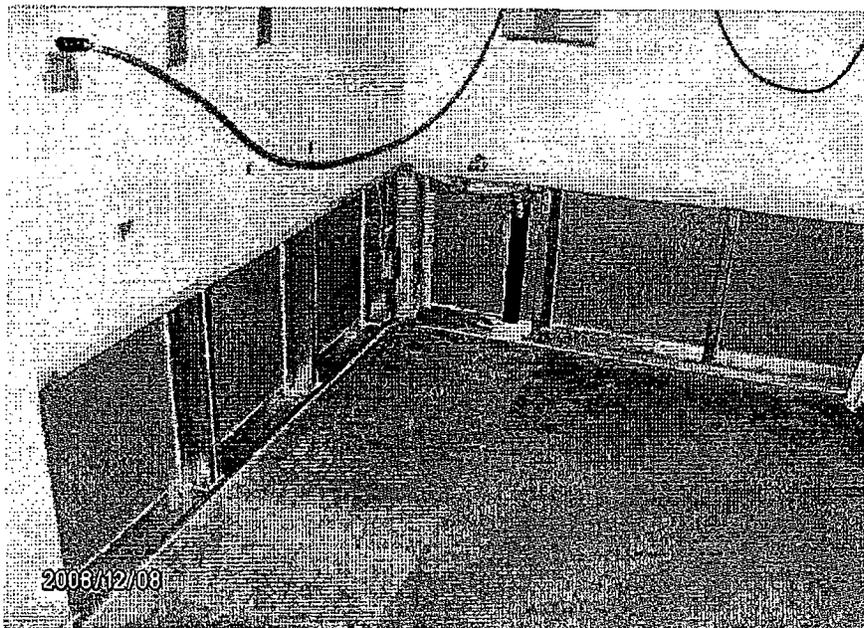
6. As verified during these assessment activities, all identified affected interior wallboard building materials had been removed from each of the noted interior areas of concern exposing interior wall cavity framing (metal) and underlayment wallboard siding materials present within each of the impacted materials and areas. Upon post mitigation inspection, all

remaining exposed building materials located within the break room exhibited no significant staining and/or elevated mold growth following the completion of prescribed physical material removal and chemical decontamination procedures performed by JLS.

- 4) Image of exposed wall cavity, exposed plumbing, removed floor tile, and delineation of wallboard removal within Break Room 2014 at time of assessment.

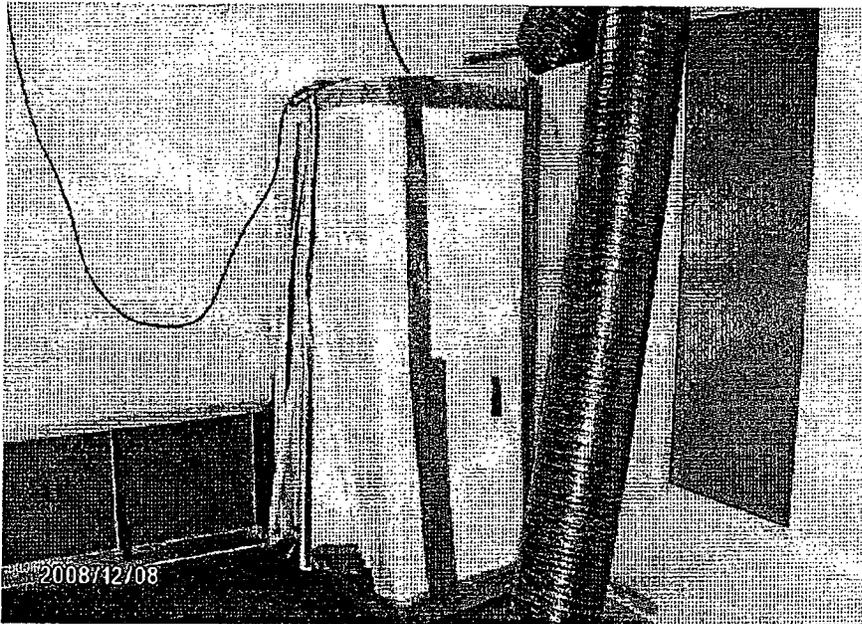
- 5) Image of interior containment entry chamber and flex exhaust HEPA ducting within Break Room 2014 at time of assessment.

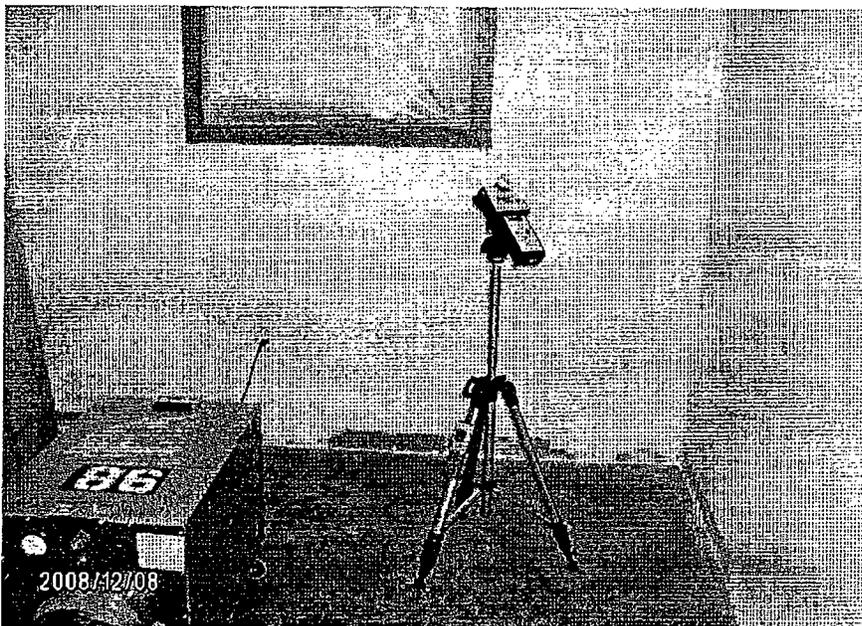
- 6) Image of air sampling equipment and critical barrier over existing tenant postings within break room 2014 area at time of assessment.

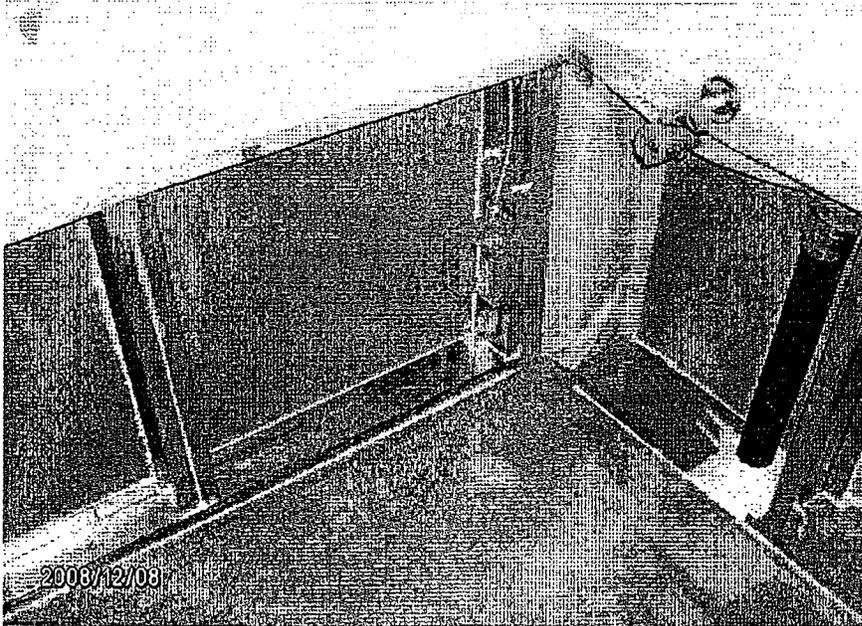
7) Close up image of exposed plumbing and metal floor sill framing following mitigative cleaning as viewed within Break Room 2014 at time of assessment.

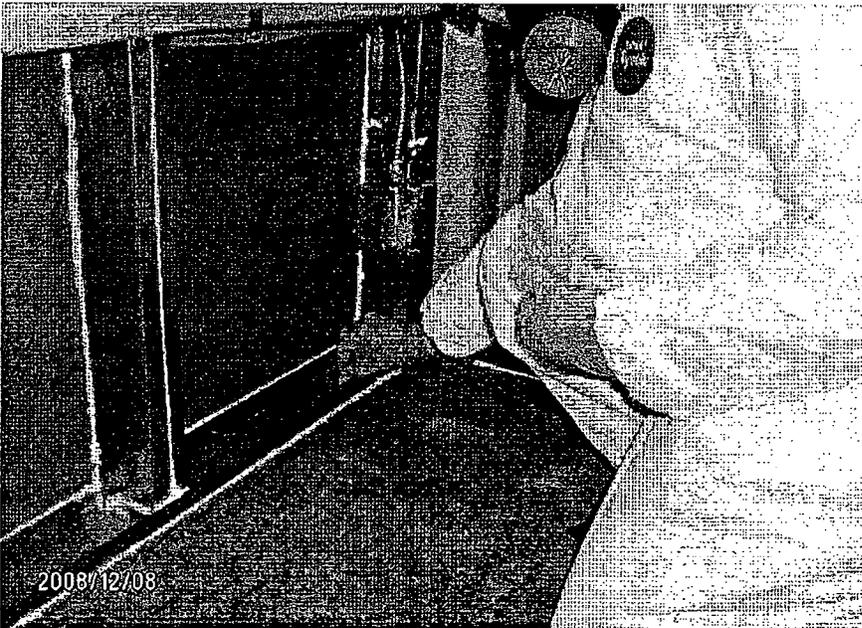
8) Image of exposed metal wall framing where HTI technician (Larry) collects surface tape lift sample at time of assessment.

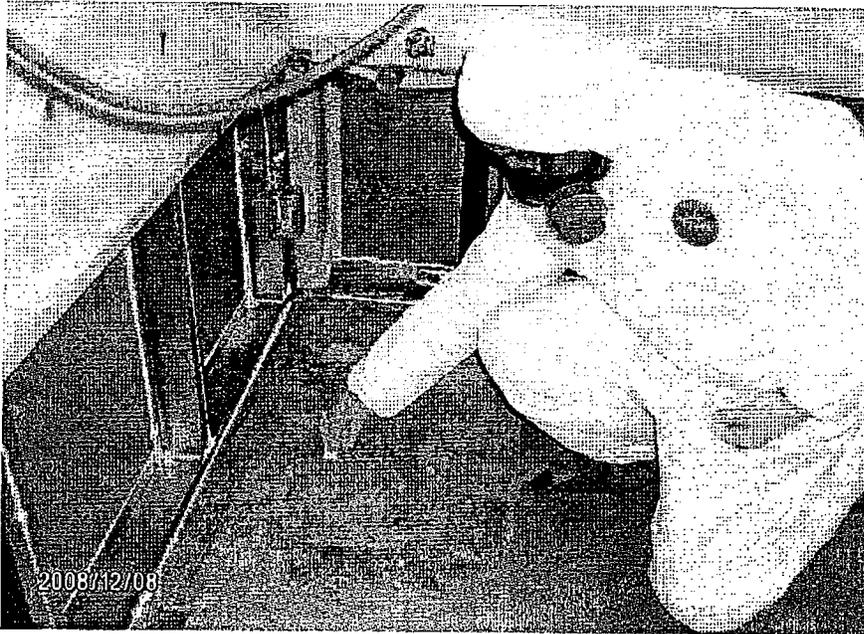
9) Close-up image of HTI technician collecting surface sample on exposed concrete surface within break room 2014 at time of assessment.

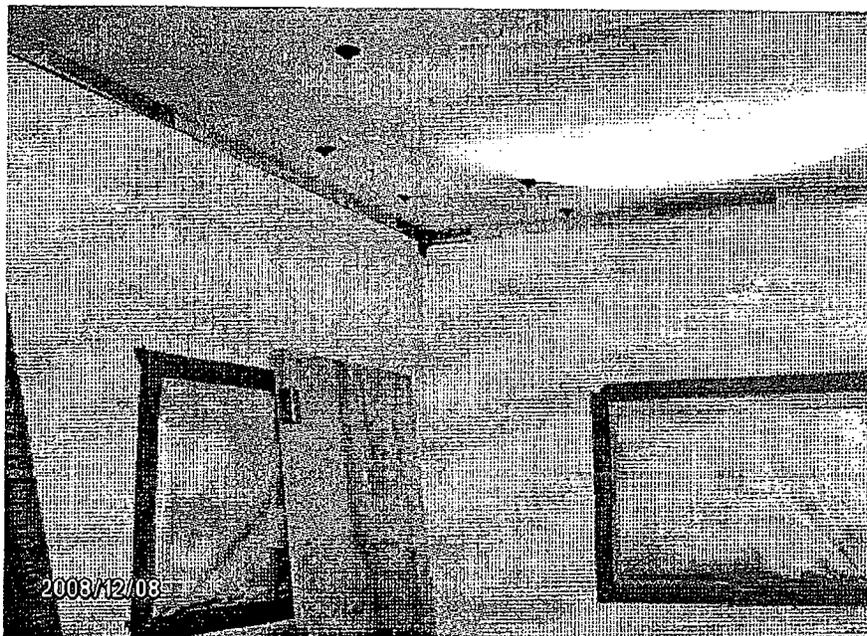
10) Image within break room 2014 containment viewing ceiling and wall posting barrier plastic maintained by JLS for duration of mitigative effort.

4. BioMax also recommends that current plastic barriers (as established during this mitigative activity) should remain during any reconstruction activity so as to minimize the potential transmission of associated nuisance construction dust and debris as desired.
