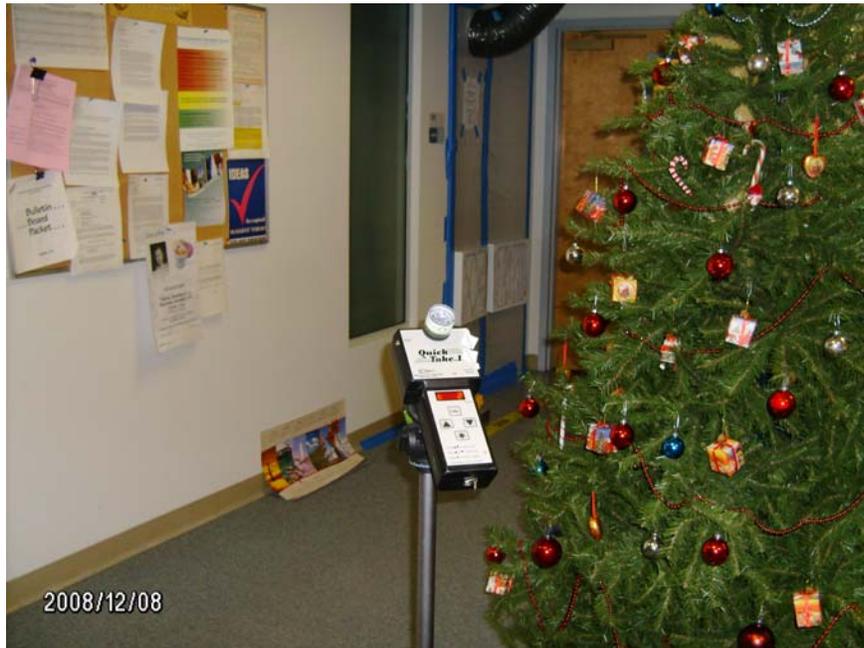
- 1) Image within tenant occupied hallway working space of 20th floor adjacent to 2014 Break Room Area at time of assessment.

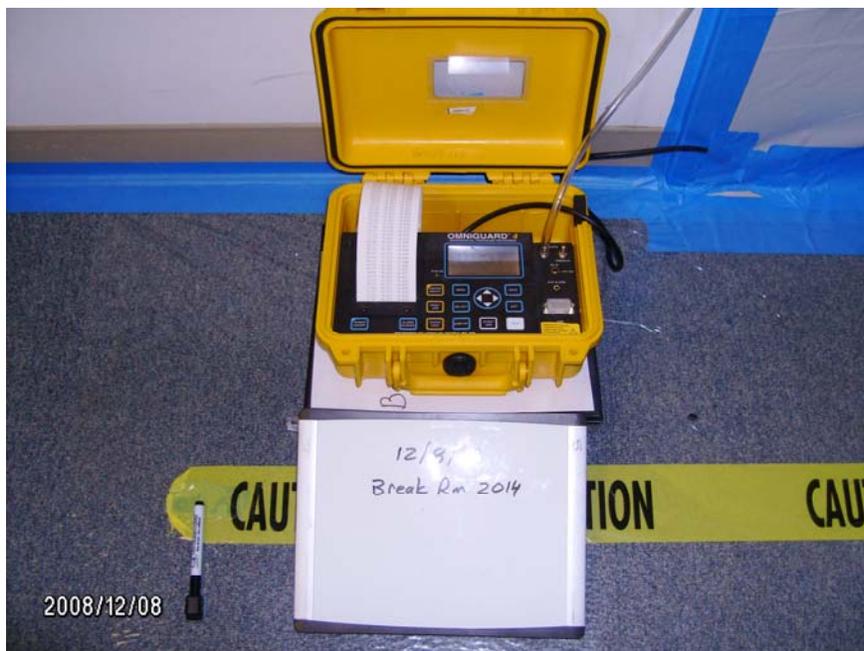
- 2) Image of Break Room 2014 pressure data logging equipment as viewed from occupied hallway at time of clearance assessment.

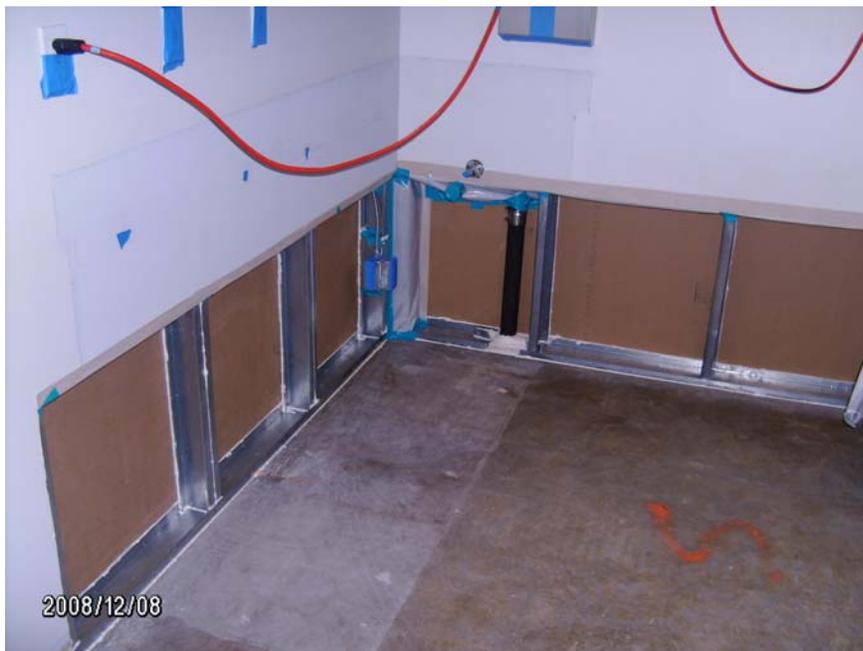
4) Image of exposed wall cavity, exposed plumbing, removed floor tile, and delineation of wallboard removal within Break Room 2014 at time of assessment.

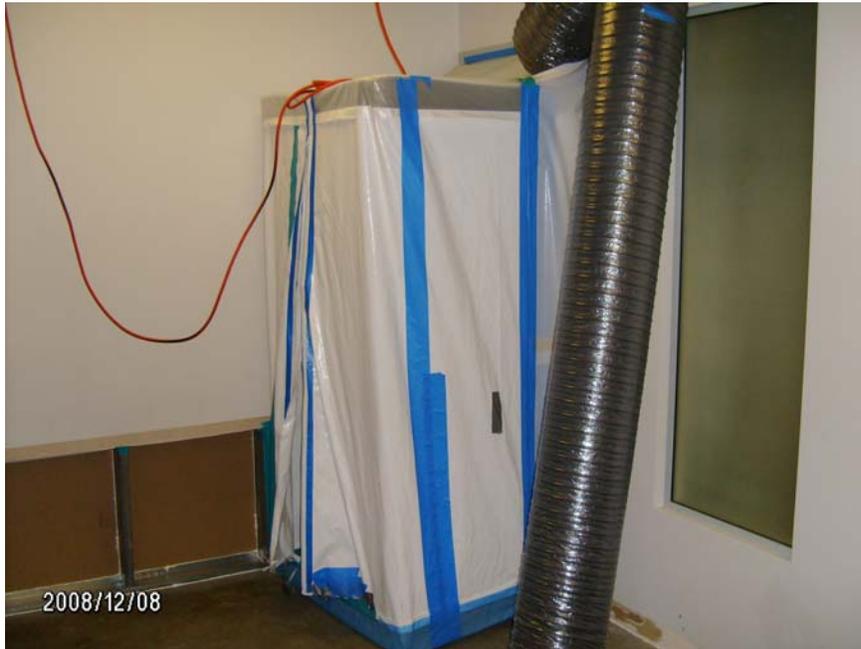
5) Image of interior containment entry chamber and flex exhaust HEPA ducting within Break Room 2014 at time of assessment.

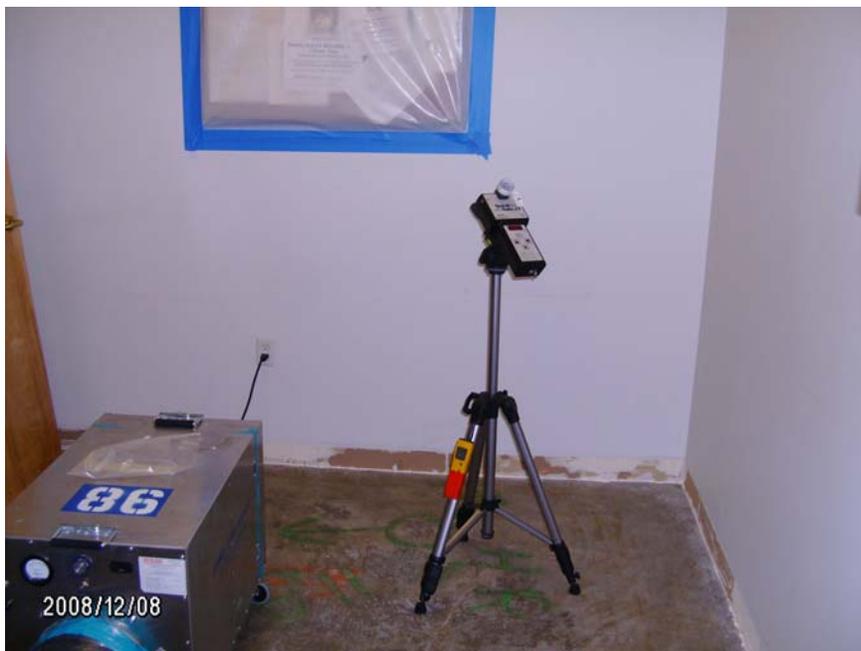
6) Image of air sampling equipment and critical barrier over existing tenant postings within break room 2014 area at time of assessment.

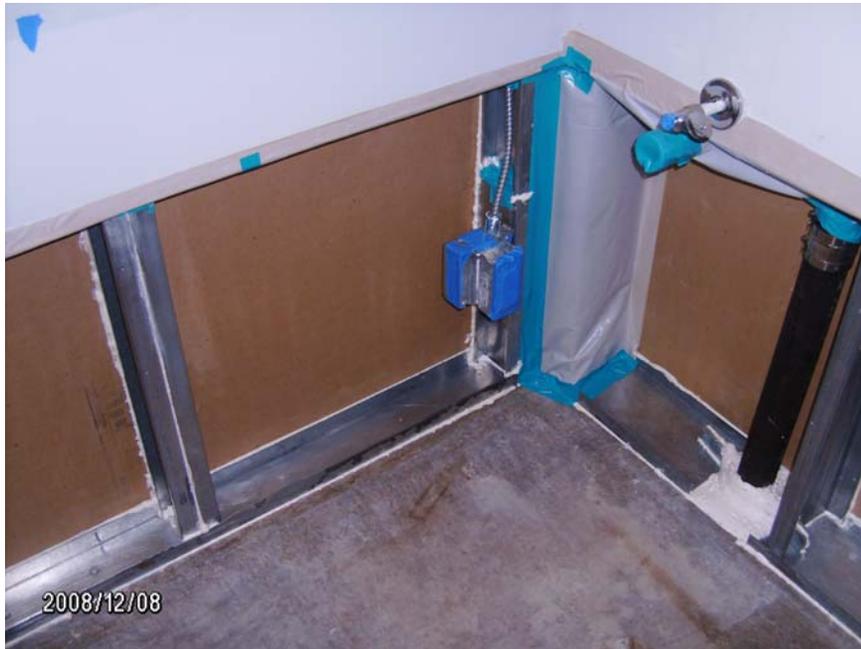
7) Close up image of exposed plumbing and metal floor sill framing following mitigative cleaning as viewed within Break Room 2014 at time of assessment.

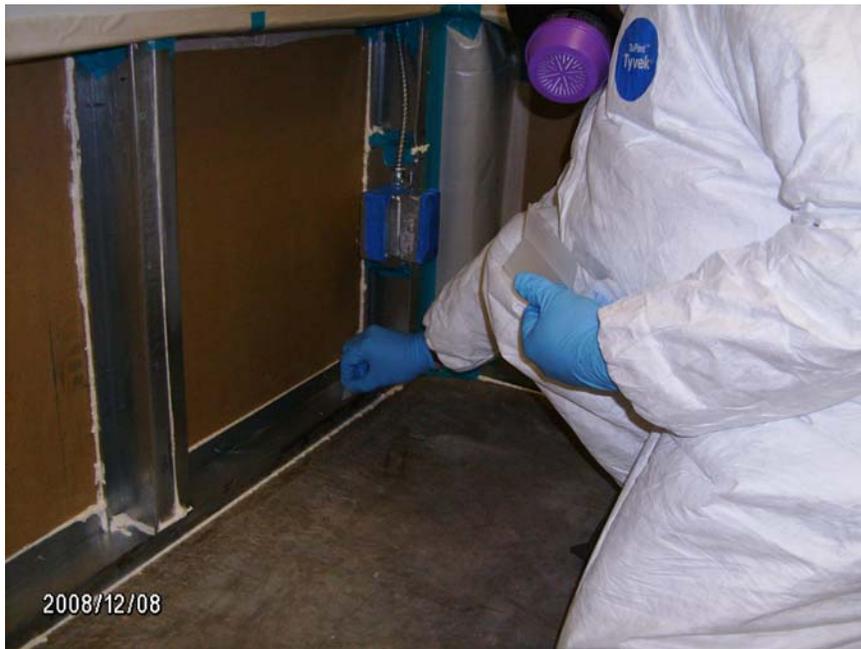
8) Image of exposed metal wall framing where HTI technician (Larry) collects surface tape lift sample at time of assessment.

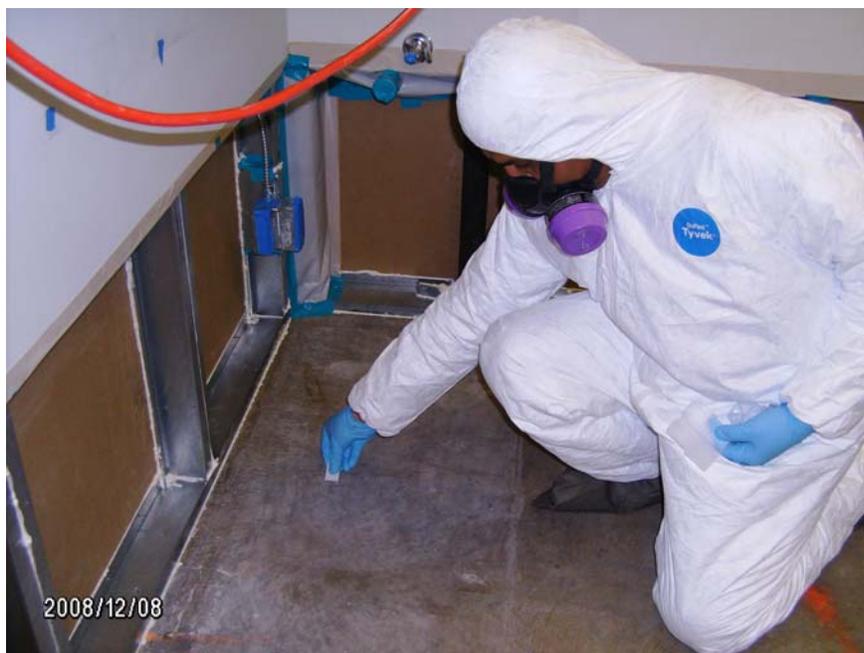
9) Close-up image of HTI technician collecting surface sample on exposed concrete surface within break room 2014 at time of assessment.

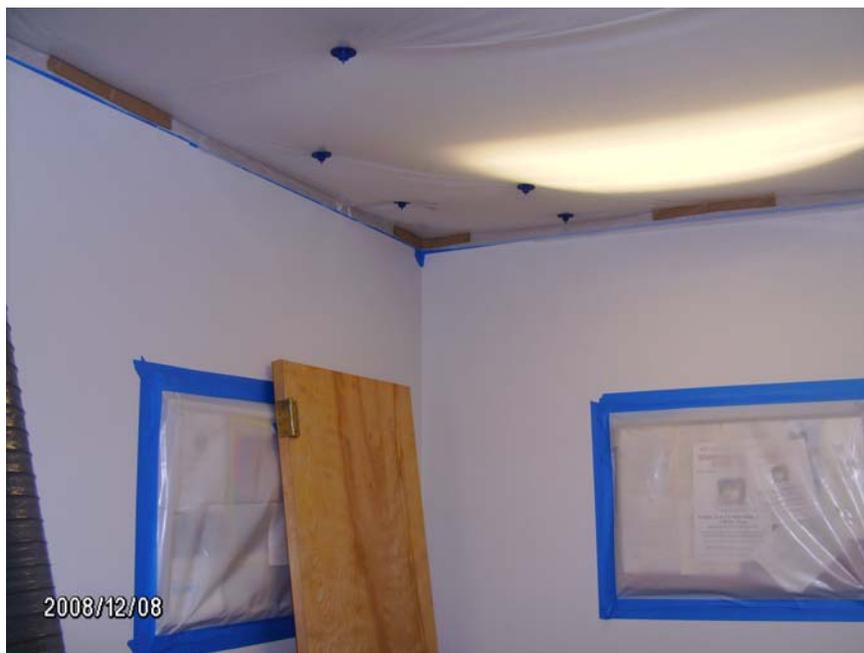
10) Image within break room 2014 containment viewing ceiling and wall posting barrier plastic maintained by JLS for duration of mitigative effort.
