BioMax Environmental

Post Mitigation Assessment Report
Department of General Services
Board of Equalization Building, 450 N. Street
Break Room 707 and 706 Areas
Sacramento, California

Attachment A: Digital Images
October 1st, 2008
BOE Building Break Room 707
450 N Street, Sacramento, CA

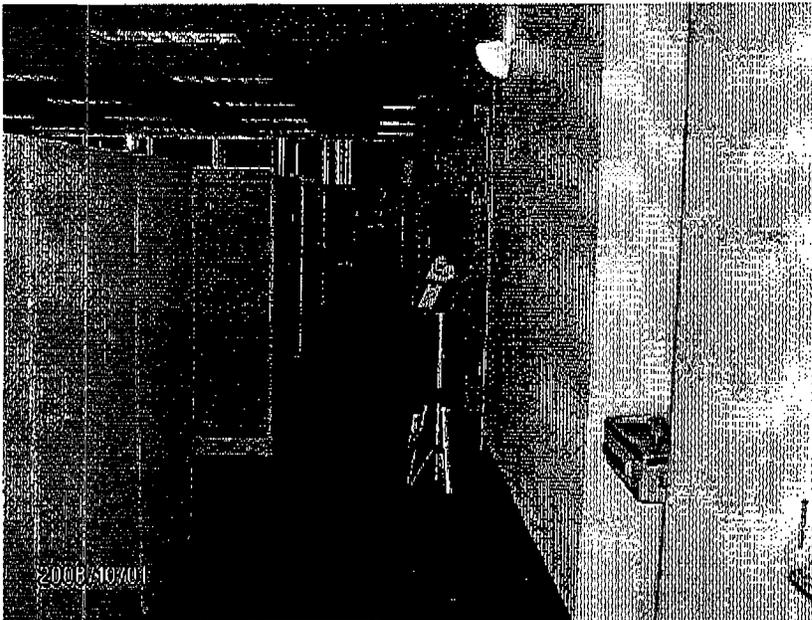
- 1) Image of hallway within BOE occupied working spaces located adjacent to 707 Break Room Area at time of assessment.

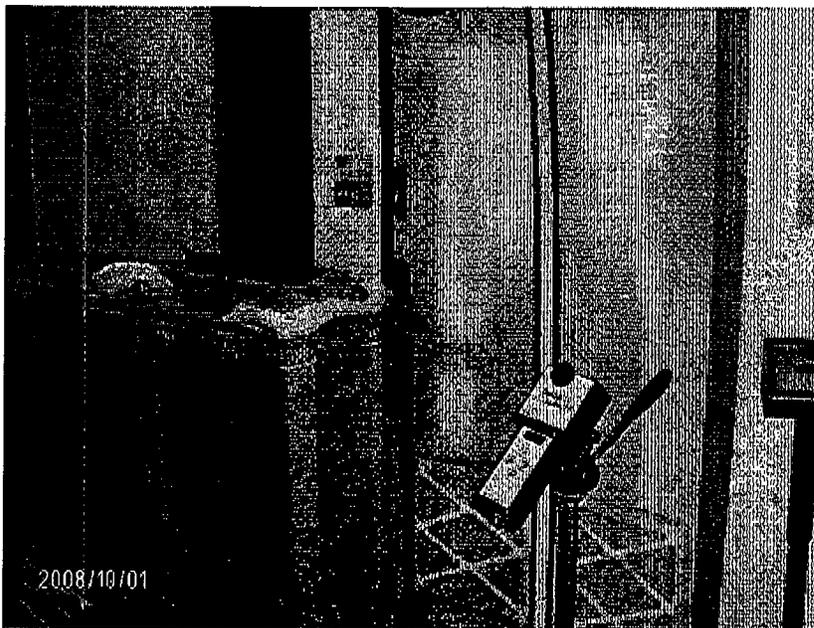
- 2) Image of Break Room 707 containment as viewed from occupied hallway at time of clearance assessment.

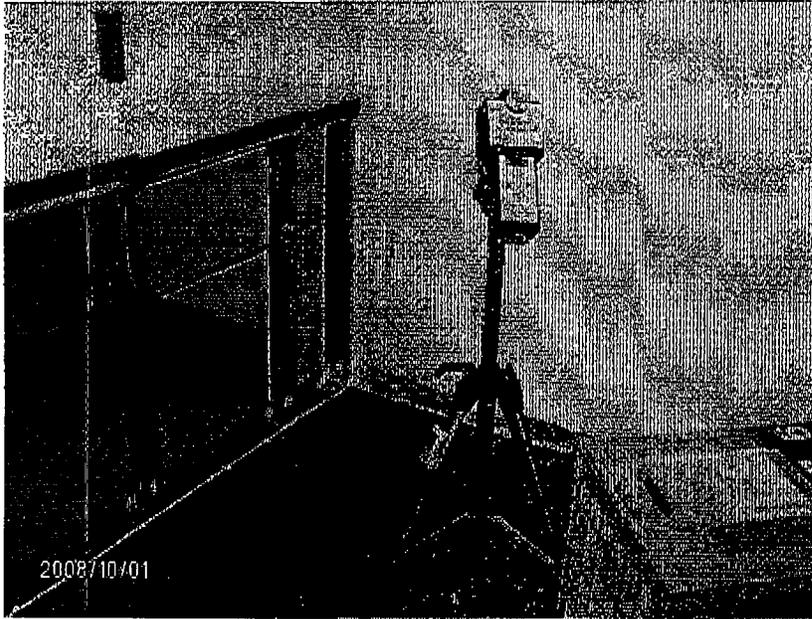
3) Image of air sampling equipment and wall removal within Break Room 707 area at time of assessment.

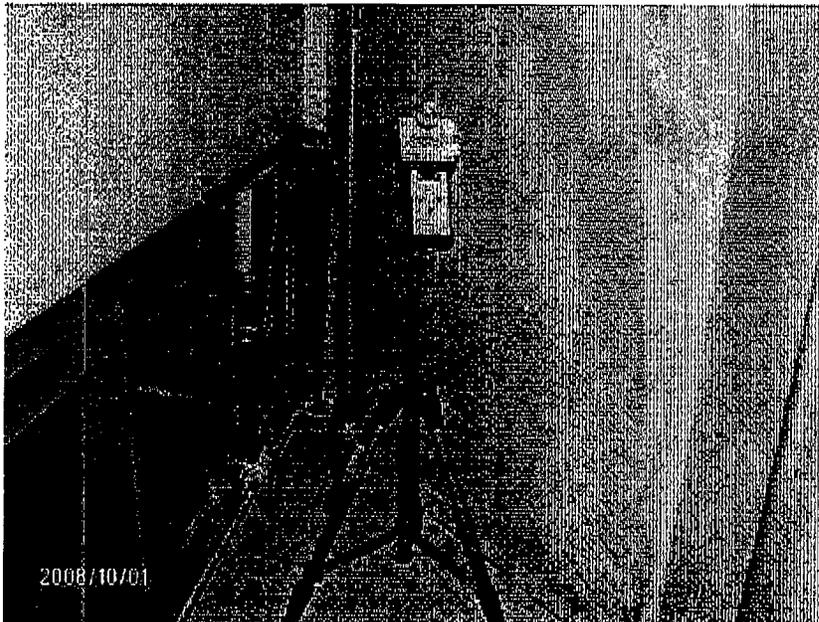
5. Primary affected areas of visible moisture damage previously identified within the noted adjacent supply room area primarily consisted of moisture staining and mold damaged materials within the shared wallboard materials adjacent to the break room sink. According to BioMax's review of current evidence and available historical data, it is likely that such material damage were similarly caused by a history of chronic plumbing deficiencies and water release events over an extended period of time as no interior sources were identified within the supply room at the time of this assessment.

6) Image of wallboard removal delineation within adjacent supply room area at time of assessment.

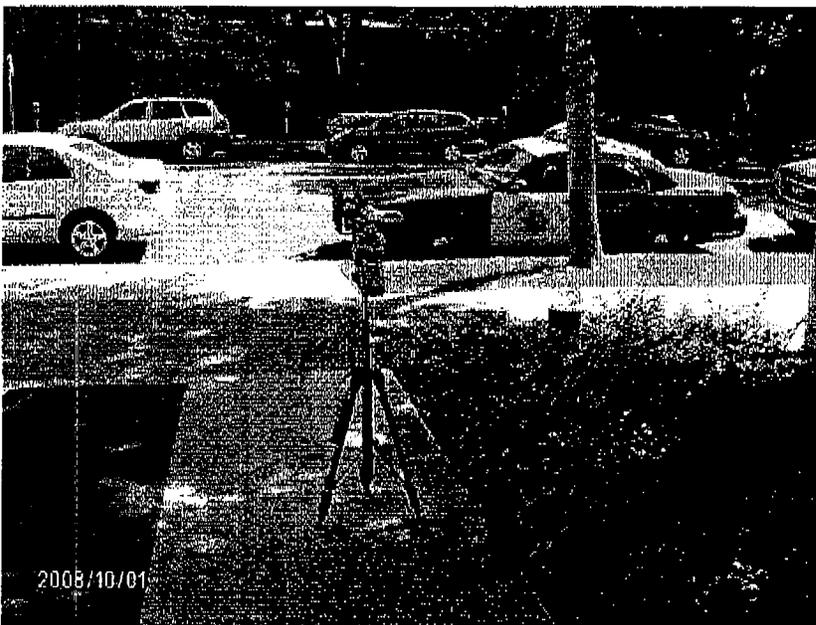
10) Image of ambient air sampling equipment location performed at conclusion of interior sampling activities.
