BioMax Environmental

February 8th, 2008

Mitigation Procedures for 10th Floor Mitigation – Break Room Area
Department of General Services Board of Equalization Building
450 N. Street
Sacramento, California

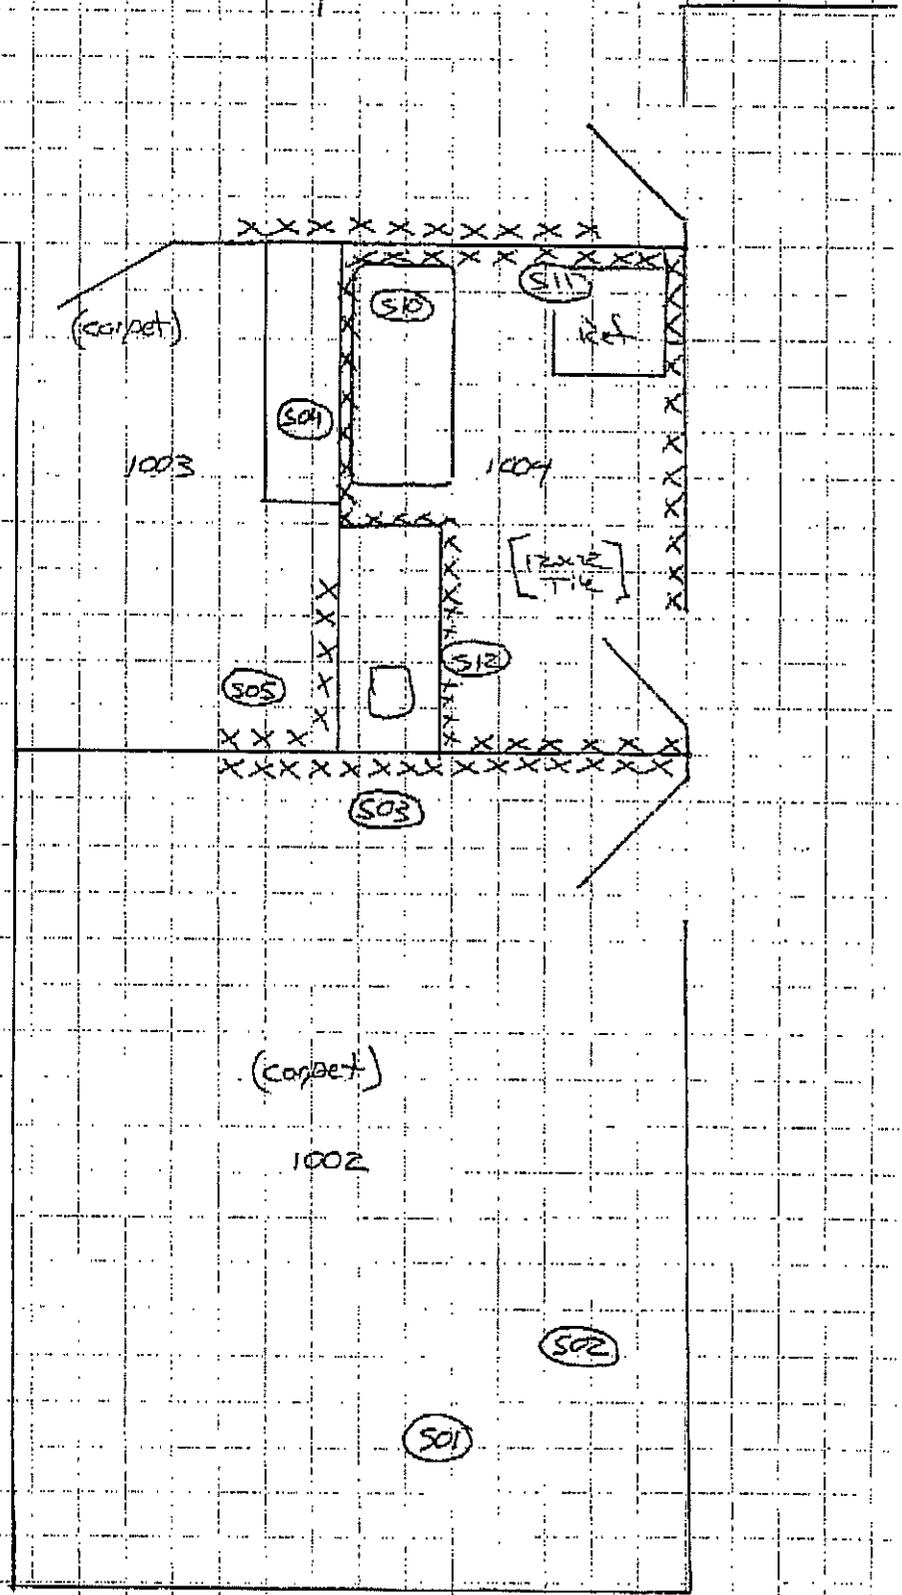
107th Floor
Break Rm Areas

X - Baseboard covered
+ taped.
