BioMax Environmental

May 26th, 2008

**Microbial Assessment and
Mitigation Procedures for 20th Floor Mitigation – Break Room Area
Department of General Services Board of Equalization Building
450 N. Street
Sacramento, California**

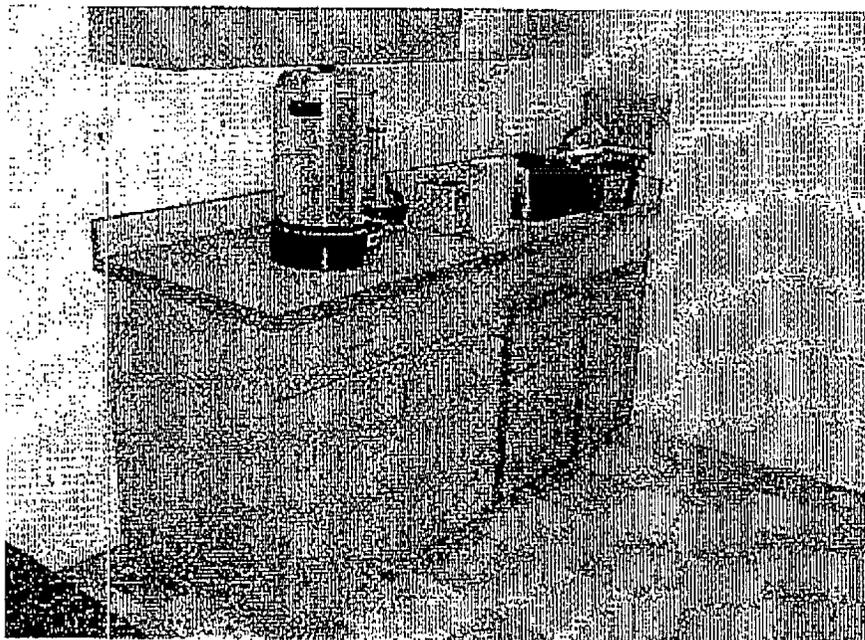
2) Image of Break Room cabinet at time of preliminary inspection. Blue tape present on impacted cabinet material as applied by BOE staff prior to BioMax's inspection.

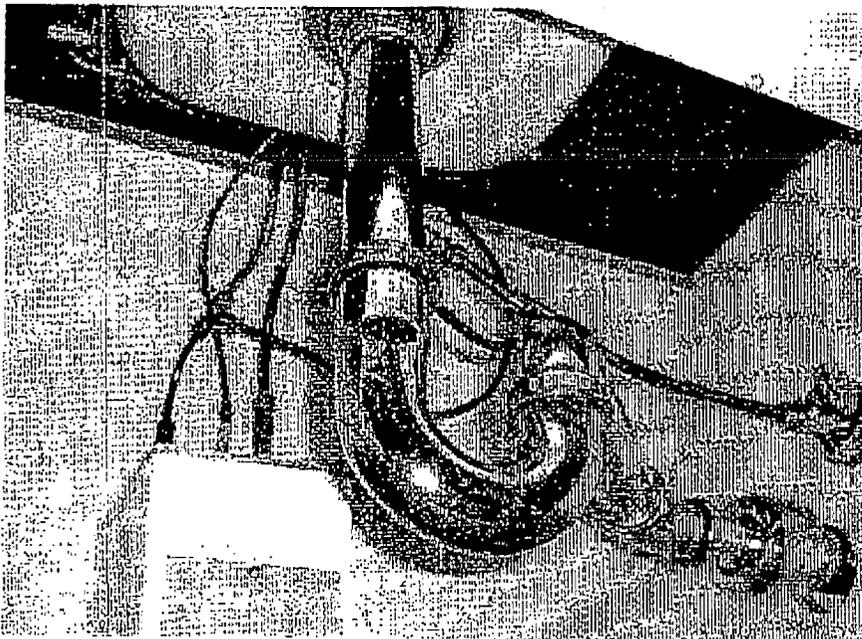
- 6) Image of sink insert base and plumbing within cabinet base. Evidence of historical leaking at base of "S" trap evident at time of assessment.

14. Following the performance of these mitigative measures, the designated site reconstruction contractor is strongly encouraged to verify that repairs to any faulty and/or deficient building penetration, drainage, plumbing and/or building envelop sealing systems have been

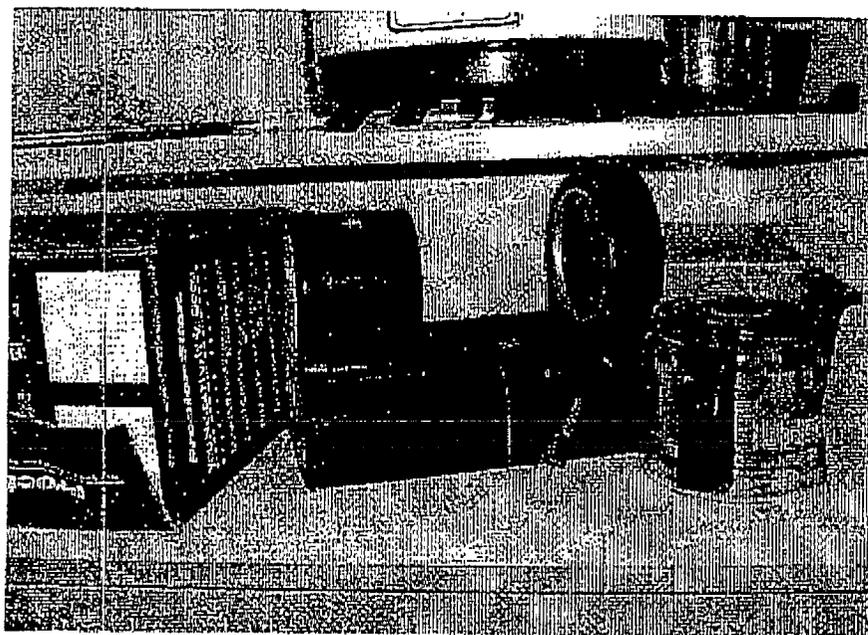
7) Close-up image of Personal appliances storage within adjacent cabinet compartment at time of assessment.

8. BioMax recommends that all interior items and/or furnishings located within the break room remain in place for cleaning by the mitigation contractor while in containment. All such materials and furnishings currently present within the Break Room area shall remain in place for appropriate disposal and/or decontamination at the option of the tenant and DGS. All hard surface furnishings within the break room deemed shall receive a thorough inspection, cleaning, mildicide wet-wiping, and HEPA vacuuming as part of these recommended procedures prior to subsequent clearance testing and reuse.

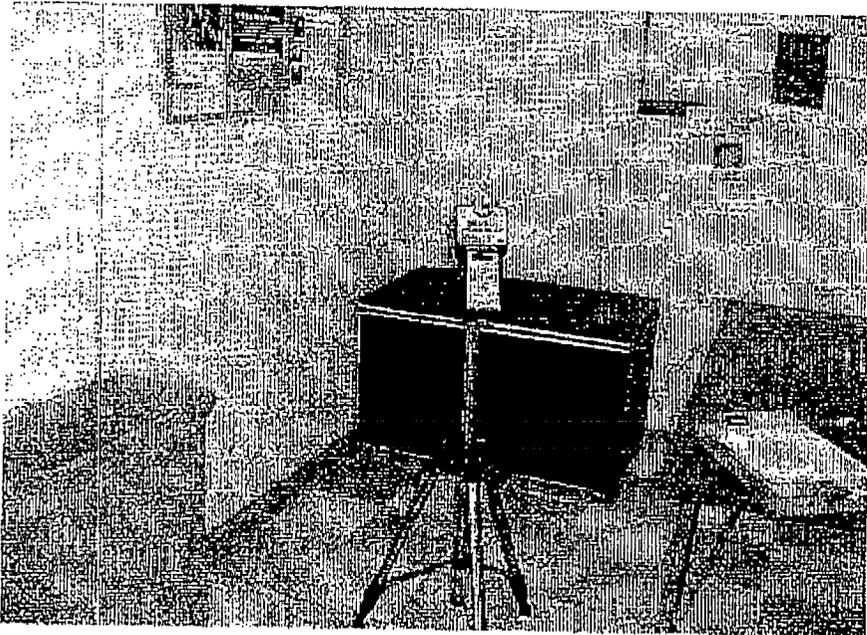
- 9) Image of air handling equipment utilized within break room and reference locations of existing furnishings where no evidence of moisture damages were noted at this time.

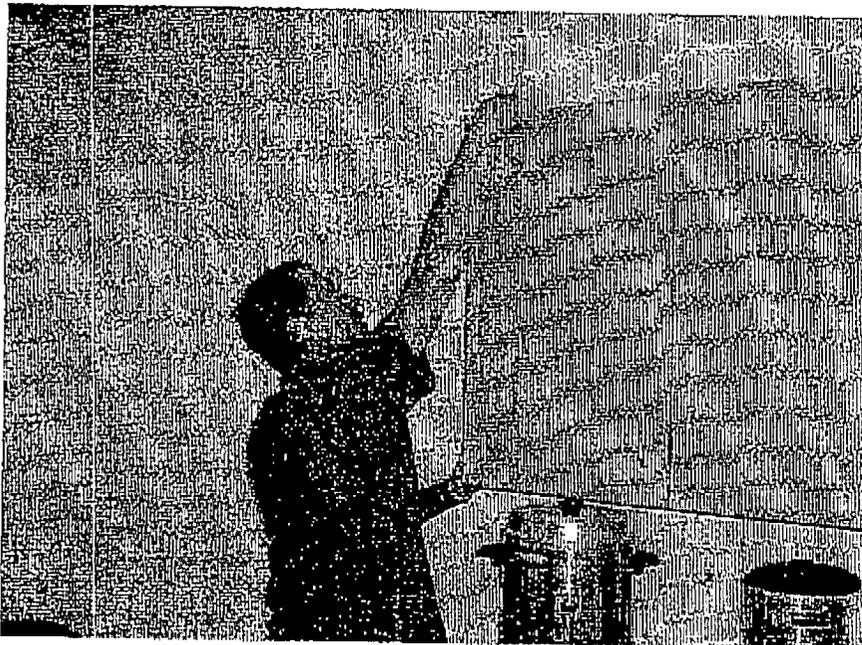
- 10) Image of Mr. Polkabla of BioMax collecting surface sample from representative material within break room not directly affected by moisture contact/release.

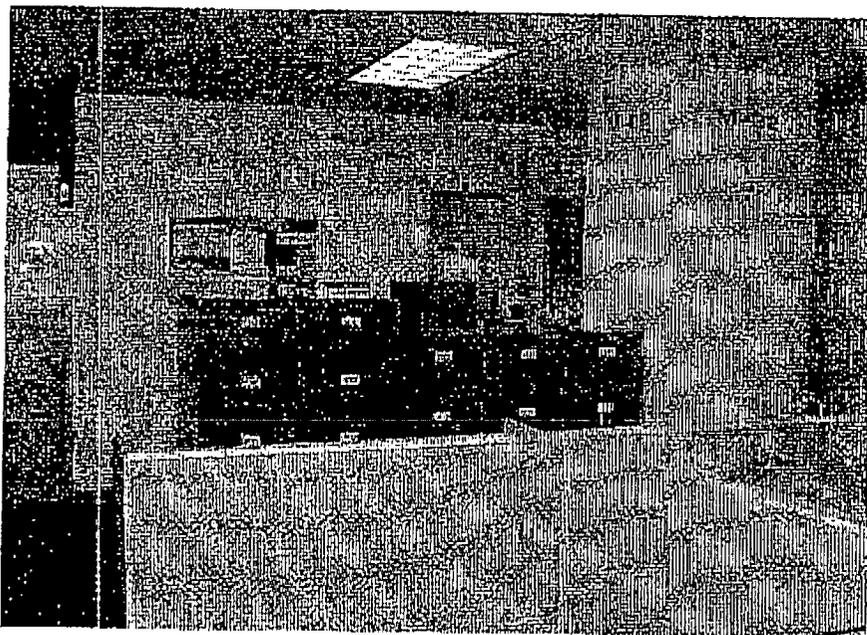
Cubicle #078 (Nikkole Thorn) - At the time of our assessment, BioMax inspected the cubicle adjacent to the noted break room occupied by Ms. Nikkole Thorn. No visual evidence of mold-like staining was observed present on the shared real wall of Ms. Thorn's cubicle area at the time inspected. Utilization of a hand-held moisture meter also indicated normal moisture content present within the cubicle divider material at the nearest location to the impacted area at the time of our assessment. An air sample was also collected from this area at this time as noted below.

11) Image of occupied cubicle area adjacent to break room. Cubicle divider top frame in foreground served as a representative area for surface sampling and comparative analysis.

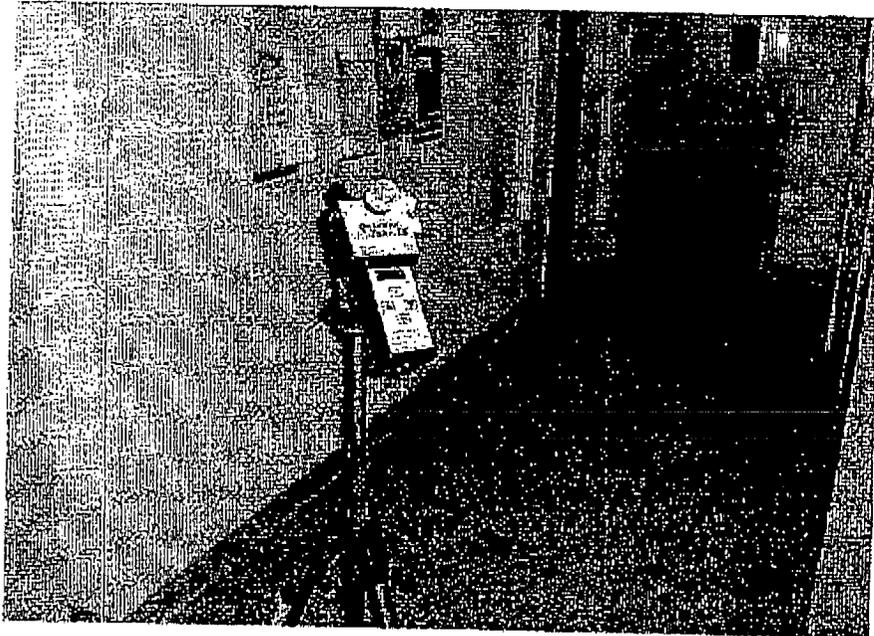
13) Image of air sampling activity performed within hallway of occupied cubicle area adjacent to break room.
