BioMax Environmental

June 26th, 2008

**Microbial Assessment and
Mitigation Procedures for 19th Floor Men's Restroom
Department of General Services Board of Equalization Building
450 N. Street
Sacramento, California**

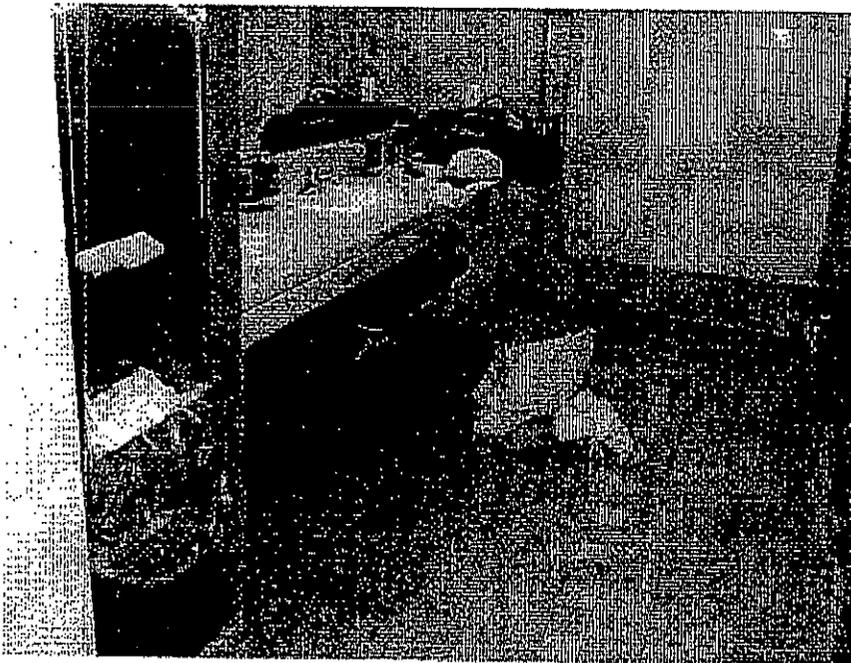
- 2) Image of JLS representative, Rick Boggs removing center panel to gain visual access to moisture impacted materials at time of preliminary assessment performed on May 1st, 2008.

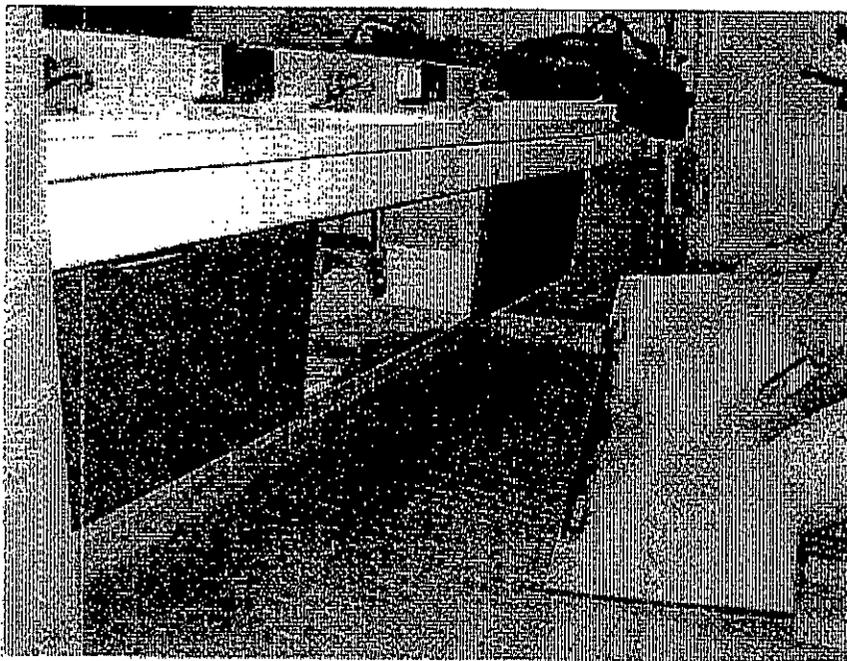
Men's Restroom – At the time of our assessment, the center sink cabinet located along the eastern side wall of the men's restroom room area indicated evidence of historical moisture damages as evidenced by cabinet staining, cracking, and delamination. Upon localized removal (for inspection) of cabinet access panel, visual indications of visible mold growth were observed present on the white venire cabinet base material particle board access panel. Based on such findings, BioMax collected a series of surface samples from the impacted materials. Following sampling, instructed the mitigation contractor (JLS) to seal the access panel to preclude unauthorized access into the areas where damaged materials were noted. For comparative purposes, supplemental surface samples were also collected from material surfaces within the adjacent cabinet areas and representative surfaces.

- 3) Image of panel and cabinet staining present with indications of historic moisture staining present on building materials.

9. BioMax specifically recommends that all damaged sink cabinet materials and impacted sheetrock and wallboard underlayment materials be inspected and removed as necessary. As

verified through visual inspection, any stained and/or moisture/mold affected interior sheetrock and building materials should be removed, wherever feasible, to the extent of visible staining, at a minimum. All visibly affected floor tile materials shall also be removed and disposed under containment controls for appropriate inspection of subflooring. Removal of moisture impacted and mold damaged materials may also employ the use of appropriate item-specific containment methods and systems (such as sealed plastic glove-bag containment systems, or equivalent) applicable to the materials being removed at the direction of the Project CIH. BioMax currently anticipates that all visually affected sub sink wall mounted cabinets and sheetrock underlayment present within the restroom shall be removed for physical inspection of wall cavities and underlayment materials, as necessary. Any underlayment materials exhibiting visible signs of moisture staining shall also be removed or decontaminated, as directed by the Project CIH, as deemed necessary.

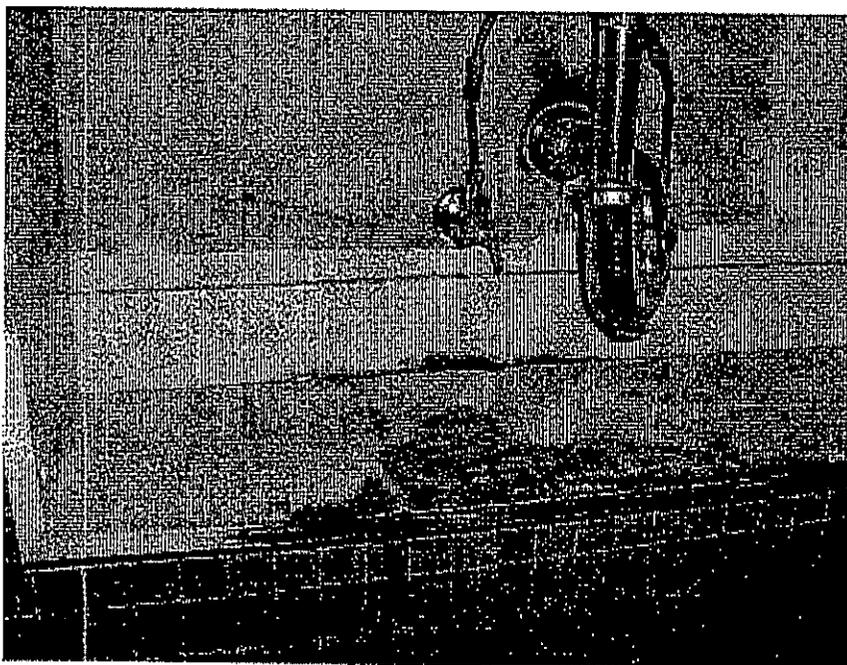
- 4) Close-up image of stained cabinet and sheetrock materials associated with historic moisture release from sink area systems.

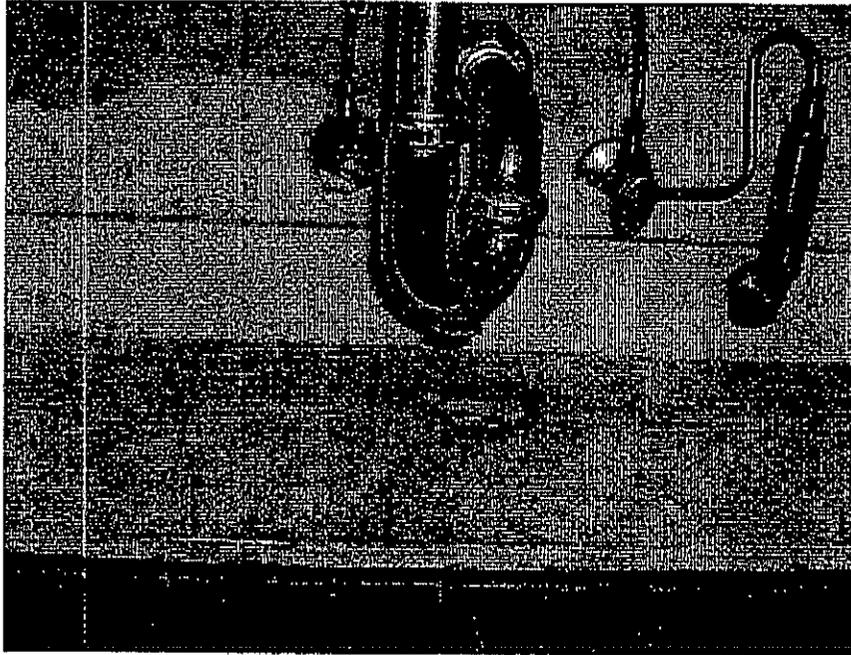
5) Image of sink cabinet cavity to right of basin area. Similar staining present within cabinet materials.

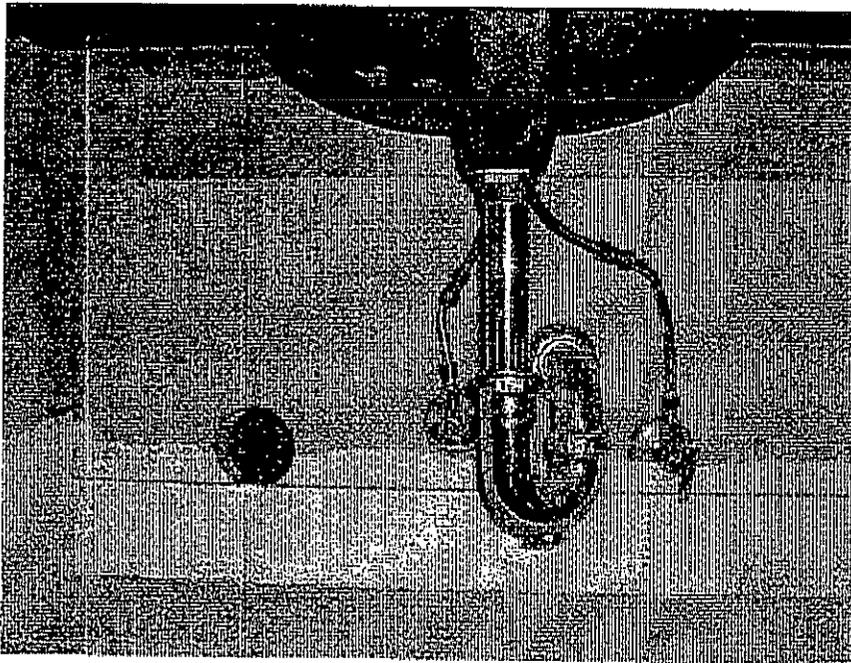
8) Image of left sink cabinet area with minimal staining present on exposed building materials.
