BioMax Environmental

June 27th, 2008

**Microbial Assessment and
Mitigation Procedures for 320 Break Room Area
Department of General Services Board of Equalization Building
450 N. Street
Sacramento, California**

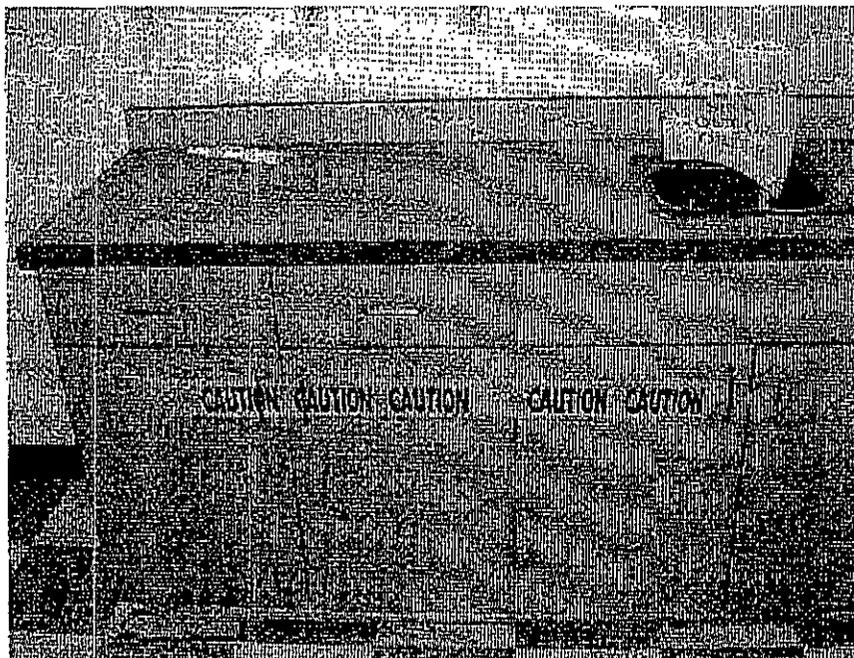
- 2) Image of sink cabinet at time of assessment. Noted signage and interim "Caution Tape" present as installed (according to DGS) by BPM site representatives.

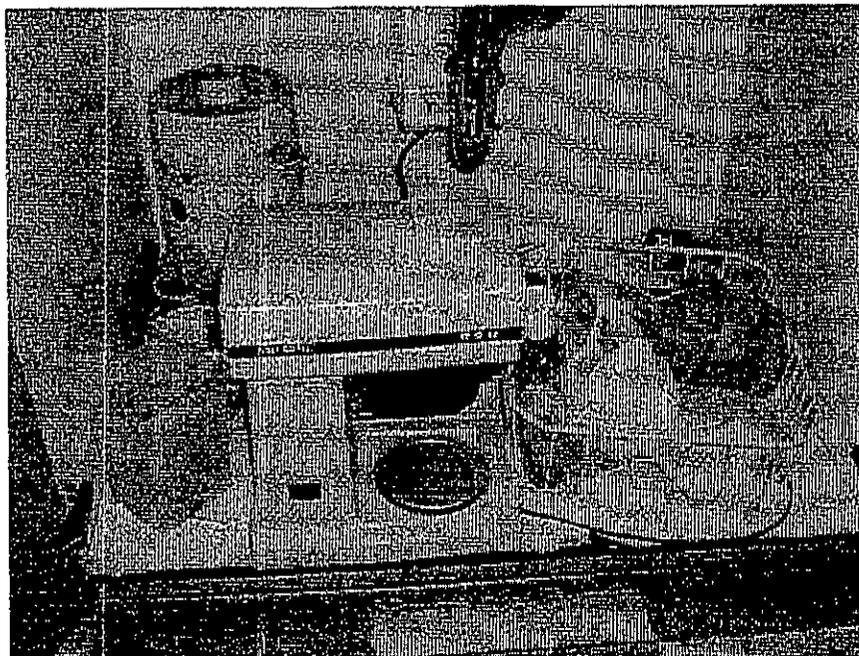
3) Image of BOE personal contents present within sink cabinet base area at time of assessment.

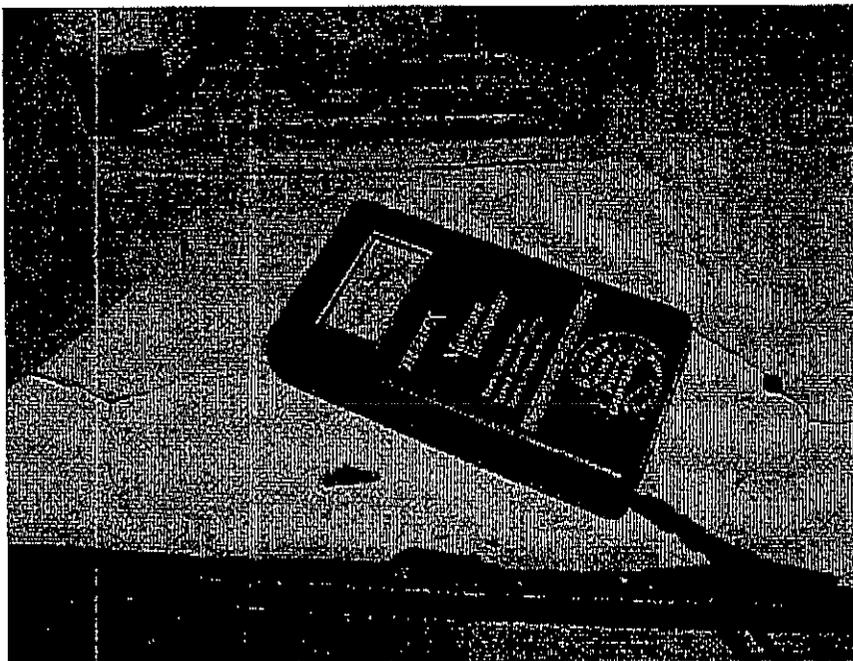
- 6) Image of moisture meter indicating elevated moisture content within cabinet base materials under sink area at the time of assessment.
