BioMax Environmental

August 26th, 2008

Post Mitigation Assessment Report
Department of General Services Board of Equalization Building
Break Rooms 2202, 2223, 2224, and 22 Men's and Women's Restrooms
450 N. Street
Sacramento, California

BOE 22nd Floor Break Room 2202, 2223, and 2224 Clearance
Sacramento, CA

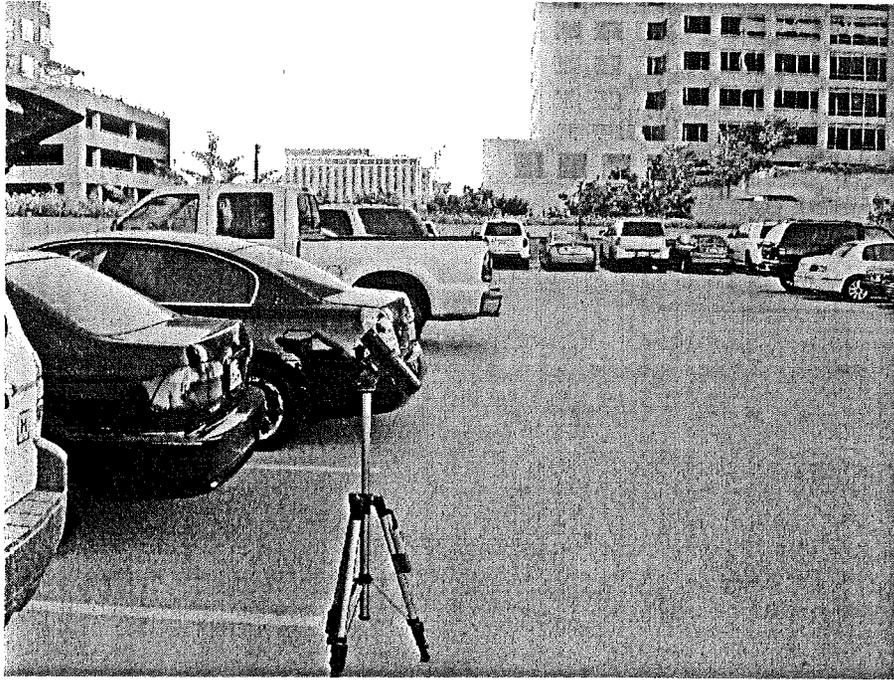
- 1) Image of ambient air sampling location at rooftop of garage structure adjacent to the BOE building (Subject Building) located at 450 N Street, Sacramento.

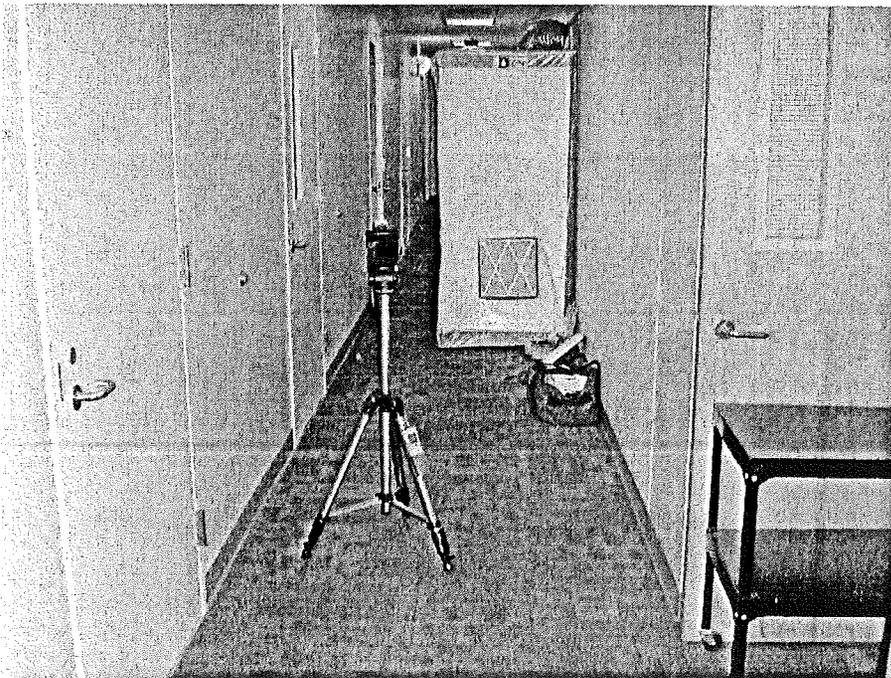
- 2) Image of air sampling equipment located within hallway of 22nd Floor near 2202 break room containment.

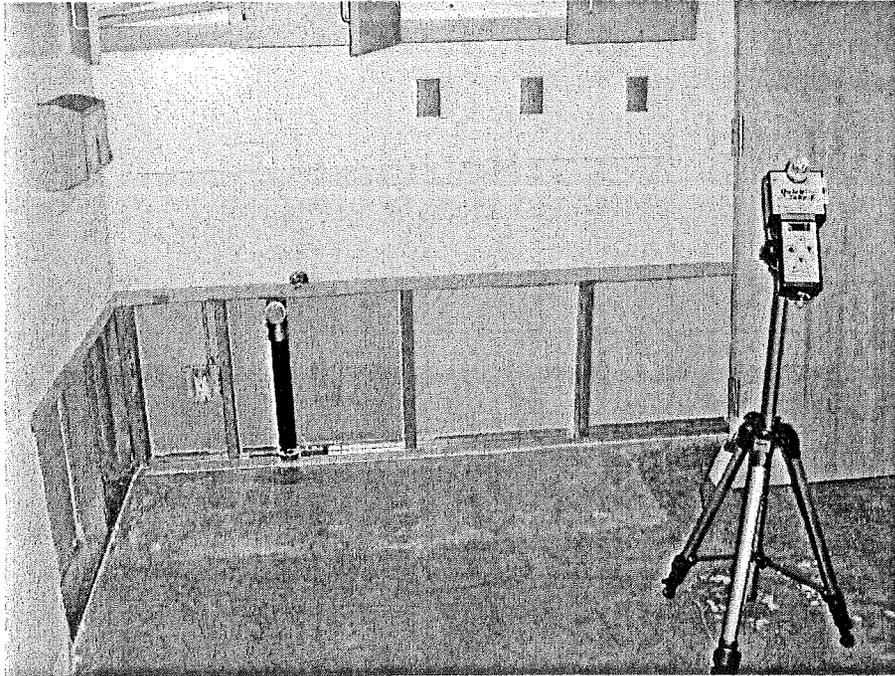
- 3) Image of wall removal delineation and air sampling activity performed within Break Room 2202 at time of assessment.

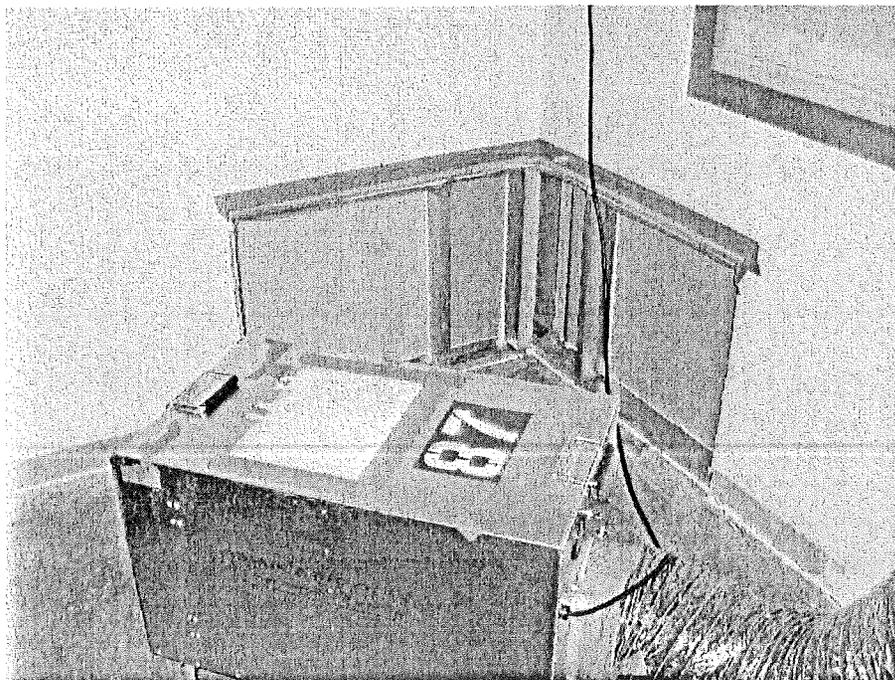
- 4) Image of adjacent wallboard removal delineation performed within Break Room 2202 as part of mitigative activity.

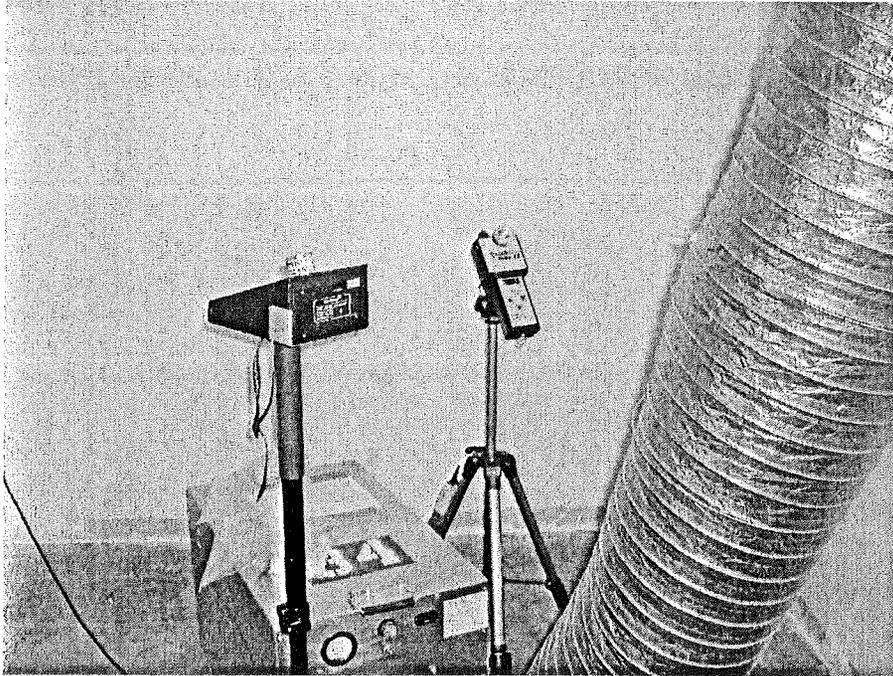
5) Image of BioMax and HTI air sampling equipment oriented within Break room 2223 at time of assessment.

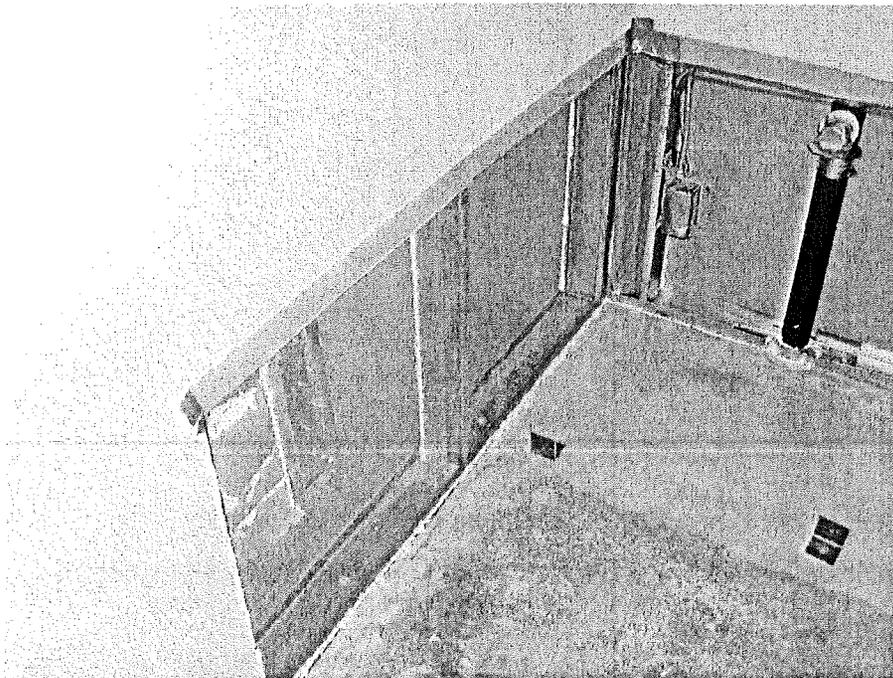
6) Image of wallboard removal delineation performed within 2223 at time of assessment.

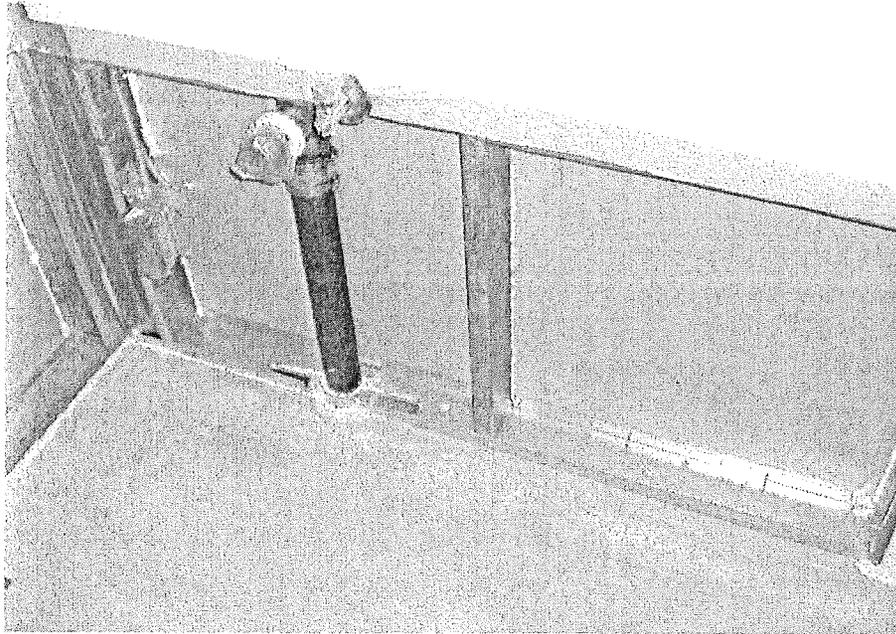
- 7) Additional perspective image indicating extent of wallboard removal performed within break room 2223 as part of the mitigative activity.

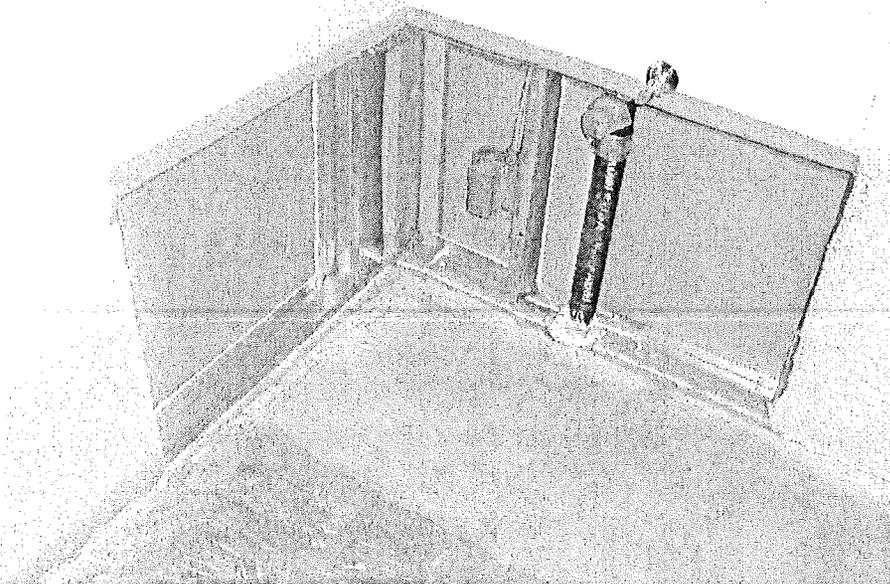
- 8) Image of wallboard removal delineation performed within Employee Lounge (Break Room 2224) as part of the mitigative efforts.

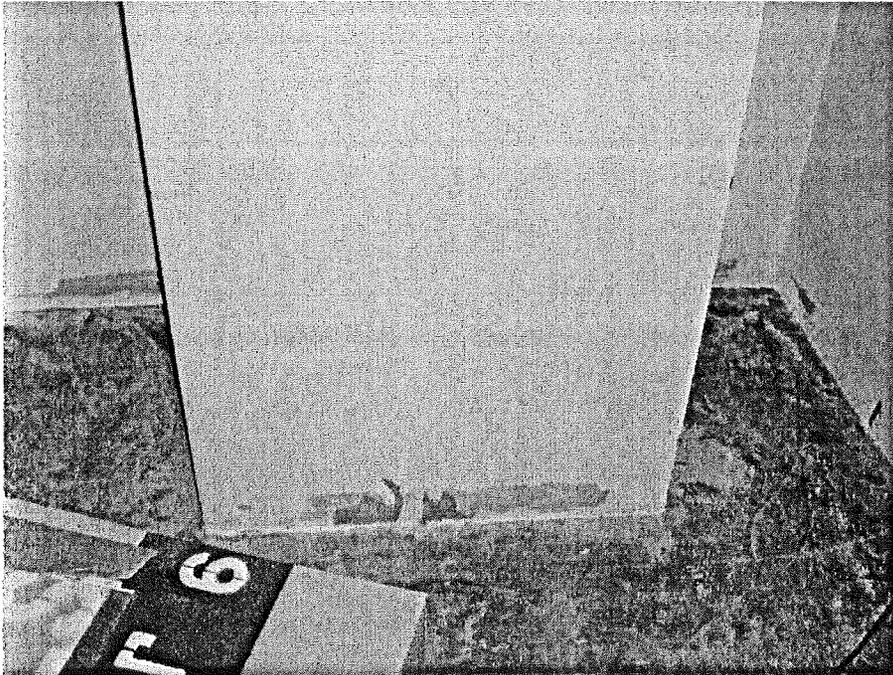
- 9) Image of baseboard removal performed within 2224 at structural support chase area. No visual indications of staining were observed at the time of assessment.

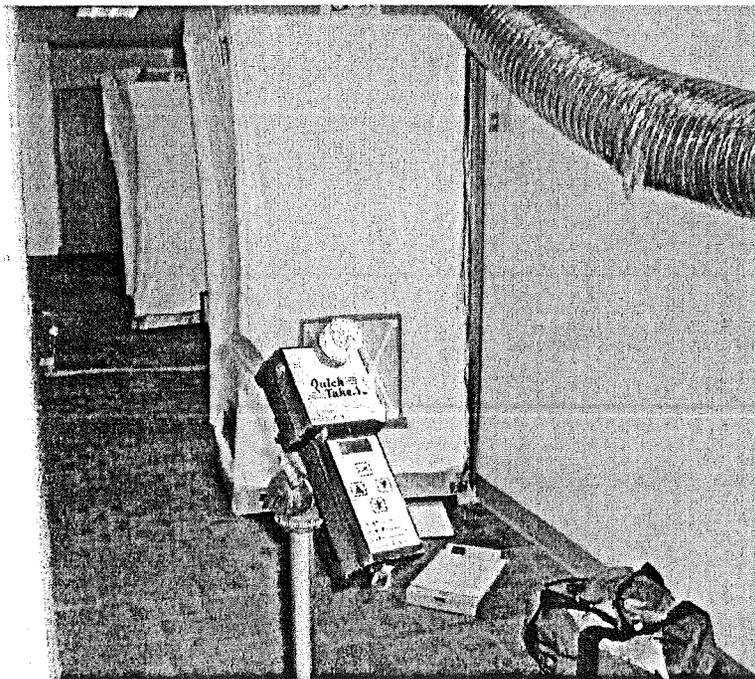
- 10) Image of air sampling activity performed in hallway adjacent to 2223 and 2224 containment areas.

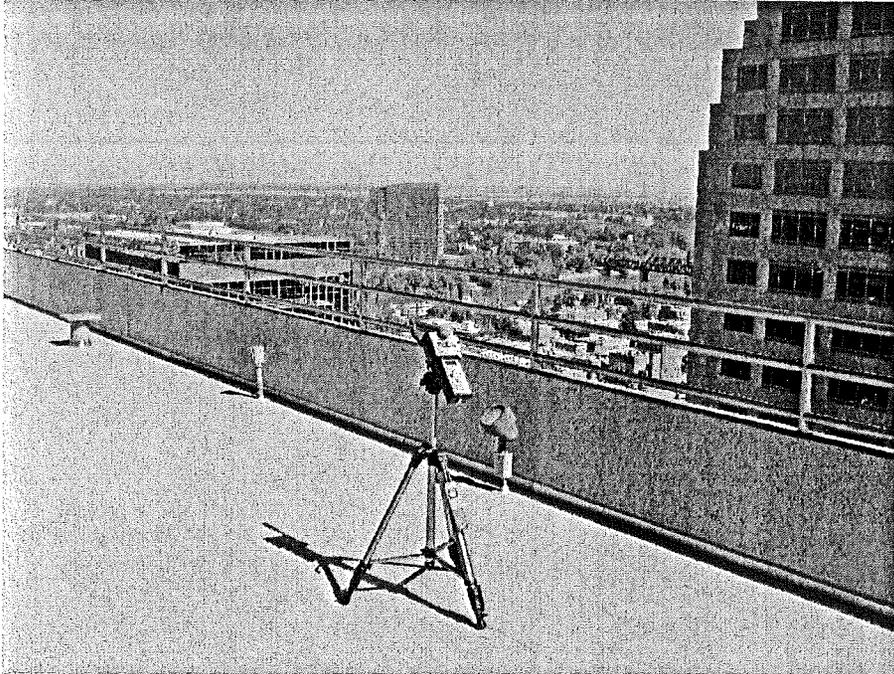
11) Image of ambient air sample location on 23rd floor northern balcony following the sample collection of interior samples.

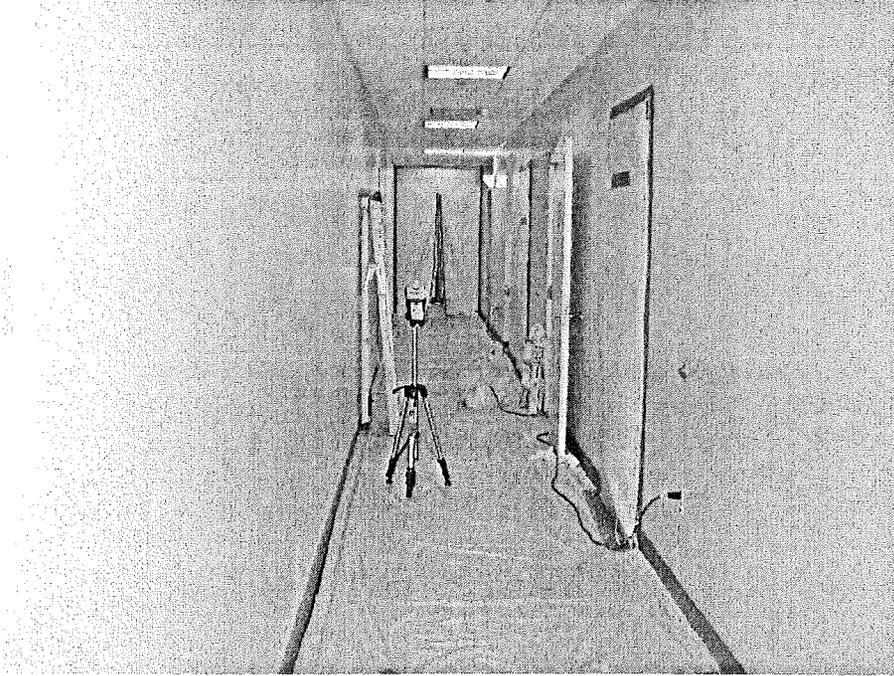
12) Image of air sampling performed within hallway near men's restroom area at time of assessment.

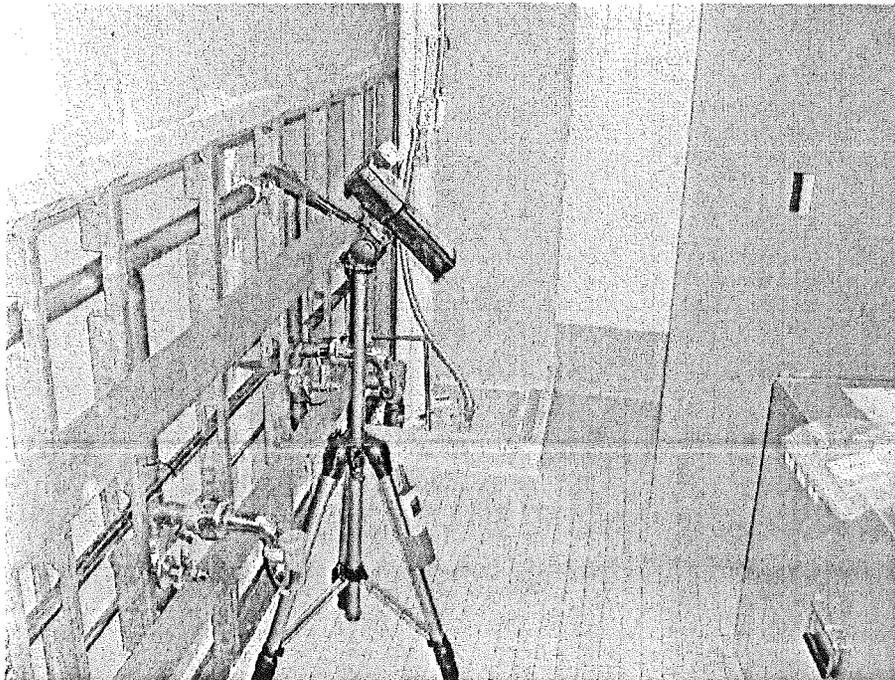
13) Image of wallboard removal and exposed plumbing within men's restroom area following mitigative activity.

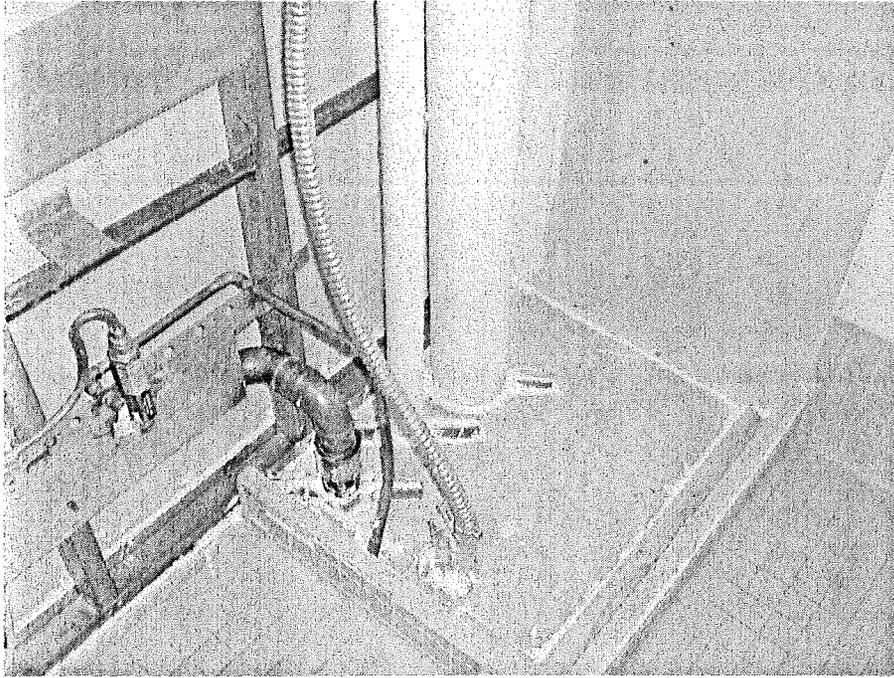
14) Close up image of paper towel chase and interior plumbing systems located to the right of sink area within men's restroom following mitigative activity.

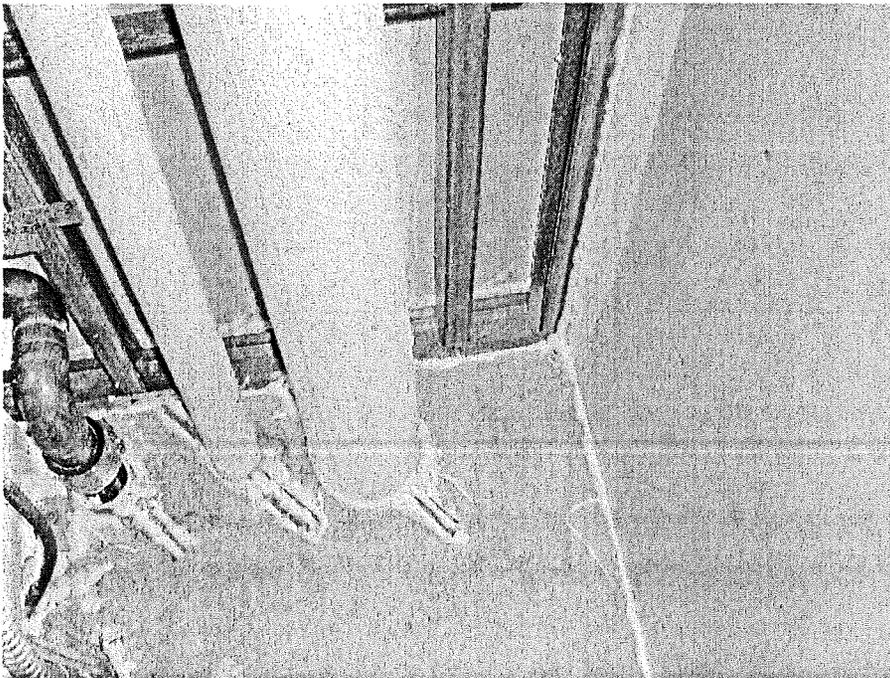
15) Close-up image of wall surface behind right-side paper towel cavity. Noted absence of elevated staining present on wall surface leading to elevator shaft.

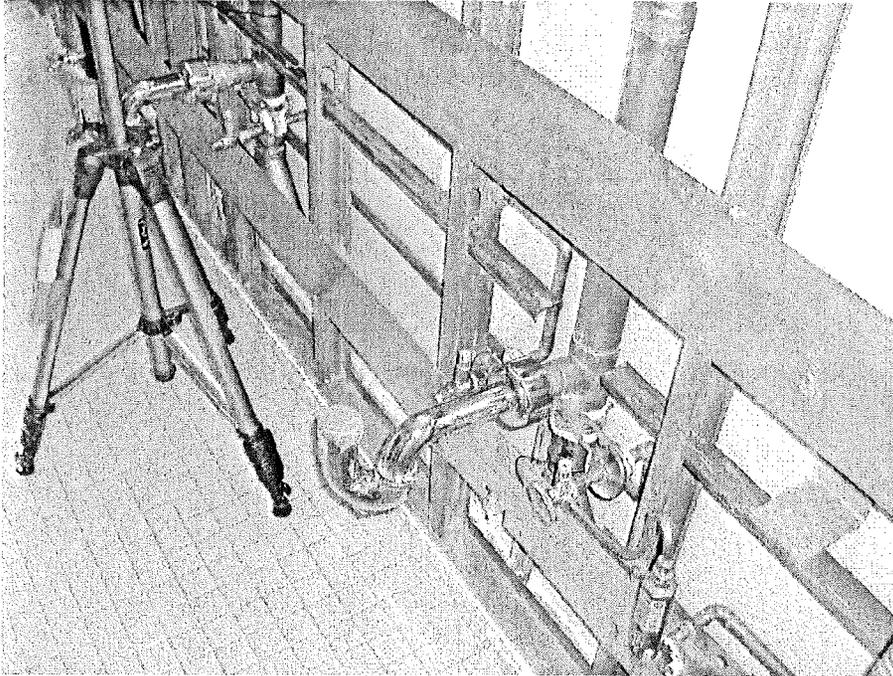
16) Close up image of exposed plumbing and metal framing located at sink area within men's restroom following mitigative removal.

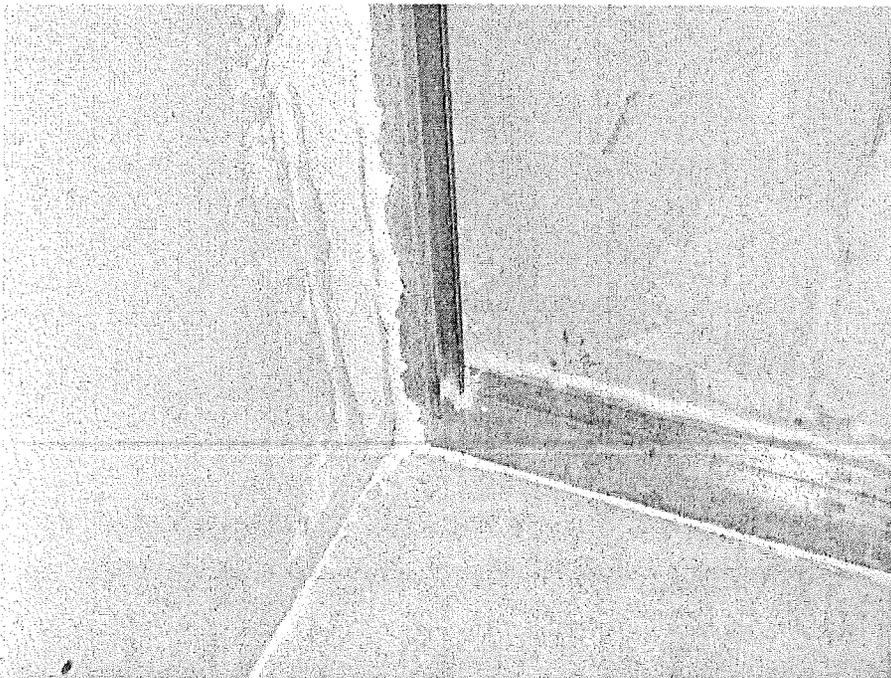
17) Close-up image of wallboard material to left side of prior sink cabinet location. Absence of elevated staining present on wallboard adjacent to elevator shaft system.

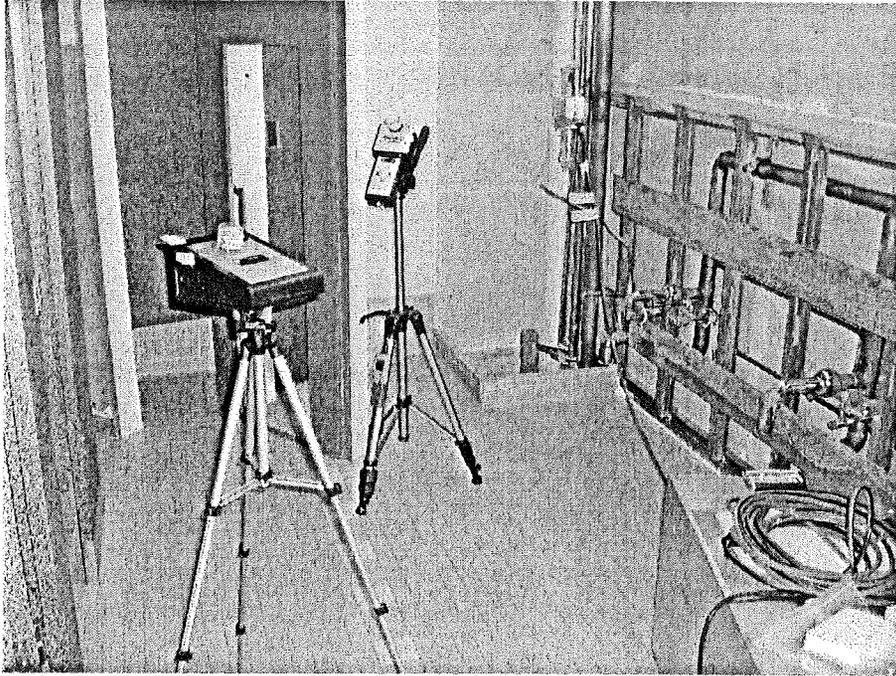
18) Image of BioMax and HTI air sampling activities performed within women's restroom containment area at time of assessment.

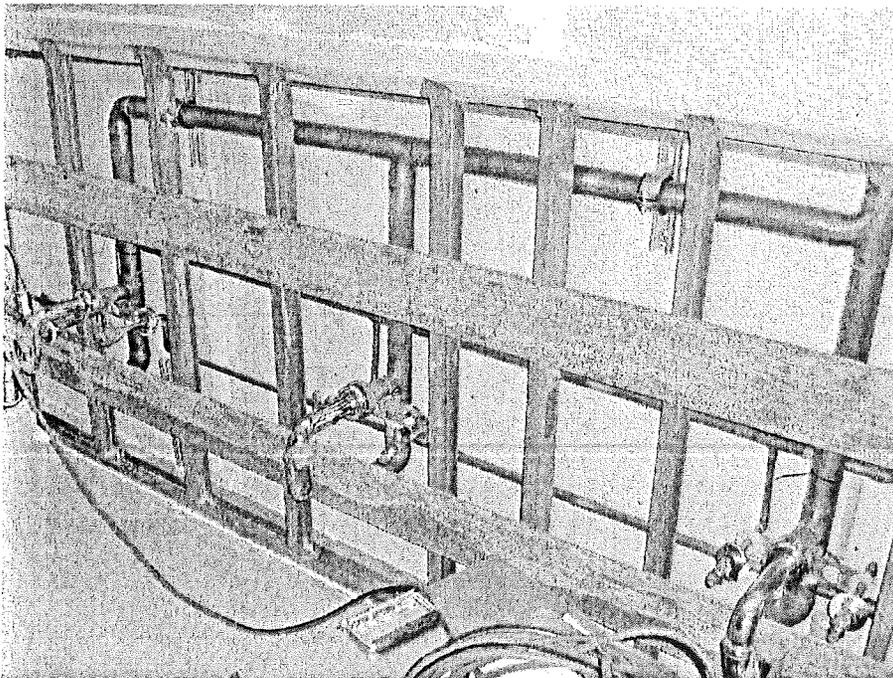
19) Image of plumbing structures and underlayment materials within women's restroom containment area at time of assessment.

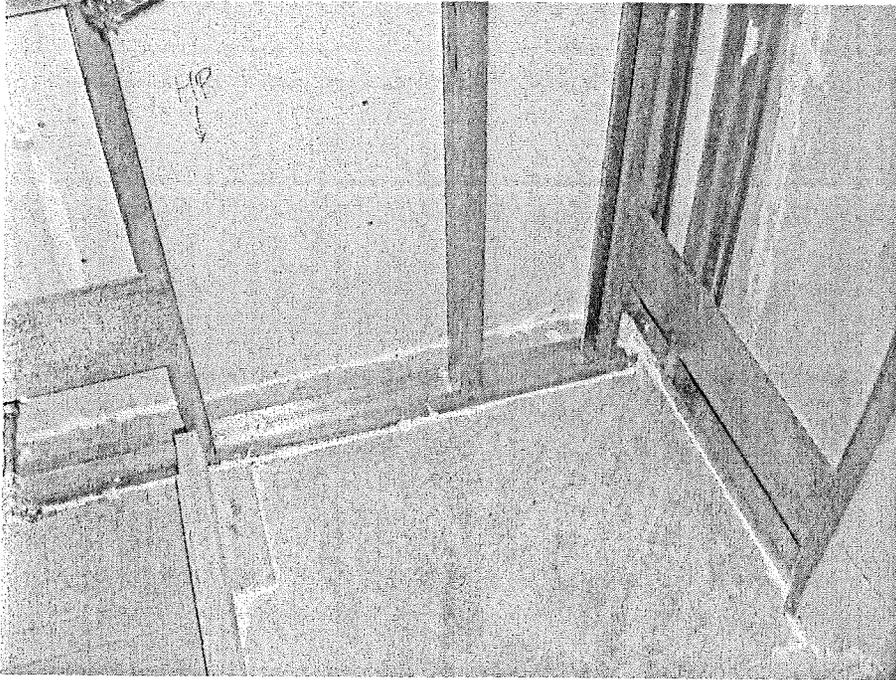
20) Close up image of exposed wallboard material to right of prior sink cabinet location of women's restroom. Absence of elevated staining noted on wall surface.

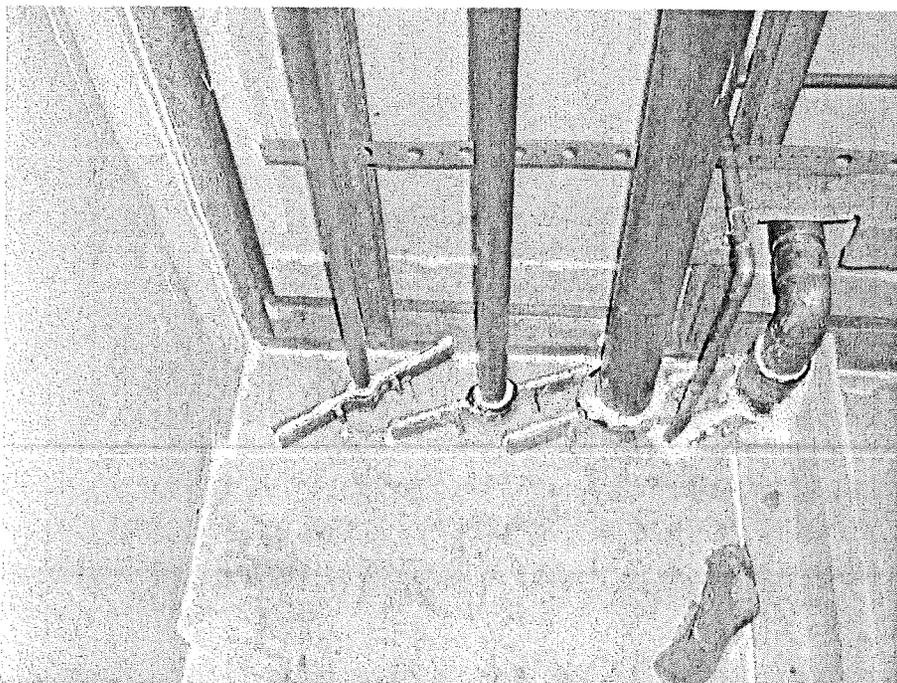
21) Image of "paper towel" cavity to left of prior sink within women's restroom area. Absence of elevated staining noted on underlayment wall surface adjacent to elevator shaft.
