BioMax Environmental

January 15th, 2010

Post Mitigation Assessment Report
Department of General Services
Break Rooms 1814, 203 and Adjacent Conference Room 204
Board of Equalization Building, 450 N. Street
Sacramento, California

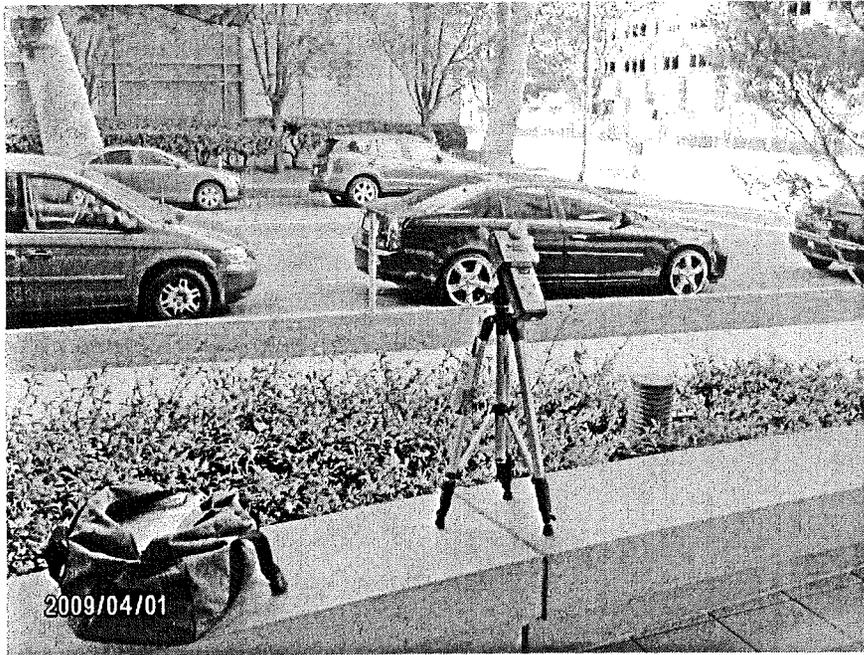
- 1) Image of ambient air sampling performed near main entry prior to interior sampling within BOE Building located at 450 N Street, Sacramento, California.

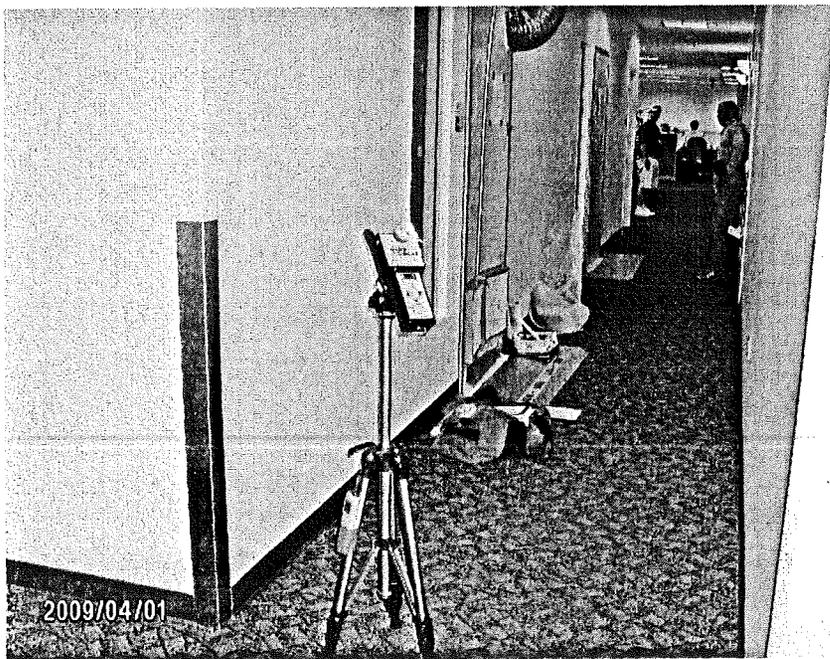
- 2) Image of tenant occupied hallway near Break Room 203 containment entrance area at time of clearance assessment.

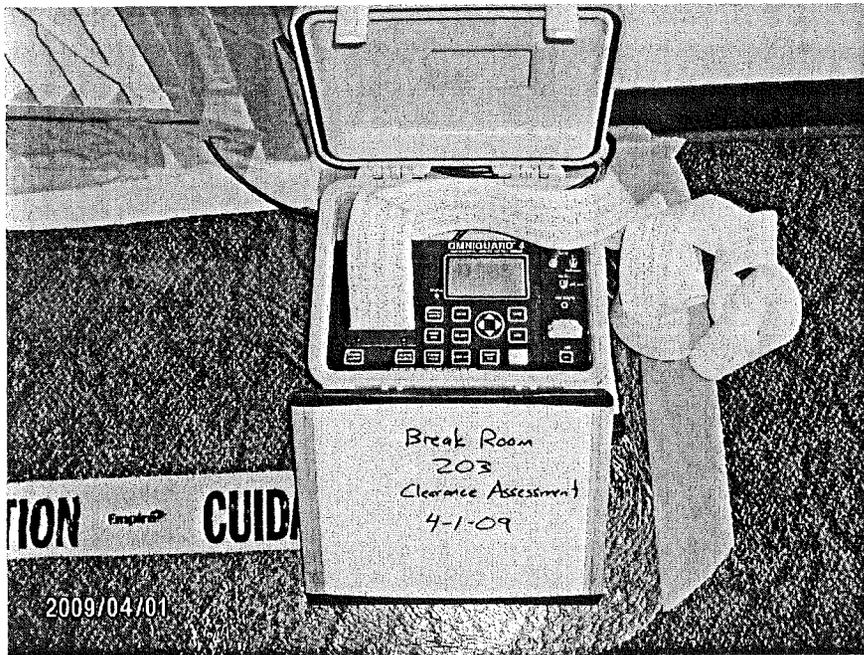
- 3) Image of pressure monitoring equipment located within hallway of Break Room 203 at time of assessment. Acceptable air pressure differential (negative pressure) recorded at negative 0.035.

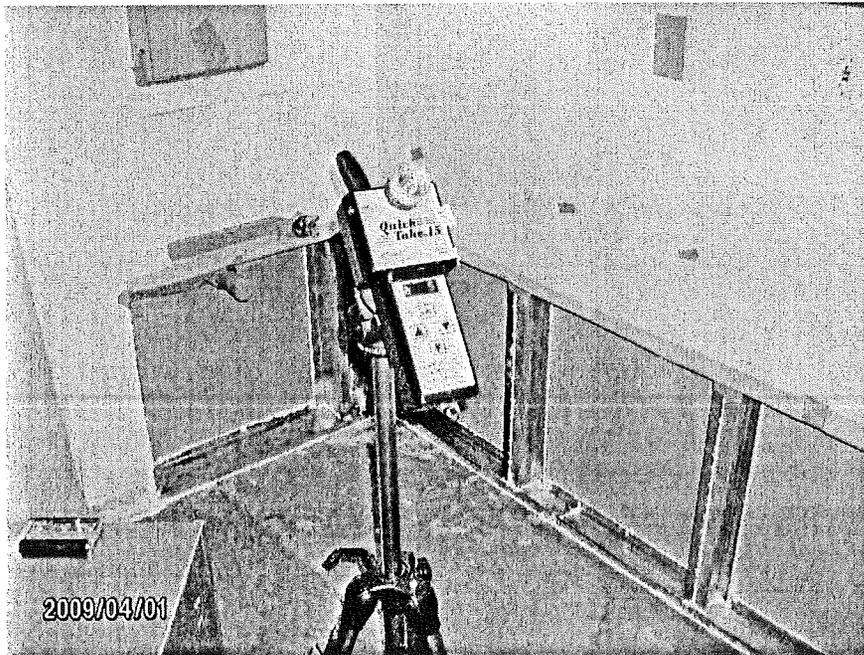
- 4) Image of air sampling equipment and wallboard removal delineation within Break Room 203 area at time of assessment.

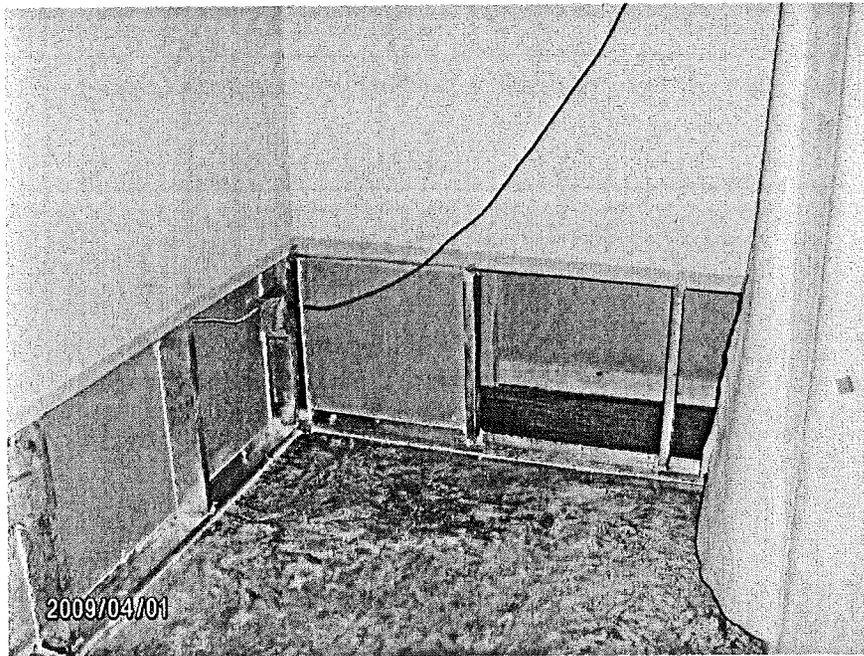
- 5) Close-up image of exposed wall framing systems and wallboard interior cavities within Break Room 203 at time of clearance assessment.

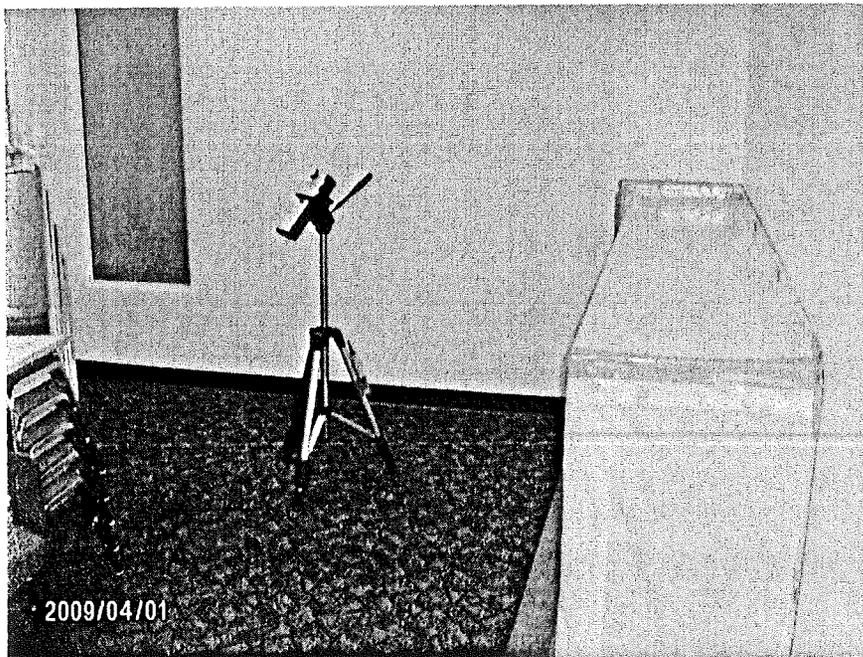
- 6) Image of mini containment "Pop Out" constructed within conference room 204 as needed to remove affected wallboard materials adjacent to Break Room 203.

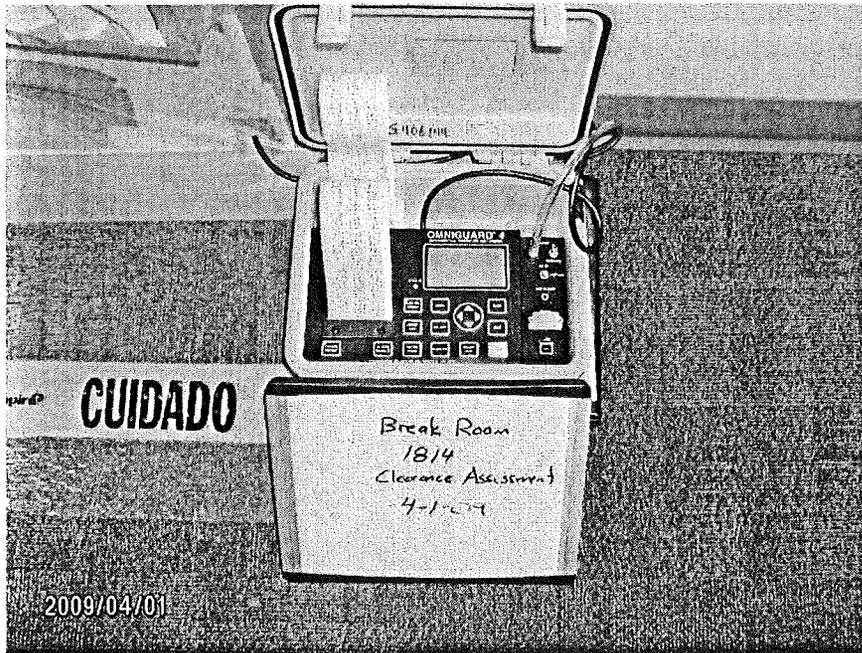
- 7) Close up image of pressure data logging manometer located at exterior of break Room 1814 indicating negative 0.038 at time of assessment.

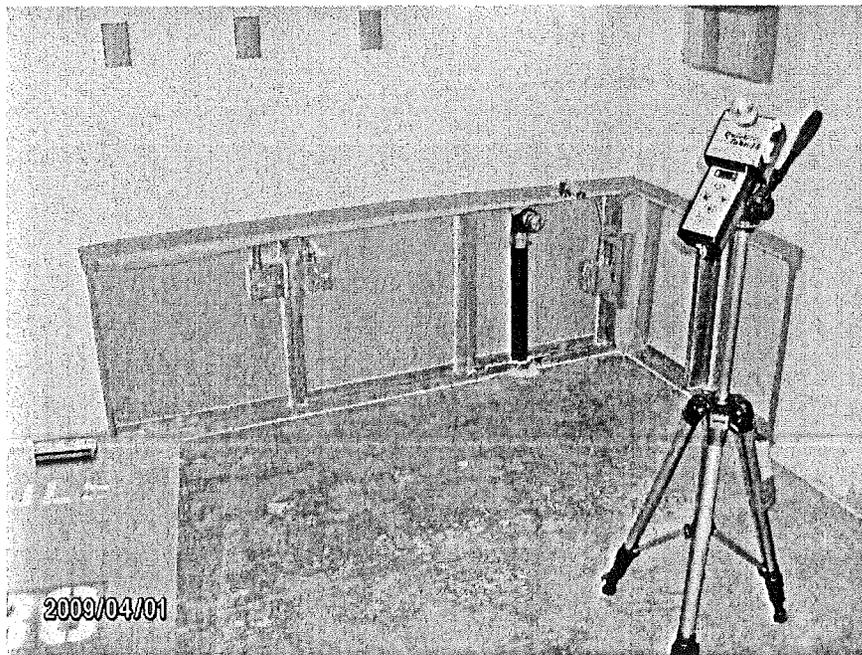
- 8) Image of air sampling activity and wall removal delineation performed within Break Room 1814 as part of the overall mitigative action.

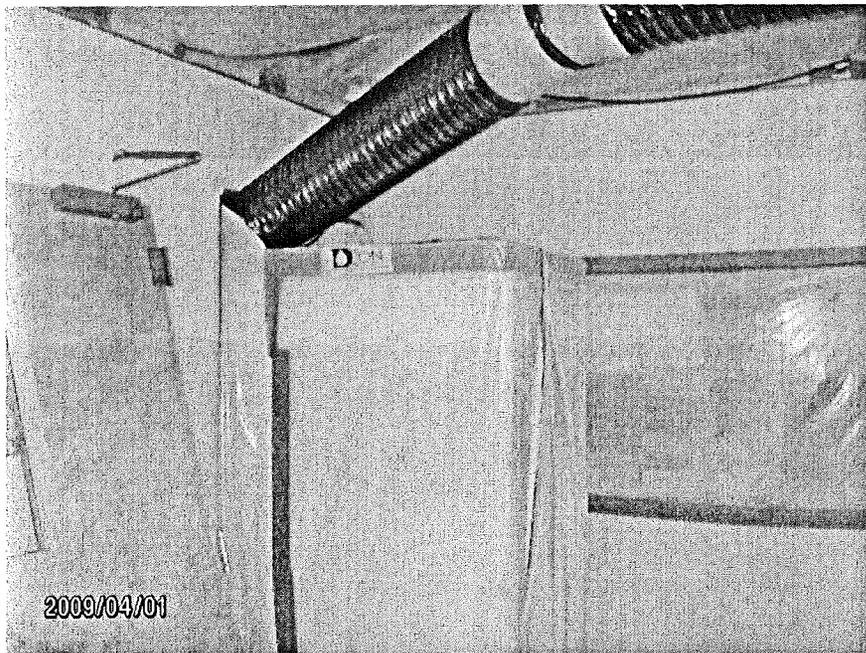
- 9) Image of containment entry chamber and flex exhaust hosing associated with the barrier controls present within Break Room 1814 at the time of assessment.

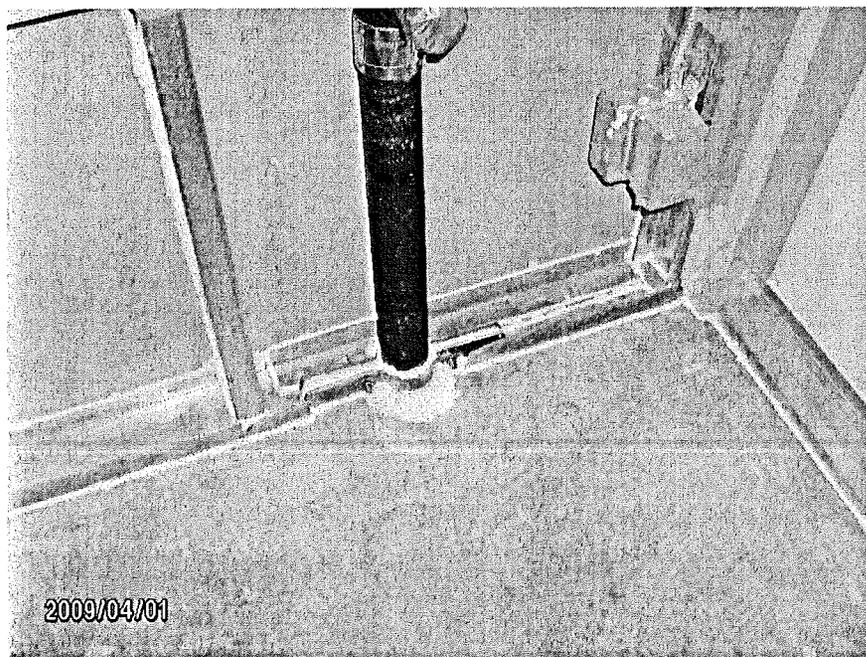
- 10) Close up image of air sampling and wall removal delineation within Break Room 1814 containment at time of assessment.
