BioMax Environmental

August 5th, 2008

Post Mitigation Assessment Report
Department of General Services Board of Equalization Building
450 N. Street – Break Rooms 1905/1908, 1009, and 320/319
Sacramento, California

BOE Building 1905, 1009, and 320 Break Room Clearances
Sacramento, CA

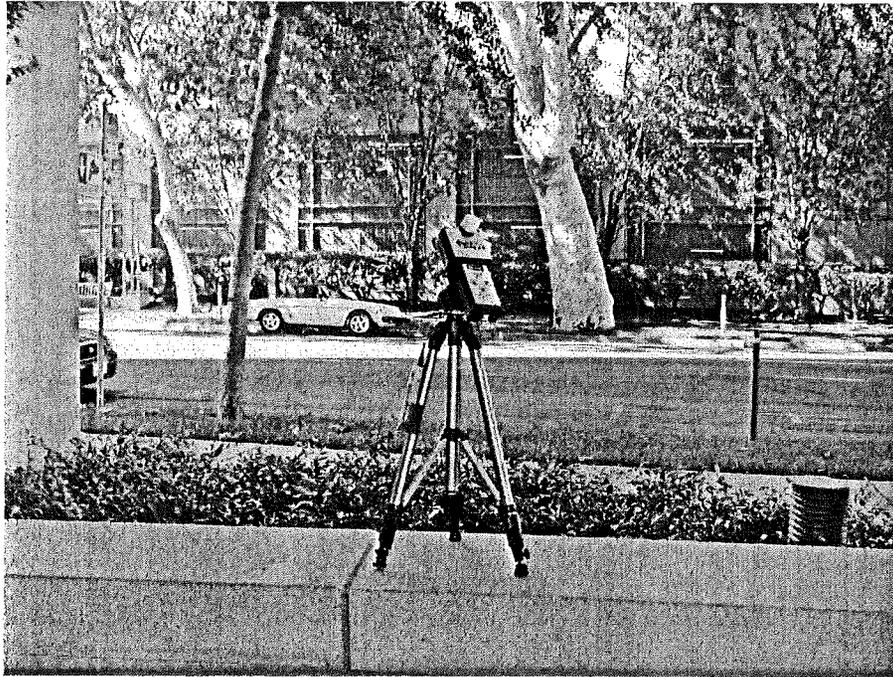
- 1) Image of ambient air sampling location at front entry of BOE Building (Subject Building) located at 450 N Street, Sacramento, California at time of assessment.

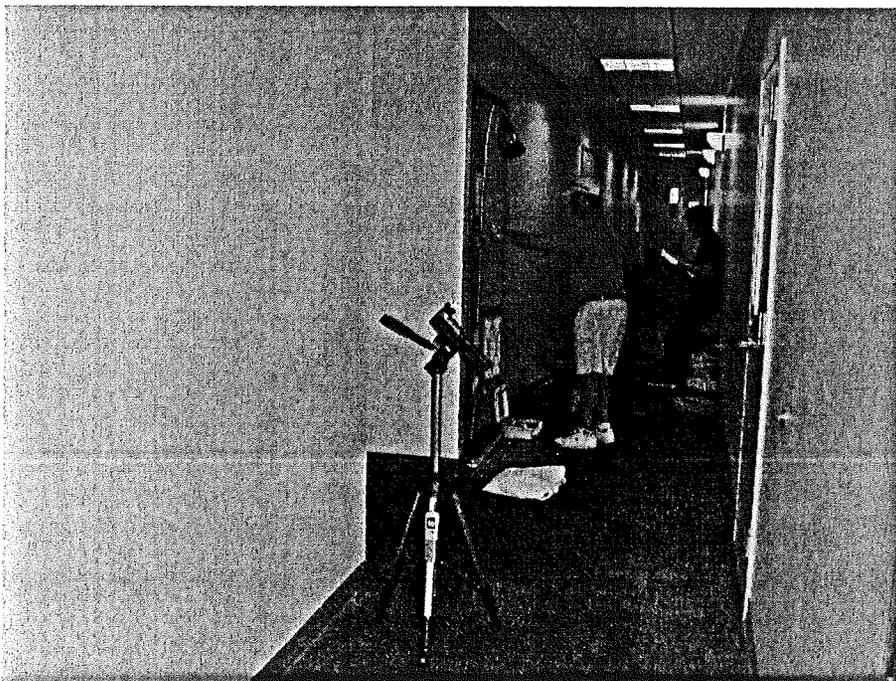
- 2) Image of air sampling activity (outside containment) within hallway leading to 1905 containment entry area at time of assessment.

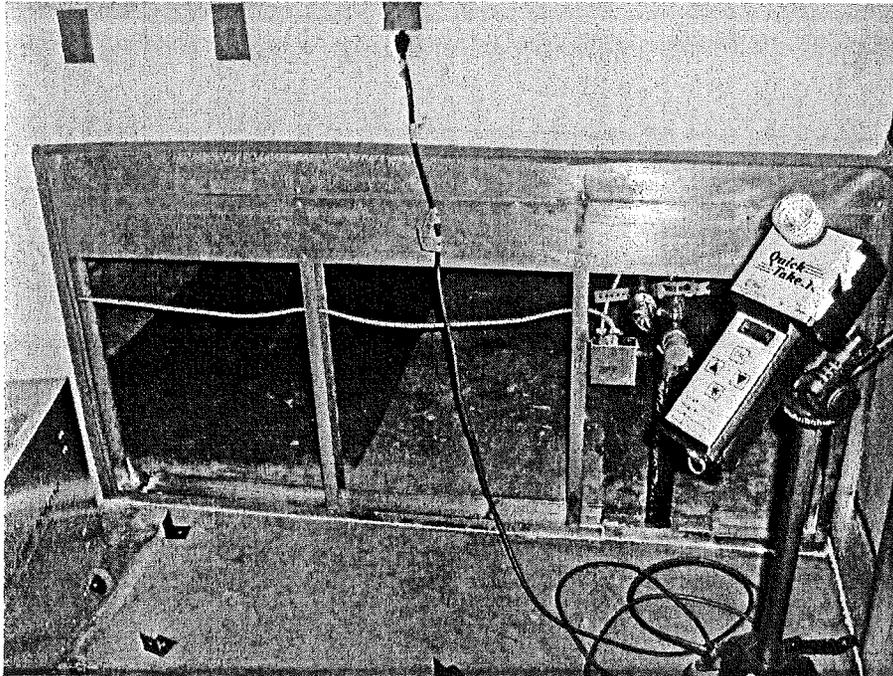
6. Based specific procedural recommendations, all identified affected interior wallboard building materials had been removed from each of the noted interior areas of concern exposing interior wall cavity framing (metal) and underlayment wallboard siding materials present within each of the impacted materials and areas. Upon post mitigation inspection, all remaining exposed building materials associated within the break room areas exhibited no significant staining and/or elevated mold growth following the completion of prescribed physical material removal and chemical decontamination procedures performed by JLS within each impacted area.

3) Image of air sampling equipment and extent of interior wall removal within 1905 Break room area and adjacent 1908 meeting room area at time of assessment.

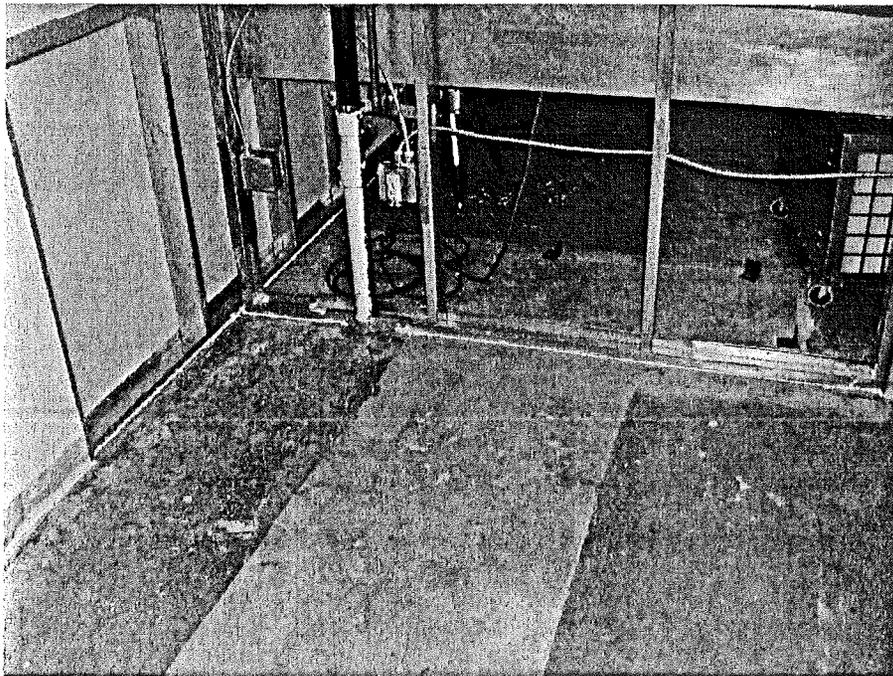
4) Additional image of physical wall removal undertaken within 1905 and 1908 containment areas at time of assessment.

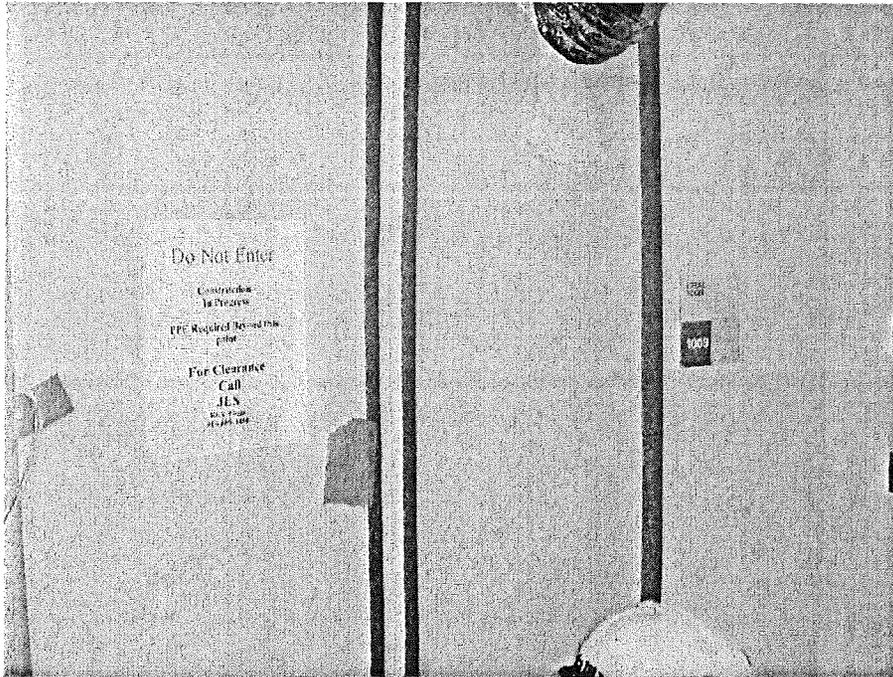
5) Image of containment system barriers leading toward 1009 Break room at time of assessment.

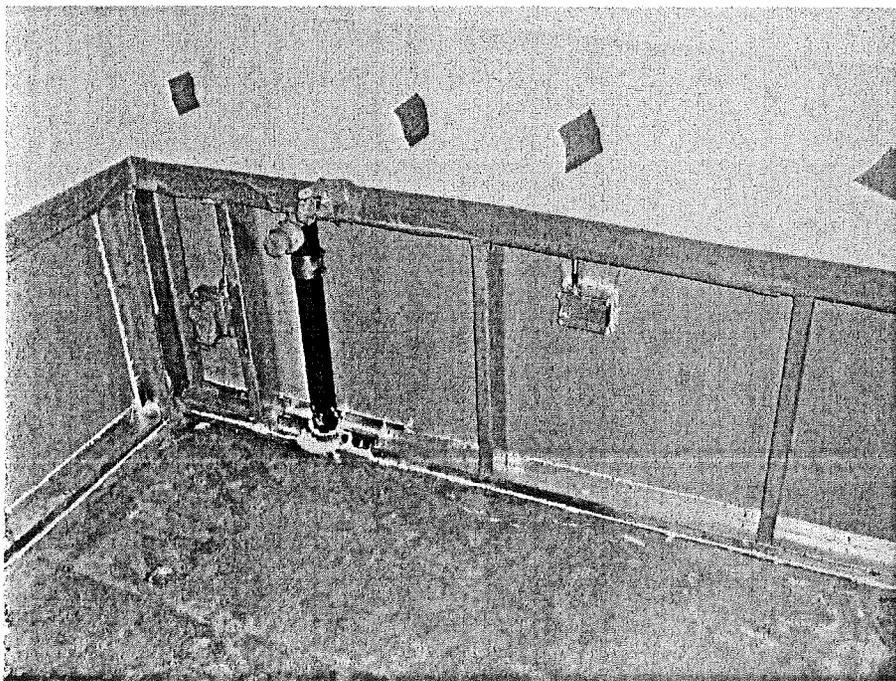
6) Image of physical wall removal undertaken within Break Room 1009 as part of the mitigative assessment evaluated as part of this assessment.

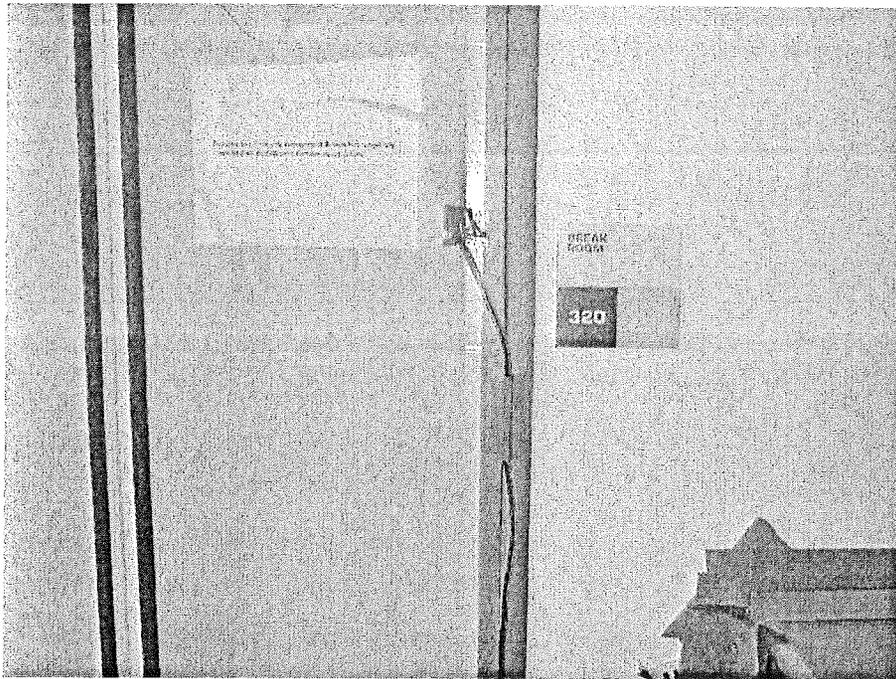
7) Image of postings on exterior of Break Room 320 containment system at time of assessment.

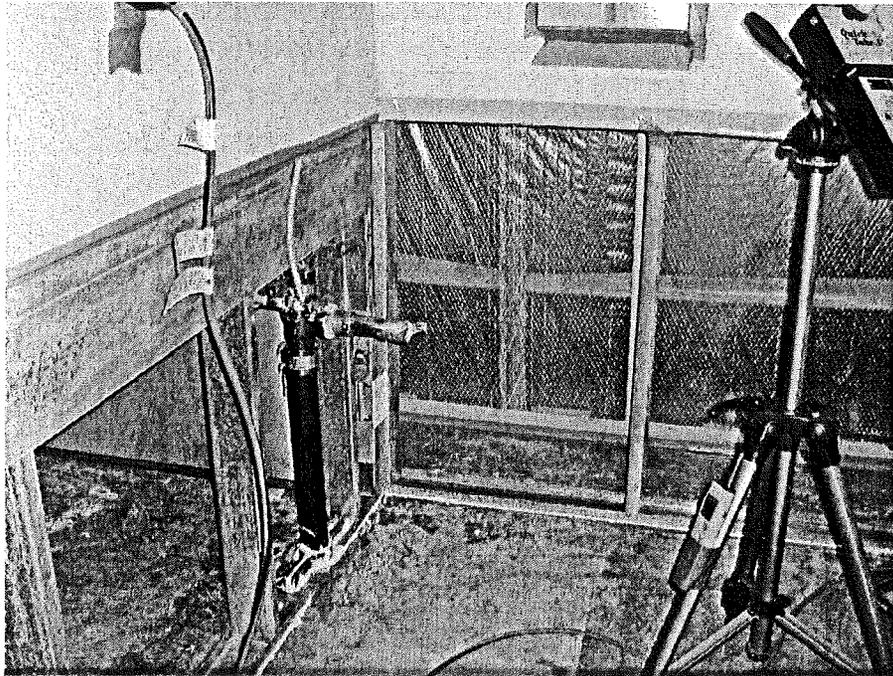
9) Additional image of wall removal delineation and air sampling activities performed within Break Room 320 at time of assessment.

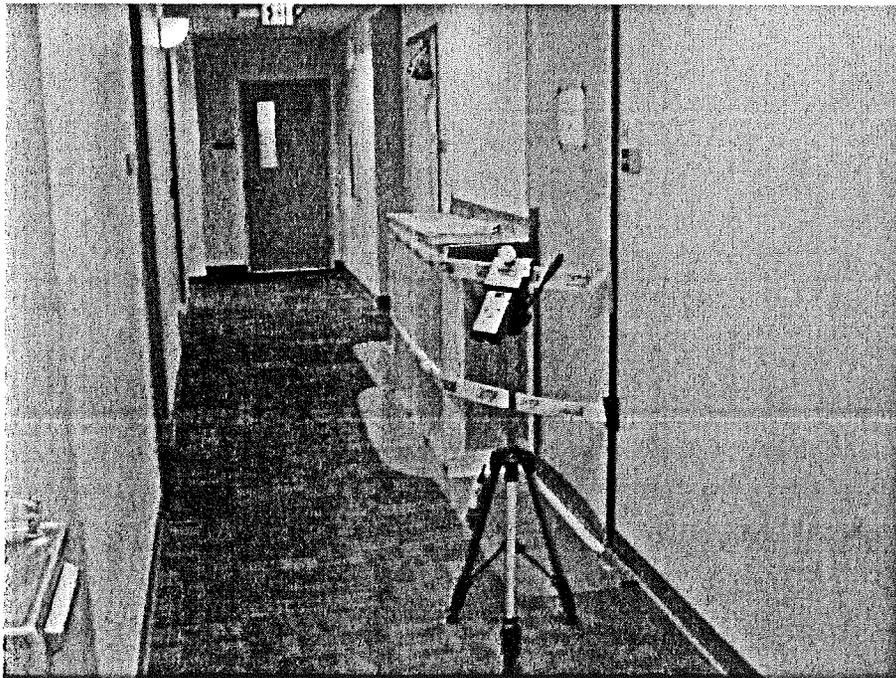
10) Image of hallway air sampling within tenant accessible areas adjacent to 320 and 319 containment systems at time of assessment.
