BioMax Environmental

January 7th, 2010

Post Mitigation Assessment Report
Department of General Services
Break Rooms 2108, 2106, 1616, and 1602
Board of Equalization Building, 450 N. Street
Sacramento, California

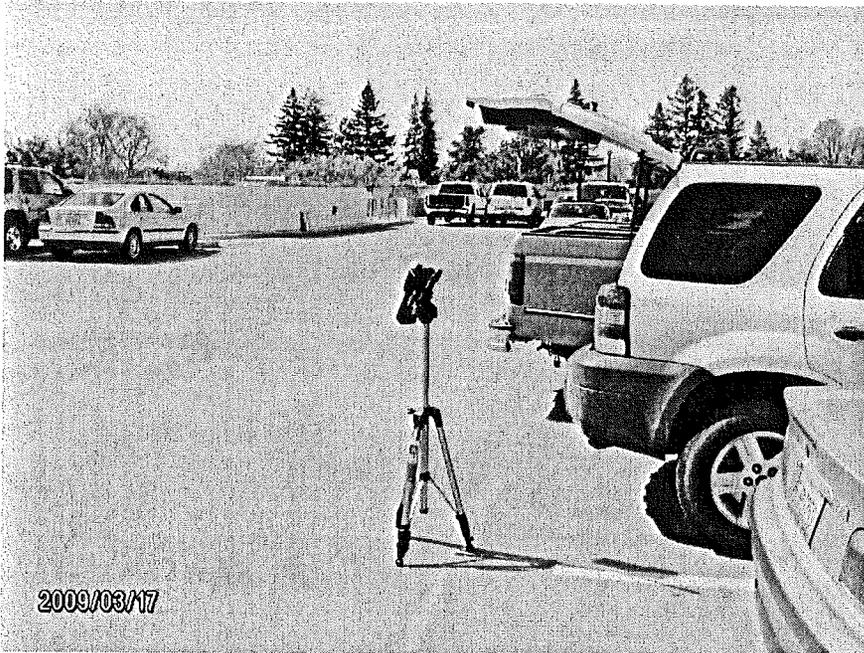
- 1) Image of ambient air sampling performed on garage rooftop location prior to interior sampling at 450 N Street, Sacramento, California.

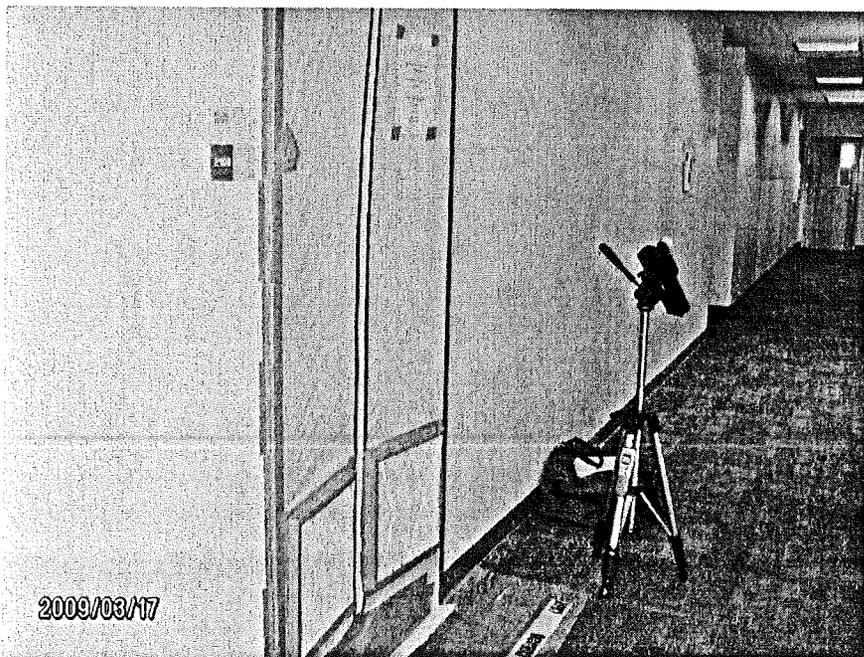
- 2) Image of tenant occupied hallway air sampling and Break Room 2108 containment entrance area at time of clearance assessment.

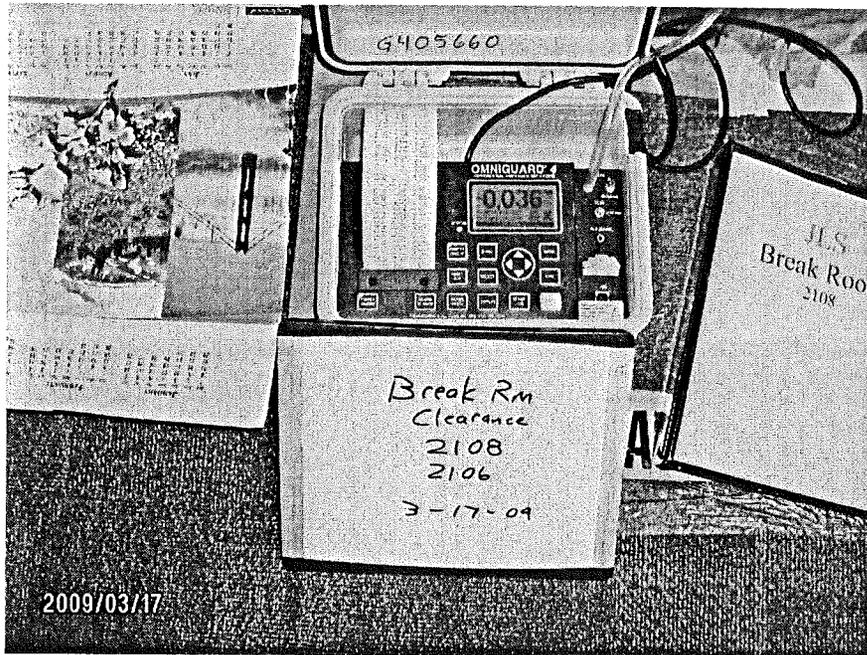
- 3) Image of pressure monitoring equipment located within hallway of Break Room 2108 and 2106 area at time of assessment. Air pressure differential (negative pressure) recorded at negative 0.036.

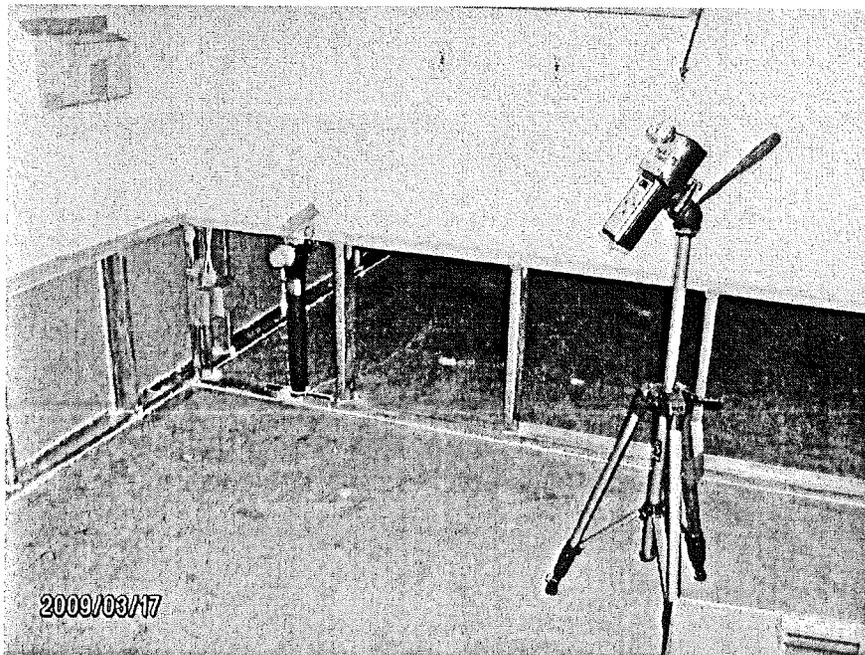
- 4) Image of air sampling equipment and wallboard removal delineation within Break Room 2108 area at time of assessment.

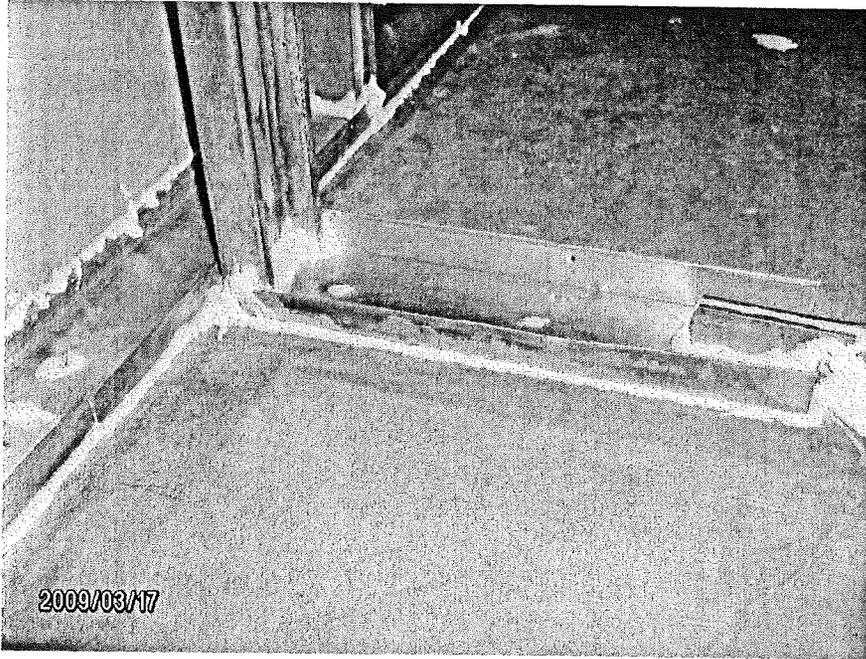
- 5) Close-up image of exposed wall framing systems and wallboard interior cavities within Break Room 2108 at time of clearance assessment.

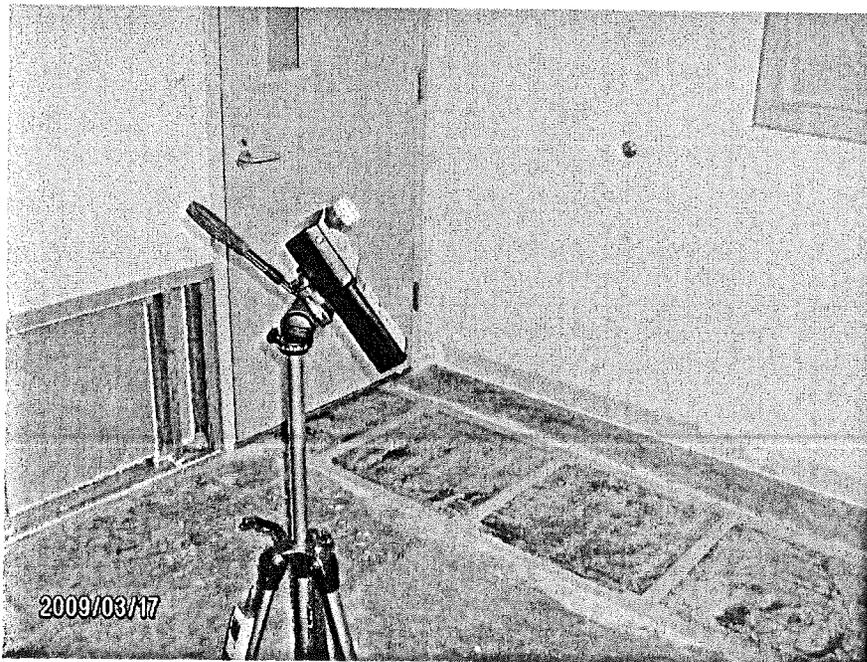
- 6) Image of air sampling equipment and sheetrock removal delineation within Break Room 2108 containment at time of assessment.

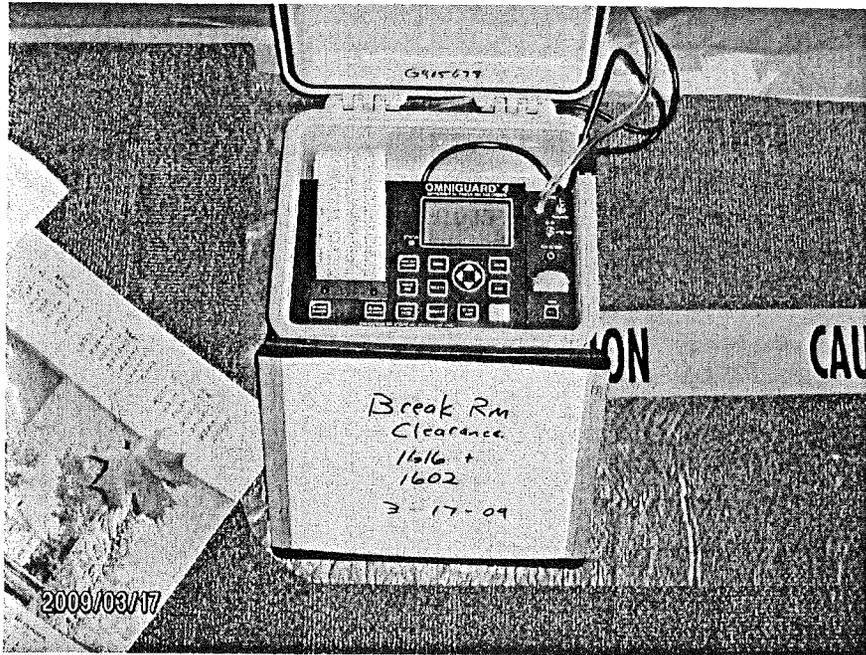
- 7) Close up image of pressure data logging manometer located at exterior of break Room 1616 at time of assessment.

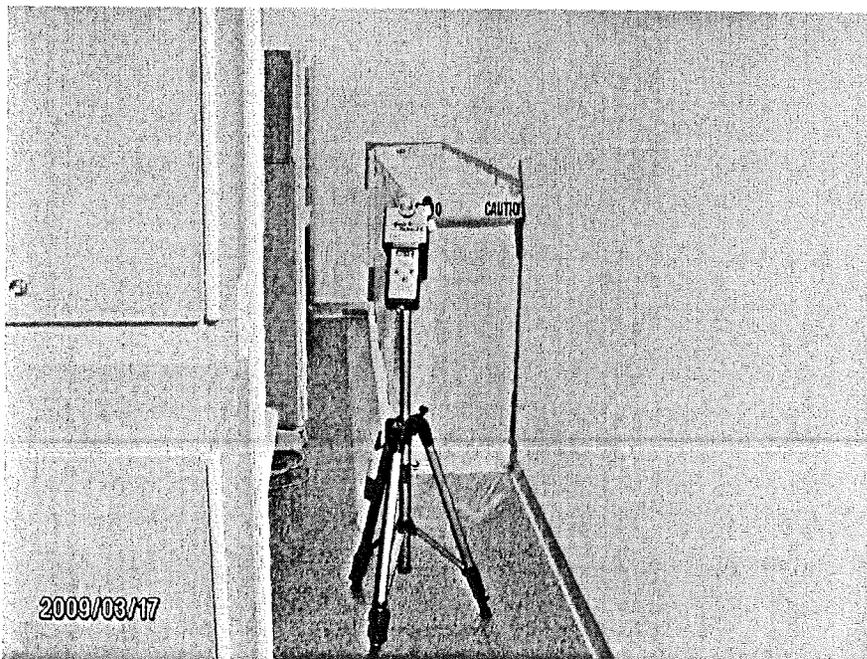
- 8) Image of air sampling performed within occupied worker cubicle area adjacent to Break Room 1616 located in area designation 1602.

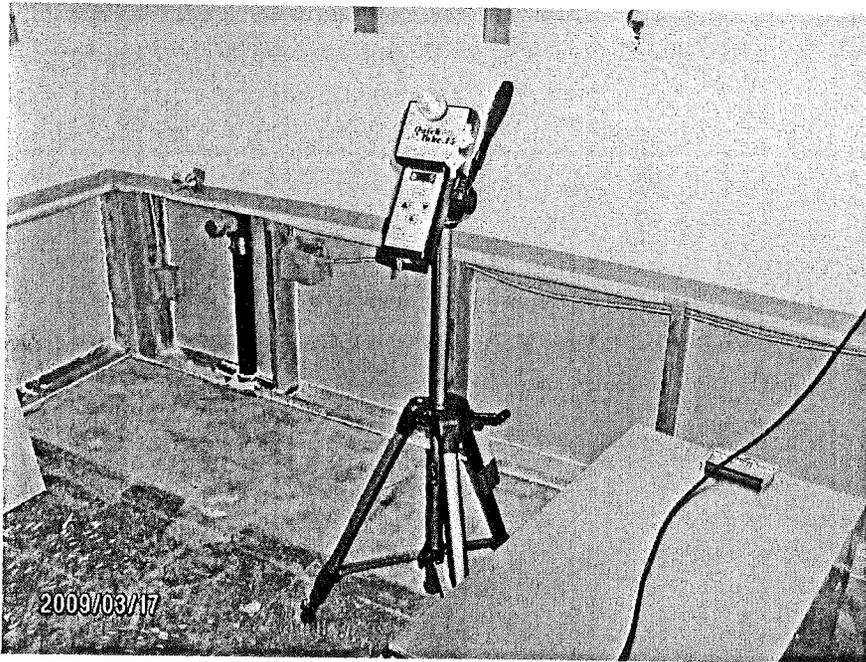
9) Image of air sampling equipment and exposed wall cavity as viewed from within Break Room 1616 containment at time of assessment.

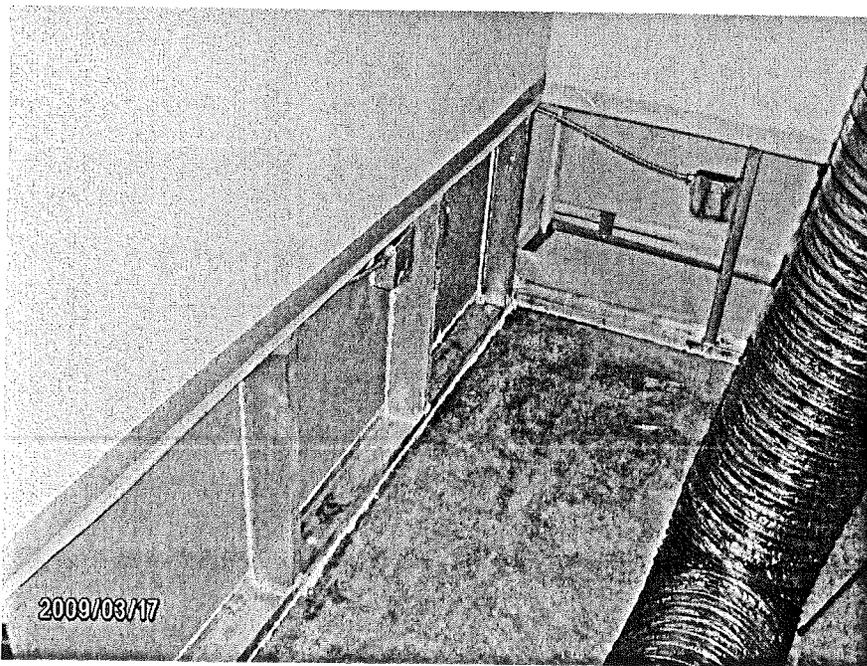
10) Close up image of wall cavity exposed electrical located within Break Room 1616 containment at time of assessment.

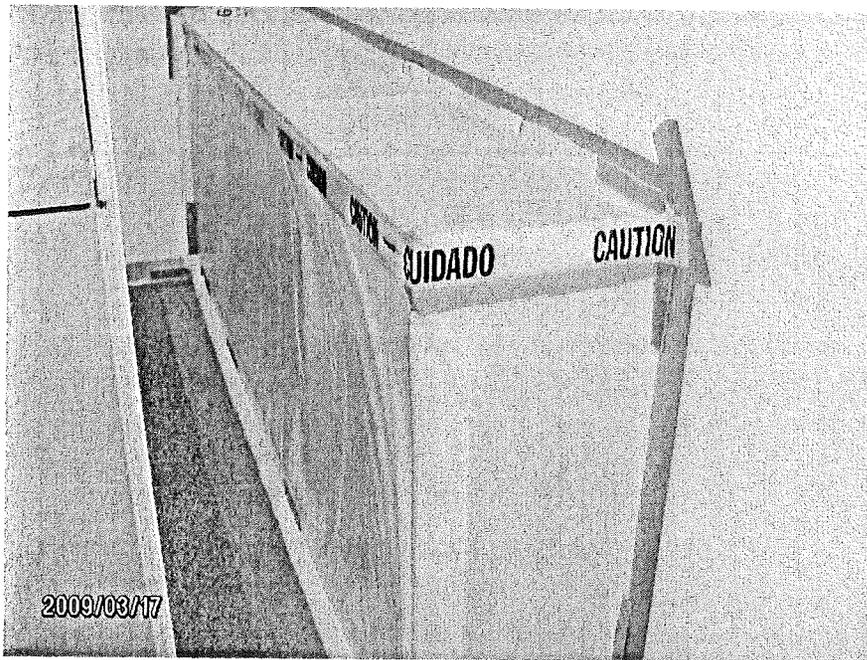
11) Image of "Pop Out" structure established within area 1602 at time of mitigation and clearance sampling assessment.

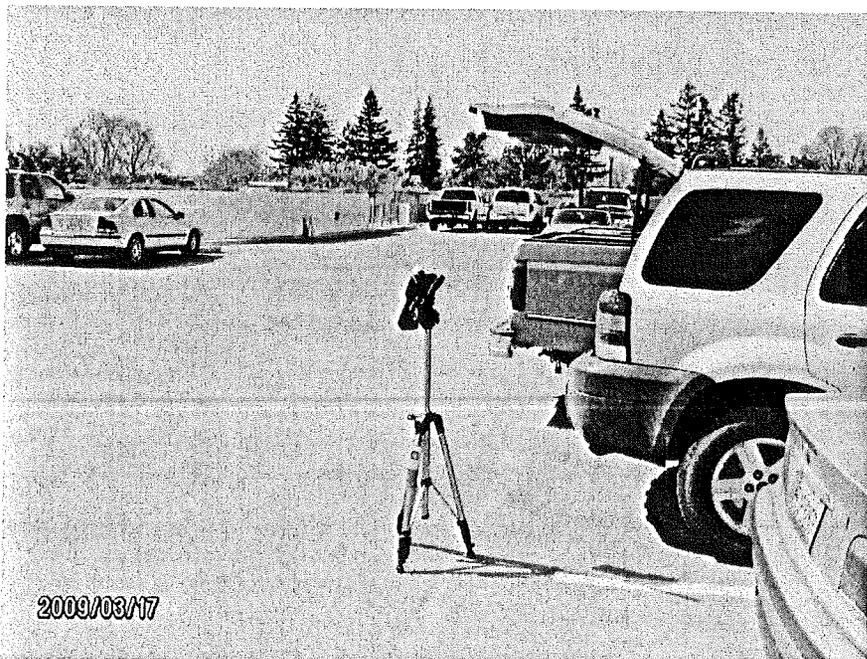
12) Image of ambient air sampling activity performed at outside location near main entrance to BOE building at conclusion of assessment.
