BioMax Environmental

February 9th, 2010

**Post Mitigation Assessment Report
Department of General Services
Break Room 214
Board of Equalization Building, 450 N. Street
Sacramento, California**

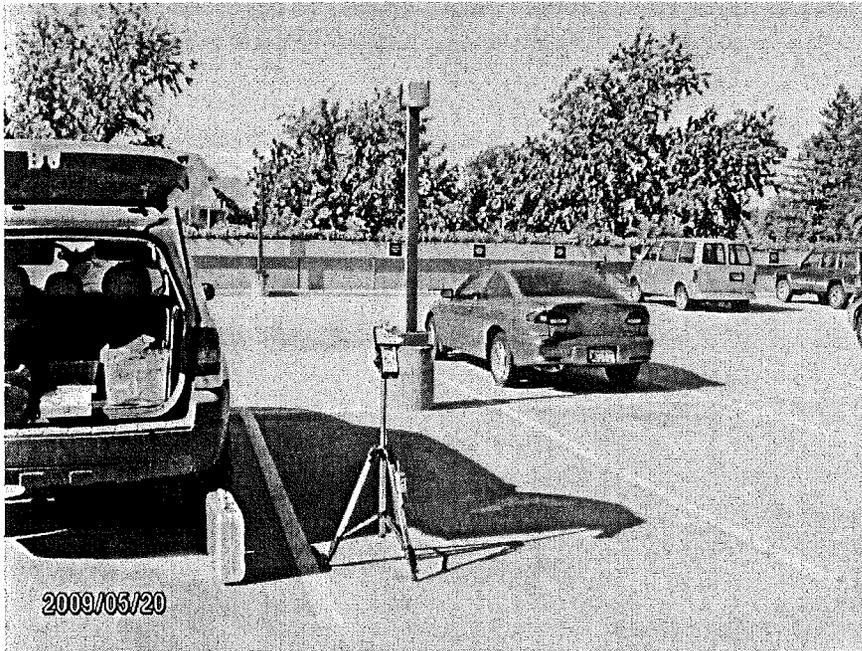
- 1) Image of ambient air sampling performed at garage rooftop location prior to interior sampling at 450 N Street, Sacramento, California.

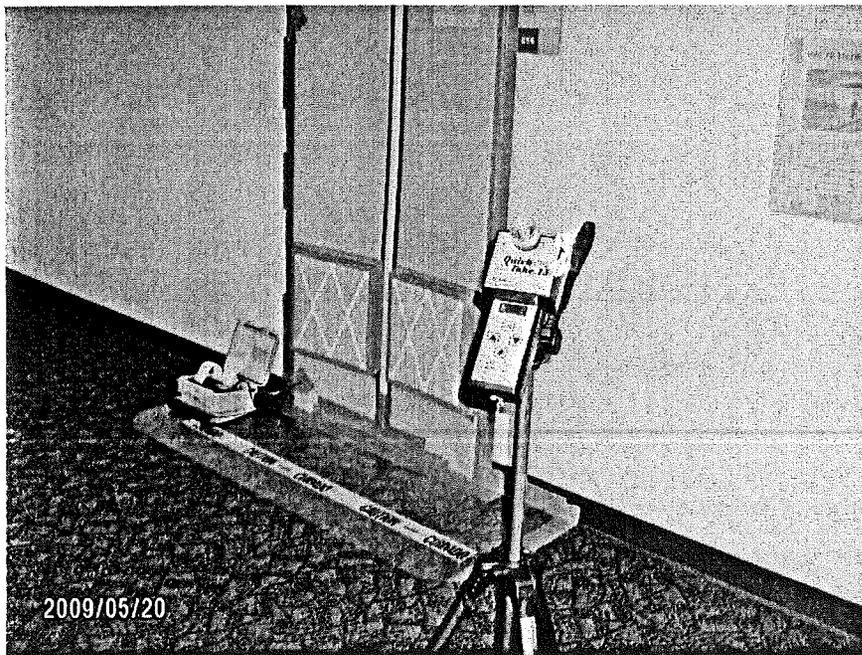
- 2) Image of tenant occupied hallway air sampling area near Break Room 214 containment entrance area at time of clearance assessment.

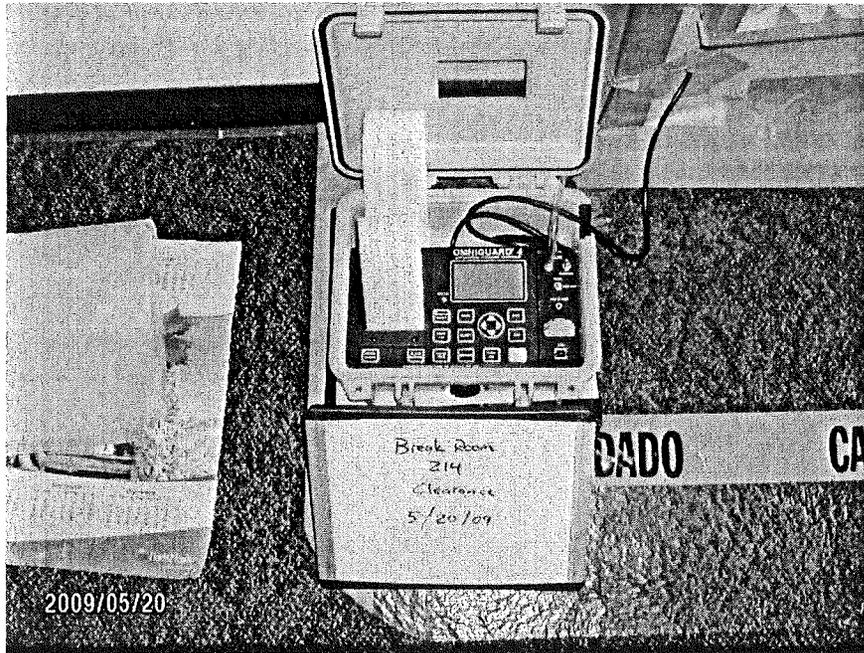
4. The establishment of zippered plastic entry barriers at the doorway entrance to the noted break room containments were observed and verified under appropriate posting and negative pressure differential at the time of this post mitigation assessment. Worker and equipment entry and exit chambers comprised of a series of zippered plastic access doorways were also observed attached to the noted containment barrier system consistent with BioMax's previously noted and approved mitigation protocols.

- 3) Image of pressure monitoring equipment located within hallway of Break Room 214 at time of assessment. Air pressure differential (negative pressure) recorded at - 0.040 inches.

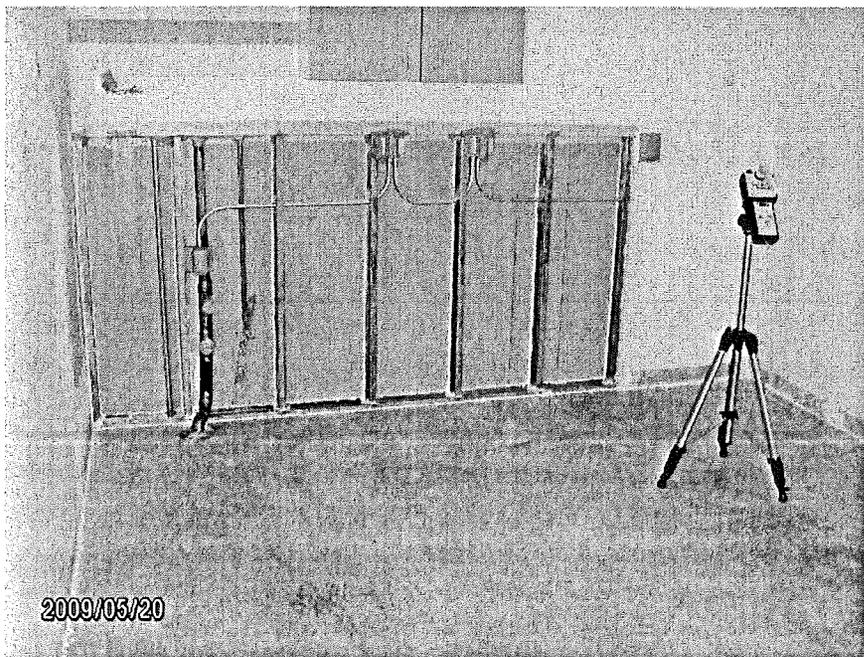
- 4) Image of air sampling equipment and baseboard removal delineation within Break Room 214 area at time of assessment.

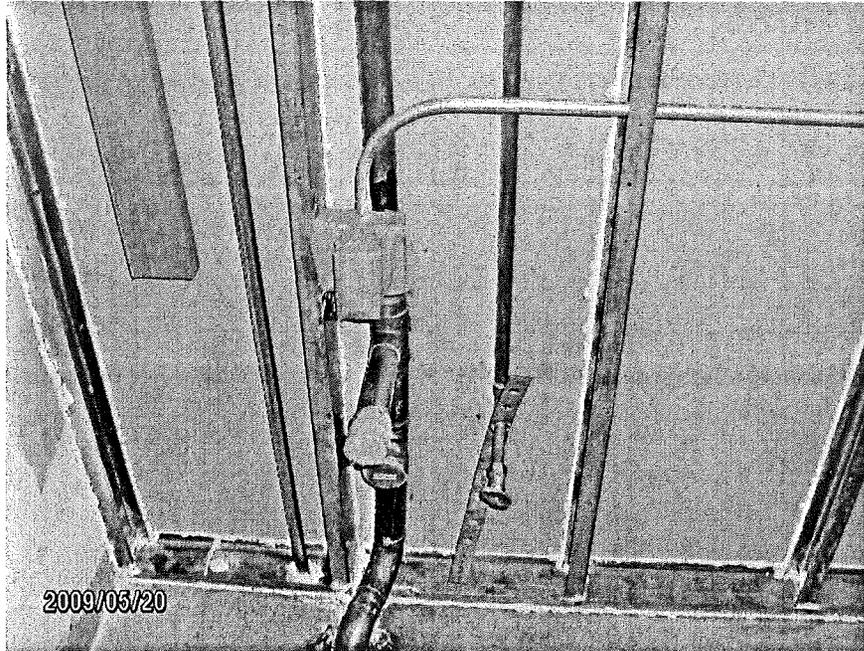
6. As verified during these assessment activities, all identified affected interior wallboard building materials had been removed from each of the noted interior areas exposing interior wall cavity framing (metal) and underlayment wallboard siding materials present within the impacted area. Upon post mitigation inspection, all remaining exposed building materials located within the break room area exhibited no significant staining and/or elevated mold

growth following the completion of prescribed physical material removal and chemical decontamination procedures performed by JLS.

5) Close-up image of exposed wall framing systems and wallboard interior cavities within Break Room 214 at time of clearance assessment.

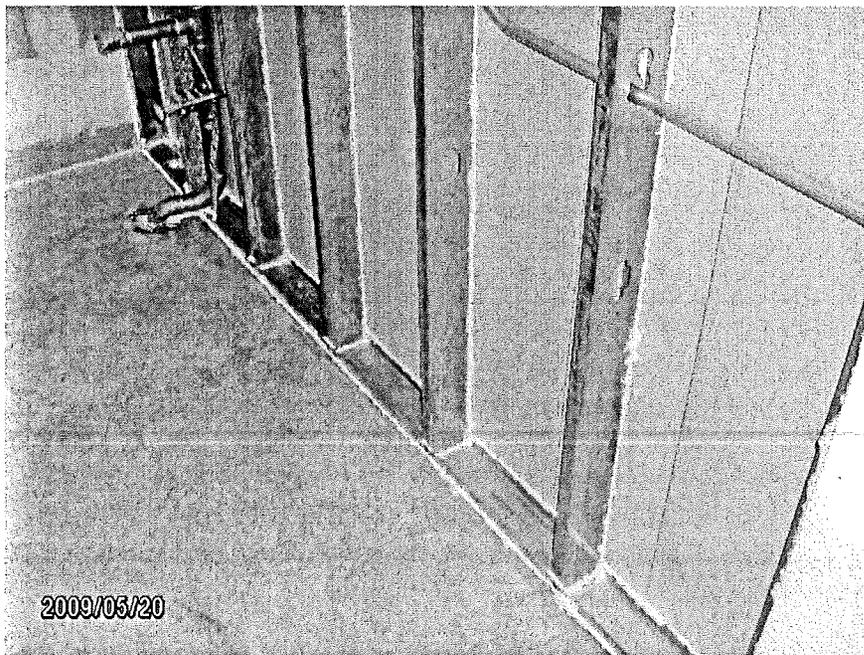
6) Additional close-up image of wallboard removal delineation performed within Break Room 214 containment at time of assessment.

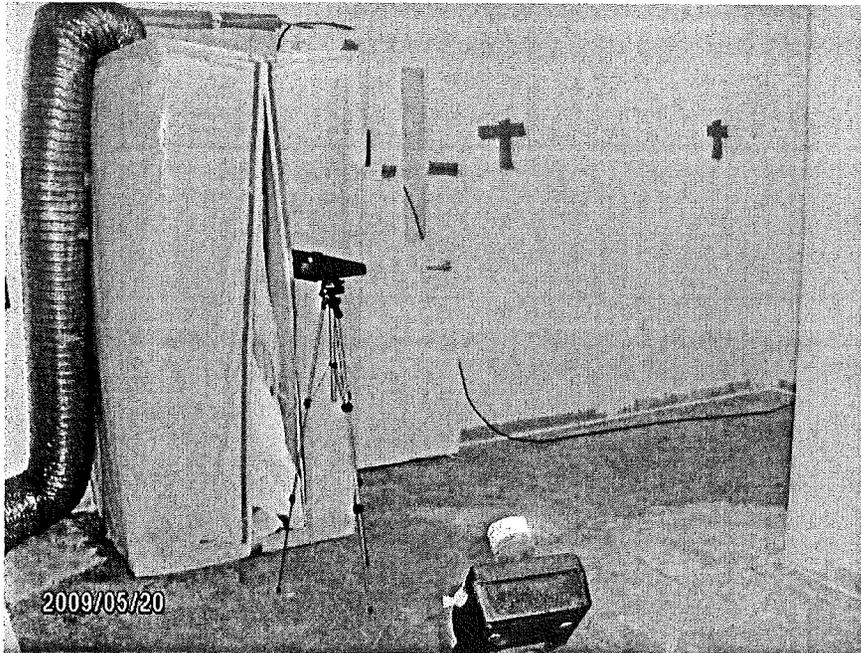
7) Image of entry chamber and construction of HEPA filtered exhaust ducting within containment of Break Room 214 at time of assessment.

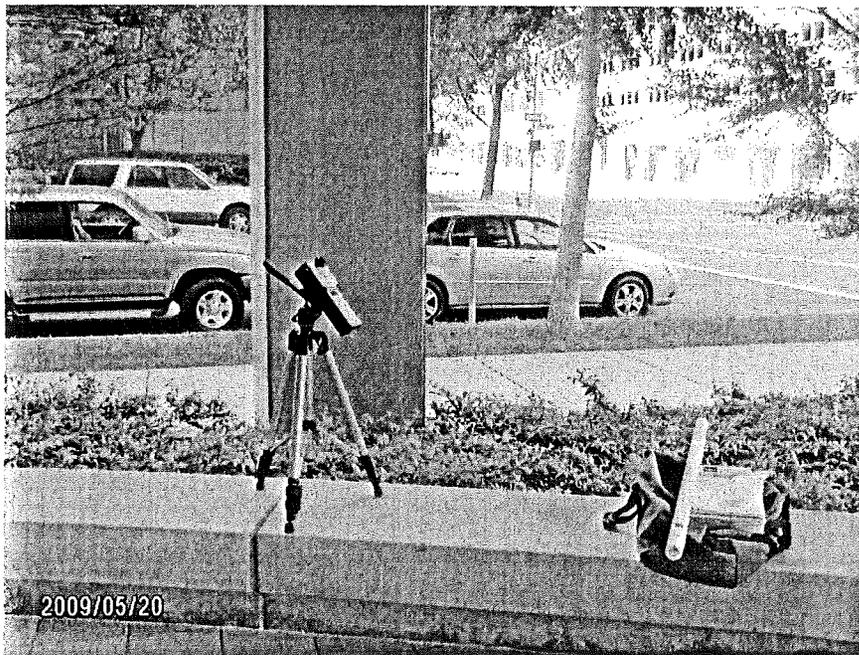
8) Image of ambient air sampling performed at main entry location following the collection of interior microbial samples at time of assessment.
