BioMax Environmental

February 5th, 2010

**Post Mitigation Assessment Report
Department of General Services
Break Room on Mezzanine Floor
Board of Equalization Building, 450 N. Street
Sacramento, California**

Attachment A: Digital Images

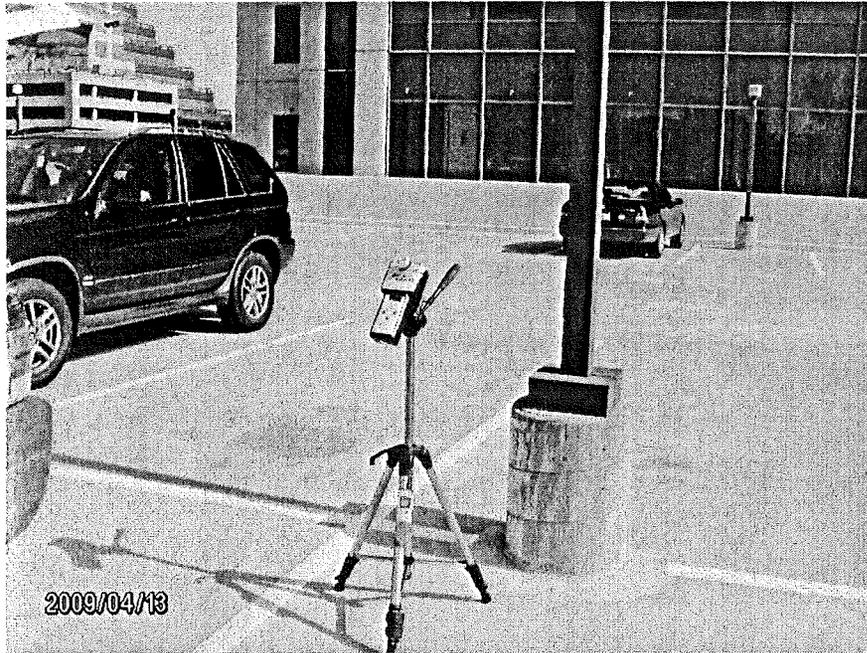
- 1) Image of ambient air sampling performed on garage rooftop location prior to interior sampling at 450 N Street, Sacramento, California.

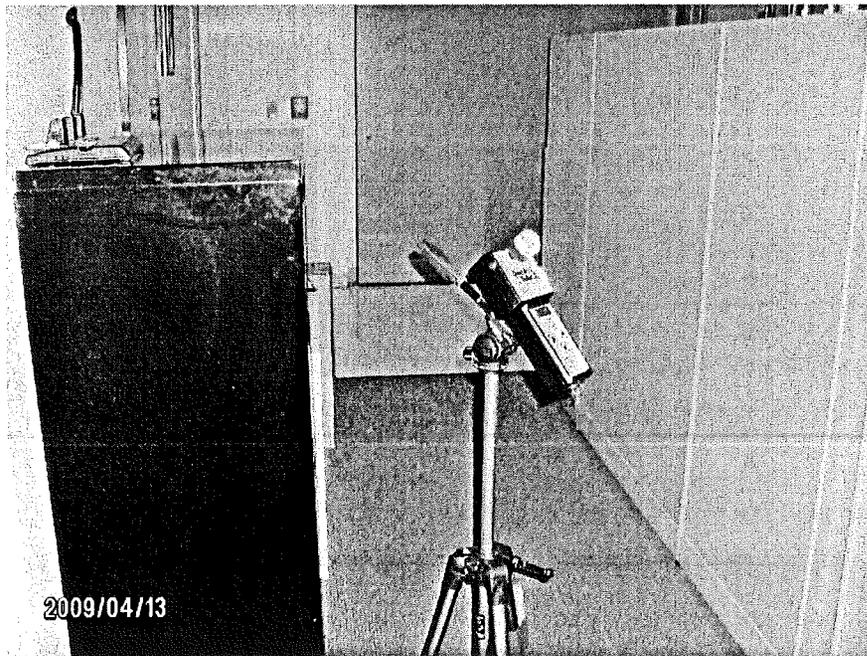
- 2) Image of tenant occupied hallway air sampling area near Break Room M containment entrance area at time of clearance assessment.

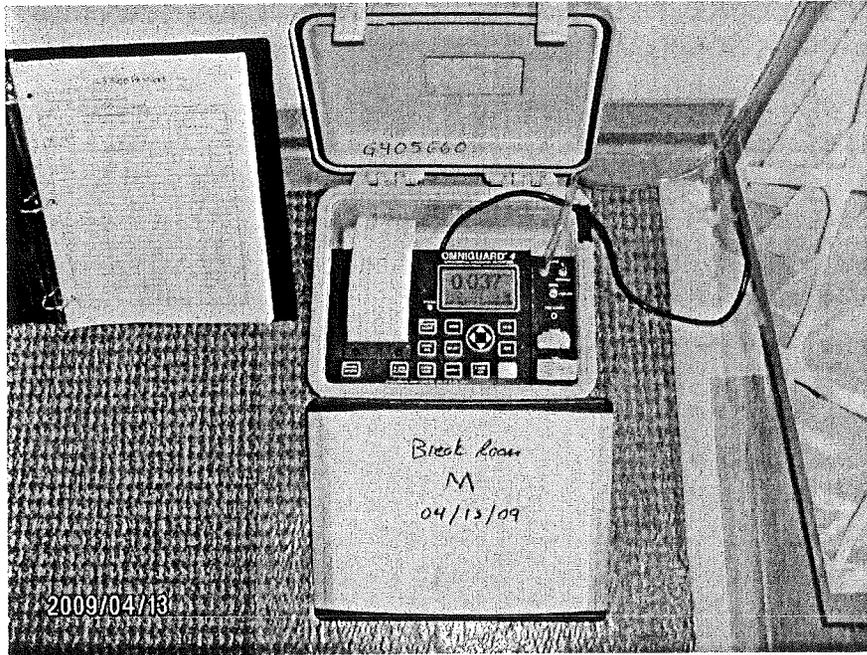
4. The establishment of zippered plastic entry barriers at the doorway entrance to the noted break room containments were observed and verified under appropriate posting and negative pressure differential at the time of this post mitigation assessment. Worker and equipment entry and exit chambers comprised of a series of zippered plastic access doorways were also observed attached to the noted containment barrier system consistent with BioMax's previously noted and approved mitigation protocols.

- 3) Image of pressure monitoring equipment located within hallway of Break Room M at time of assessment. Air pressure differential (negative pressure) recorded at - 0.037 inches.

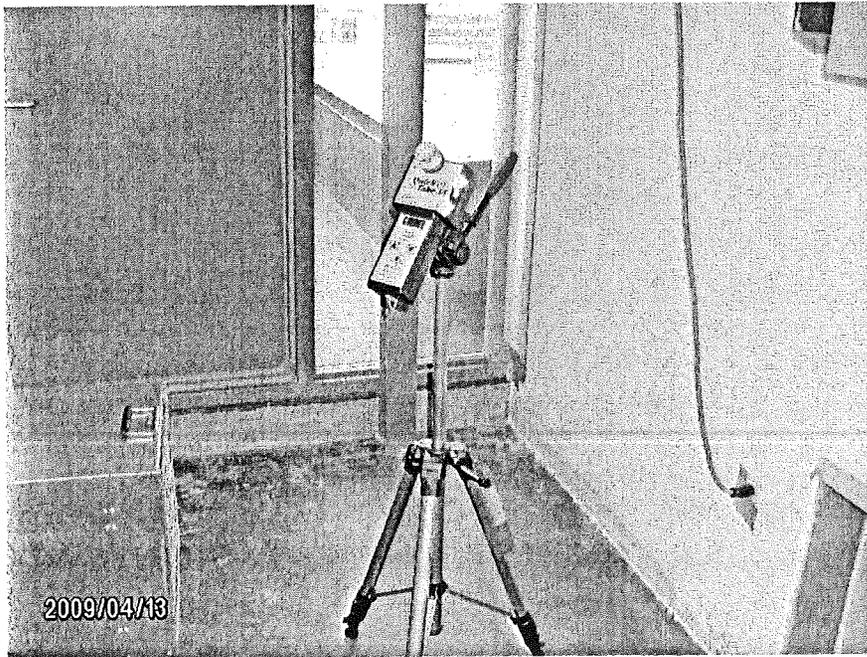
- 4) Image of air sampling equipment and baseboard removal delineation within Break Room M area at time of assessment.

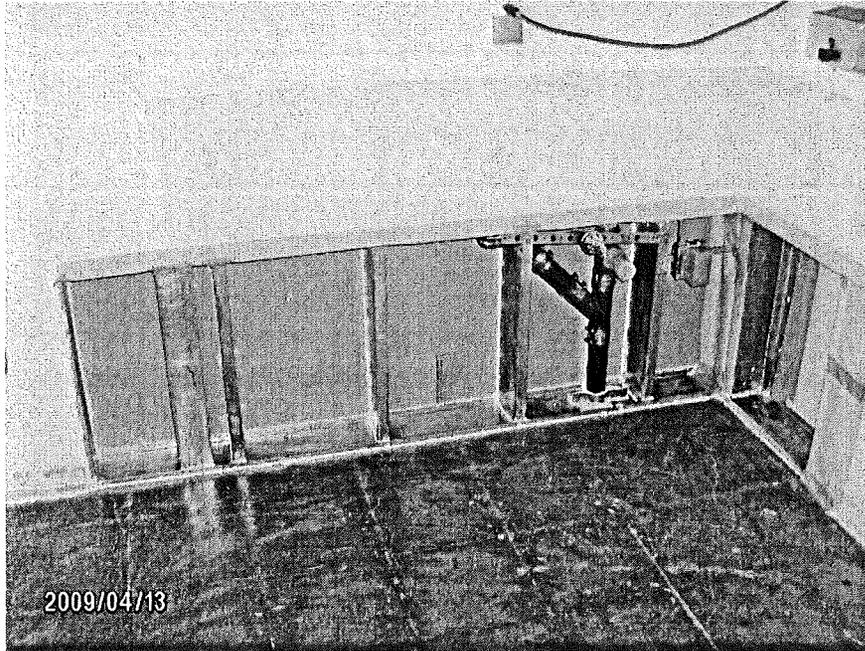
6. As verified during these assessment activities, all identified affected interior wallboard building materials had been removed from each of the noted interior areas exposing interior wall cavity framing (metal) and underlayment wallboard siding materials present within the impacted area. Upon post mitigation inspection, all remaining exposed building materials located within the break room area exhibited no significant staining and/or elevated mold

growth following the completion of prescribed physical material removal and chemical decontamination procedures performed by JLS.

5) Close-up image of exposed wall framing systems and wallboard interior cavities within Break Room M at time of clearance assessment.

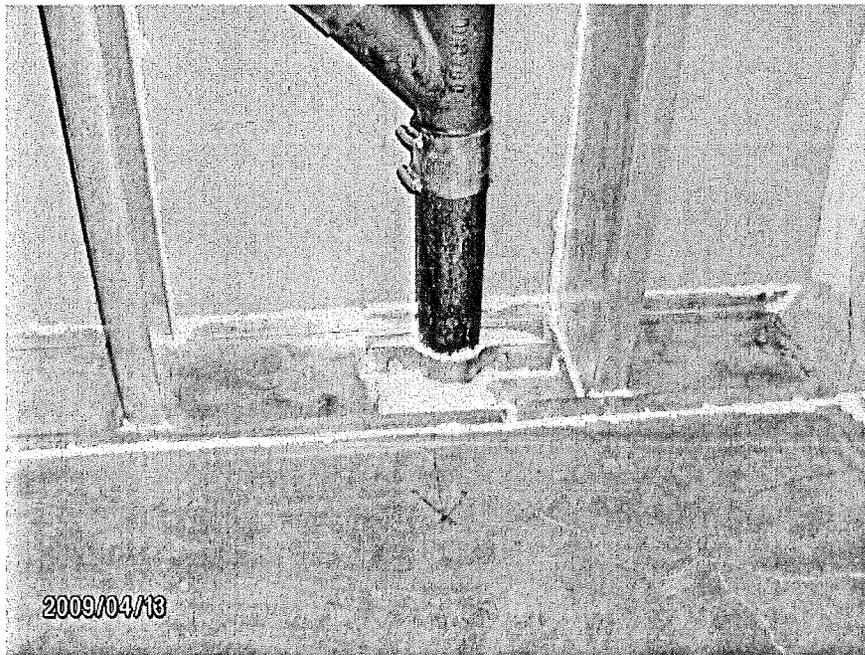
6) Additional close-up image of wallboard removal delineation performed within Break Room M containment at time of assessment.

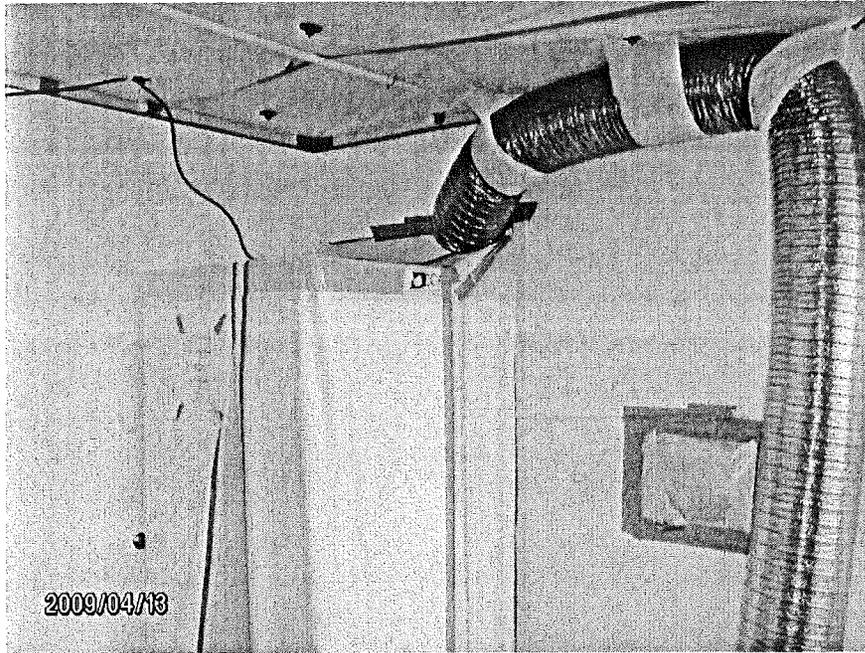
7) Image of entry chamber and construction of HEPA filtered exhaust ducting within containment of Break Room M at time of assessment.

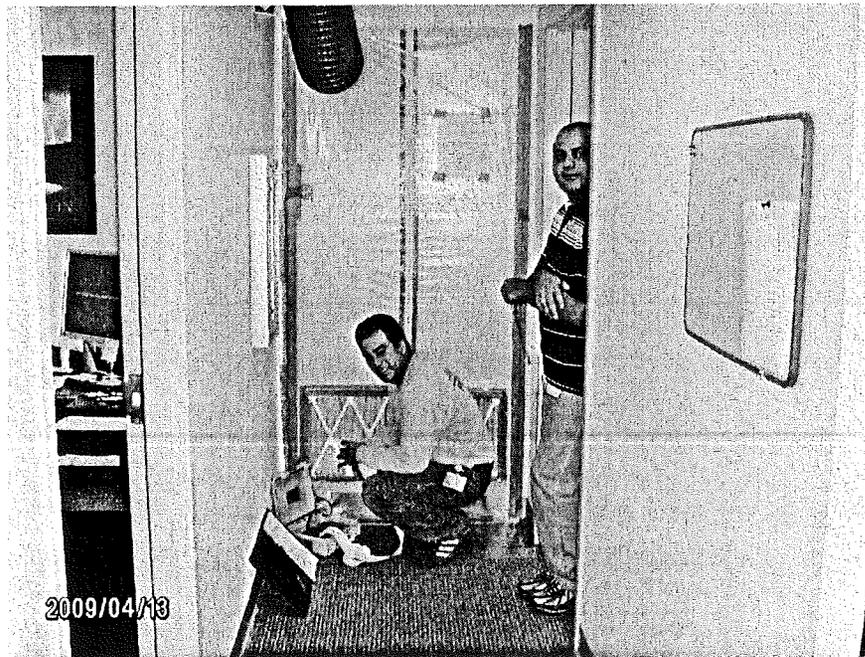
8) Image of entry chamber and construction of HEPA filtered exhaust ducting within containment of Break Room M at time of assessment. JLS and HTI representatives present.
