BioMax Environmental

Post Mitigation Assessment Report
Department of General Services Board of Equalization Building
450 N. Street – Break Rooms 704, 143 and Areas 2304 and 23 Women's Restroom
Sacramento, California

BOE Building Break Rooms 704, 143, Area 2304, and 23WRR Clearances
Sacramento, CA

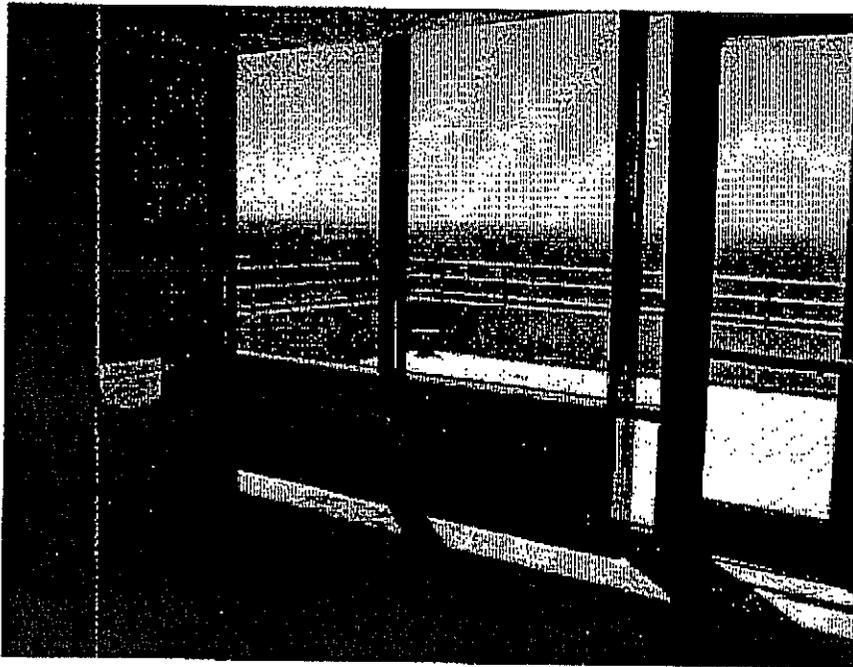
- 4) Image of interior of 2304 containment area ("Edwards Corridor") indicating extent of wall/floor removal and conditions at time of assessment.

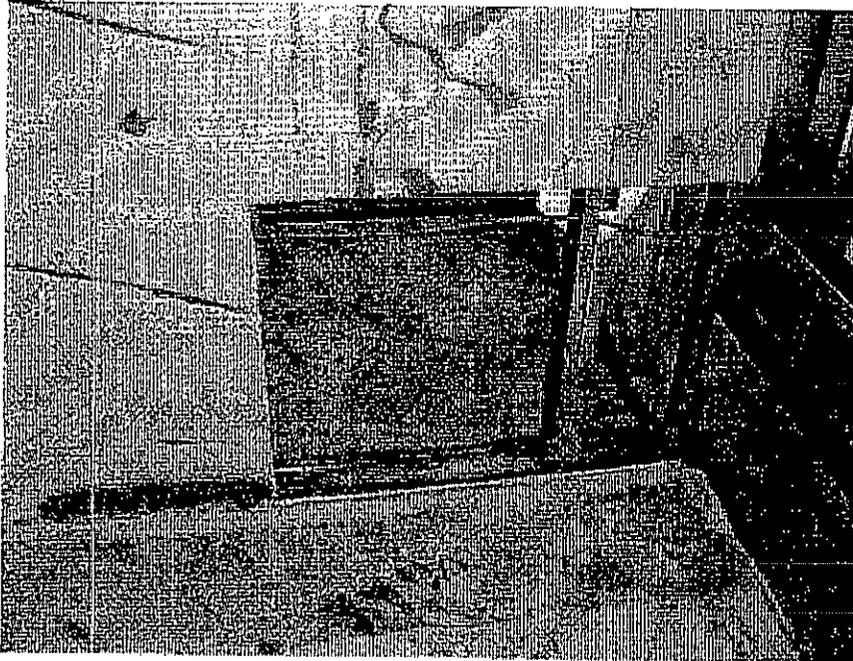
- 5) Image within containment 2304 indicating interior wall section removal at perimeter wall as removed during mitigative effort.

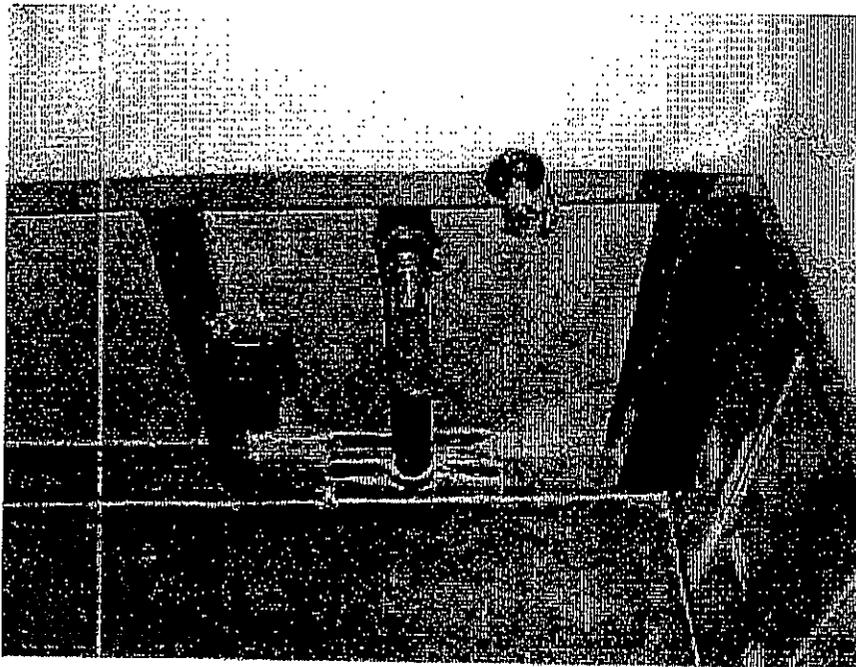
8) Close-up image of plumbing and wall cavity areas at former location of break room cabinetry within 704 at time of post mitigation assessment.
