PROJECT
STATE OF CALIFORNIA, DGS
BOE ASSESSMENT

DESCRIPTION
WATER DAMAGE SURVEY

LOCATION
11TH FLOOR

SHT NO. 12
SHT NAME A11

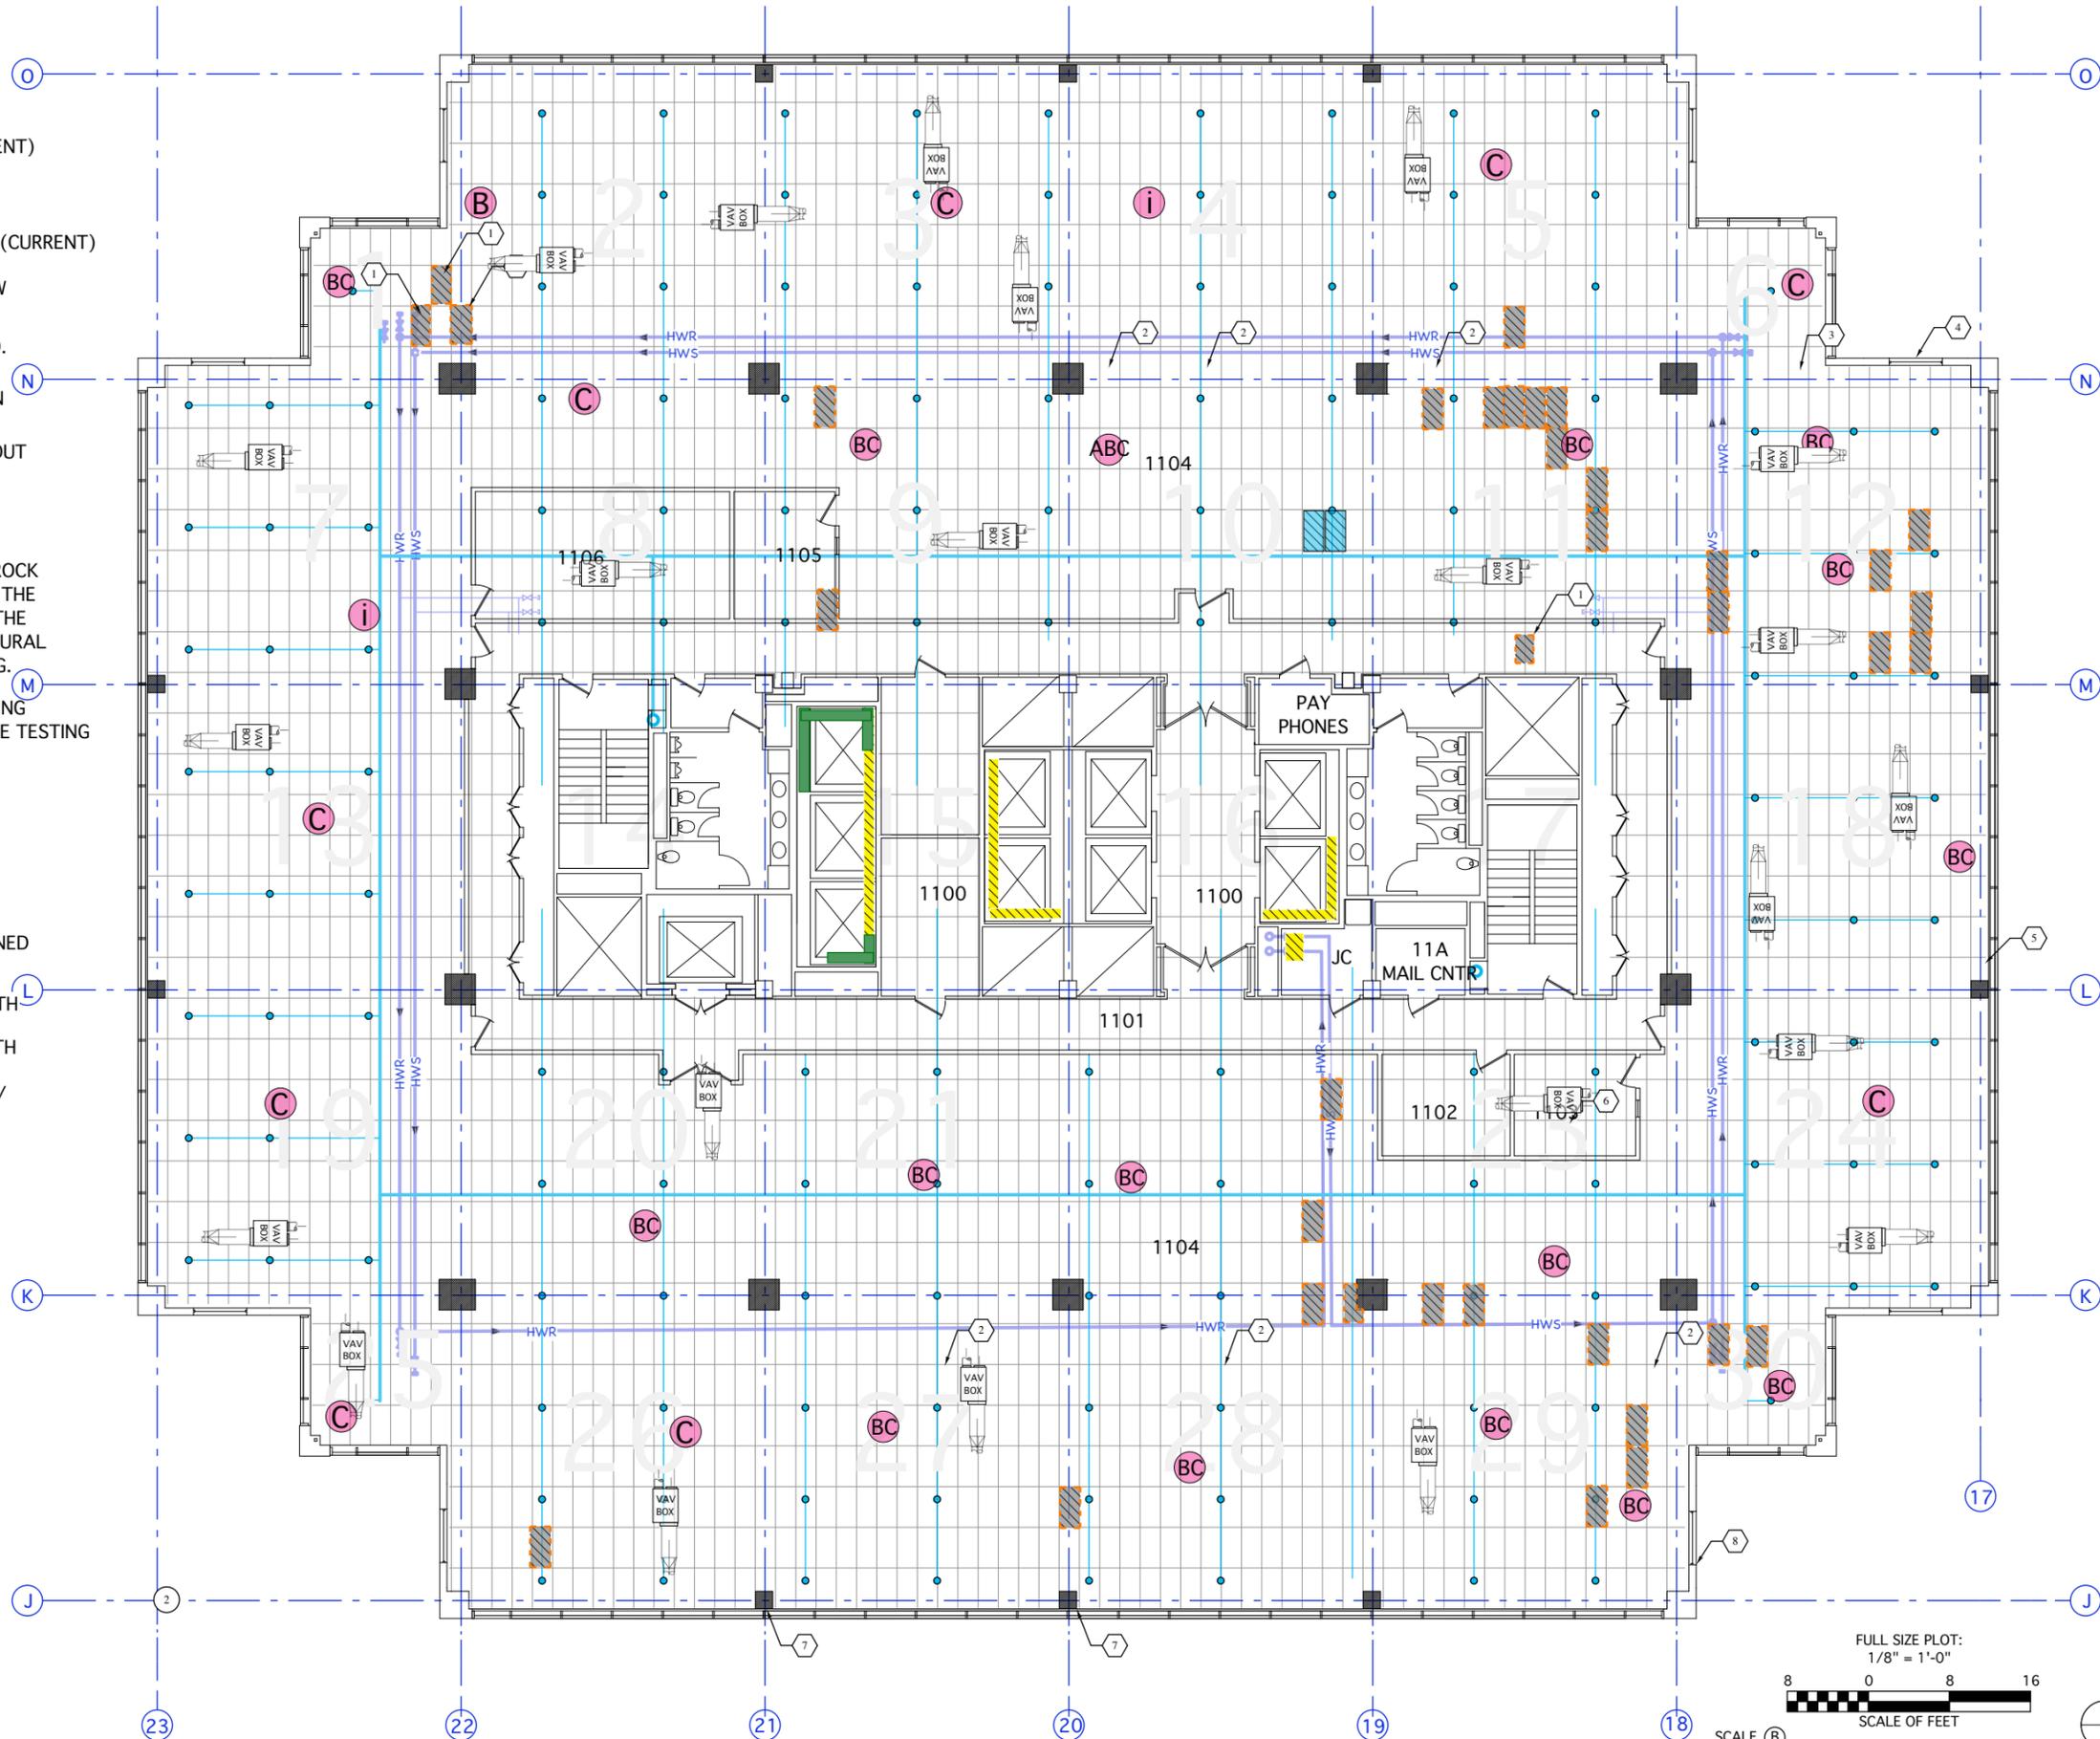
- 1 N/22 AND M/18.5 HIST. WS ON SHEETROCK CLG MEMBRANE ABOVE T-BAR.
- 2 WS IN LIGHT FIXTURE (CURRENT)
- 3 WS ON C.T. (CURRENT)
- 4 WS ON PUNCHOUT WINDOW (CURRENT)
- 5 WATER DAMAGE AT WINDOW
- 6 VMG IN BREAKROOM-SEALED.
- 7 WATER DAMAGE AT COLUMN
- 8 DAMAGE PAINT. AT PUNCH OUT WINDOW
