PROJECT
STATE OF CALIFORNIA, DGS
BOE ASSESSMENT

DESCRIPTION
WATER DAMAGE
SURVEY

LOCATION
1ST FLOOR

SHT NO. SHT NAME
2 A1

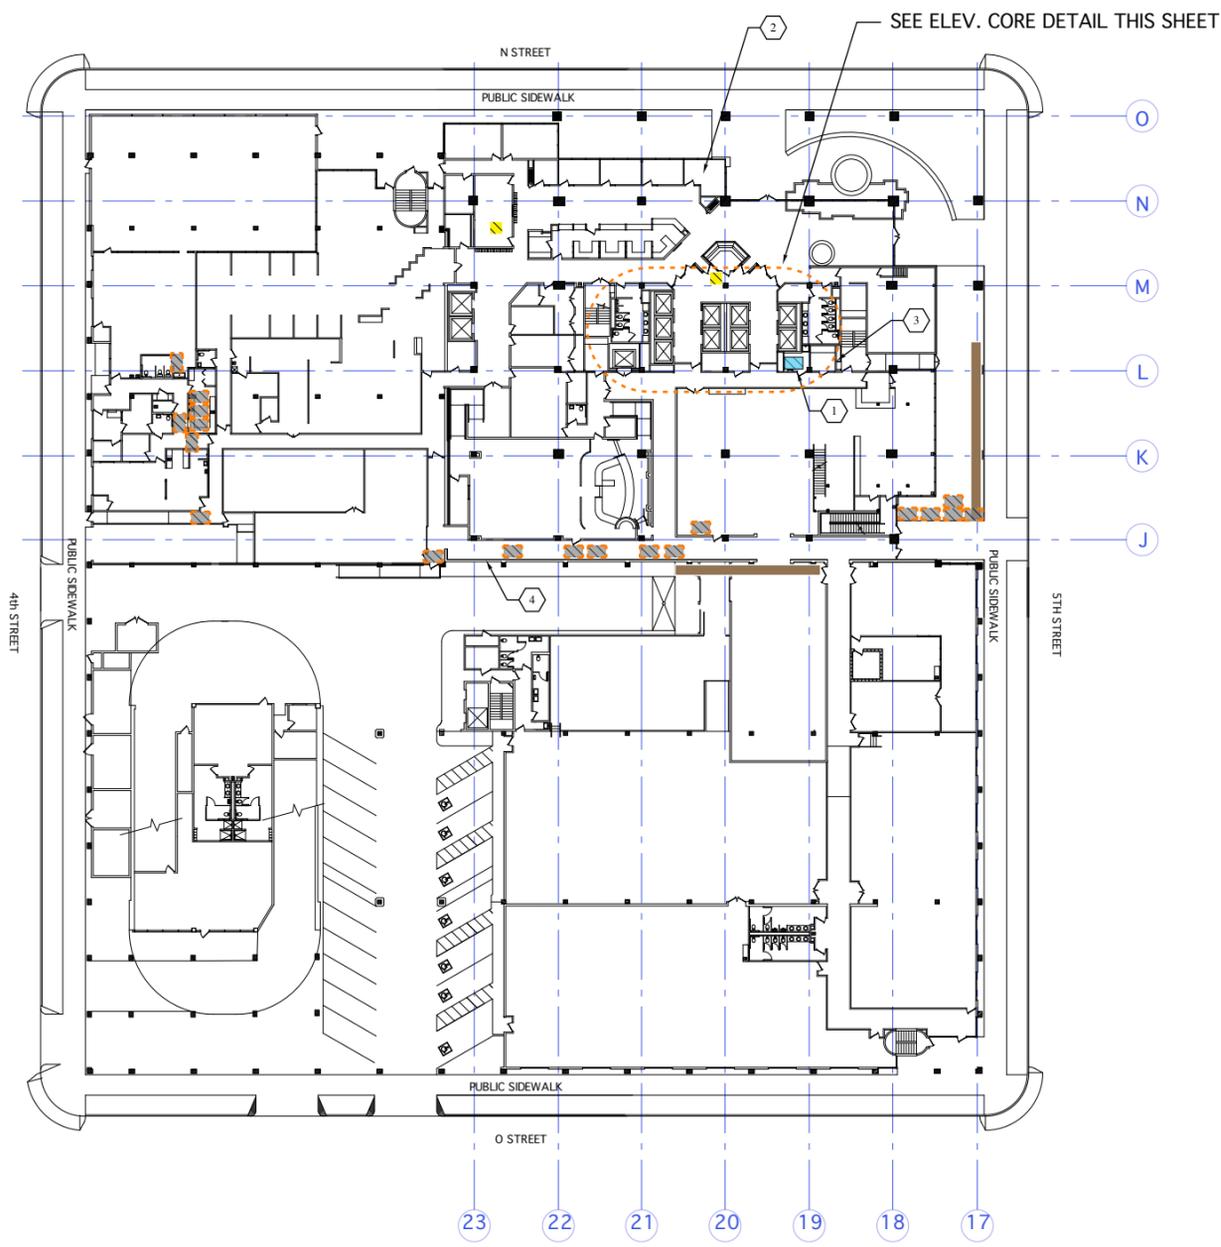
- ① L/19 WEeping PIPES WITH WS ON WALLS AND CLGS.
- ② N.5/20 CITY STORM DRAIN CAUSE OF WATER DAMAGE
- ③ L/18.6 FIRE SPRINKLER RISER VMG
- ④ J LINE. WATER DAMAGE FROM PARKING GARAGE TO BUILDING FLASHING PROBLEM.
- ⑤
