PROJECT LOCATION
BOARD OF EQUALIZATION
450 N STREET
SACRAMENTO, CA. 95814

PROJECT
STATE OF CALIFORNIA, DGS
BOE ASSESSMENT

DESCRIPTION
WATER DAMAGE SURVEY

LOCATION
2ND FLOOR

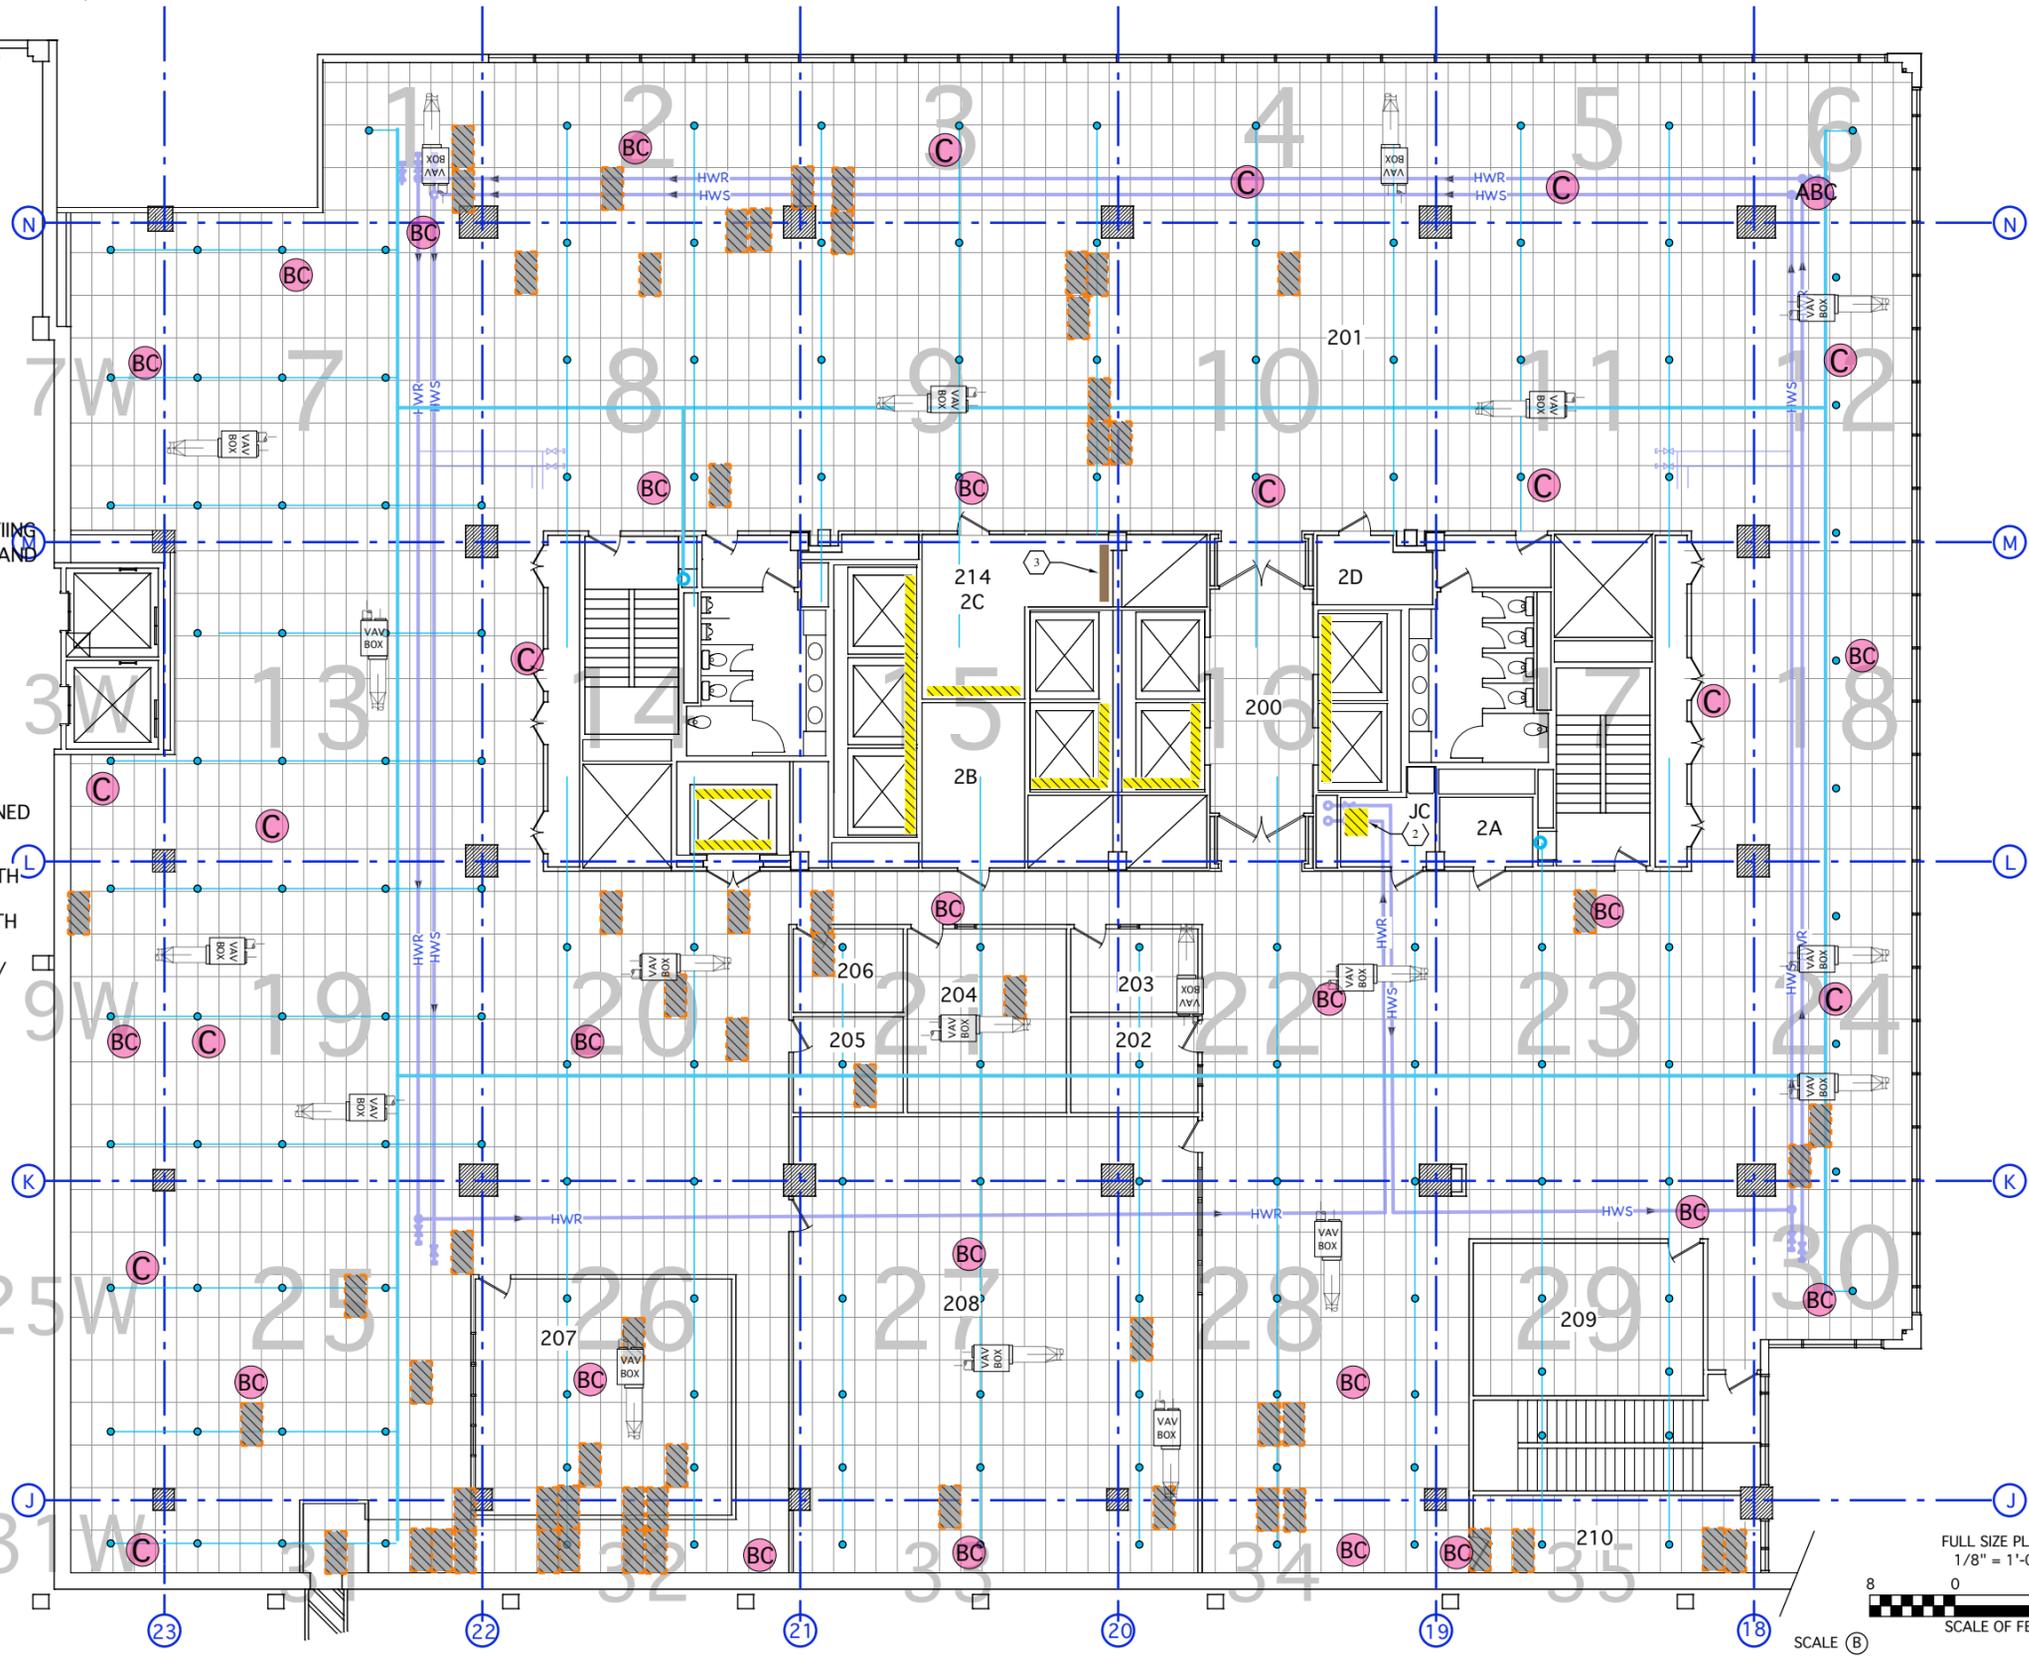
SHT NO.	SHT NAME
3	A2

- ① L/18.6 WS AT STANDPIPE (CURRENT)
- ② L/19.5 STAIN BELOW PIPE (CURRENT)
- ③ M/20 VMG 10 SF (CURRENT)
- ④
