PROJECT  
STATE OF CALIFORNIA, DGS  
BOE ASSESSMENT

DESCRIPTION  
WATER DAMAGE SURVEY

LOCATION  
7TH FLOOR

SHT NO. 8  
SHT NAME A7

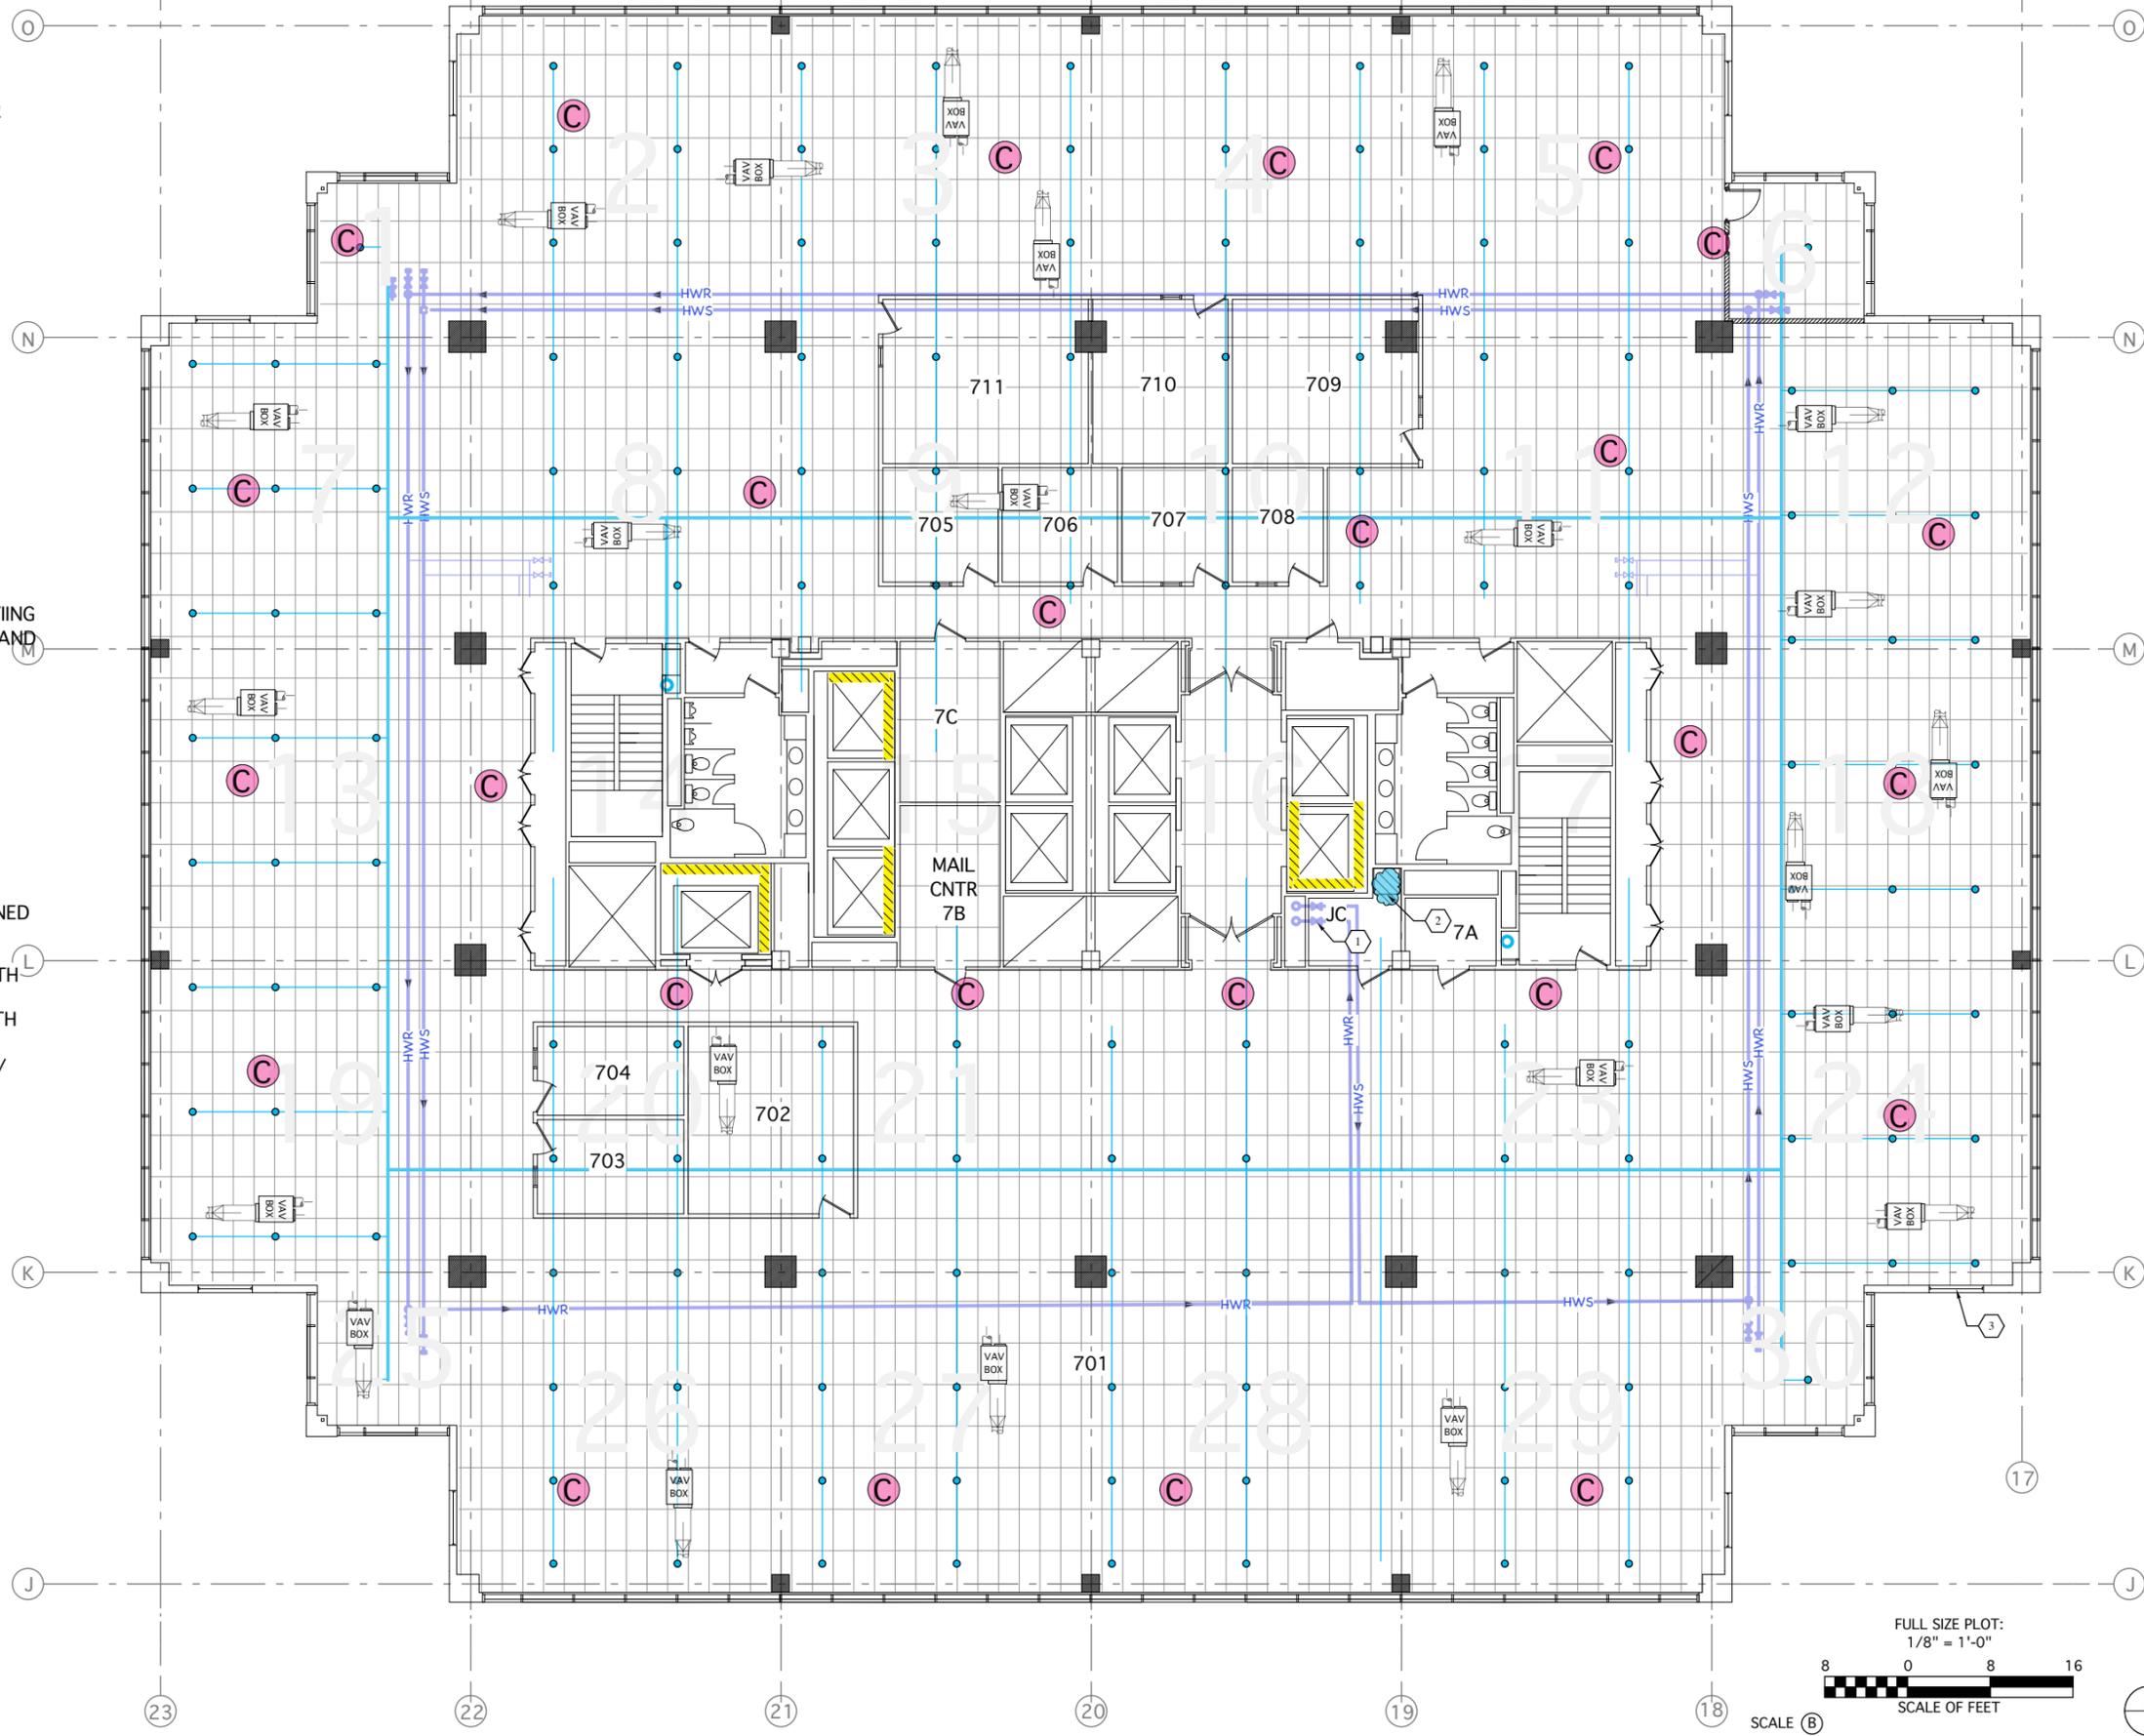
- ① RUSTY VALVE, WS
- ② STANDING WATER ON FLOOR
- ③ WS ON PUNCH PUT WINDOW
- ④
