## California State Board of Equalization Building Assessment

450 N Street  
Sacramento, California

### Preliminary Interim Report, Rev. 1

*Project No. 2372-572*

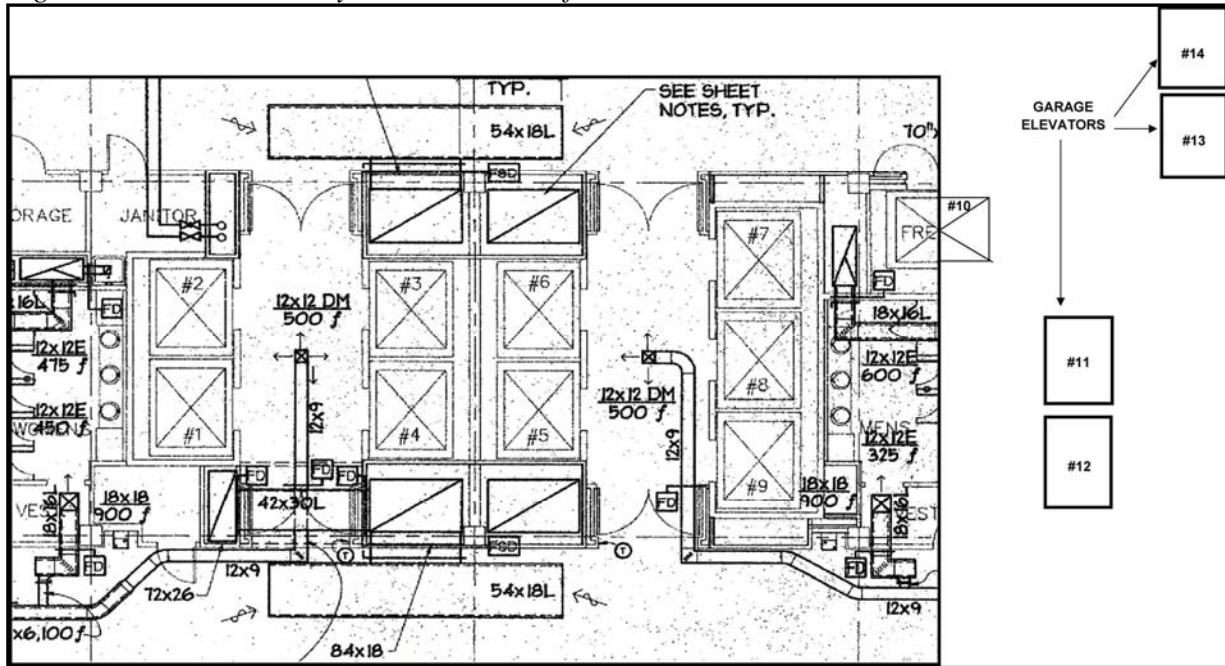
Figure 3.1 Preliminary Location Plan of Elevator Cars

Less than one percent of the visually inspected elevator shaft surface area showed signs of what appears to be visible mold growth. Less than ten percent of the visually inspected surface area showed varying degrees of water staining.

The water staining and suspect mold growth in the east low rise elevators (Elevators #1&2) appears to be related to water leaks from the janitor rooms and the women's rest rooms adjacent to these elevator shafts. It appears that water staining and suspect mold growth in the other elevator shafts may be due to a variety of causes as identified during the interview and document review phase of the investigation, with no single event or events being able to account for both the historical and current conditions.

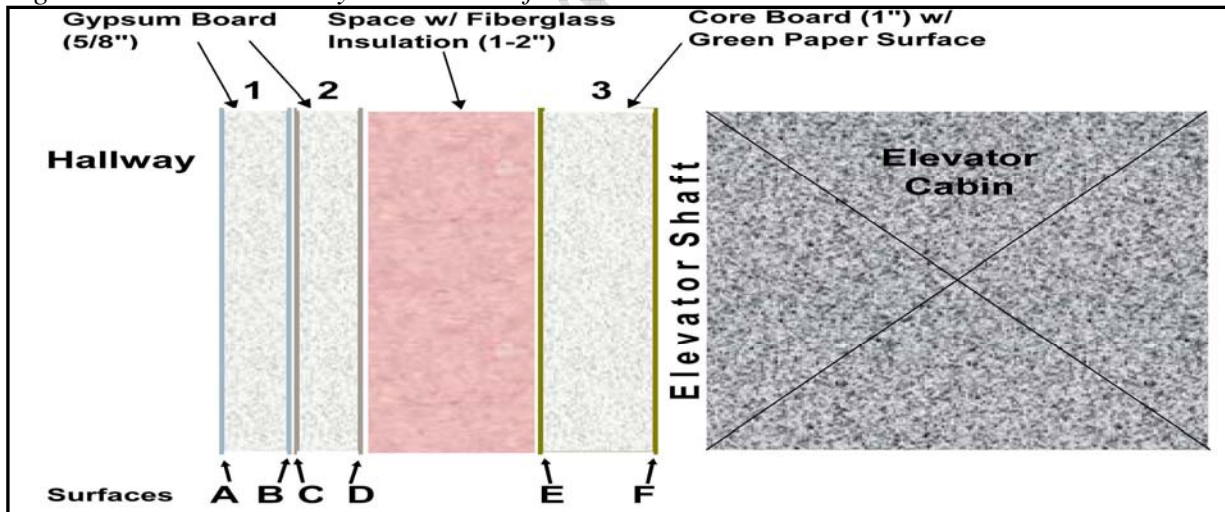
Figure 4.3 Preliminary Elevator Shaft Wall Detail

The presence of what appears to be visible mold growth and water staining on the interior walls of the elevator shafts was not an effective indicator and did not correlate with the location of where mold growth or water staining was detected on the exterior walls of the elevator shafts.

Visible mold growth was detected on various wall surfaces with the exception of the elevator shaft core board exterior. All investigation locations of elevator shaft core board exterior were observed or tested to be free of mold growth.
