**California State Board of Equalization**  
450 N Street, Sacramento, California

**Mold Remediation – 11th Floor**  
**June 10, 2009 – October 8, 2009**  
**Closure Report**  
*Project No. 2372.02-572*

**Report Date:**  
December 18, 2009

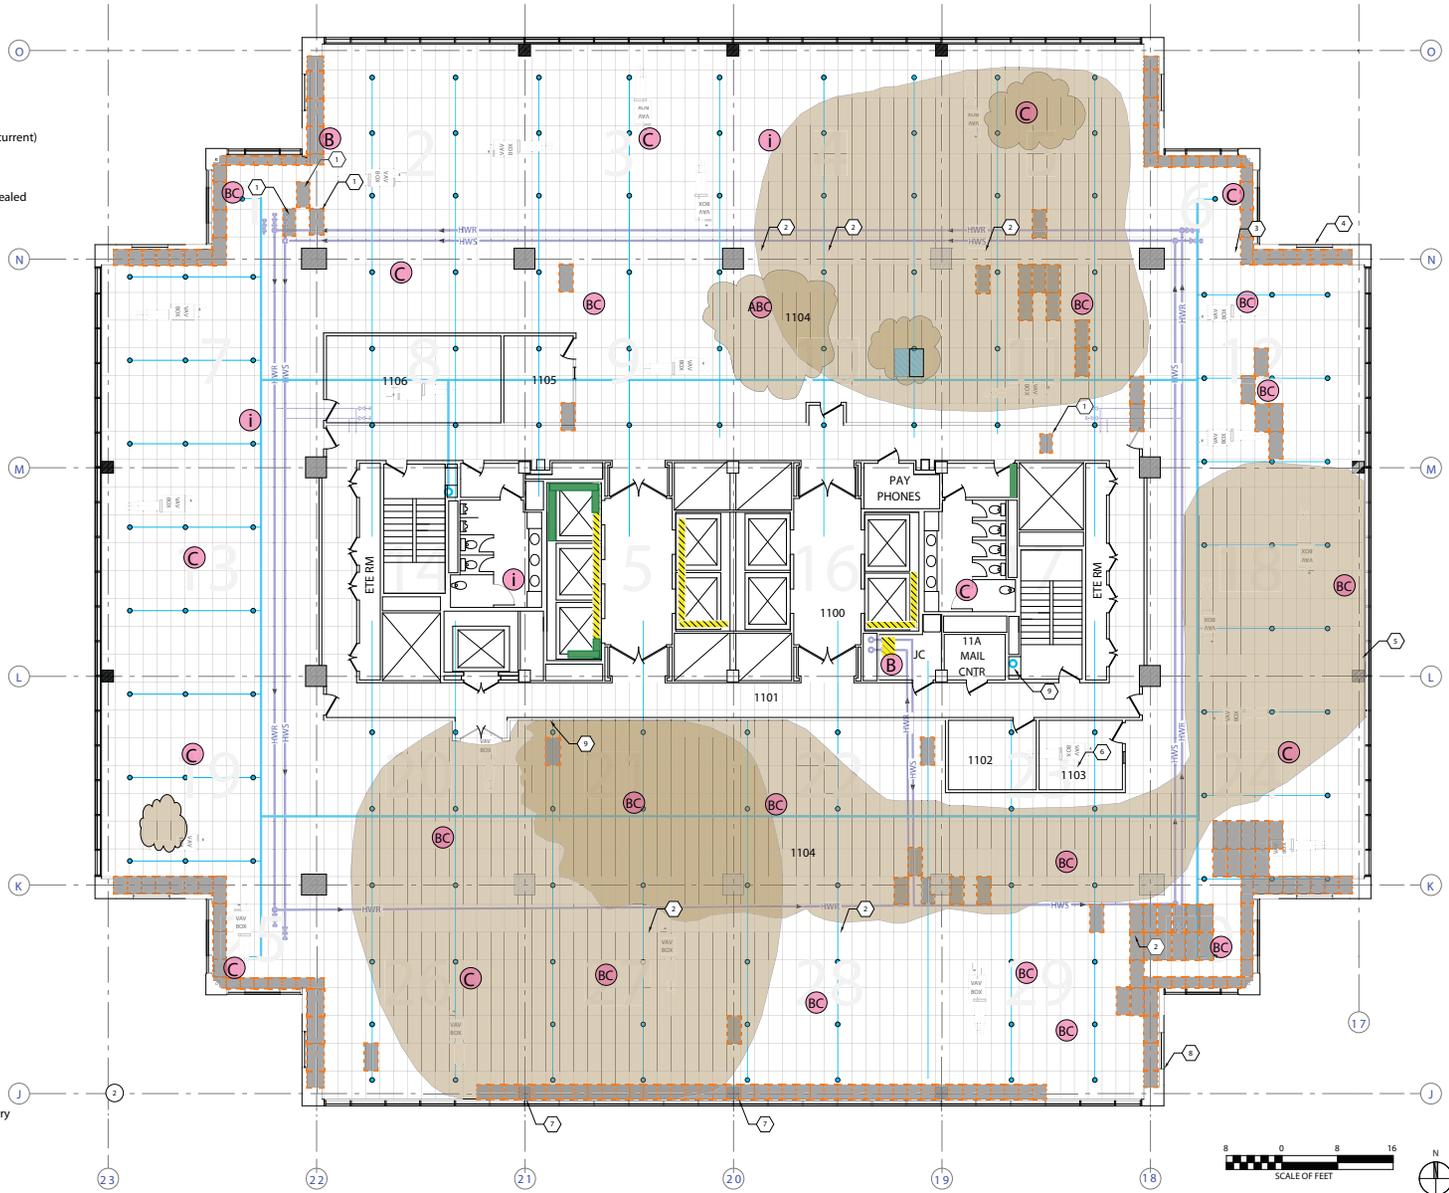
Prior to Floor 11 being released to the DGS Mold Remediation Project Team for remediation, BOE staff currently and previously working on Floor 11 were interviewed regarding historic events on the floors. Many of the interviewed BOE staff members have worked on the same floor since the building was placed in operation in 1993. BOE staff participation in the interviews was strictly voluntary. The interviews were performed by Chris Corpuz on August 7, 2009 and on August 16, 2009 by Ben Heckman. Table 1 in the Table Section summarizes the interview findings. Water and mold-related findings are depicted in Figure 1 in the Figure Section.

- ① Historic water stain on sheetrock ceiling membrane above T-bar.
- ② Water stain in light fixture (current)
- ③ Water stain on ceiling tile (current)
- ④ Water stain on punch-out window (current)
- ⑤ Water damage at window (current)
- ⑥ Visible mold growth in breakroom-sealed
- ⑦ Water damage at column (current)
- ⑧ Damaged paint at punch-out window (current)
- ⑨ Water stain on wall (current)

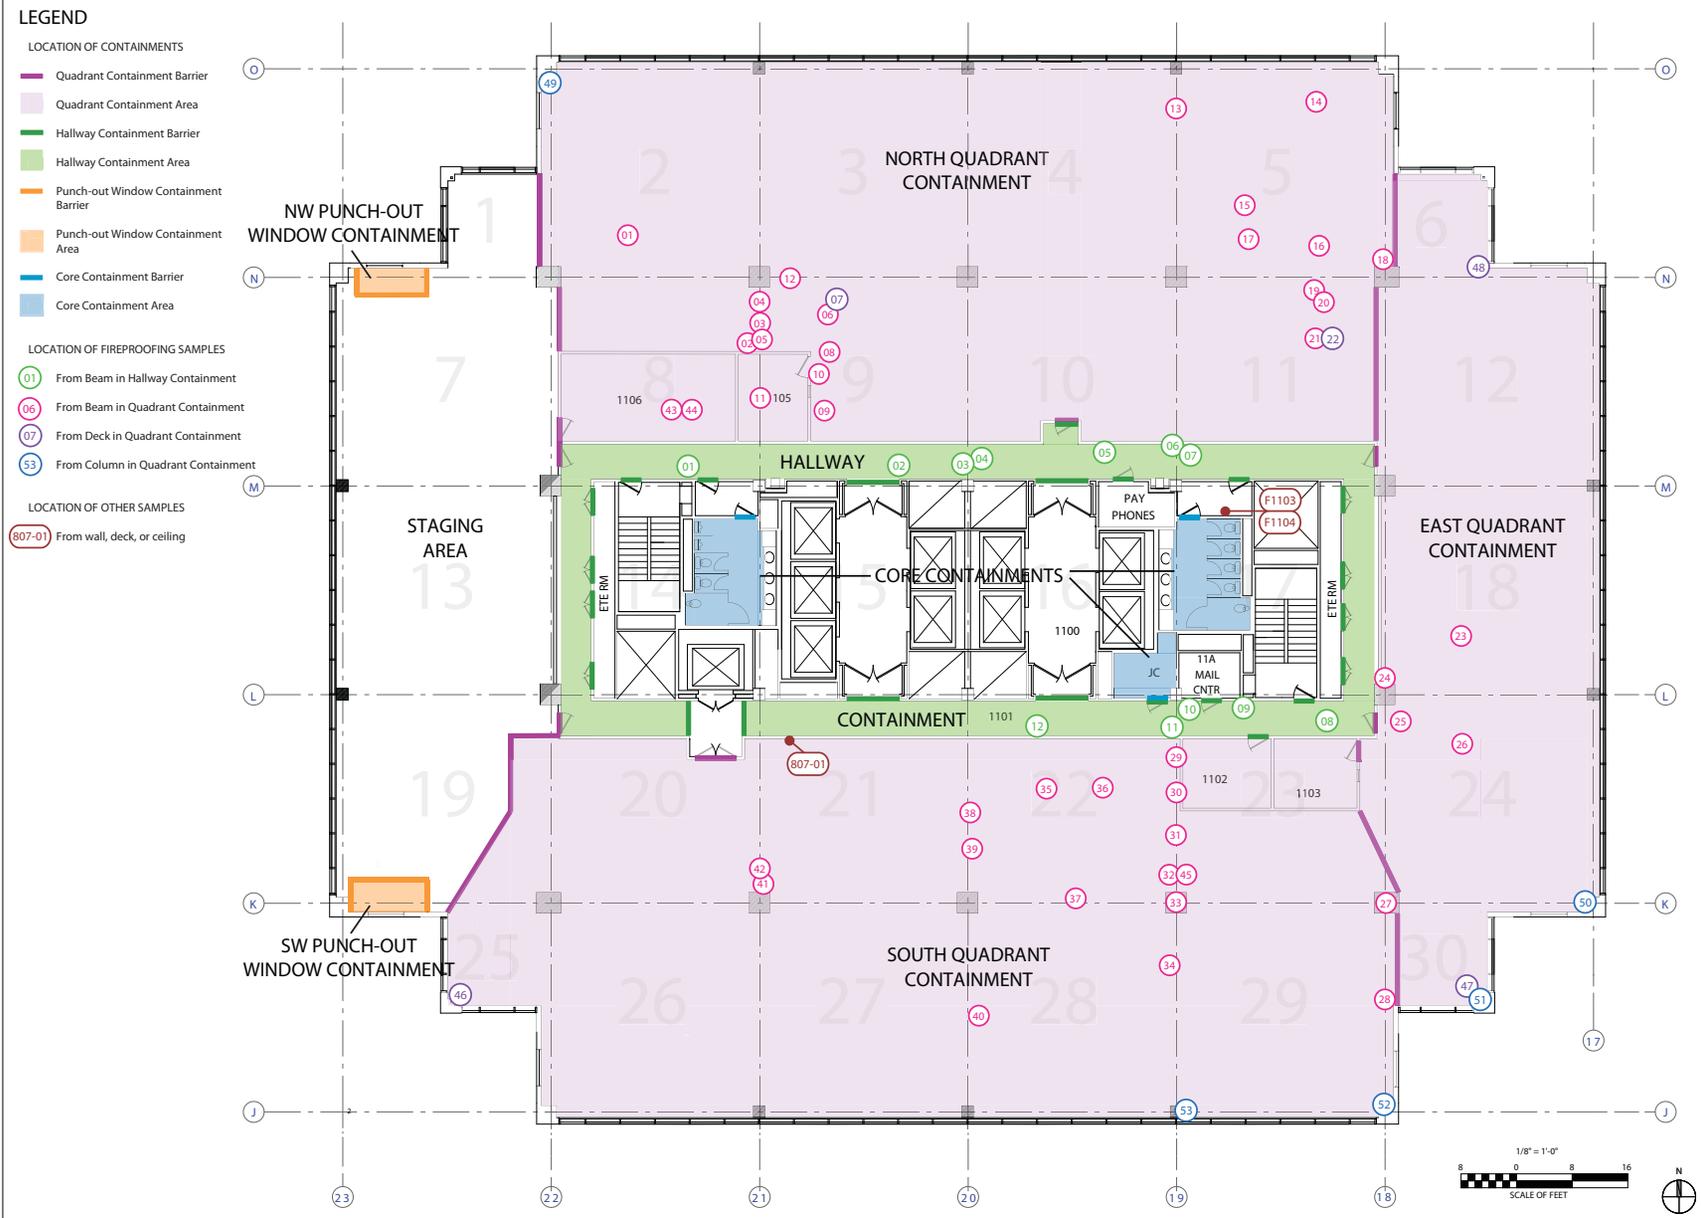
Figure 2

Identified areas were subjected to sampling. Using a combination of surface tape lift and bulk samples, LCD tested stains on walls and other building materials to determine if the stains were indicative of VMG. The sample locations are depicted in Figure 2.

Areas and materials that were identified to contain mold growth were subsequently placed under containment and subjected to an appropriate mitigative or remedial action. These actions were taken to eliminate or minimize potential exposures to VMG by personnel that may later access the subject area. The containment locations are shown in Figure 2.
