Appendix B
Daily Logs

Client	Department of General Services (DGS)	Shift	DAY PM
Project	California State Board of Equalization	Number of Workers	
Building	450 N Street, Sacramento CA	Compound(s) of Concern	Mold
Location	All floor fire sprinkler cabinets Floor: <u>10</u> Room: _____	Area:	<u>Containments</u>
LCD Project #	2372.02-572; SOW <u>5.0</u>		<u>SE Sawtooth</u>
Contractor	JLS Environmental ⁰³ <u>H2O FS RISERS</u>		<u>Room 1614</u>

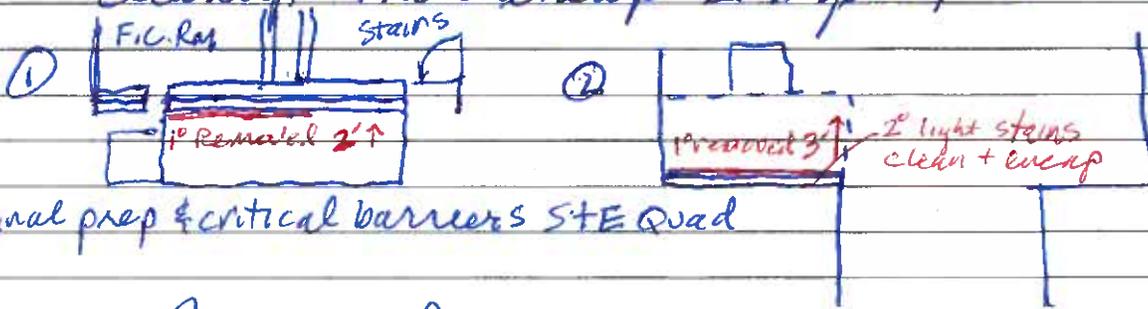
- ① Fire Control Hall - No stairs on reverse side - OK to cleanup containment & No encap necessary
- ② Mail Room - very light stain on 2^o layer OK to cleanup then encap 2^o layer.
