**California State Board of Equalization**  
450 N Street, Sacramento, California

**Mold Remediation – Second Floor**  
**August 30 – October 26, 2010**  
**Closure Report**  
*Project No. 2372.02-572*

**Report Date:**  
November 30, 2010

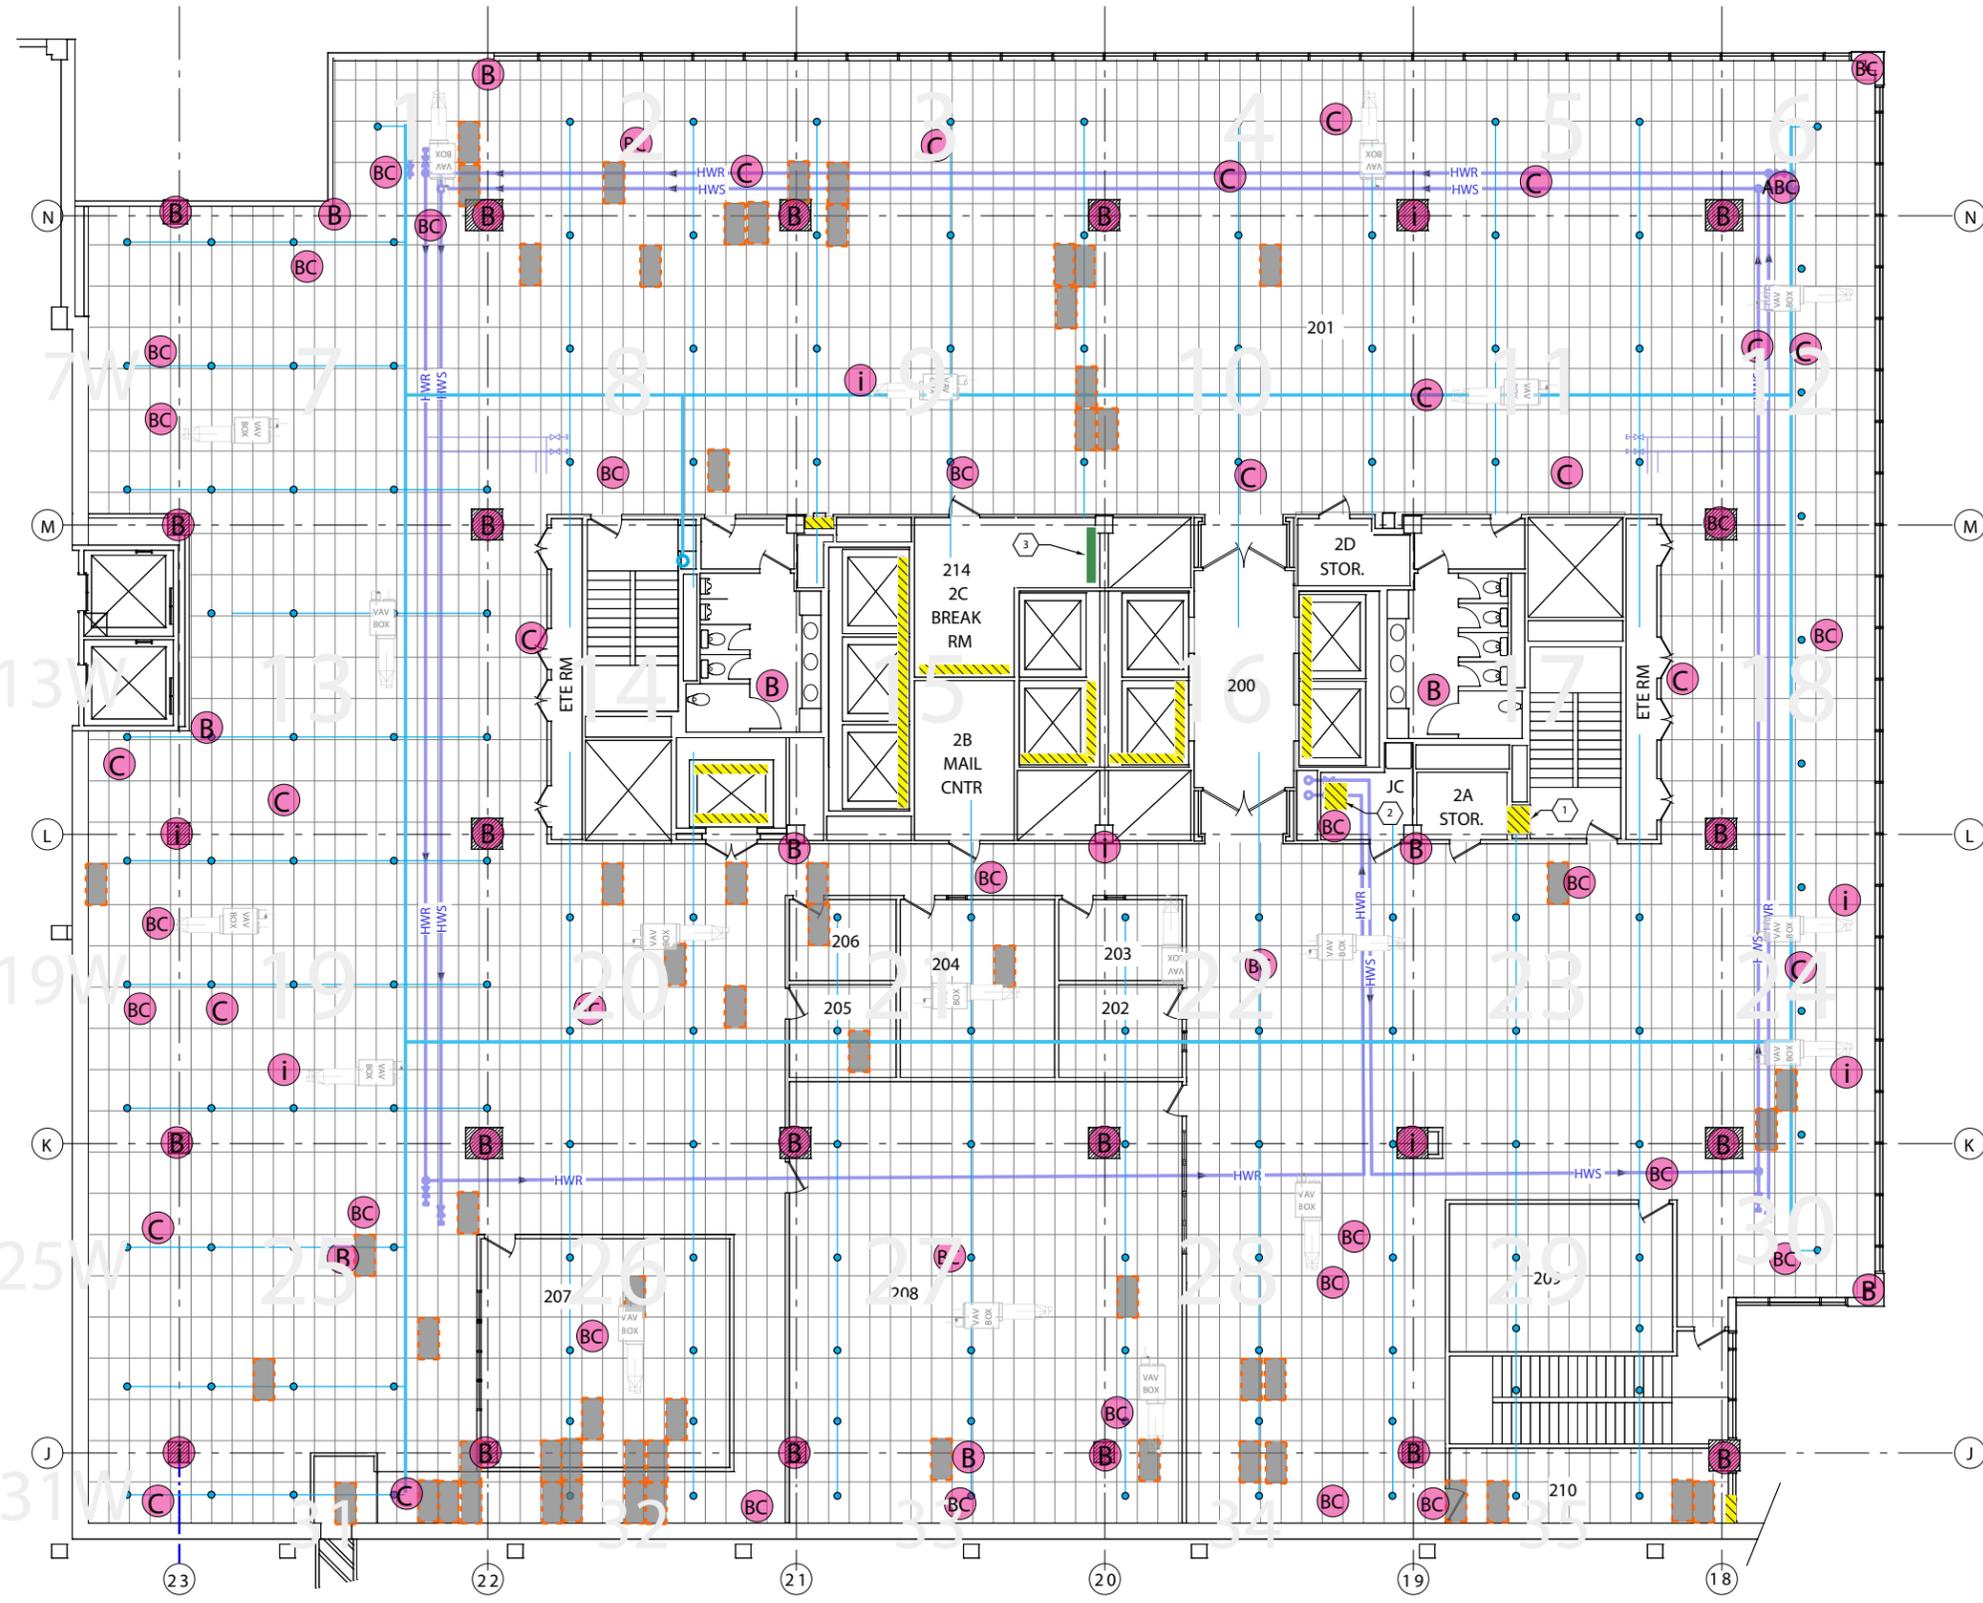
**Figure 1**    **Water Damage Assessment Revised**

- ① Water stain at standpipe
- ② Stain below pipe
- ③ Visible mold growth 10 sq.ft. above ceiling

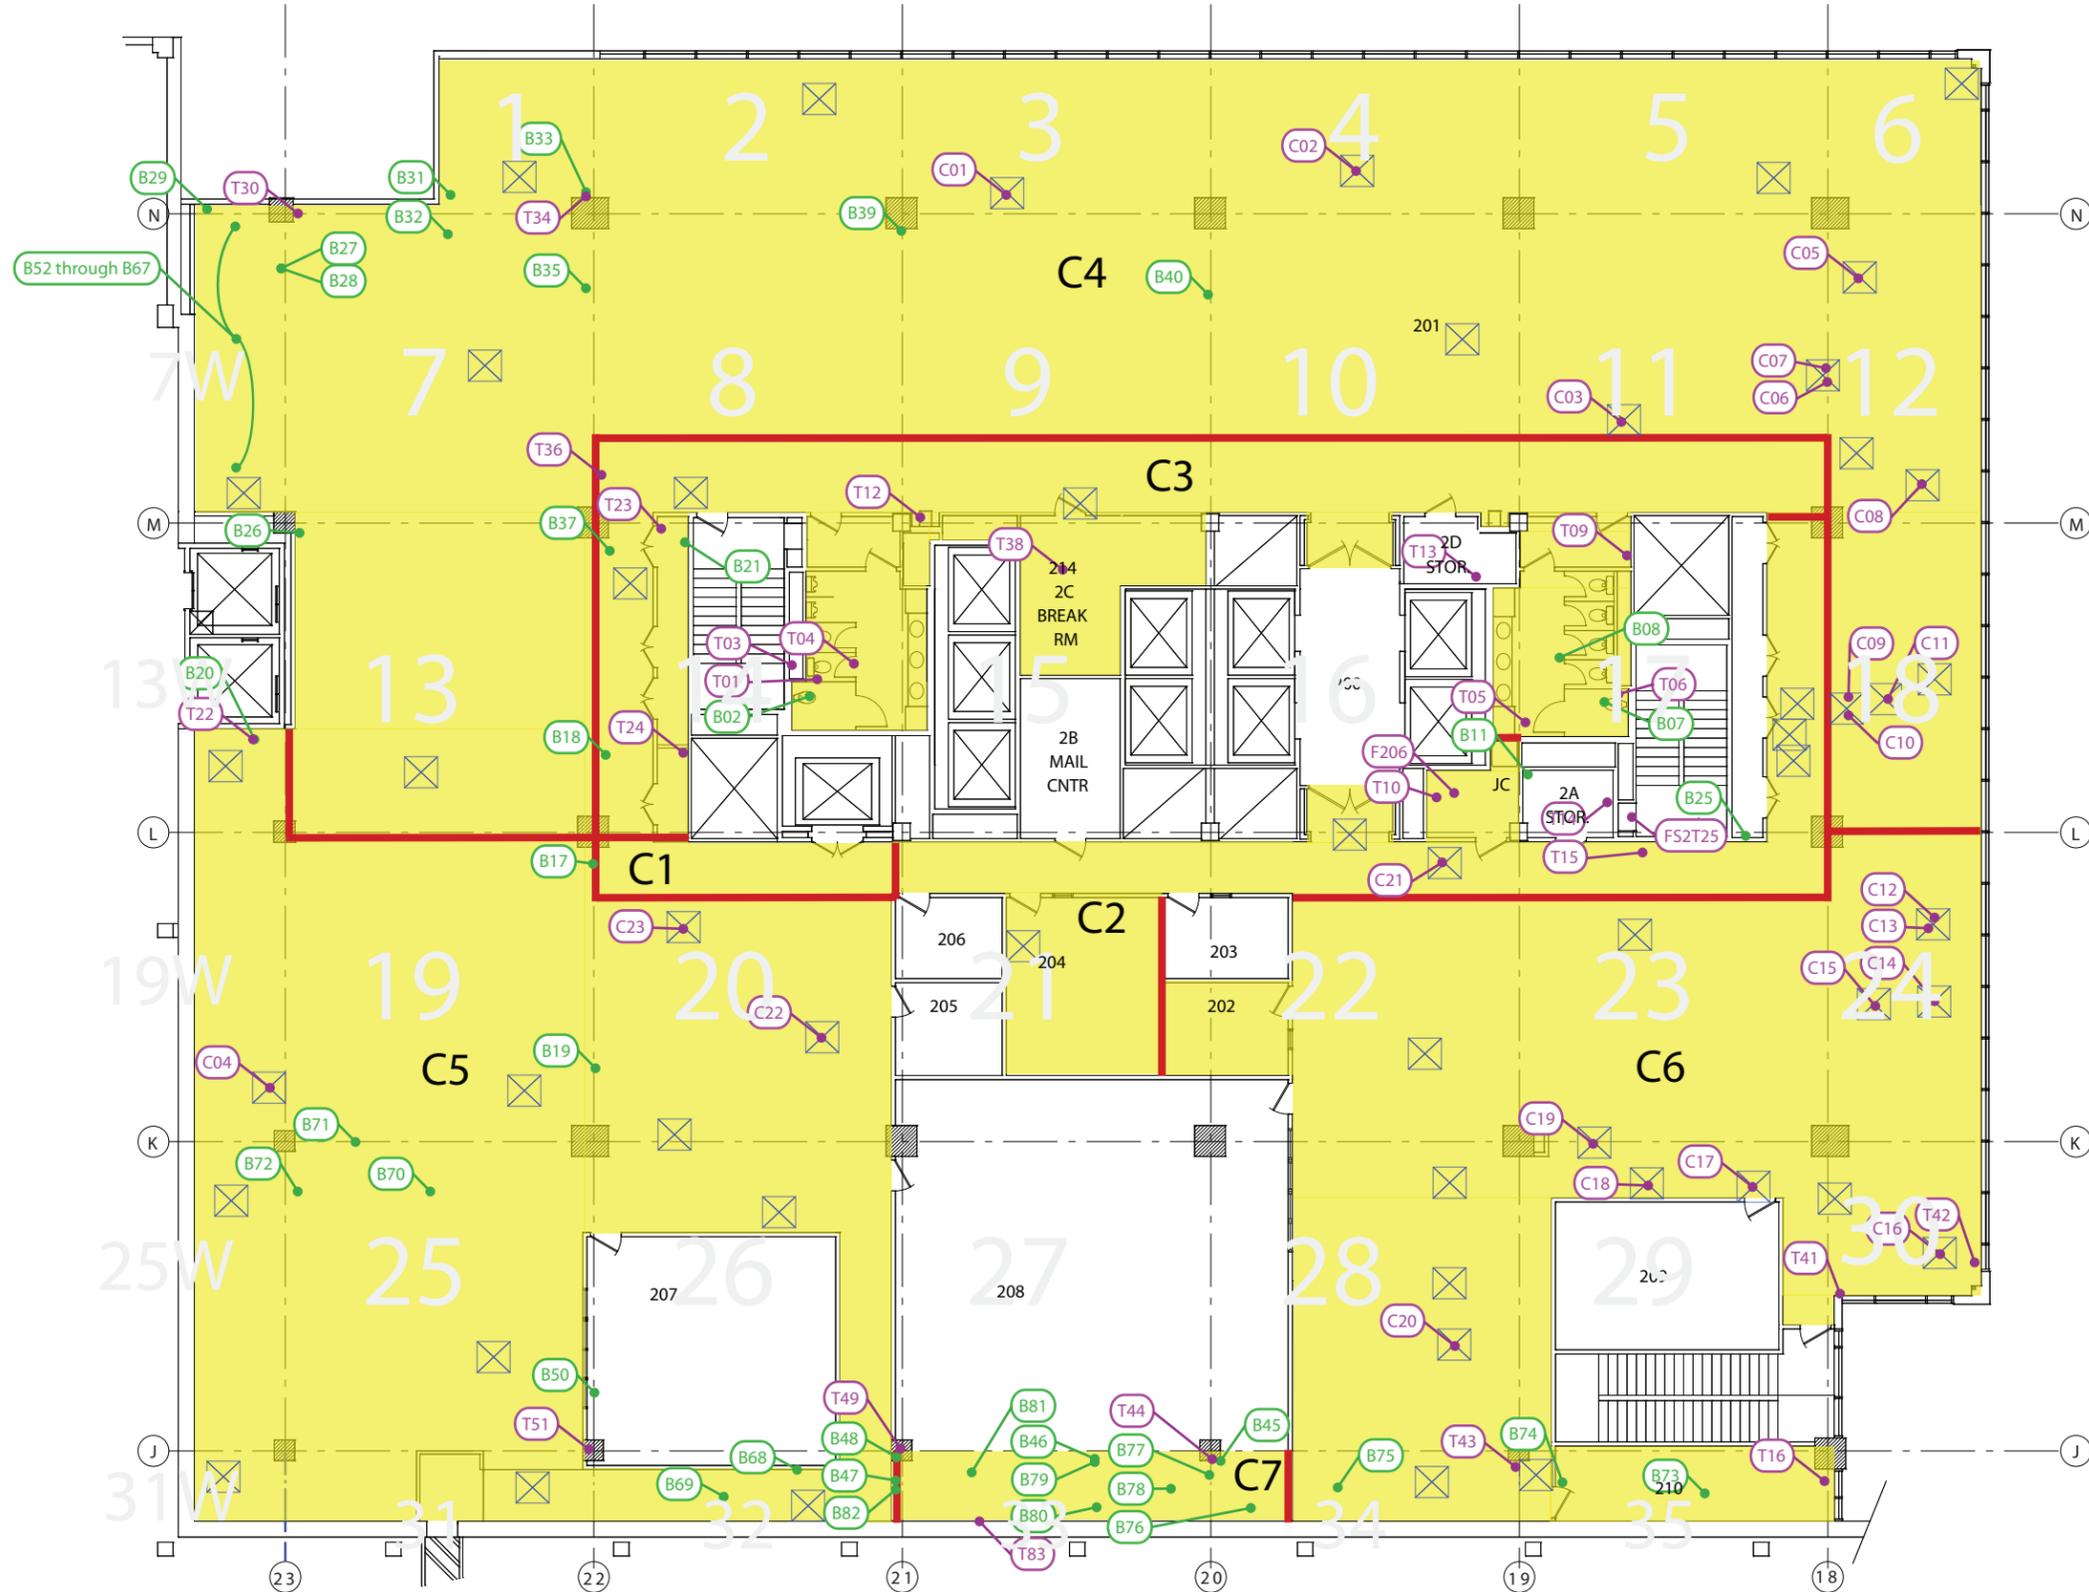
**Figure 2**    **Containment and Sample Locations**

Identified areas were subjected to sampling. Using a combination of surface tape lift and bulk samples, LCD tested stains on walls and other building materials to determine if the stains were indicative of VMG. The sample locations are depicted in Figure 2.

Areas and materials that were identified to contain mold growth were subsequently placed under containment and subjected to an appropriate mitigative or remedial action. These actions were taken to eliminate or minimize potential exposures to VMG by personnel that may later access the subject area. The containment locations are shown in Figure 2.
