California State Board of Equalization
450 N Street, Sacramento, California

Mold Remediation – 6th Floor
April 1 – May 5, 2010
Closure Report
Project No. 2372.02-572

Report Date:
June 29, 2010

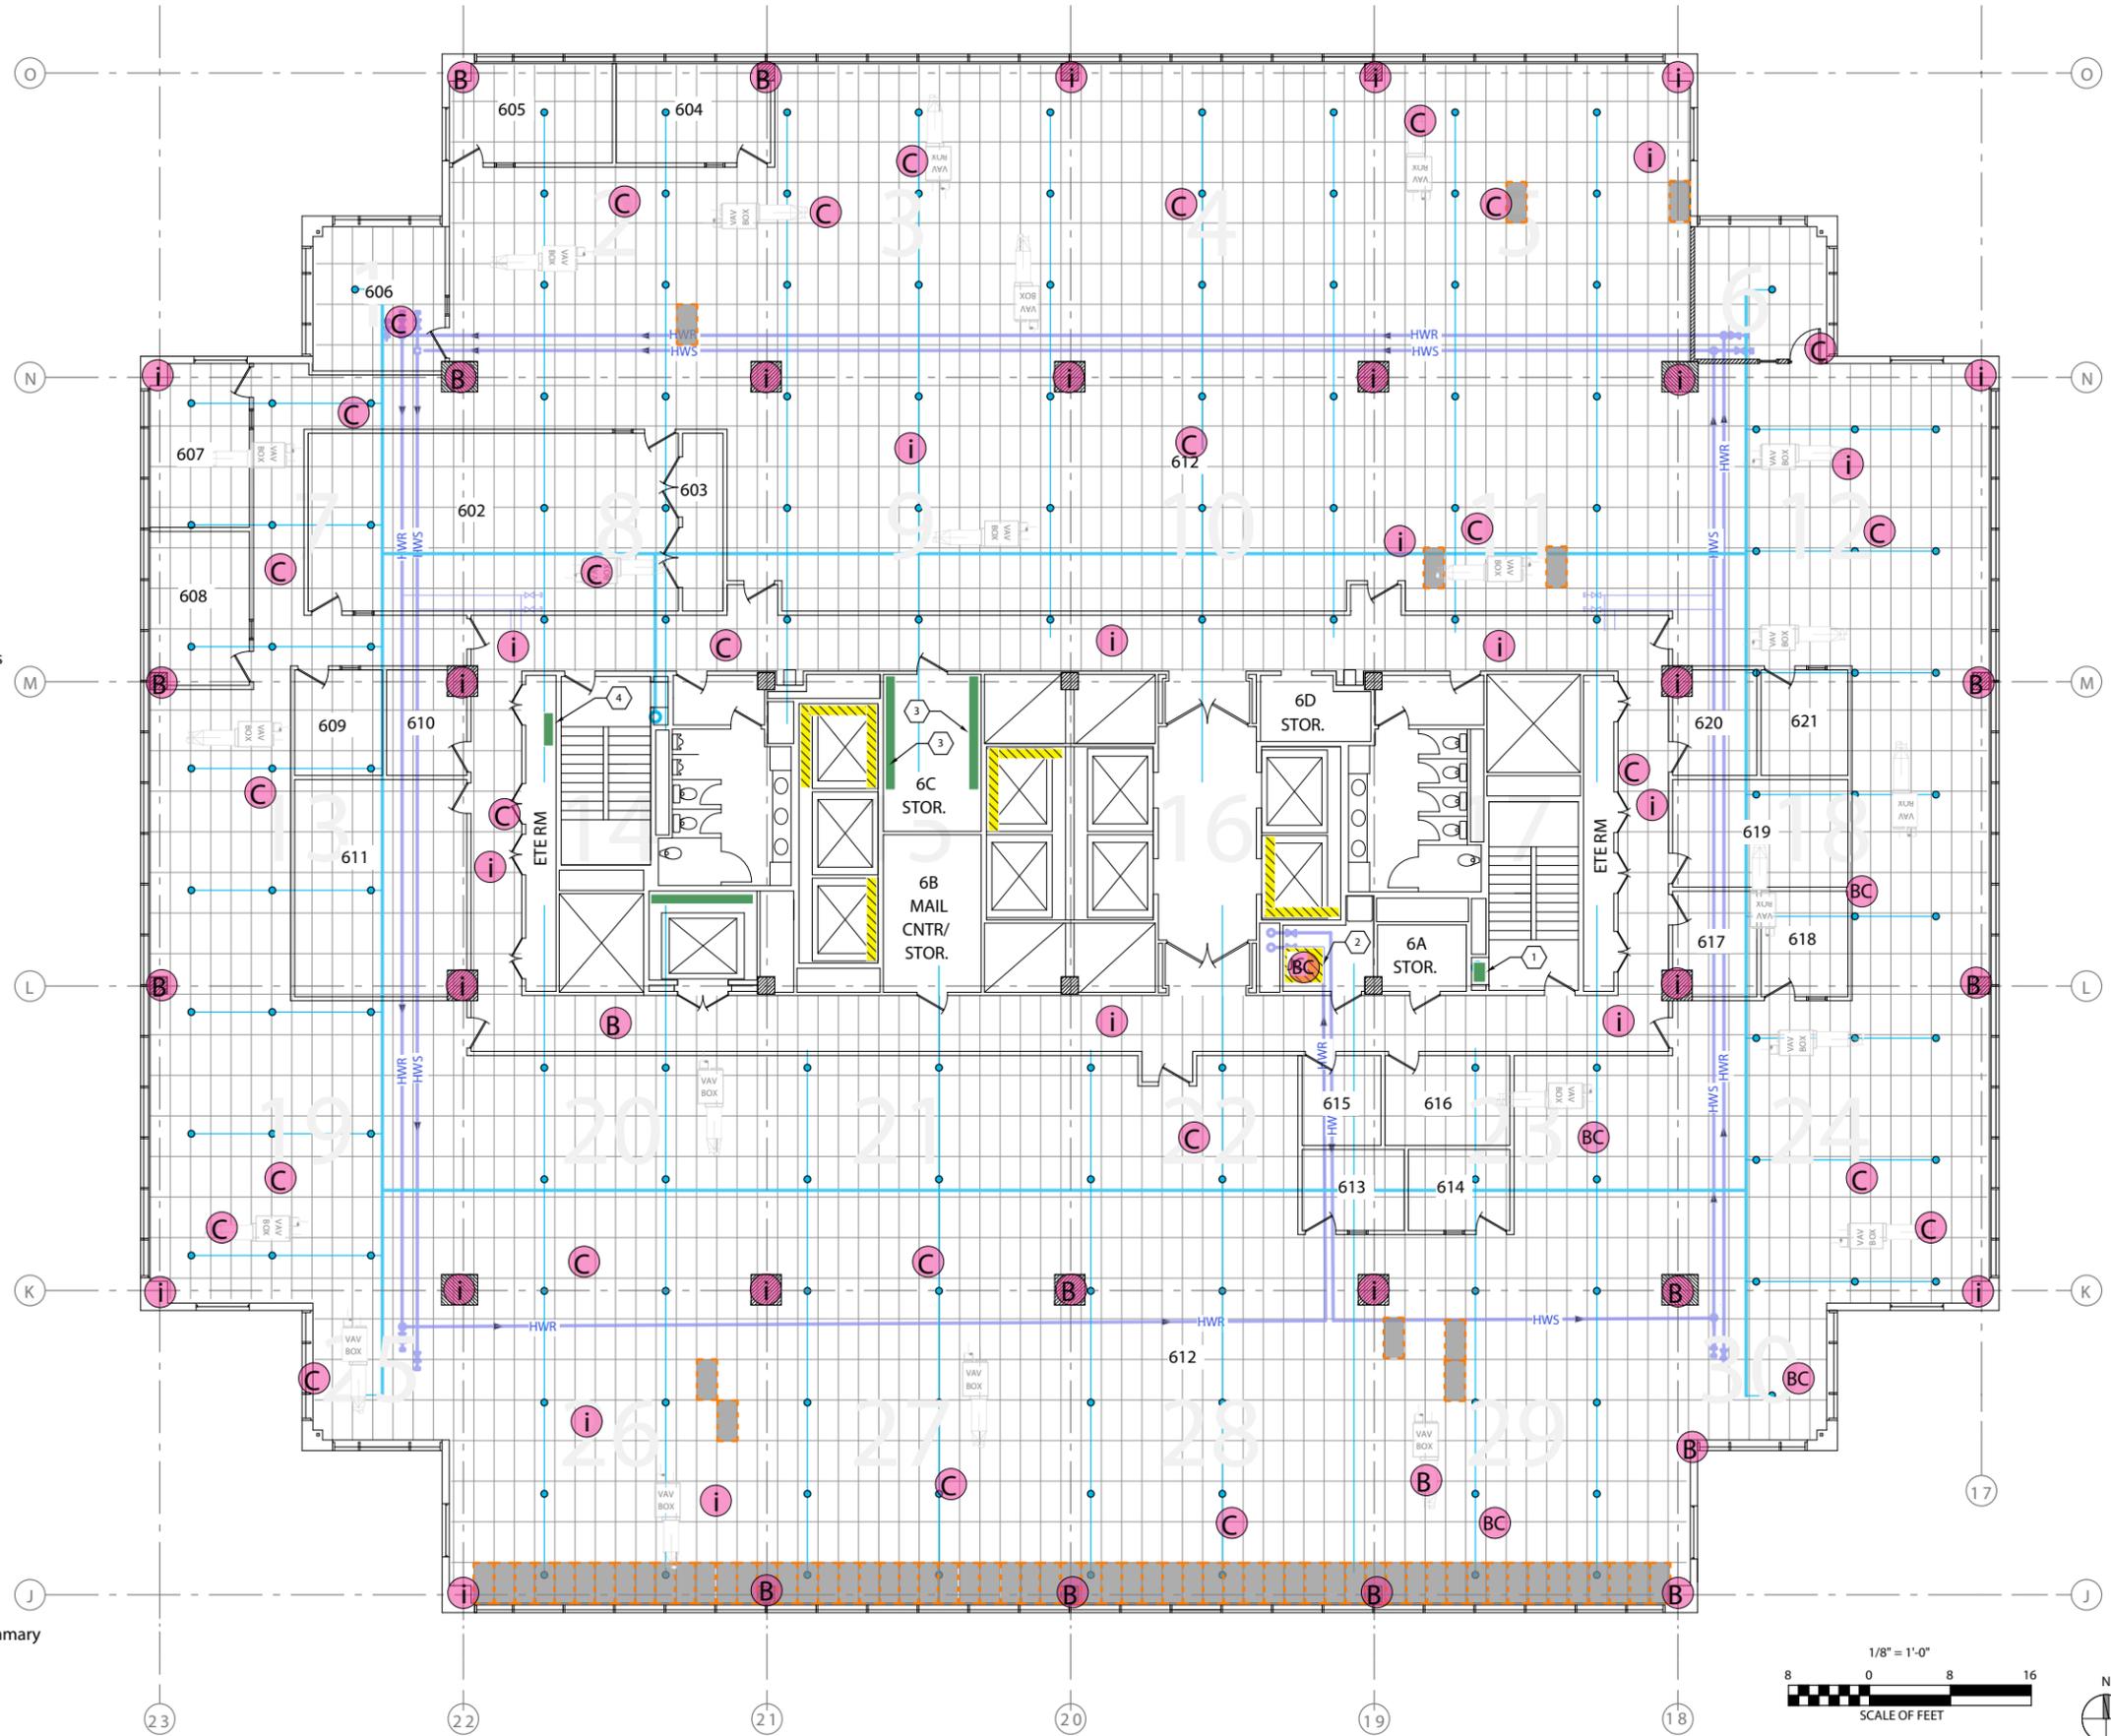
Figure 1 Water Damage Assessment Revised

- 1 Visible mold growth 10 sq. ft. on South and West walls
- 2 Water stain on ceiling, extensive water damage
- 3 Visible mold growth 100 sq. ft. above ceiling
- 4 Visible mold growth 1 sq. ft.

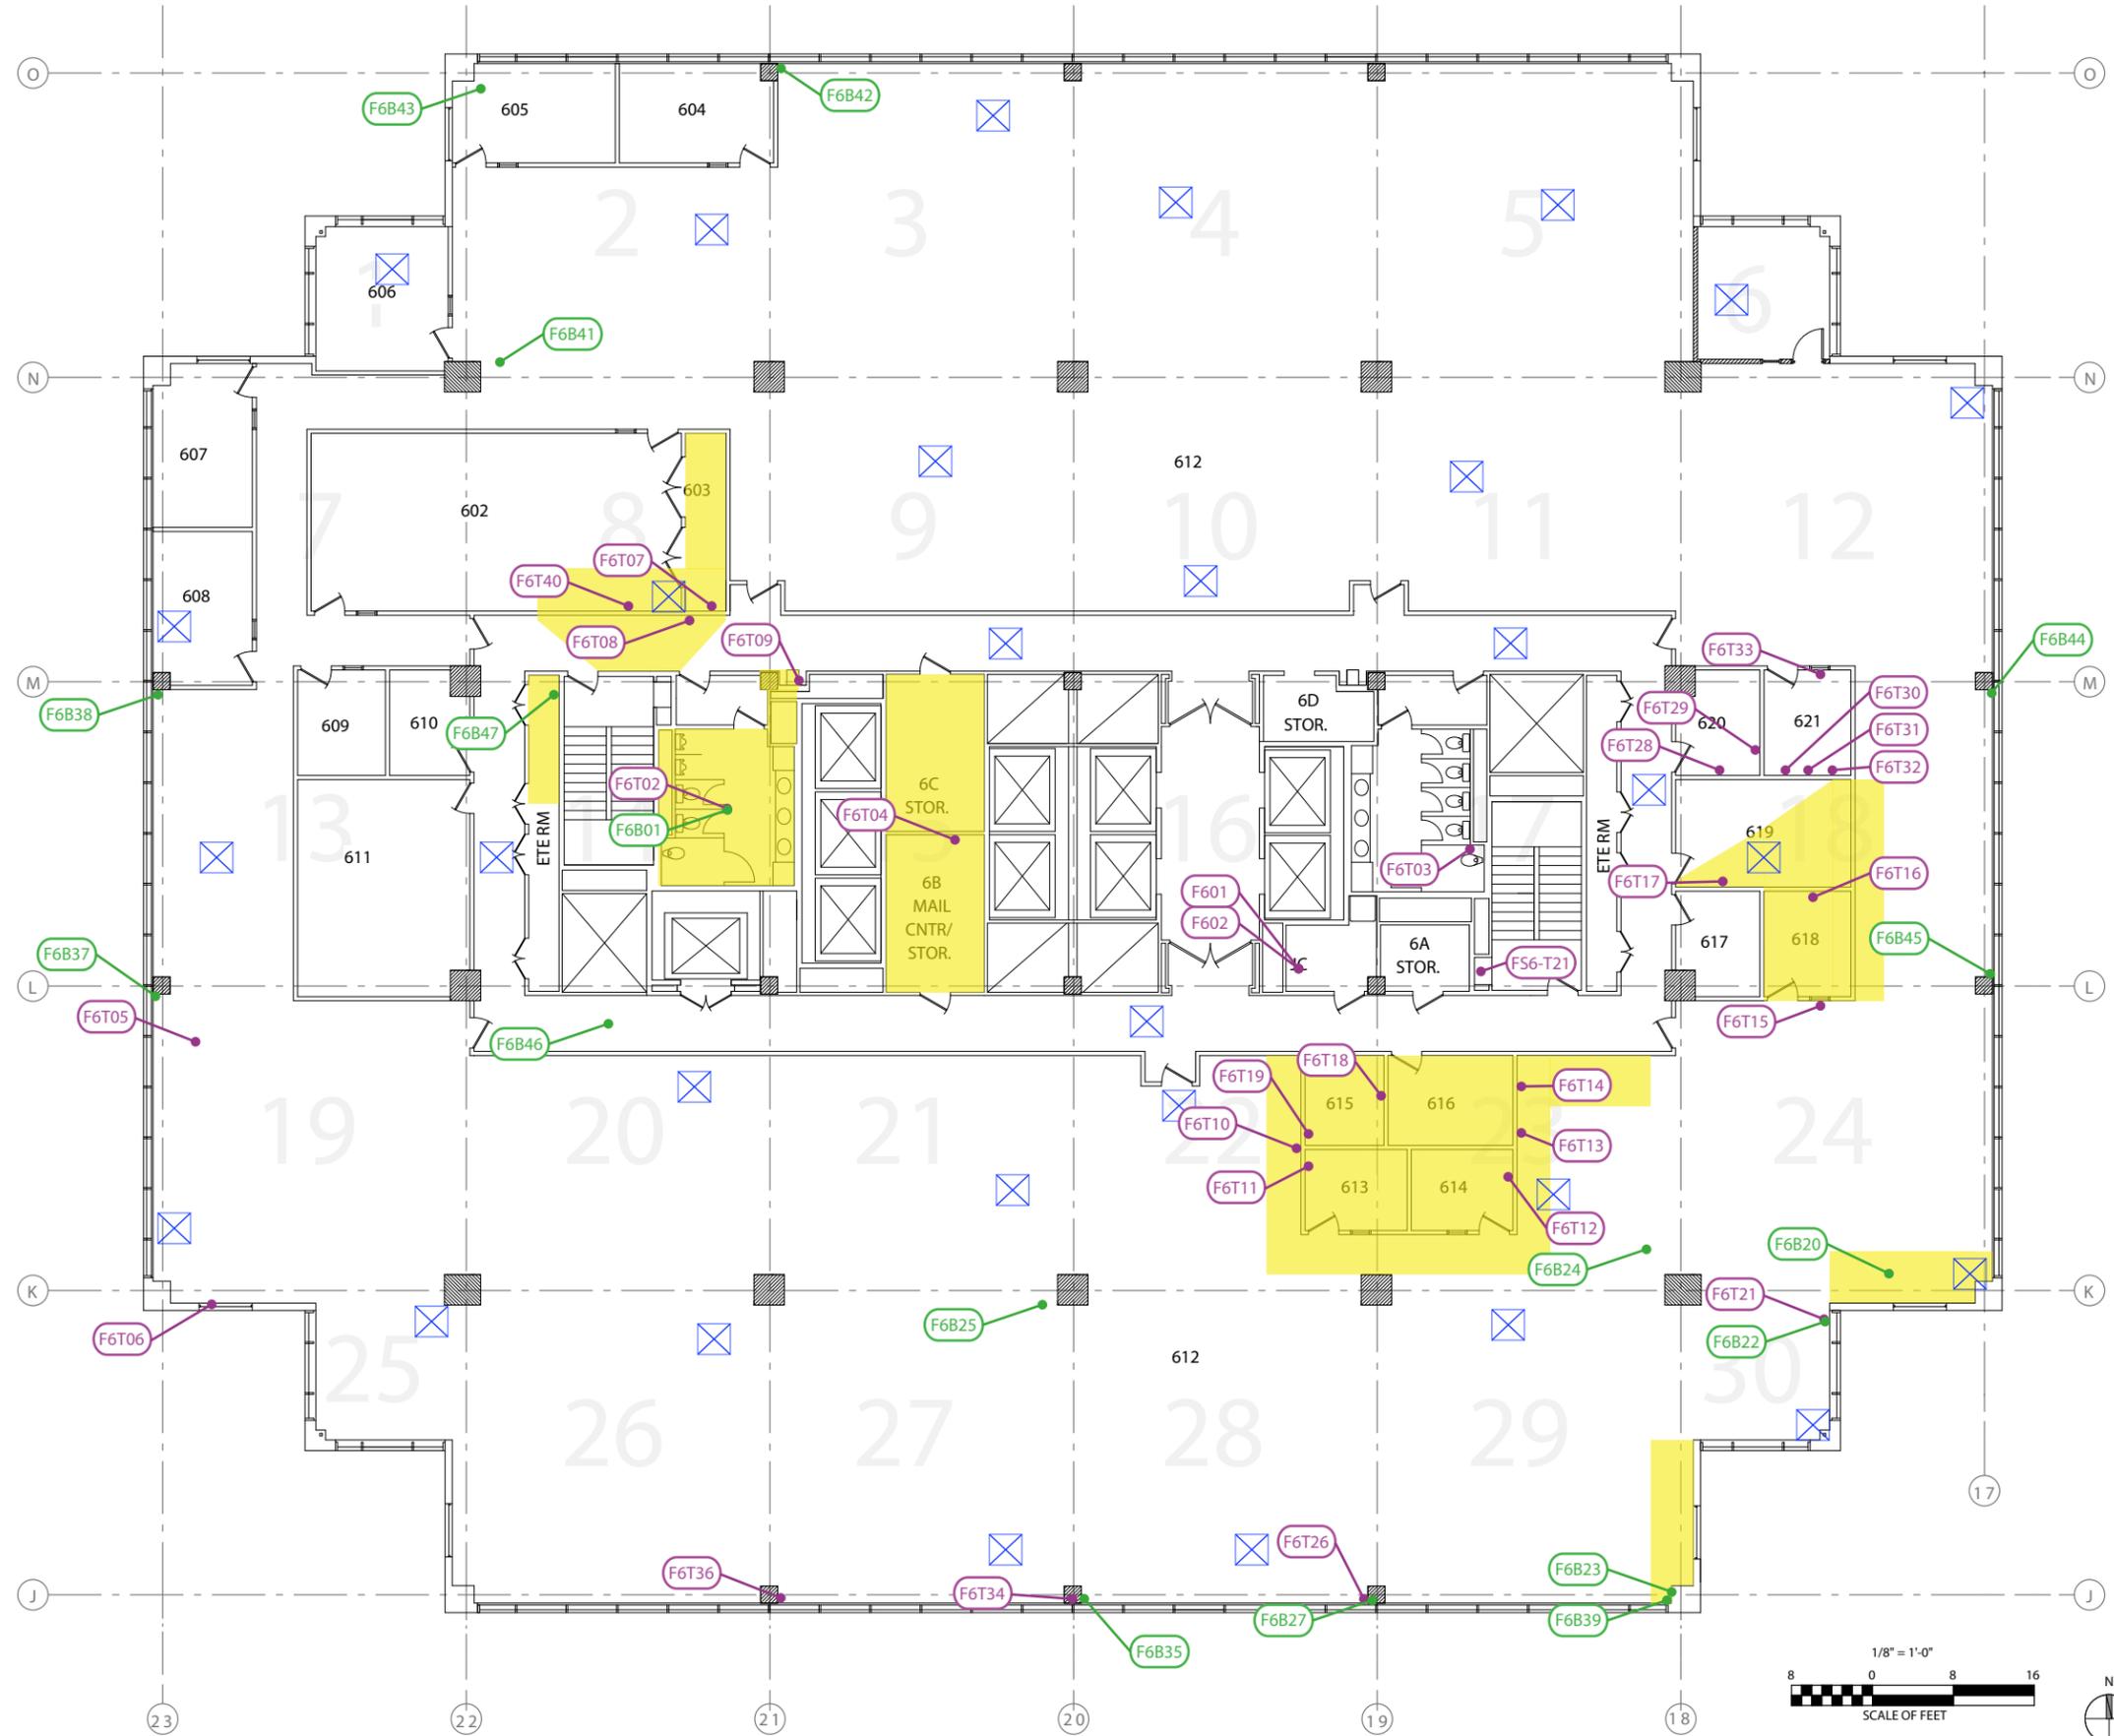
Figure 2 Containment and Sample Locations

Areas and materials that were identified to contain mold growth were subsequently placed under containment and subjected to an appropriate mitigative or remedial action. These actions were taken to eliminate or minimize potential exposures to VMG by personnel that may later access the subject area. The containment locations are shown in Figure 2.

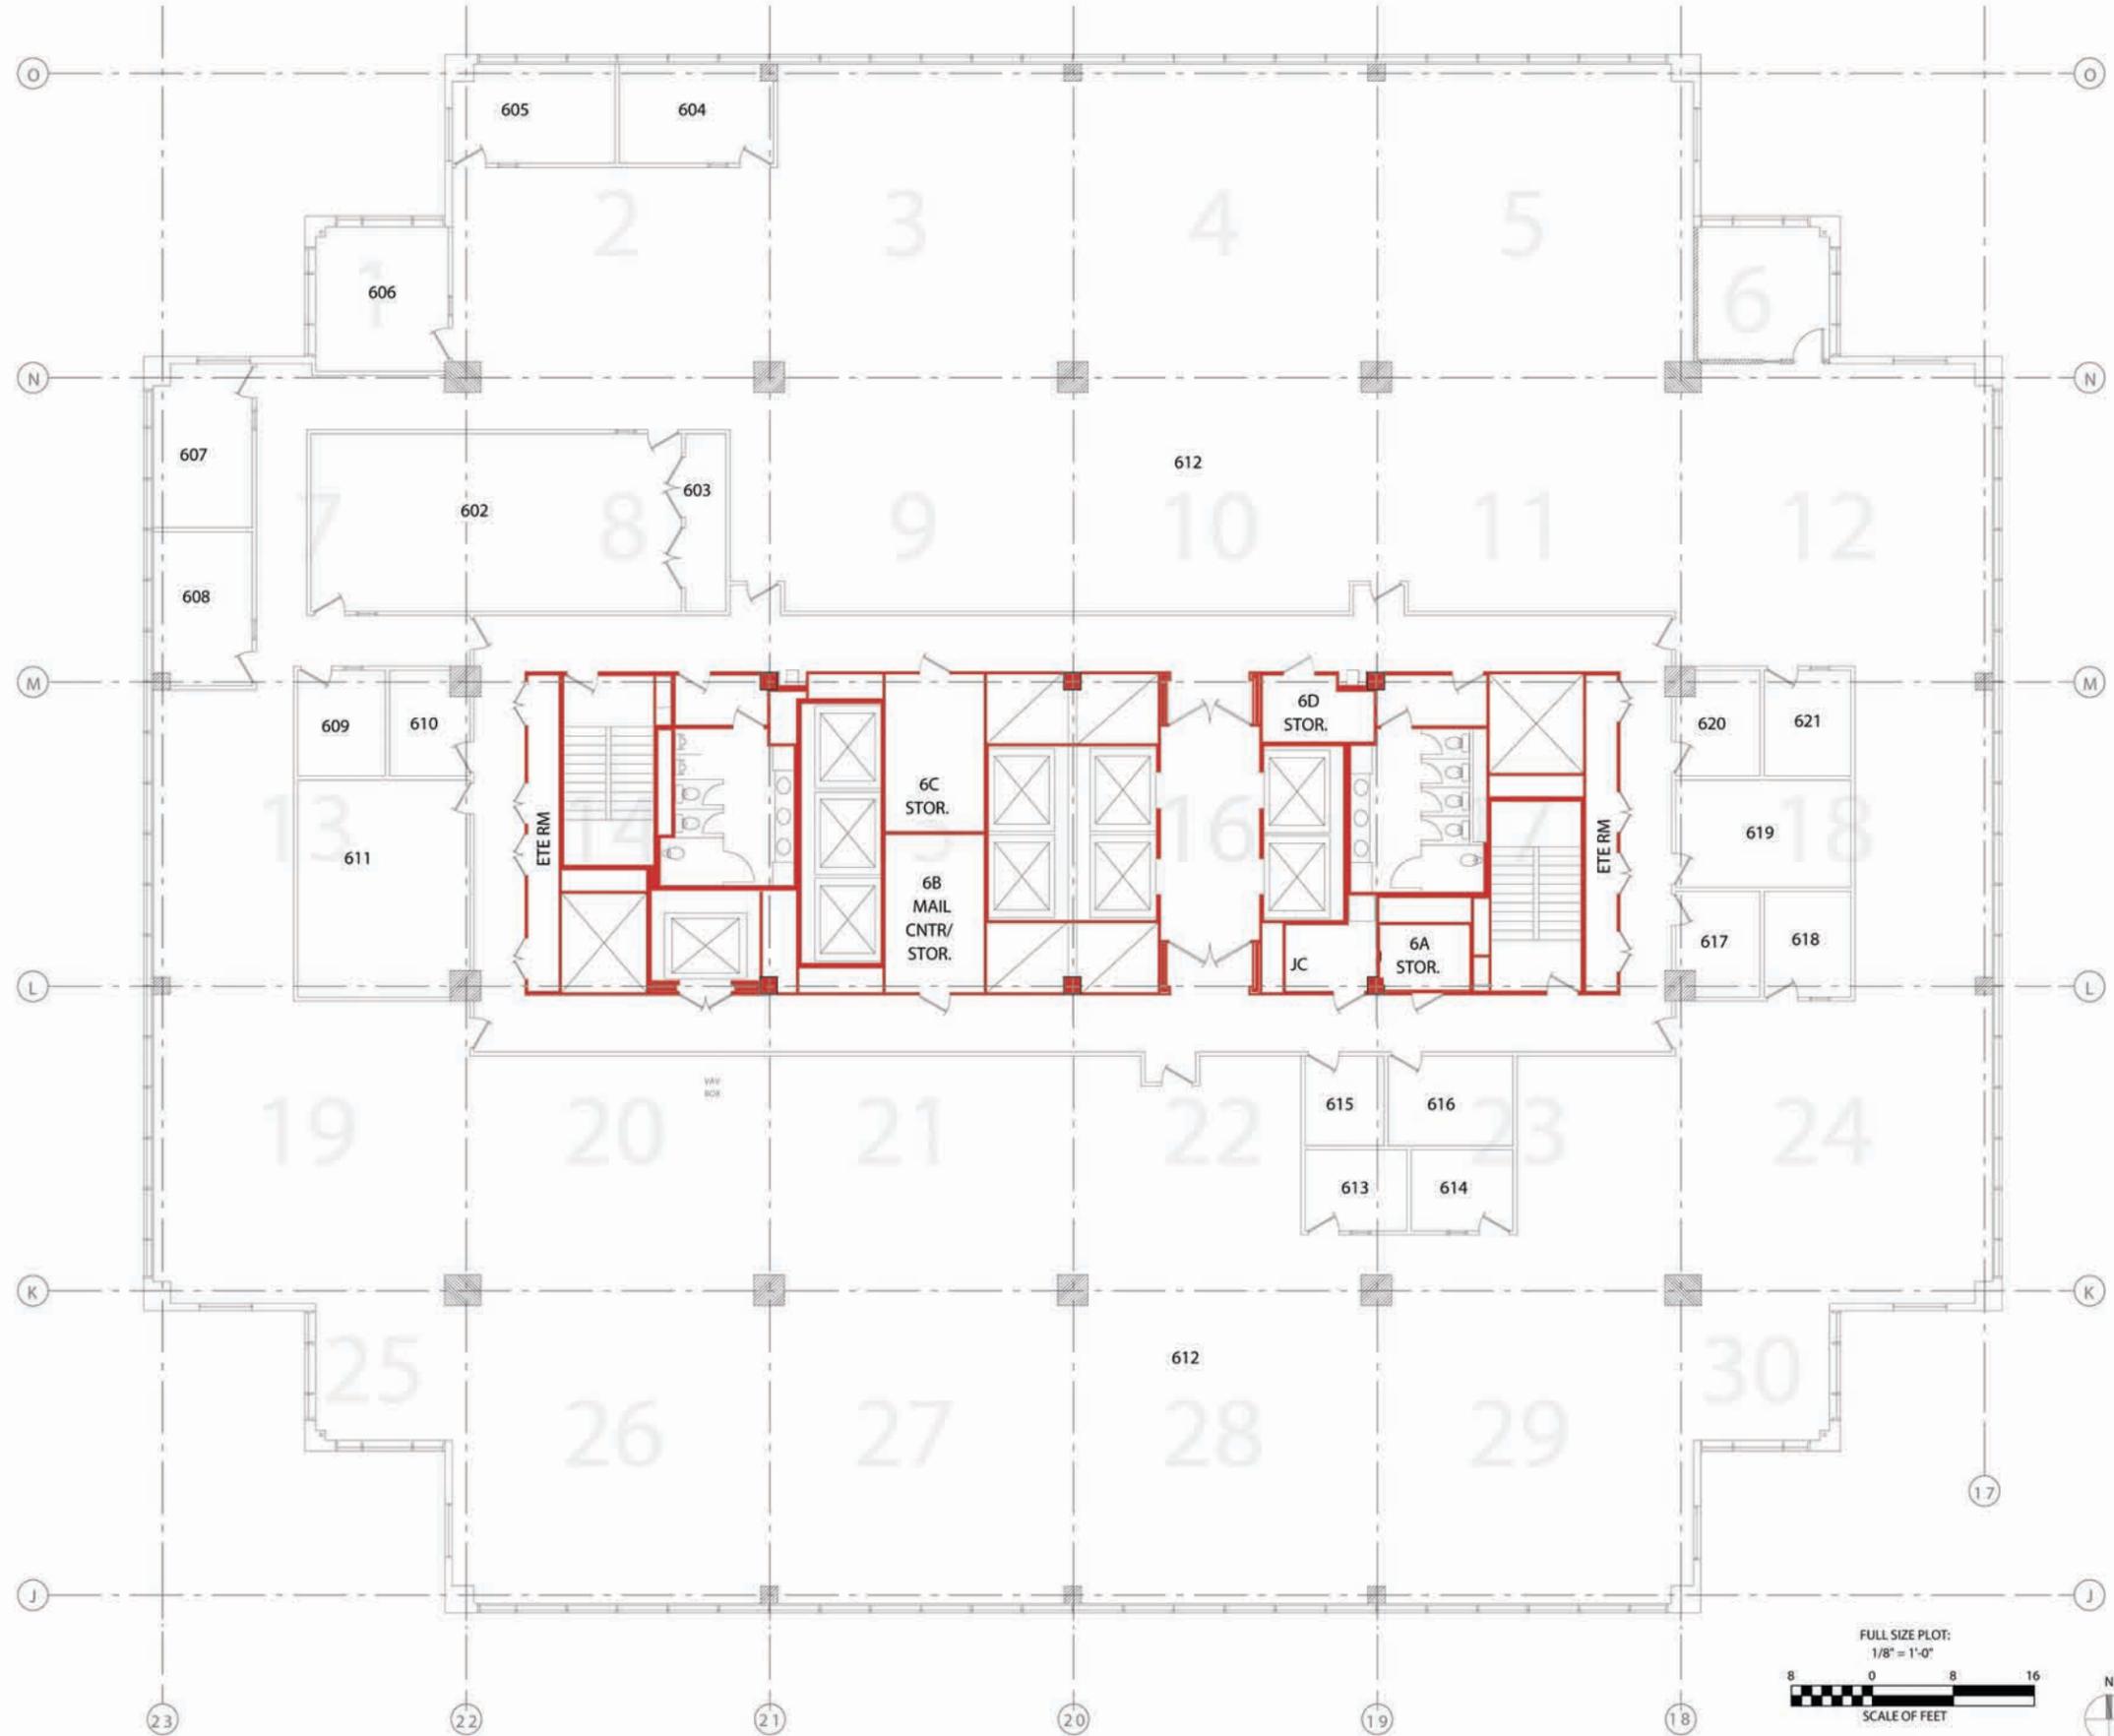
Figure 3

Suspect Mold - May 2010
Board of Equalization Building, Mold Remediation
450 N Street, Sacramento, California
