California State Board of Equalization
450 N Street, Sacramento, California

Mold Remediation – Mechanical Floor
April 1 – August 24, 2011
Closure Report
Project No. 2372.02-572

Report Date:
February 17, 2012

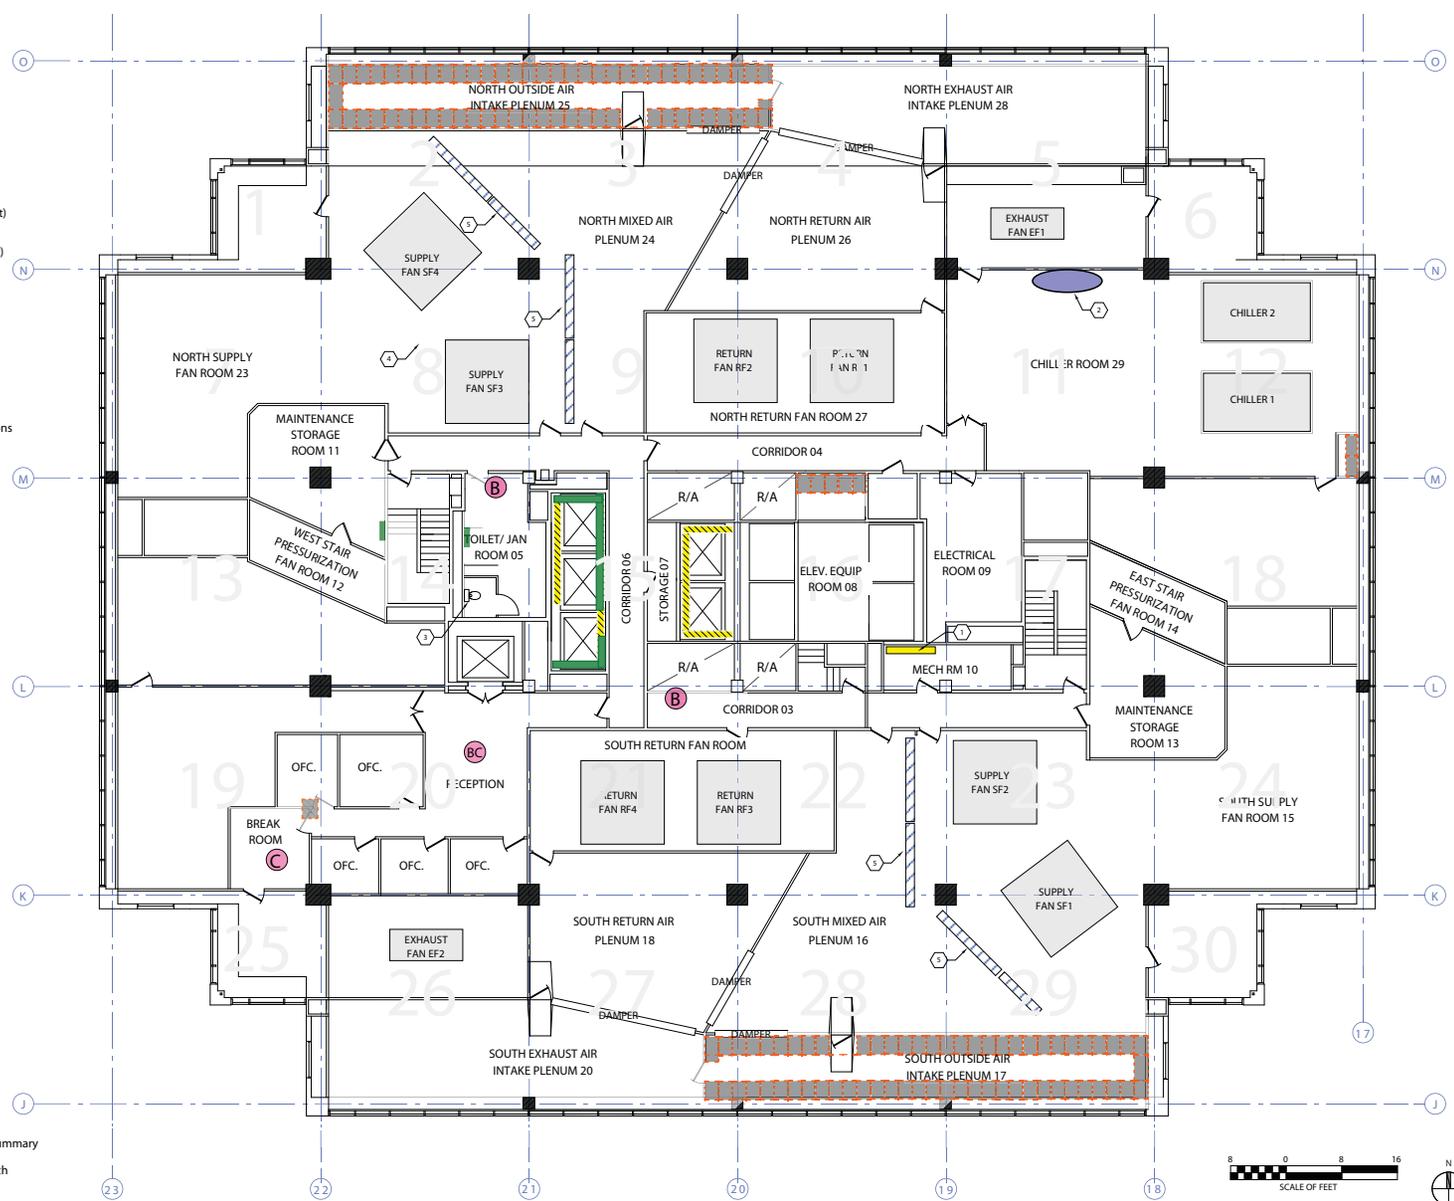
Figure 1 **Water Damage Assessment Revised**

- ① L/19 Water stain on concrete floor (current)
- ② N/18.5 failure of chiller tank chemical manifold (historic)
- ③ Floor tile damage from water behind toilet (current)
- ④ Loose acoustic ceiling tile (current)
- ⑤ Condensate pans rusting (current)

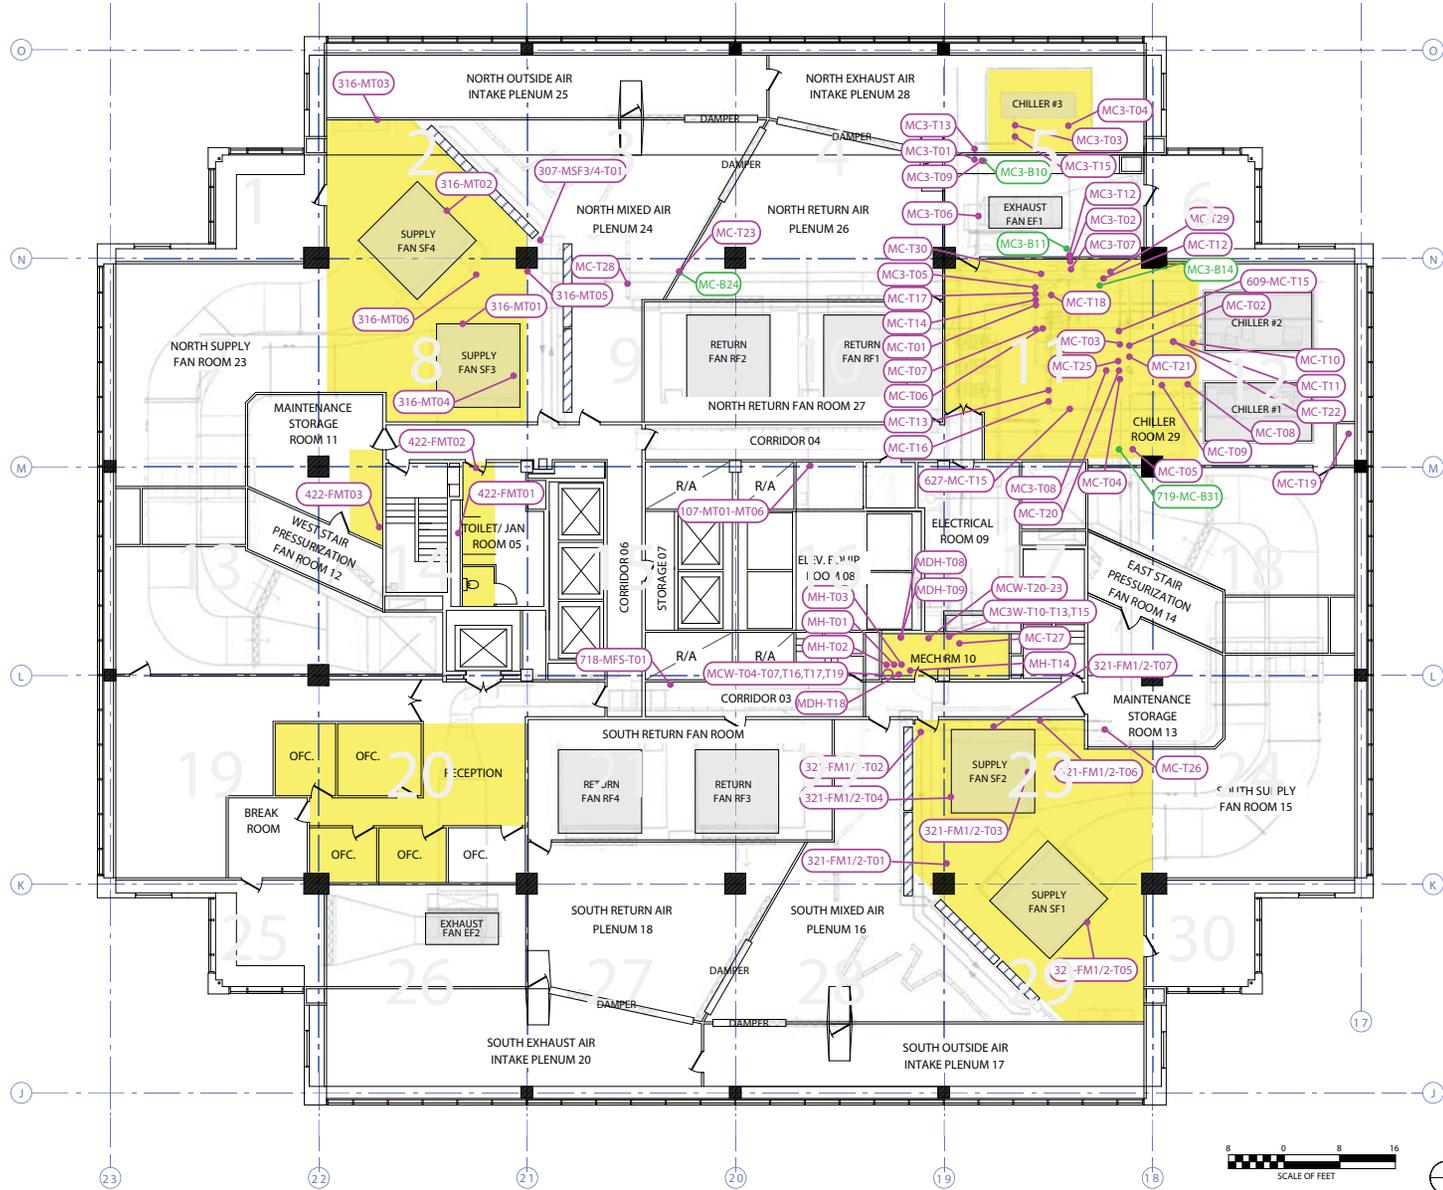
Figure 2

Identified areas of concern were subjected to sampling. Using a combination of surface tape lift and bulk samples, LCD tested stains on walls and other building materials to determine if the stains were indicative of visible mold growth (VMG). The sample locations are shown in Figure 2.

Areas and materials that were identified to contain mold growth were subsequently placed under containment and subjected to an appropriate mitigative or remedial action. These actions were taken to eliminate or minimize potential exposures to VMG by personnel that may later access the subject area. The containment locations are shown in Figure 2.

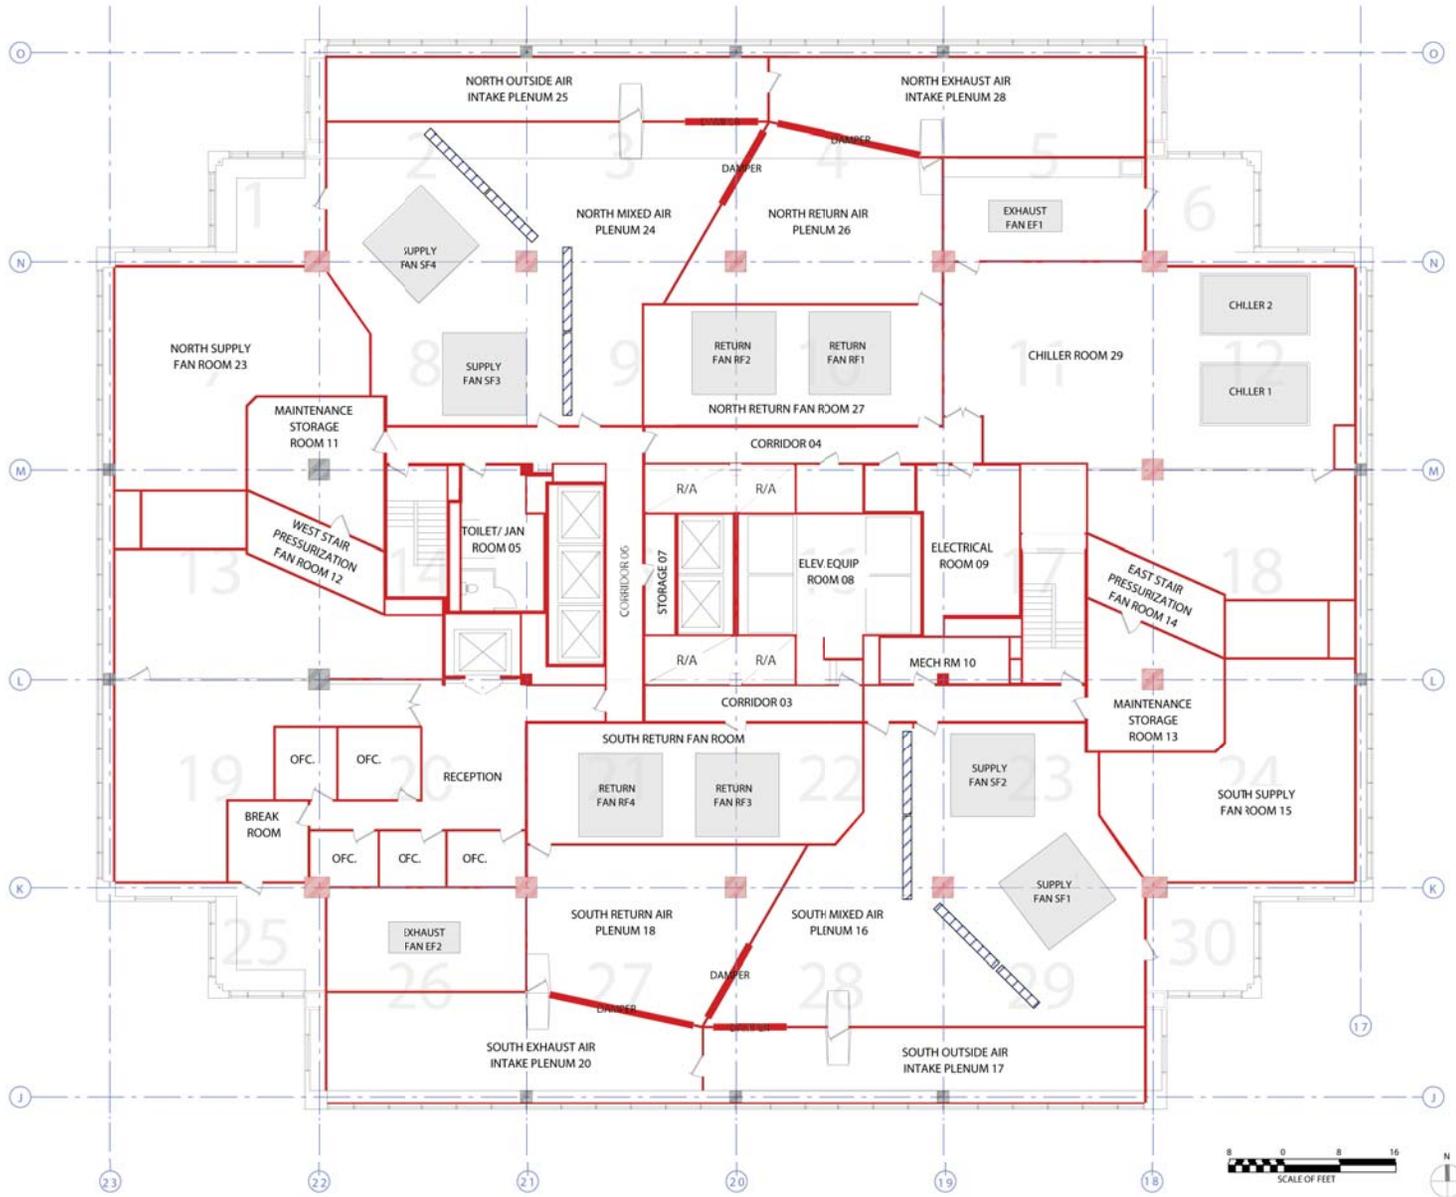
Figure 3

Suspect mold location
