APPENDIX B – INVESTIGATION PHOTOGRAPHS

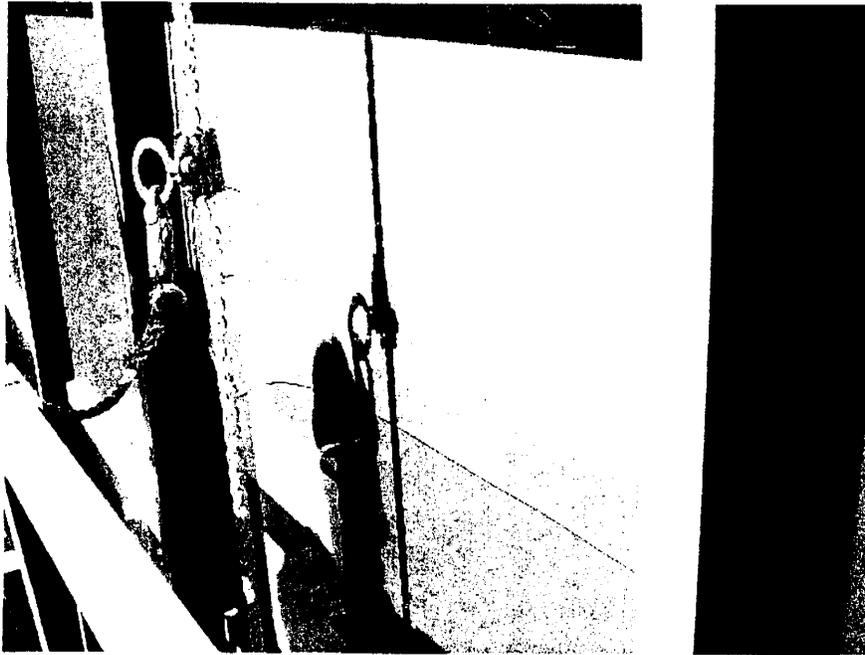
Photo 1: Cracked spandrel glass near gold bull-nose attachment
