30 January 2012

Project 060230 – Spandrel Glass Stress Measurement, 450 N Street, Sacramento, CA

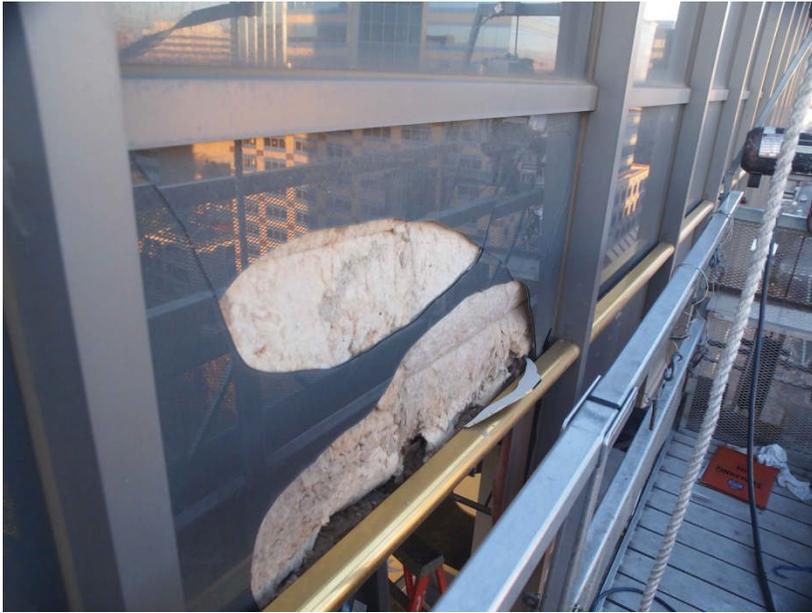
Martin Photo 016

- A horizontal bar that is attached to the vertical members of the curtain wall framing and sits slightly outboard of the outside surface of the glass, casts shade onto the glass (Martin Photo 016).
- A closely spaced series of fracture lines emanate from a point in the vicinity of the horizontal bar (Martin Photo 022).
- Another confluence of fracture lines is shown in Martin Photo 005 emanating from what appears to be the sill glazing pocket.

- **Projectile Impact:** We cannot assess the likelihood of this cause based on the information we have.
- **Thermal stress:** The shadow cast by the horizontal bar and the insulation in contact with the inboard side of the glass can create reasonably high thermal stress. Heat strengthened glass, however, is very resistant to thermal stresses of the magnitude likely imposed by these features. Excessive thermal stress is not a likely cause of the fracture.

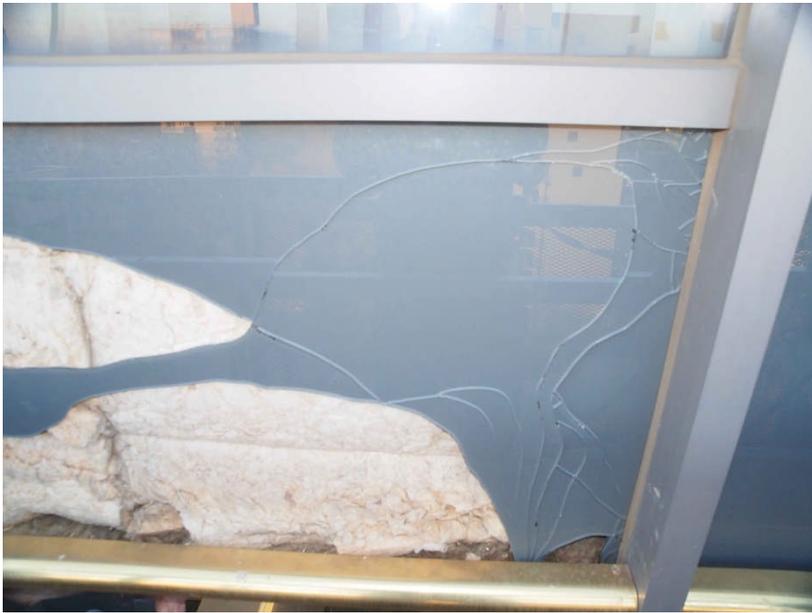
Martin Photo 022

- **Spontaneous Fracture from Nickel Sulfide Impurity:** The RSCS measurements of the spandrel glass that we conducted in 2006 show that much of the glass has residual stress sufficient to make the glass susceptible to breakage from a Nickel Sulfide (NiS) impurity. This impurity can undergo a change in its solid state (i.e., a phase transformation), which is accompanied by slight expansion. If the particle exists near the mid-plane of fully tempered glass, or the mid-plane of highly tempered heat-strengthened glass, the particle expansion, in combination with the residual tension that exists near the mid-plane of the glass, can propagate a fracture in the glass. The phase transformation of NiS is triggered by the cumulative effect of thermal energy on the particle since the time of manufacture. The time to the phase transformation can be days to decades.

Our 2006 measurements show that the spandrel glass on this building generally has high residual stresses. (Current heat strengthened glass is limited by ASTM Standards to an upper limit of 7,500 psi, many years ago the limit was 10,000 psi). This level of built-in residual stress makes this glass susceptible to NiS-generated fractures. The fact that fractures of the spandrel

glass on this building have apparently occurred over a long period of time, without any obvious external source of stress, further indicate NiS impurities as the most likely cause.

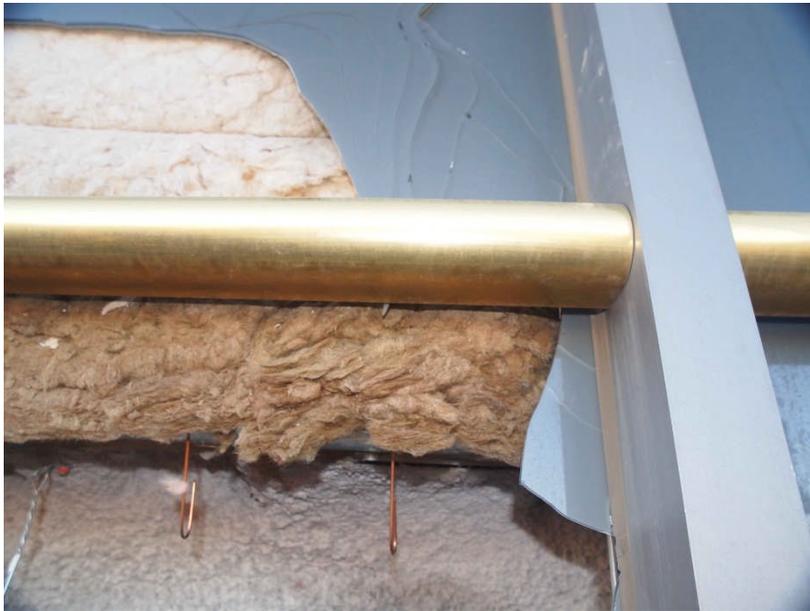
Martin Photo 033

- The spandrel insulation appears to be in contact with the inboard side of the glass (Martin Photo 033)
