Attachment A: Digital Images

June 11th, 2008

BOE Building 19th Floor Break Room Areas (1905 + 1908)
Sacramento, CA

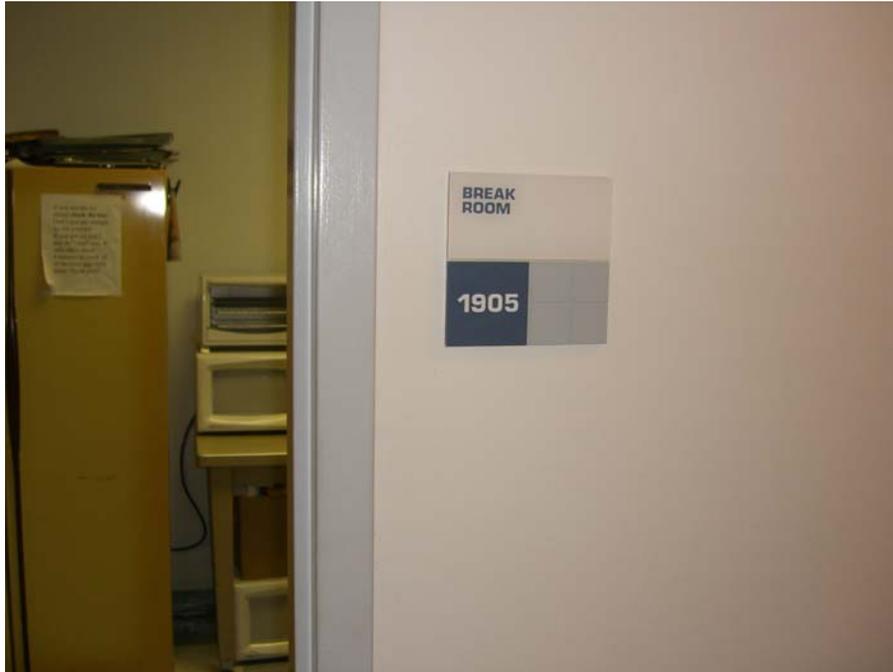
- 1) Image of 19th Floor Break Room (1905) main entrance at time of assessment of BOE Building (Subject Building) located at 450 N Street, Sacramento, California.

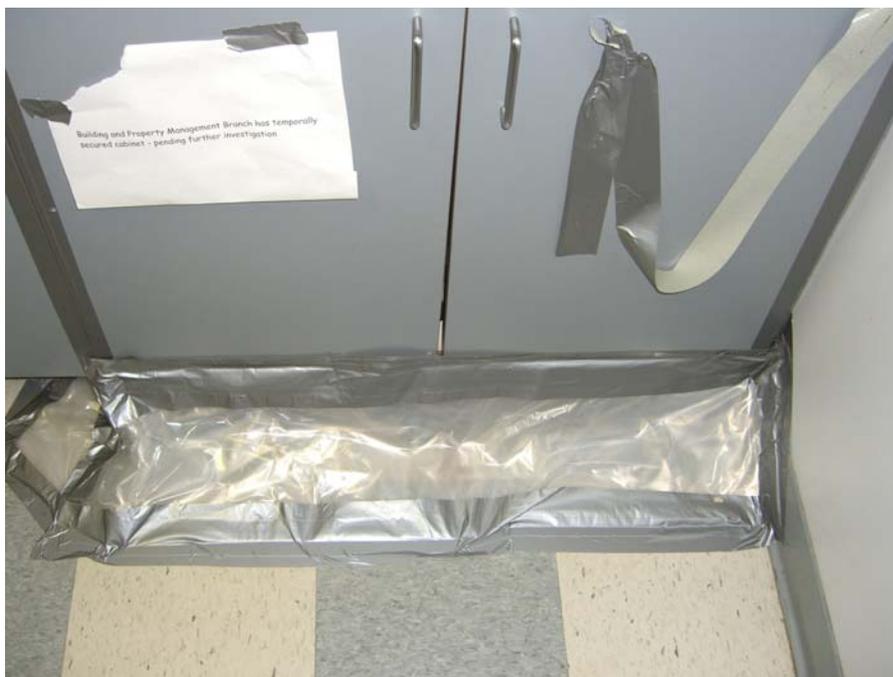
- 2) Image of sink cabinet at time of assessment. Noted signage and interim plastic and duct tape barriers were present as noted as installed (according to DGS) by BPM site representatives.

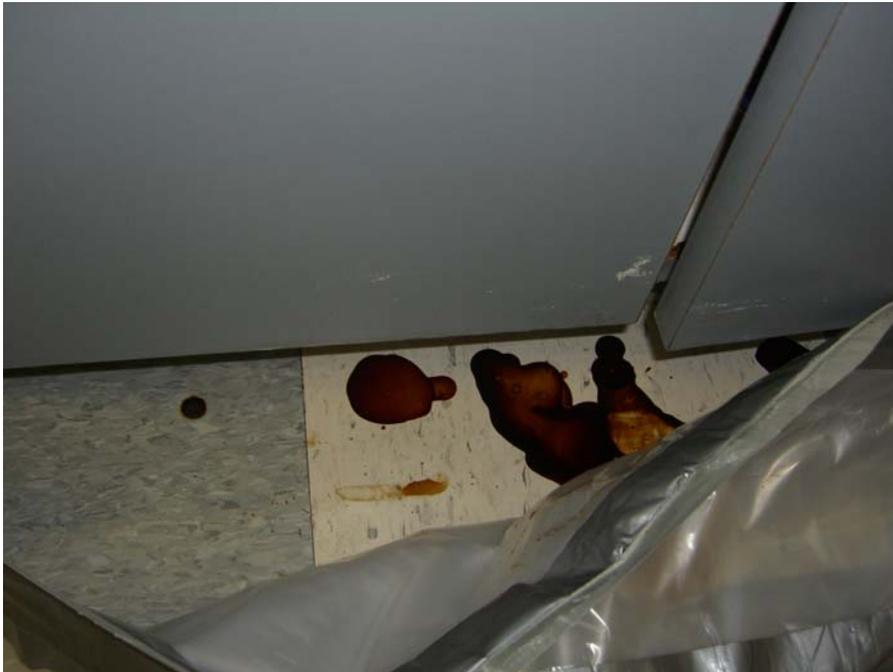
3) Image of dark liquid staining present on tile flooring at cabinet door entry at time of assessment.

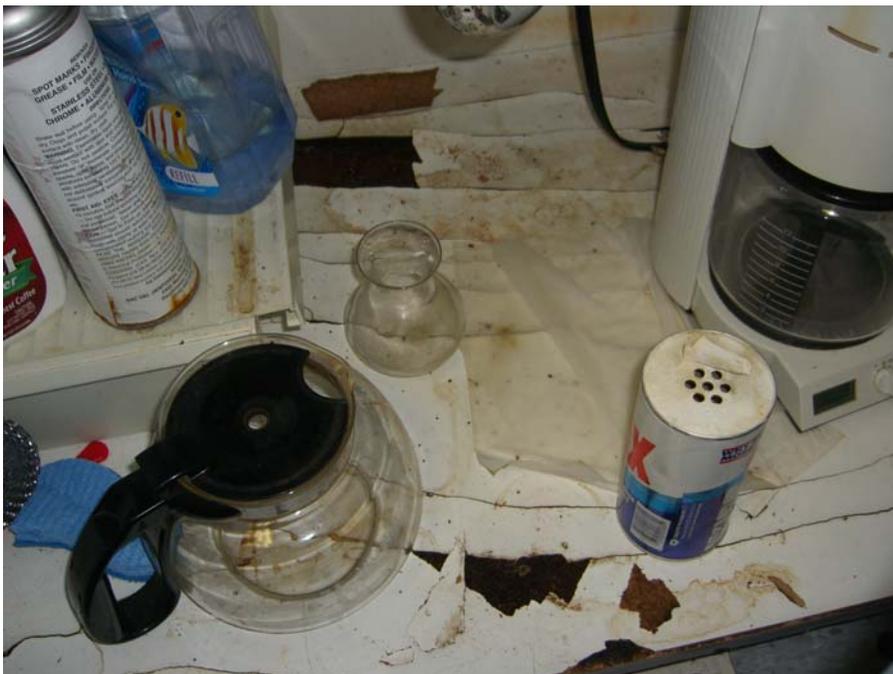
4) Close-up image of stained and cracked cabinet materials associated with chronic historic moisture release within sink area plumbing systems.

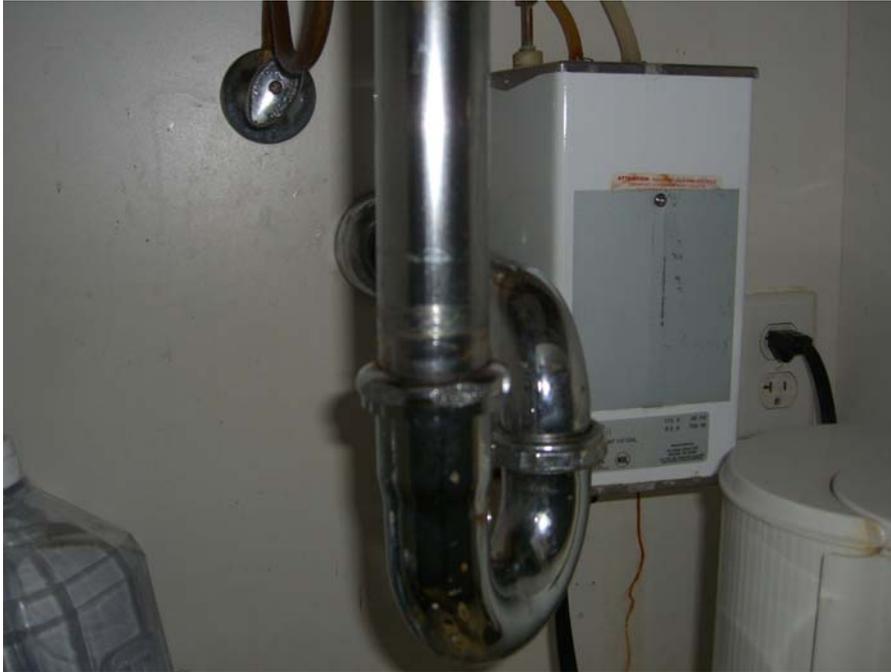
- 5) Image of sink cabinet “S” effluent trap and InstaHot water heater unit on rear wall. Note staining trail from InstaHot unit visible in image at time of assessment.

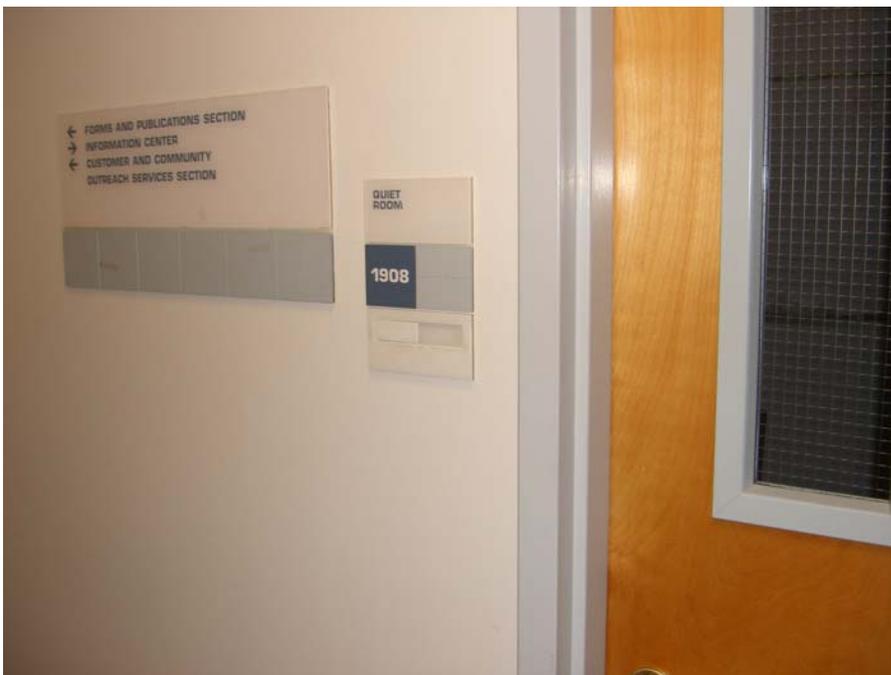
- 6) Image of entry to room 1908 which shares an interior wall and is adjacent to break room 1905.

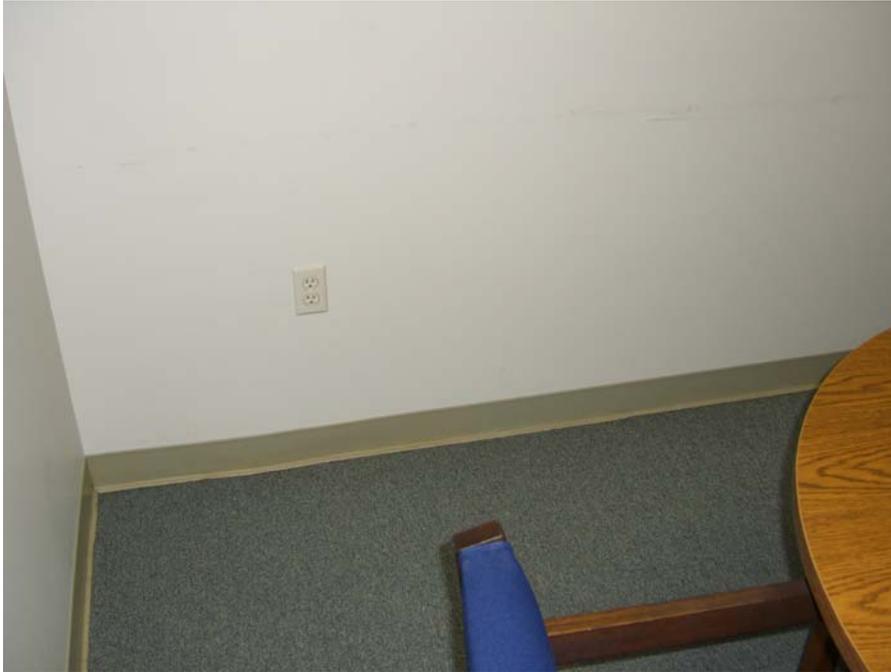
- 7) Image of staired wall within 1908 which is immediately adjacent to the break room impacted cabinet materials. Baseboard and sheetrock materials indicated elevated moisture content at the time of assessment.
