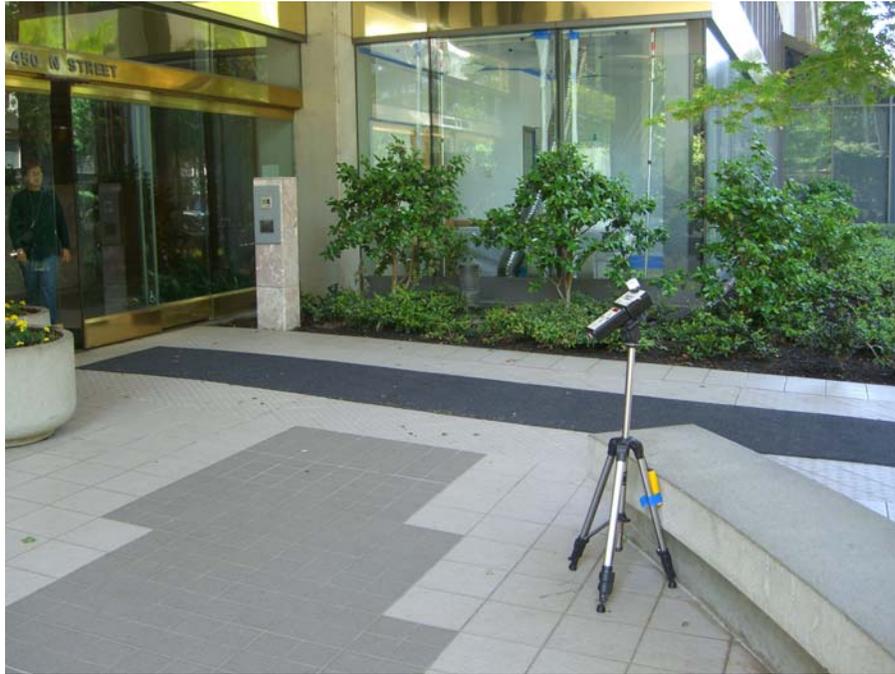
- 1) Image of ambient air sampling location at front entry of BOE Building (Subject Building) located at 450 N Street, Sacramento, California at time of assessment.

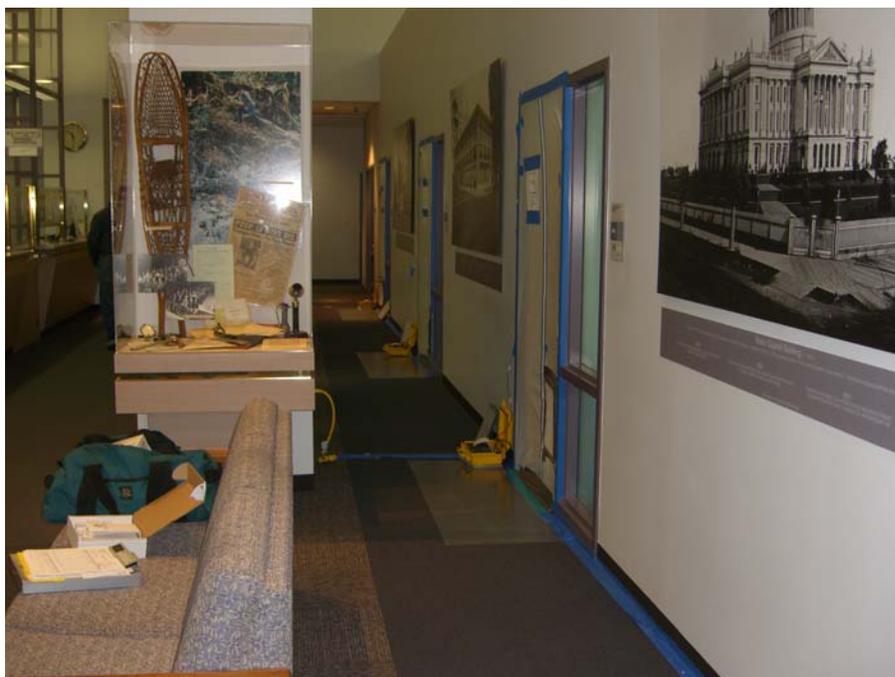
- 2) Image of interior first floor reception area with conference rooms on right of picture. Barrier systems established at doorway at time of assessment.

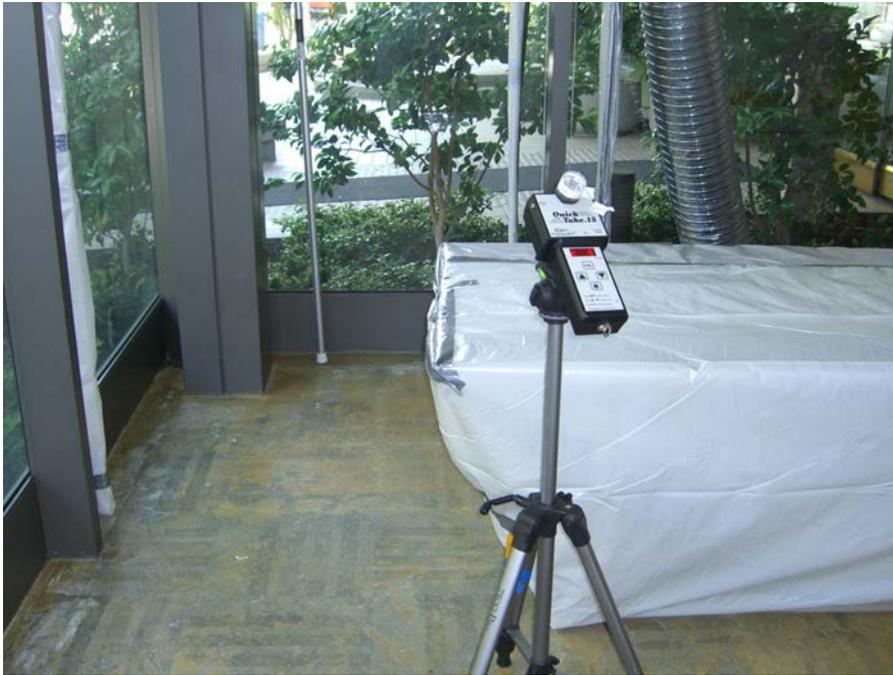
3) Image of air sampling equipment utilized within interior of conference room 105 at time of assessment.

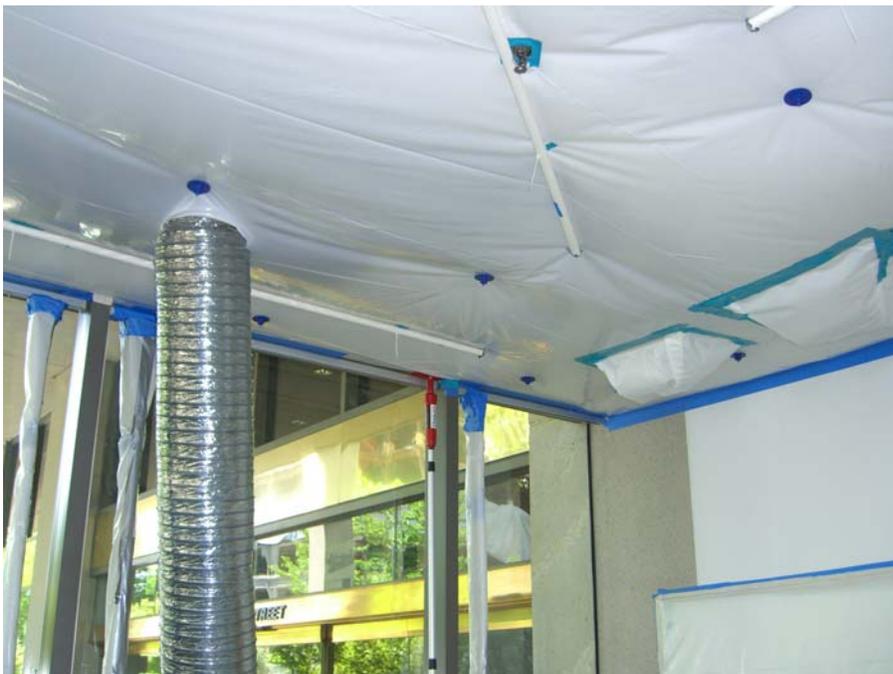
4) Image of representative ceiling barrier system (Room 105) utilized within each conference room as recommended by BioMax.

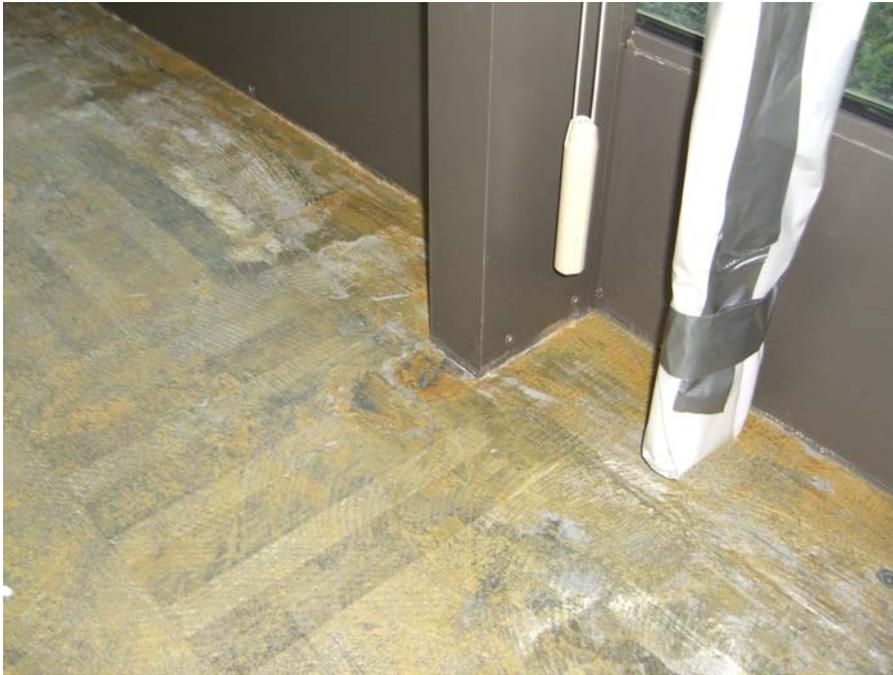
- 5) Image within 106 of concrete subflooring and perimeter metal framed supports present following carpet removal and detail cleaning.

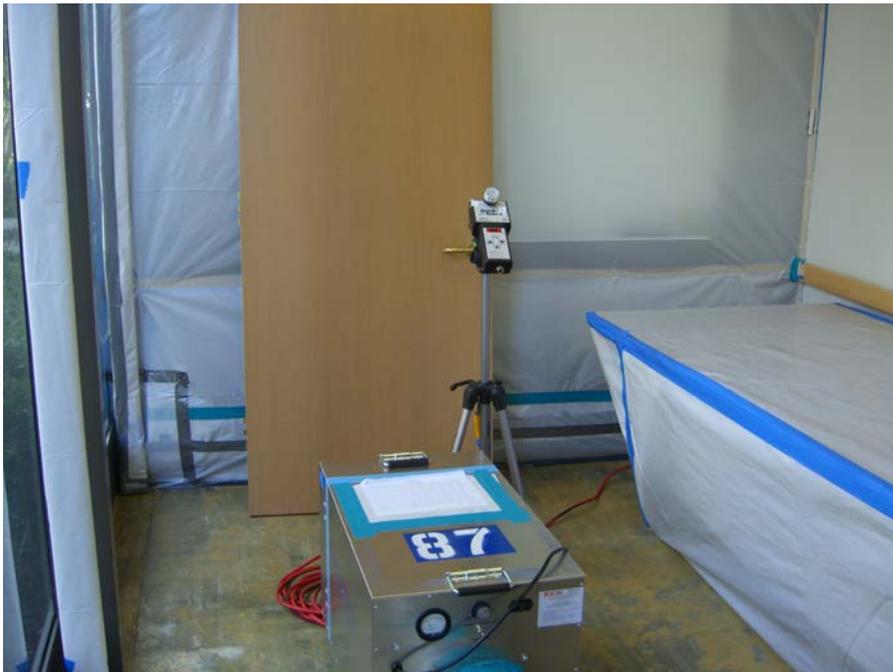
- 6) Image within 106 of containment barriers and equipment in use at time of clearance assessment.

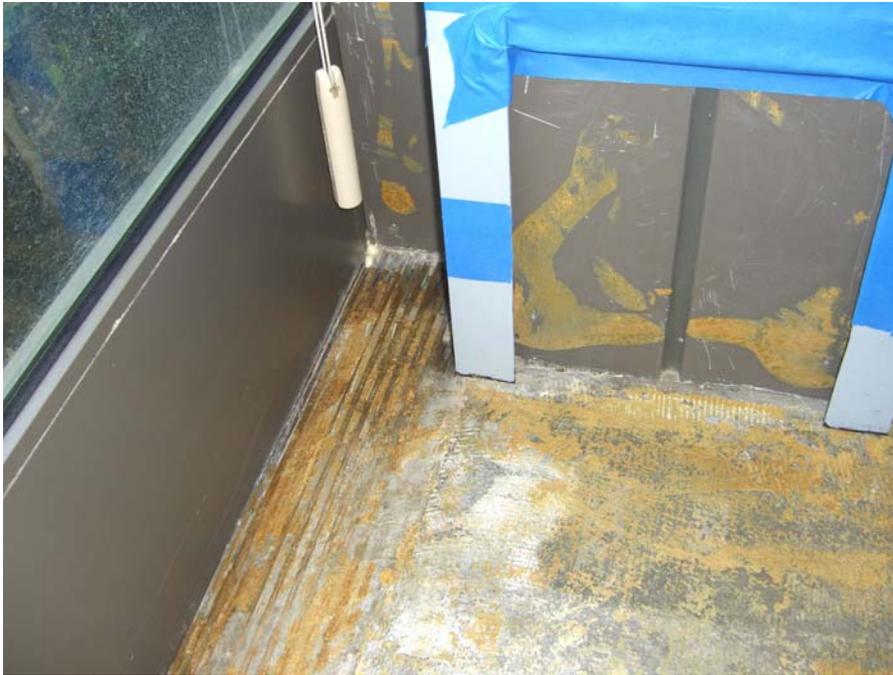
- 7) Image within 107 perimeter wall indicating residual stained concrete flooring at metal wall framing.

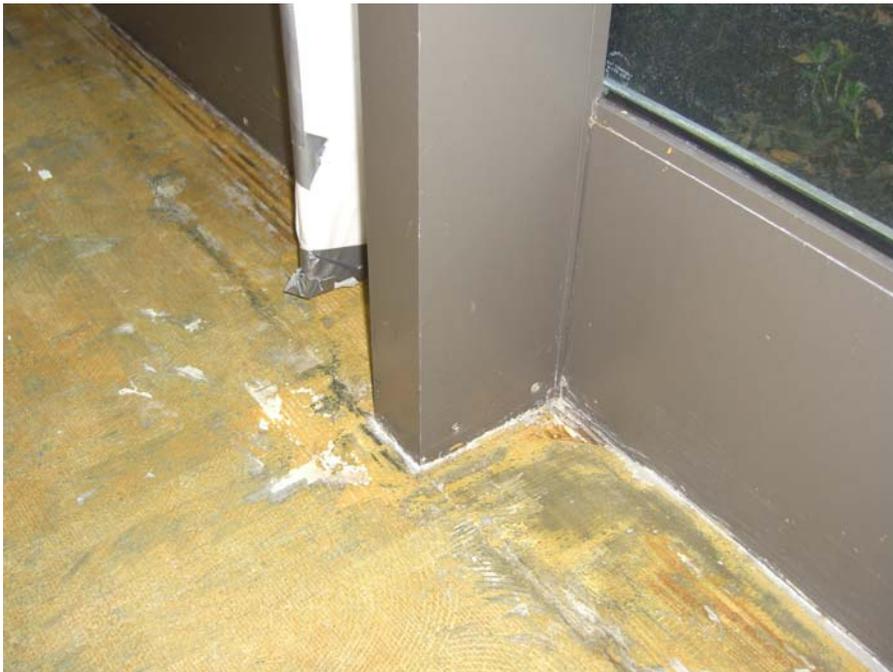
- 8) Additional close-up image of within 107 indicating condition of perimeter wall building materials following the performance of extensive clean up measures by JLS.

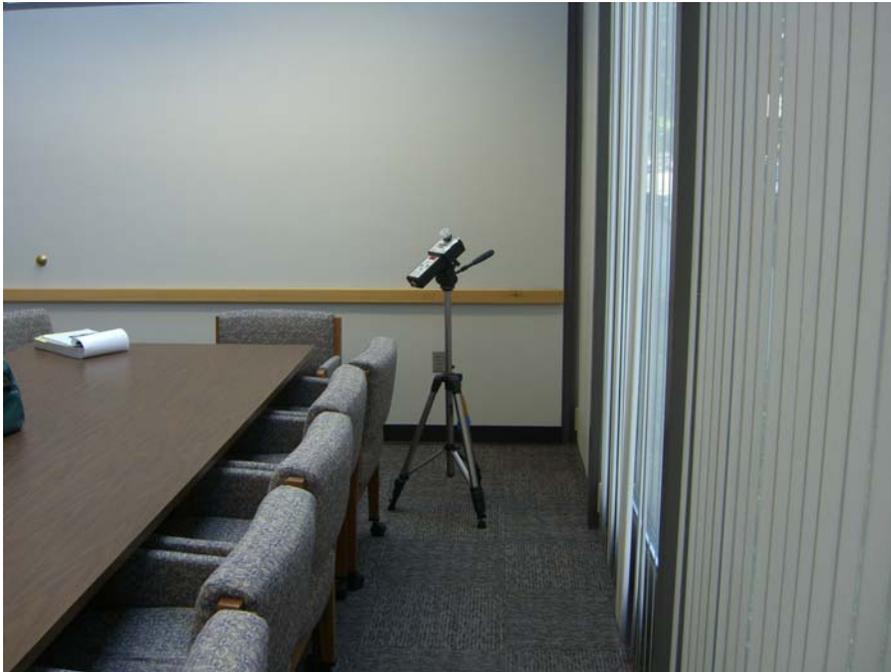
- 9) Image within conference room 110 where no mitigative carpet removal was performed. Air sampling for verification purposes only.

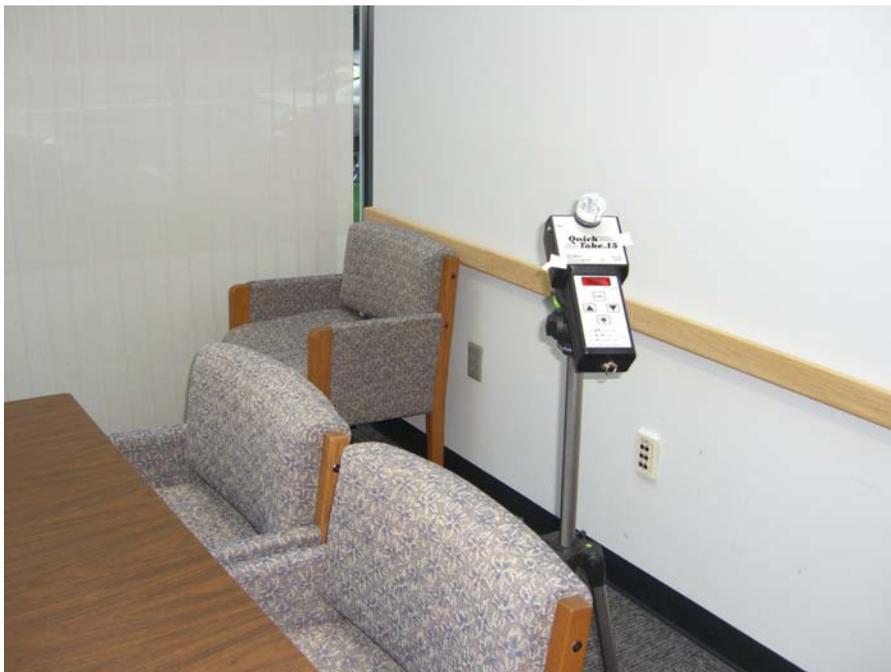
- 10) Image of air sampling equipment and location within conference room 111 at time of assessment.
