BioMax Environmental

April 10th, 2009

**Microbial Assessment of Rest Room Areas
Department of General Services Board of Equalization Building
450 N. Street
Sacramento, California**

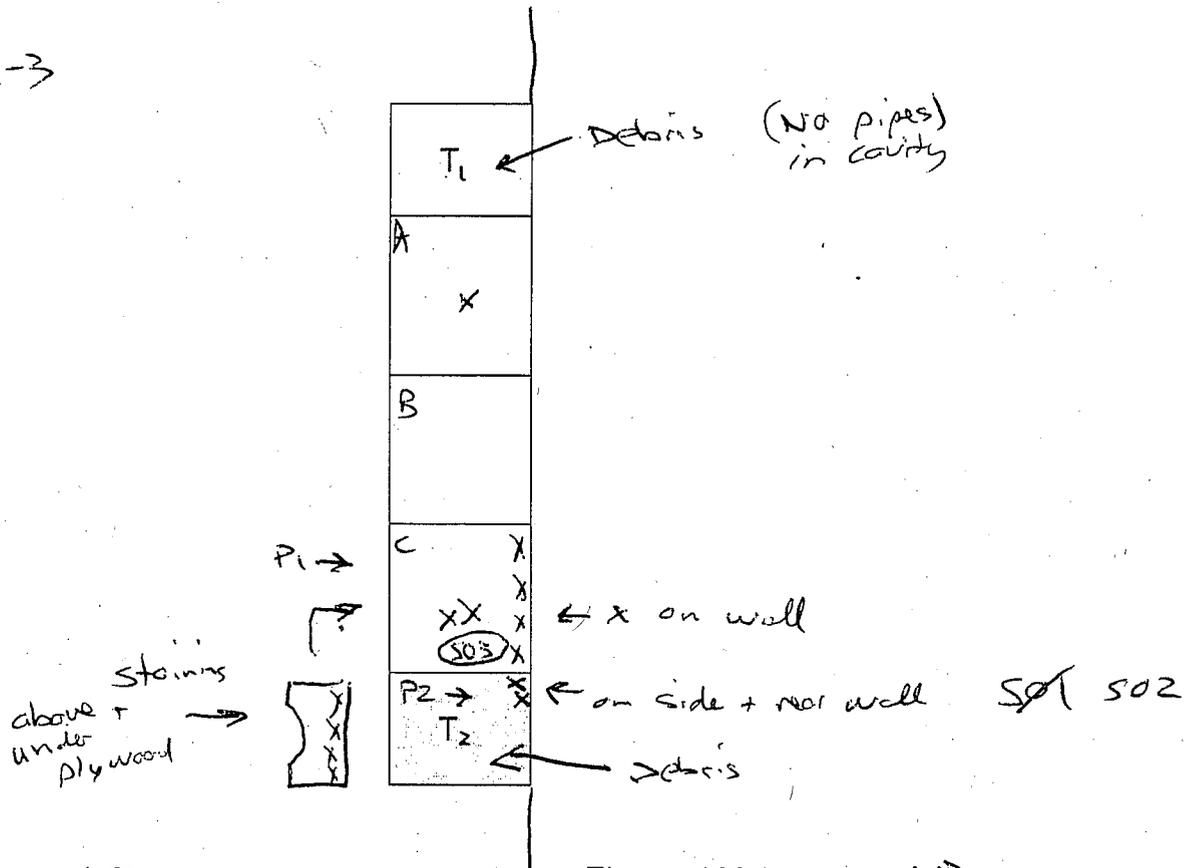
Level 2-3

Visible Staining: yes

Elevated Moisture: ND

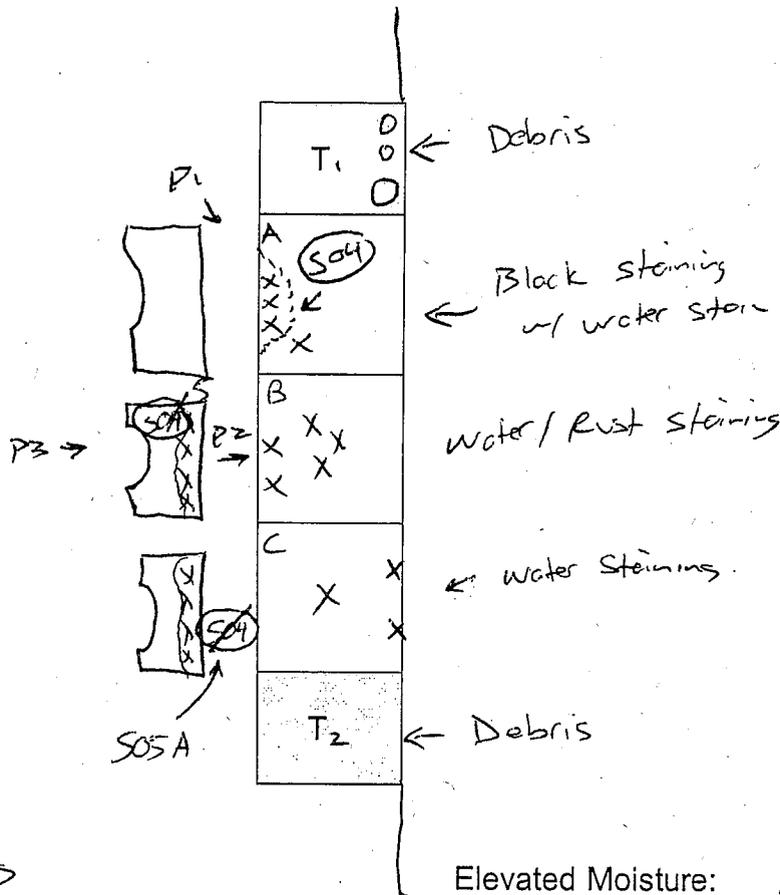
Level 2

Visible Staining: yes

Elevated Moisture: ND

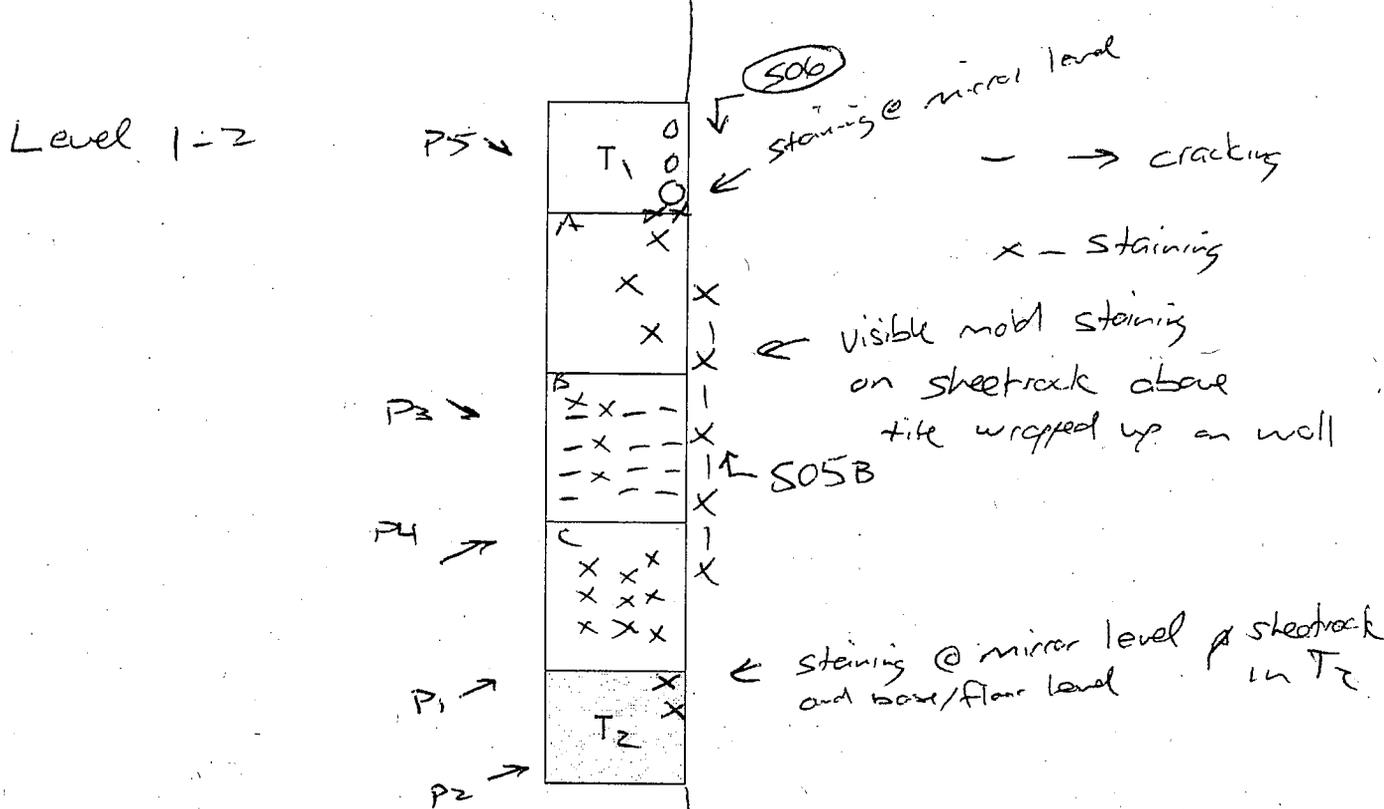
Restroom ID / Location: WRR 18

Visible Staining: yes

Elevated Moisture: ND

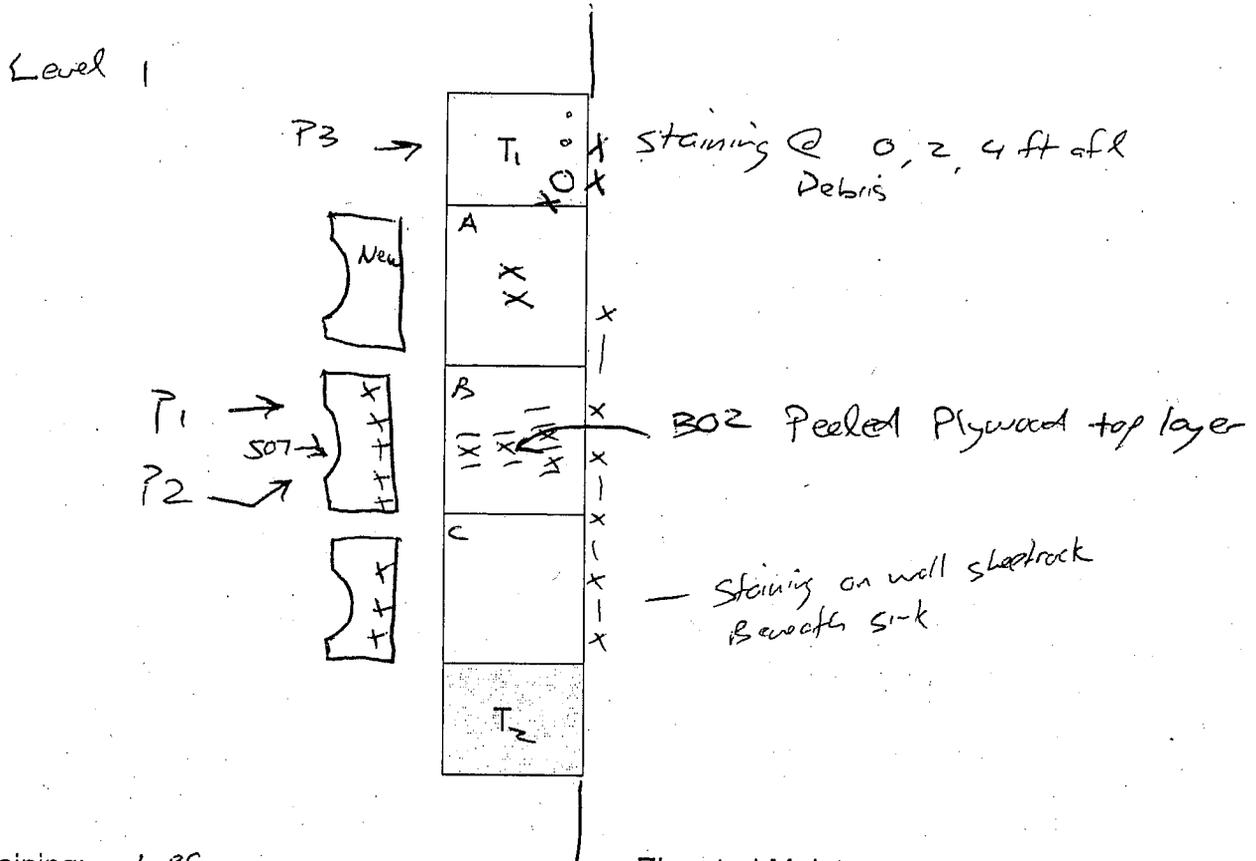
Restroom ID / Location: WRR 17

Visible Staining: yes

Elevated Moisture: ND

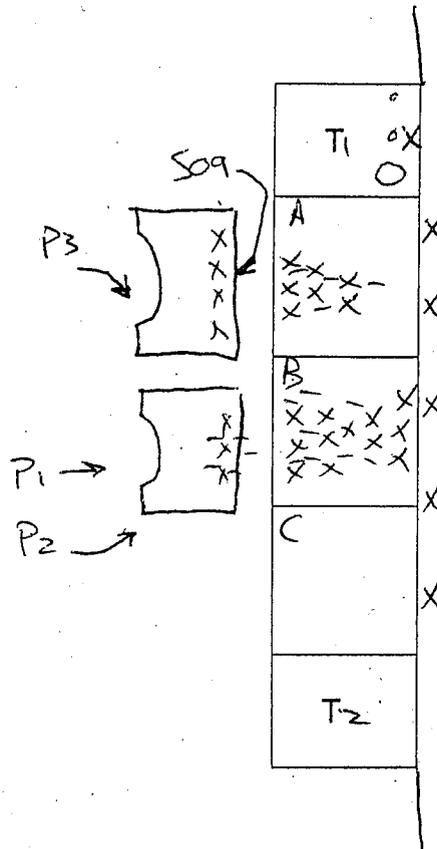
Level 1 +

Toilet making noise
 HC Stall #4

→ Greenboard staining
 Debris

← mold-like growth on sheetrock wall under sink

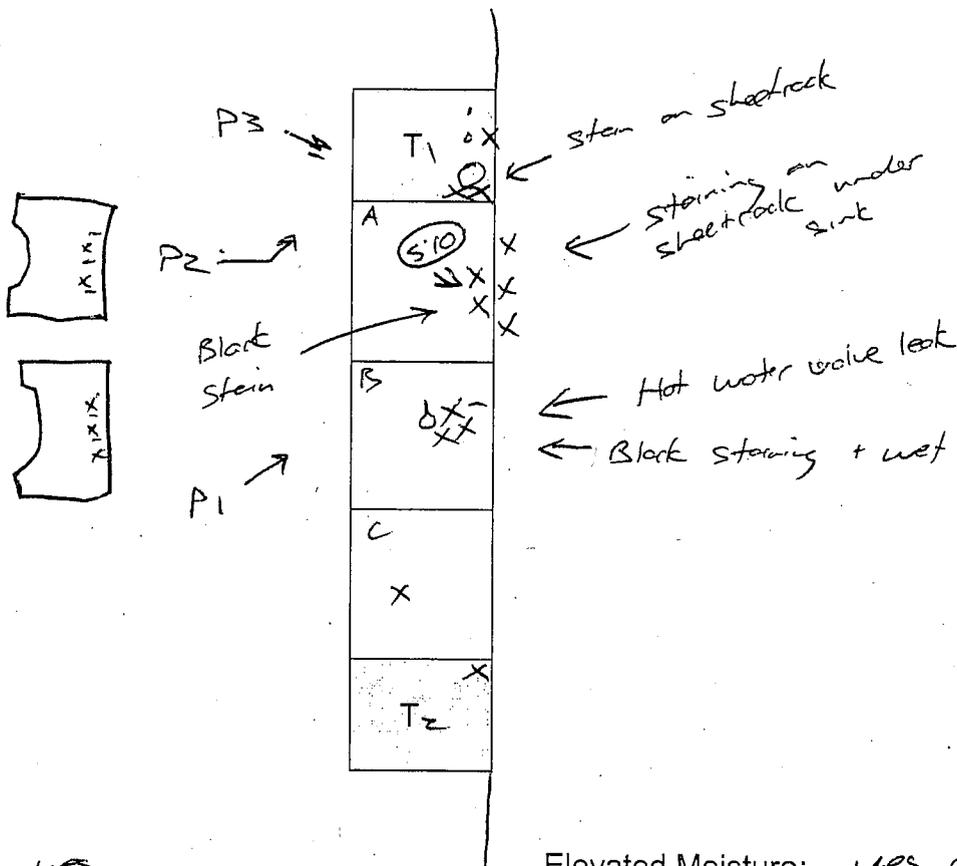
Level 1/2

Visible Staining: yes

Elevated Moisture: yes @ cabinet B

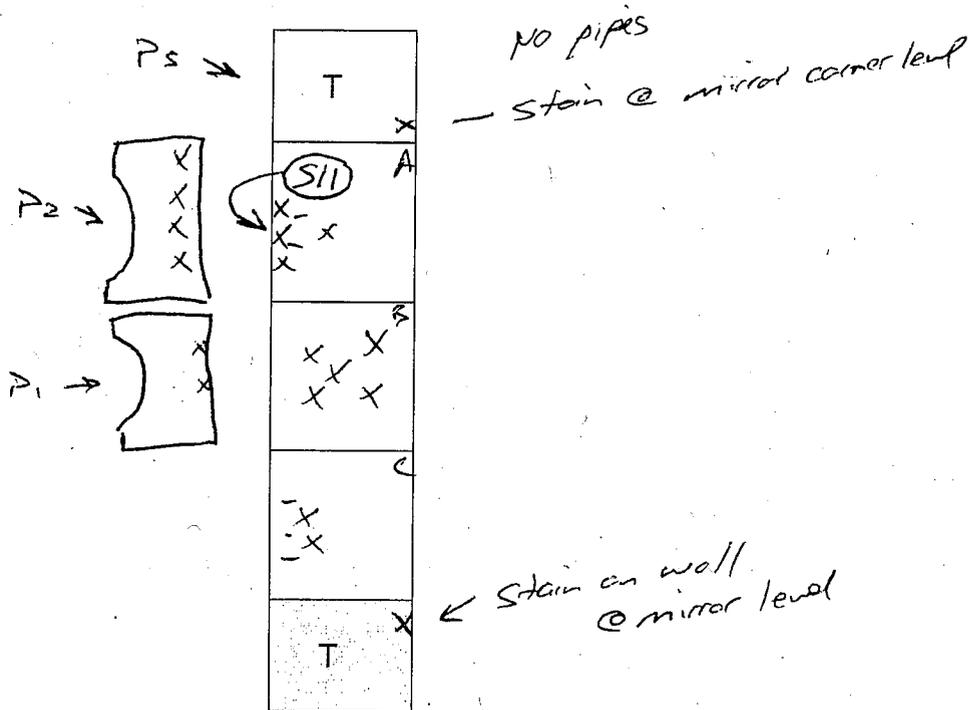
Level 2

Visible Staining: yes

Elevated Moisture: ND

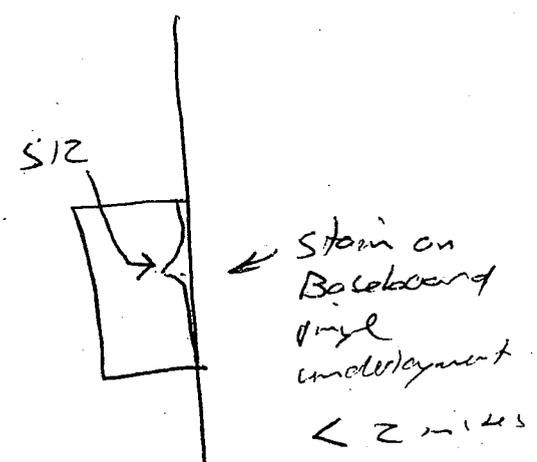
Restroom ID / Location: Floor 17^z - Mezzanine Floor WRR

Visible Staining: yes on Baseboard

Elevated Moisture: NO

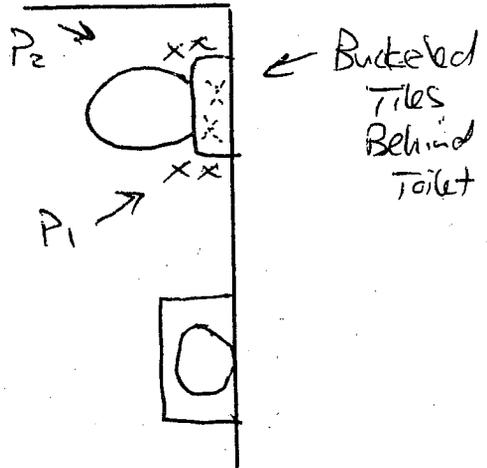
Restroom ID / Location: Men's RR on 12th Floor - Mezzanine

Visible Staining: yes

Elevated Moisture: yes

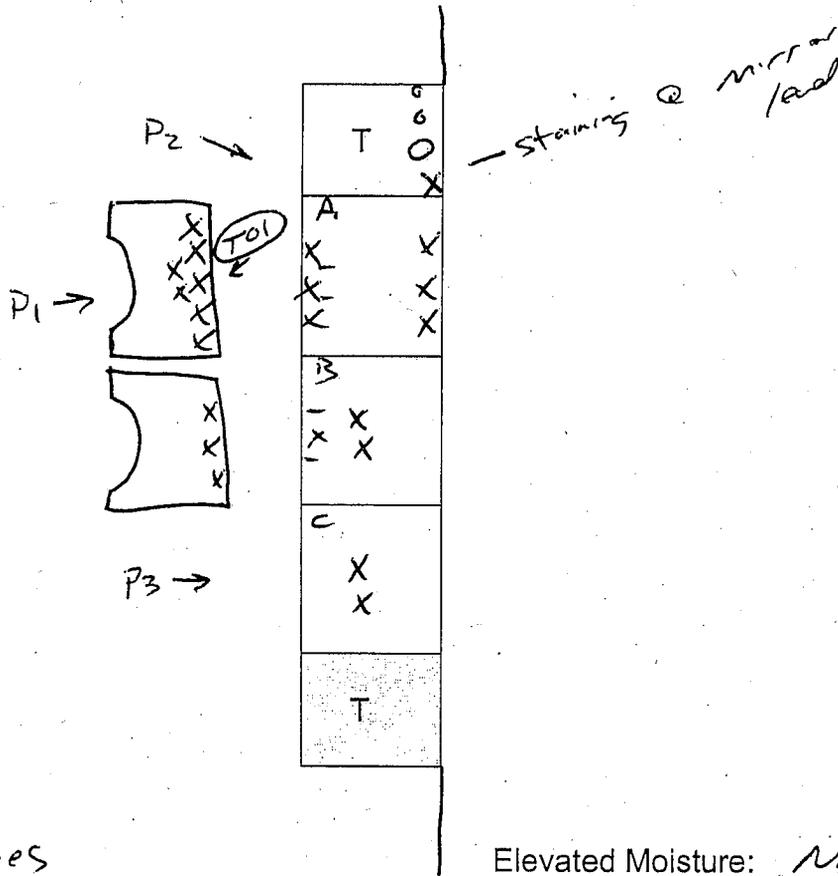
Level 2

Visible Staining: yes

Elevated Moisture: NO

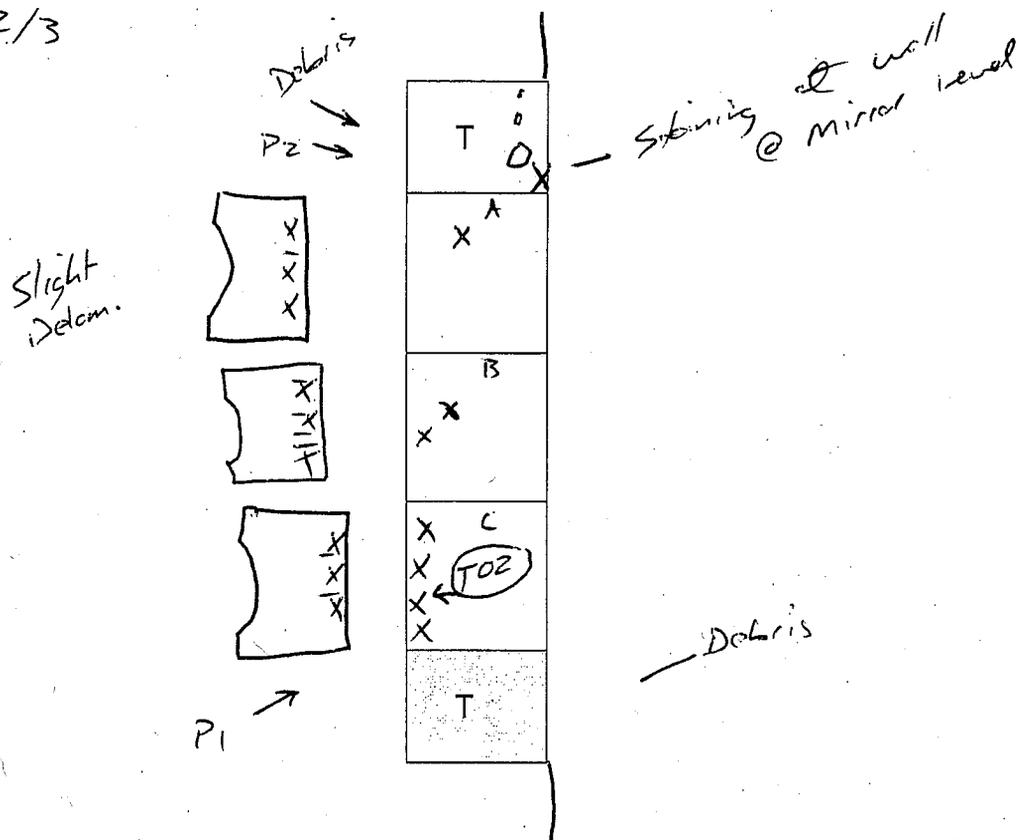
Level 2/3

Visible Staining: YES

Elevated Moisture: NO

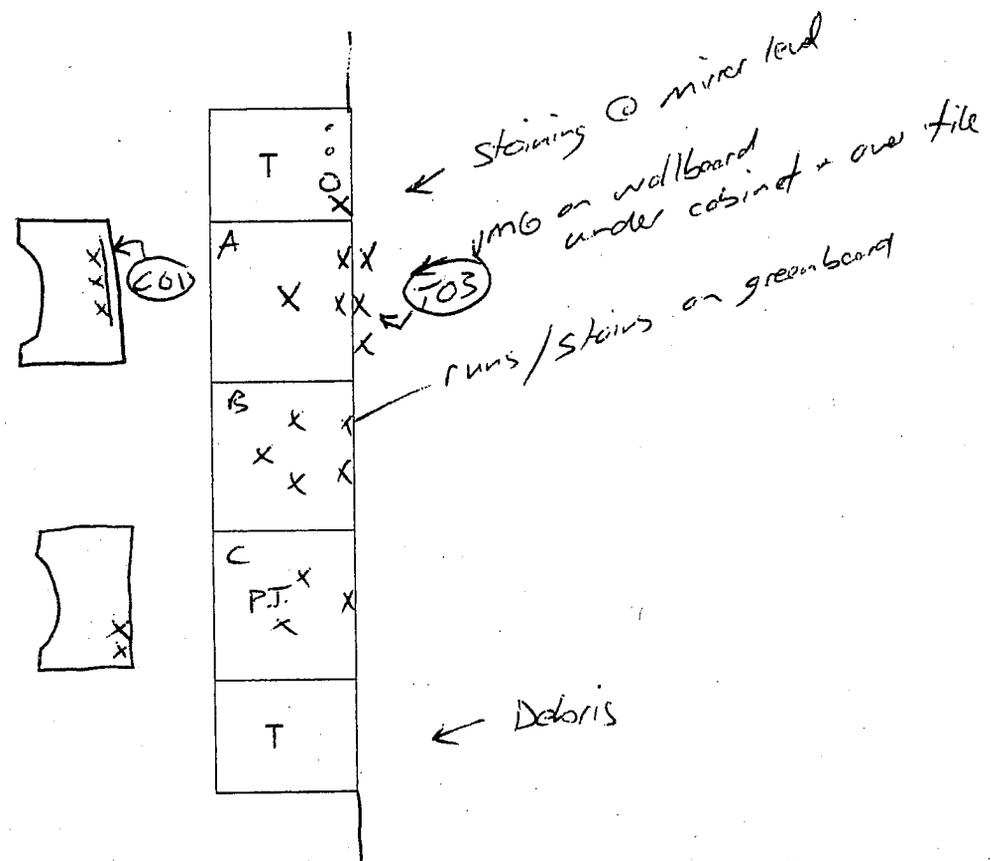
Level 1/2

Visible Staining: yes

Elevated Moisture: ND

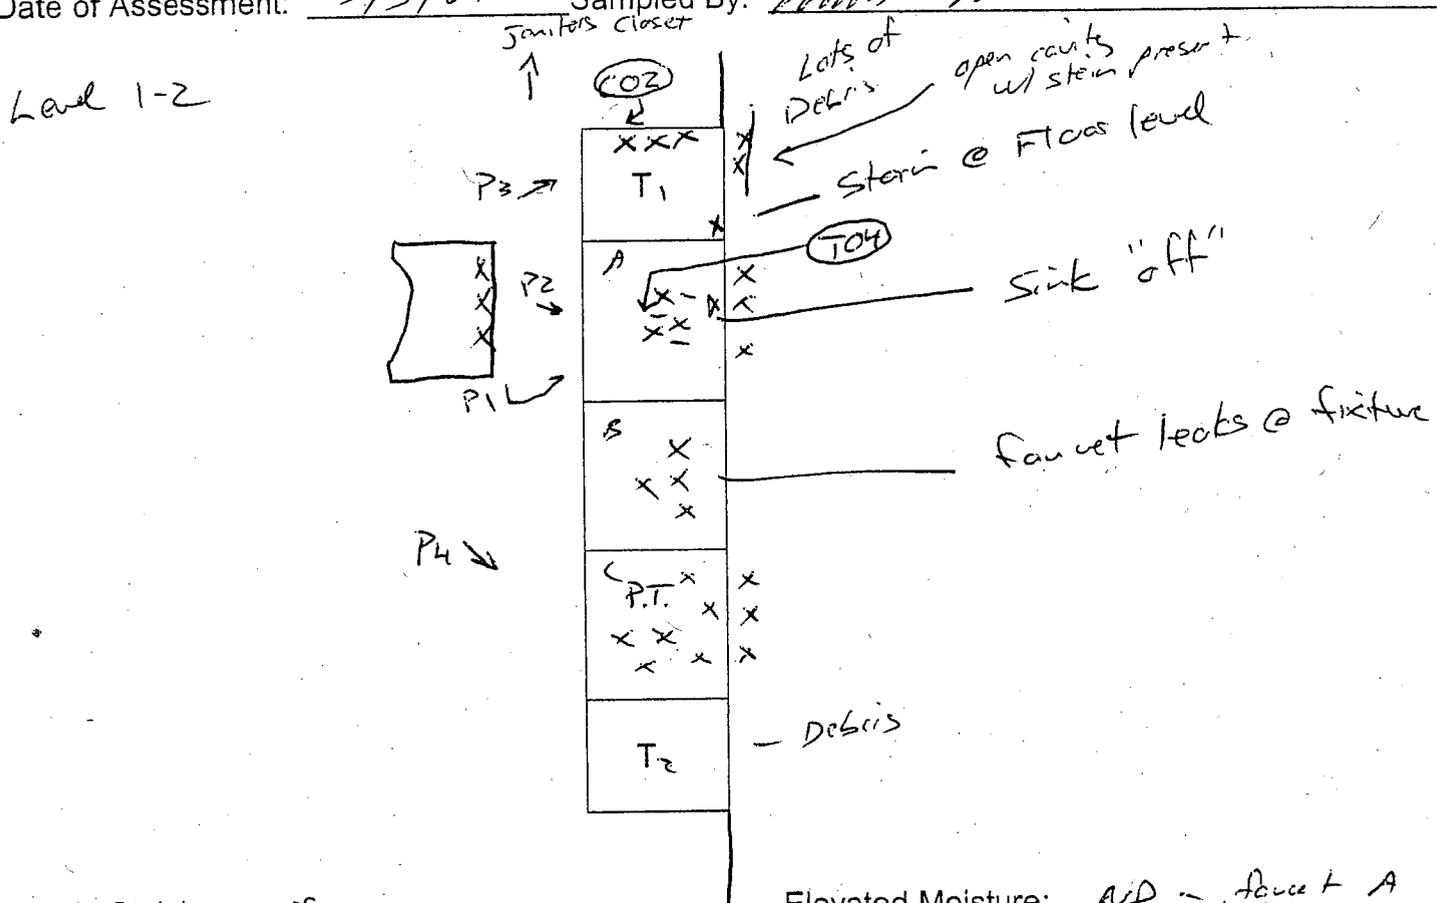
Restroom ID / Location: WRR Floor 8

Visible Staining: yes

Elevated Moisture: ND - faucet A off

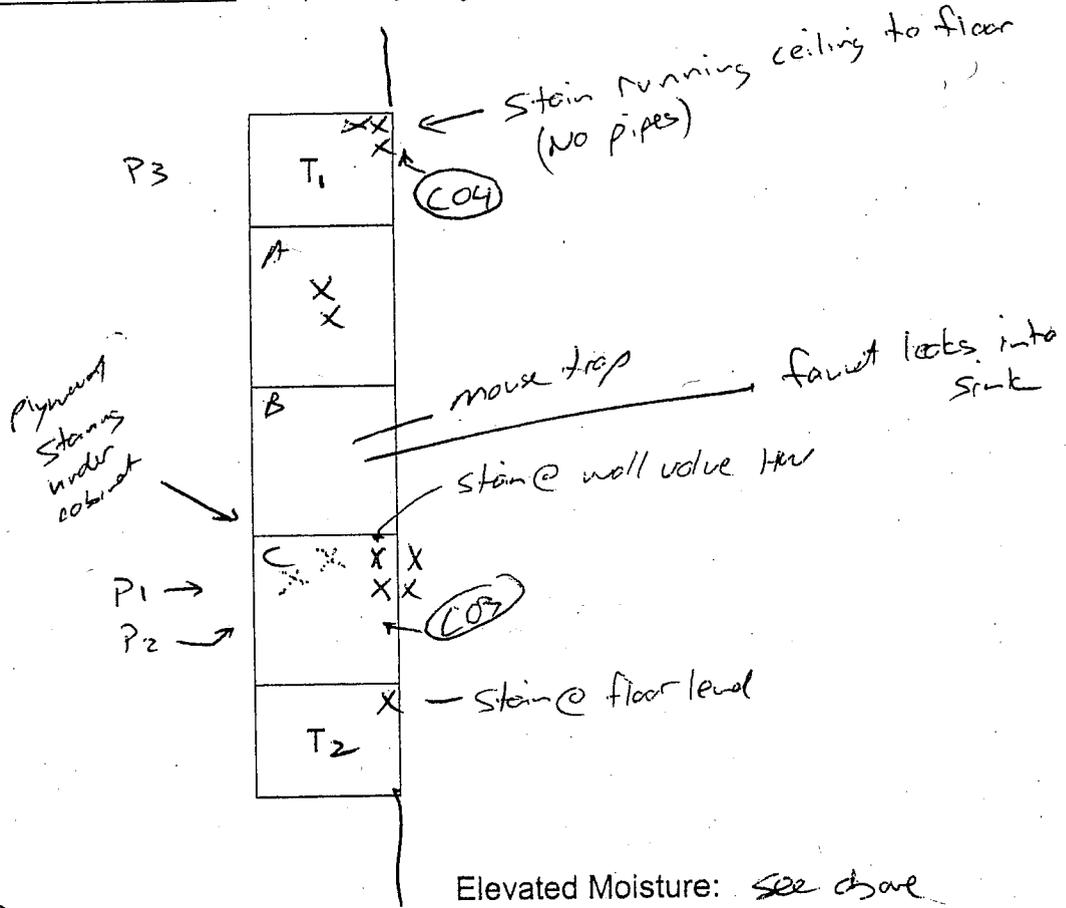
Level 2

Visible Staining: yes

Elevated Moisture: see above

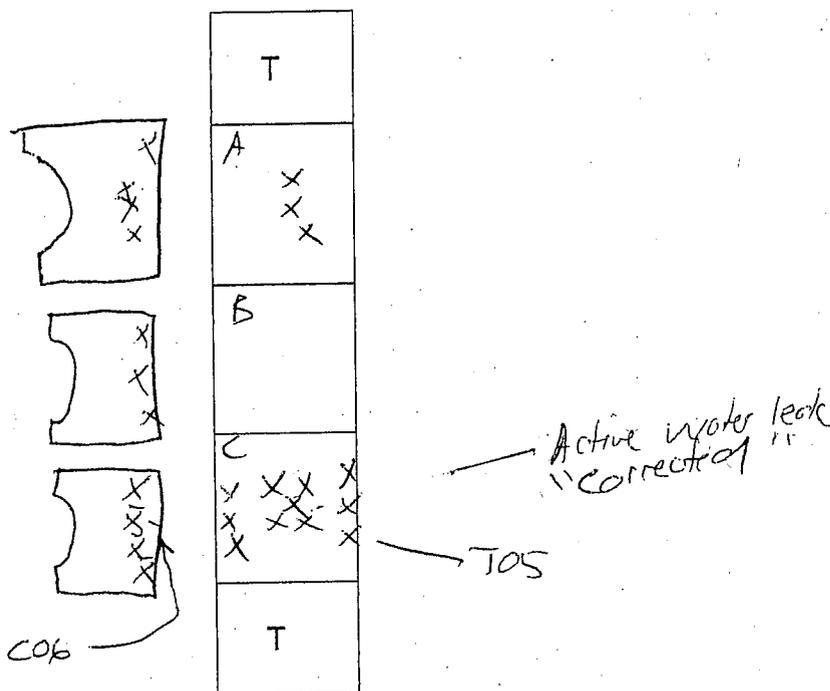
Level 2

Visible Staining: *yes*

Physical Damage: *yes*

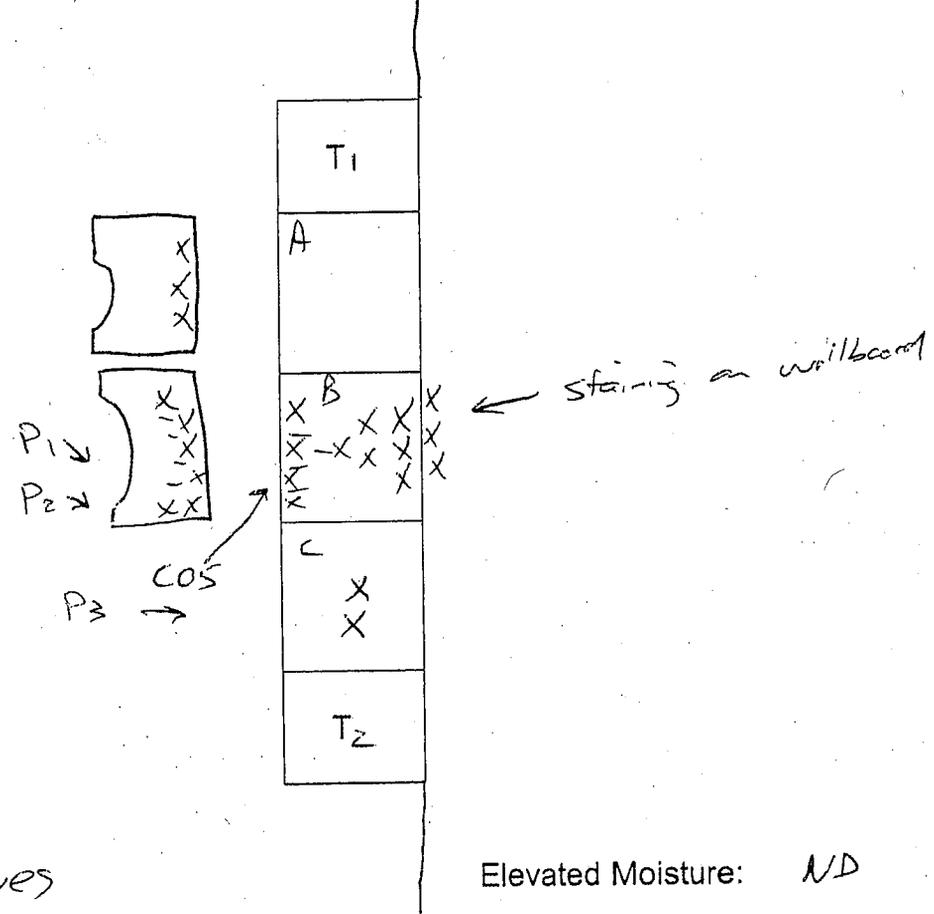
Level 2-

Visible Staining: yes
 Physical Damage: yes Delam

Elevated Moisture: ND

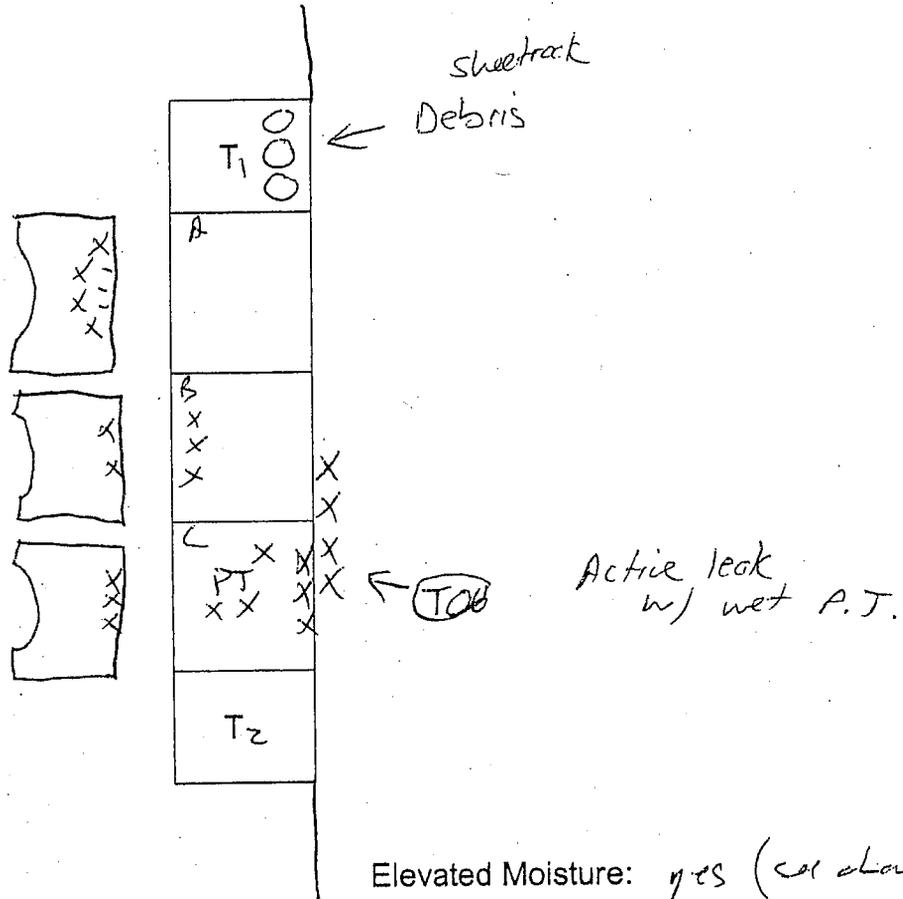
Level 2

Visible Staining: yes

Elevated Moisture: yes (see above)

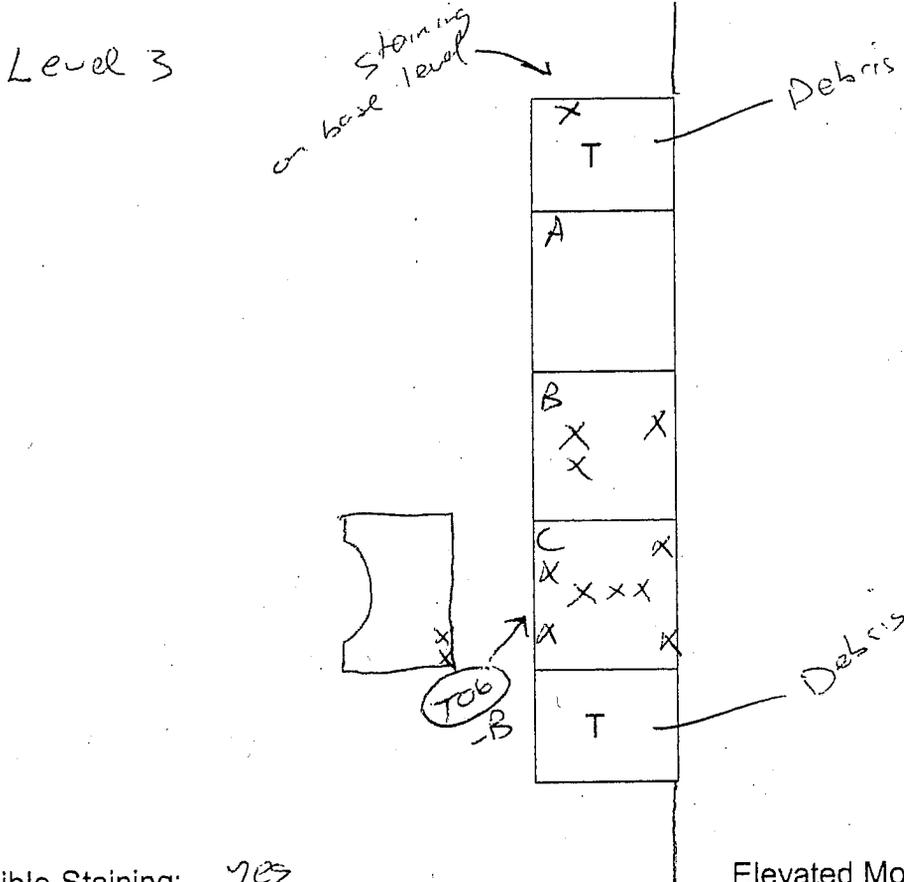
Restroom ID / Location: WRR Level 3

Visible Staining: yes

Elevated Moisture: NID

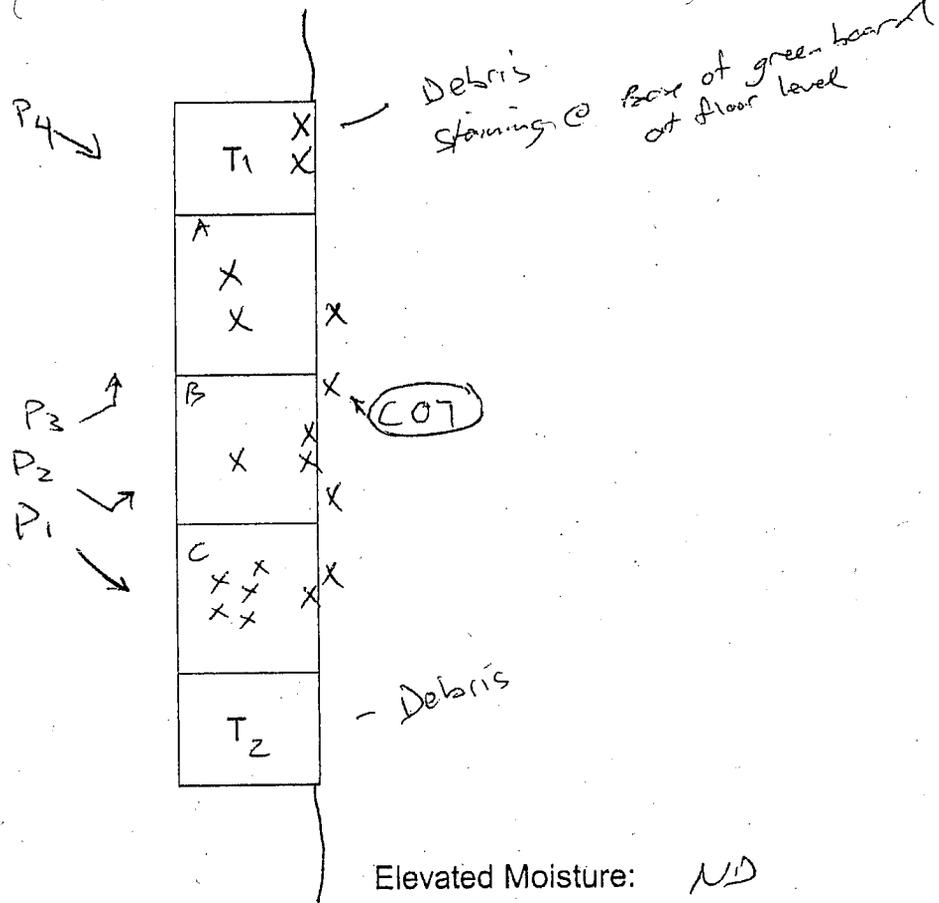
Level 2-3

Visible Staining: yes

Elevated Moisture: ND

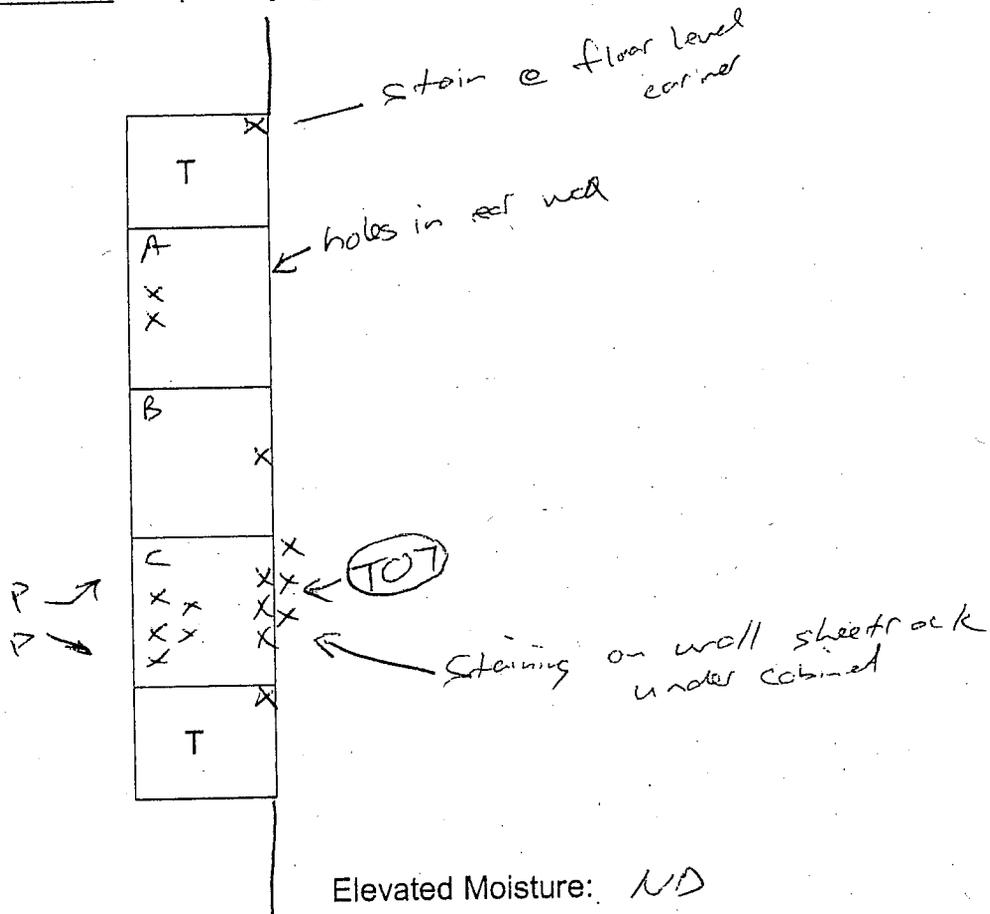
Level 1-2

Visible Staining: yes

Elevated Moisture: ND

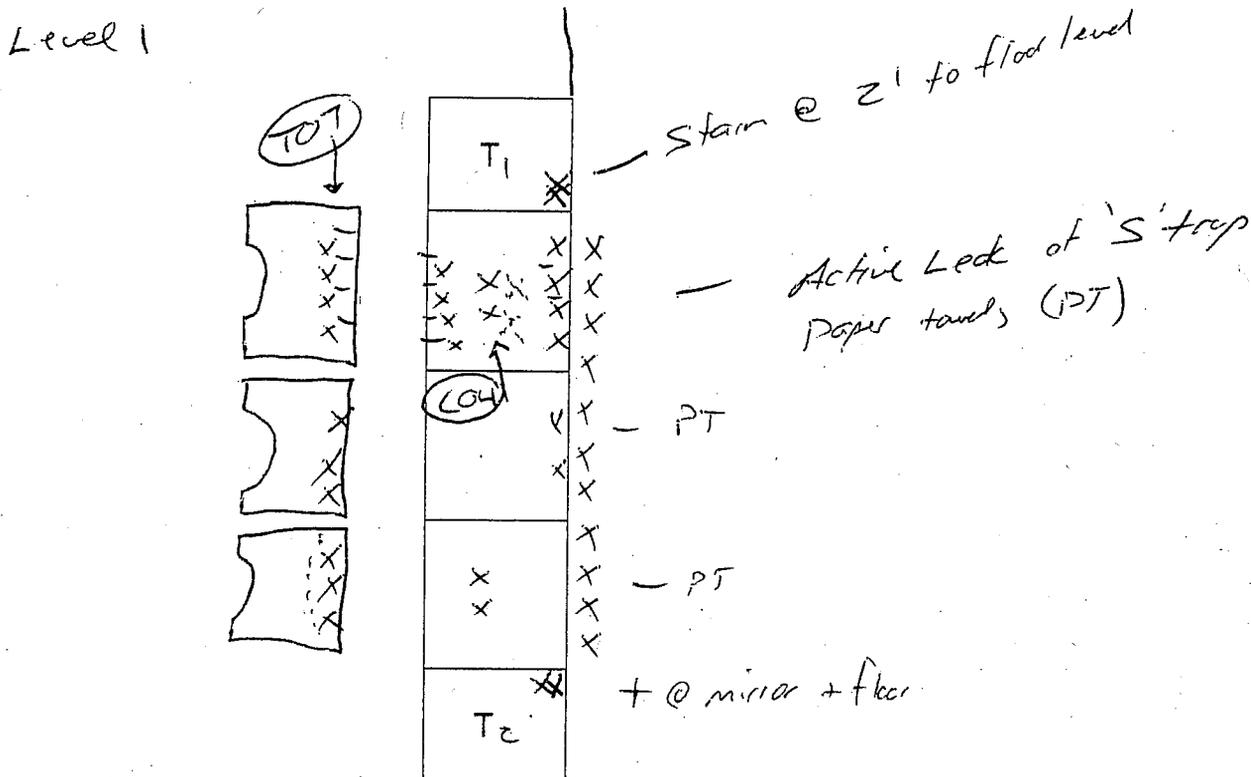
Restroom ID / Location: MRR 1

Visible Staining: Y Cabs A + B, + C

Elevated Moisture: Yes

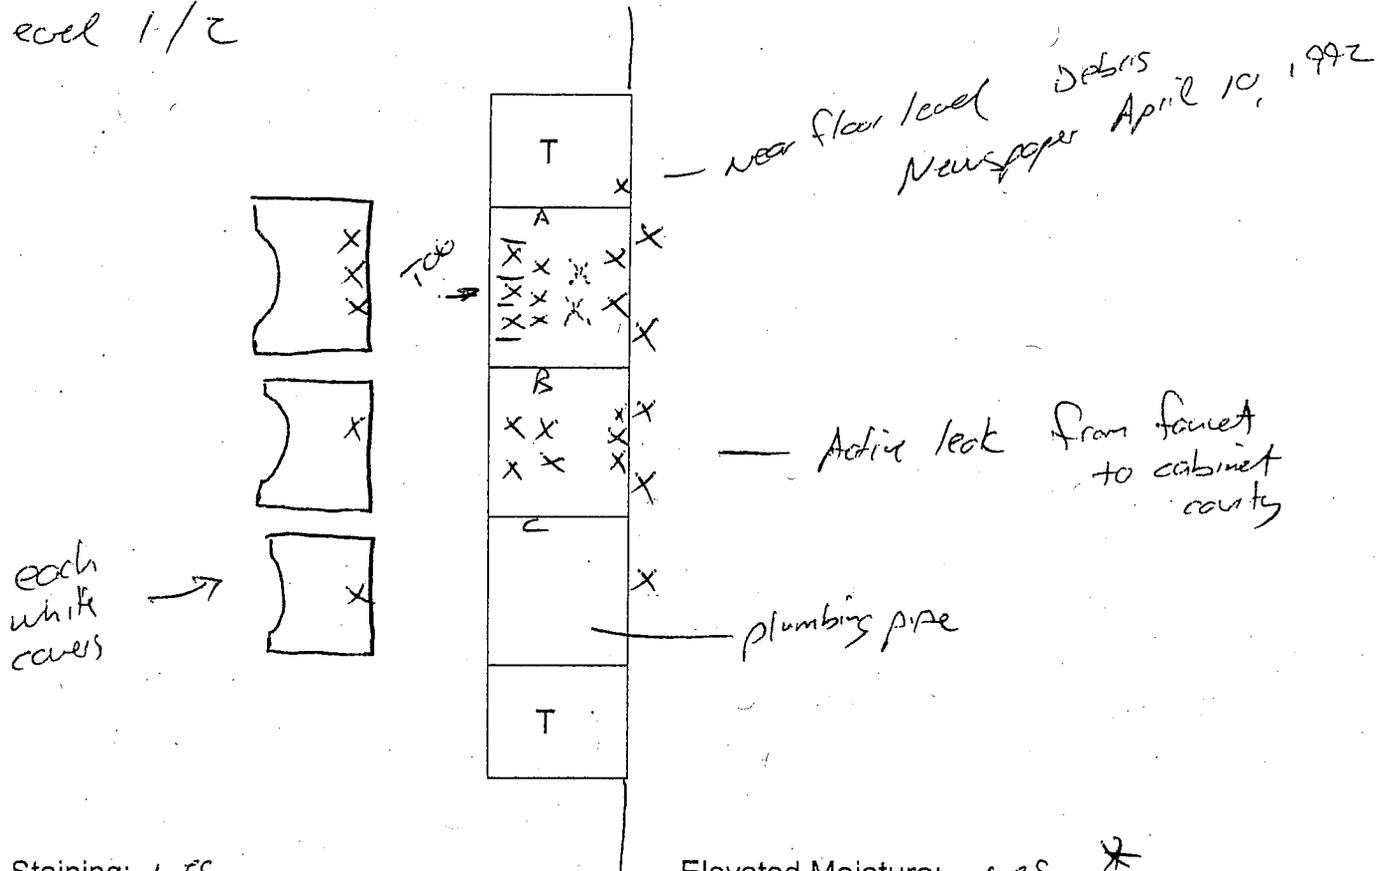
Level 1/2

Visible Staining: yes

Elevated Moisture: yes *

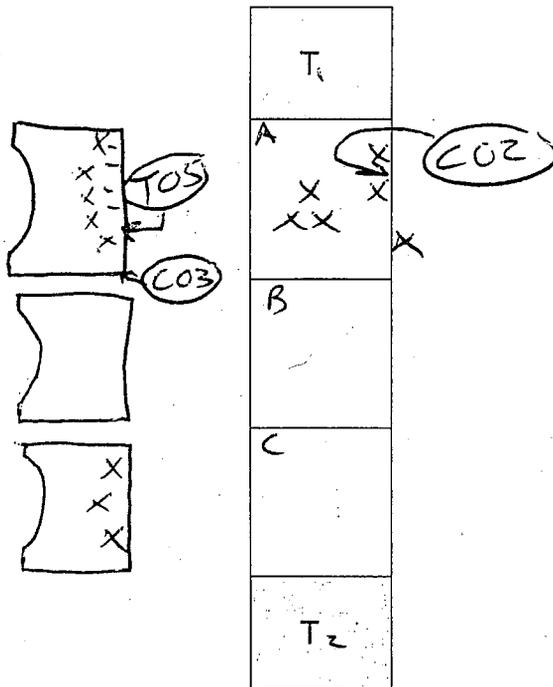
Level 3-2

Visible Staining: y (A + cabinet covers)

Elevated Moisture: ND

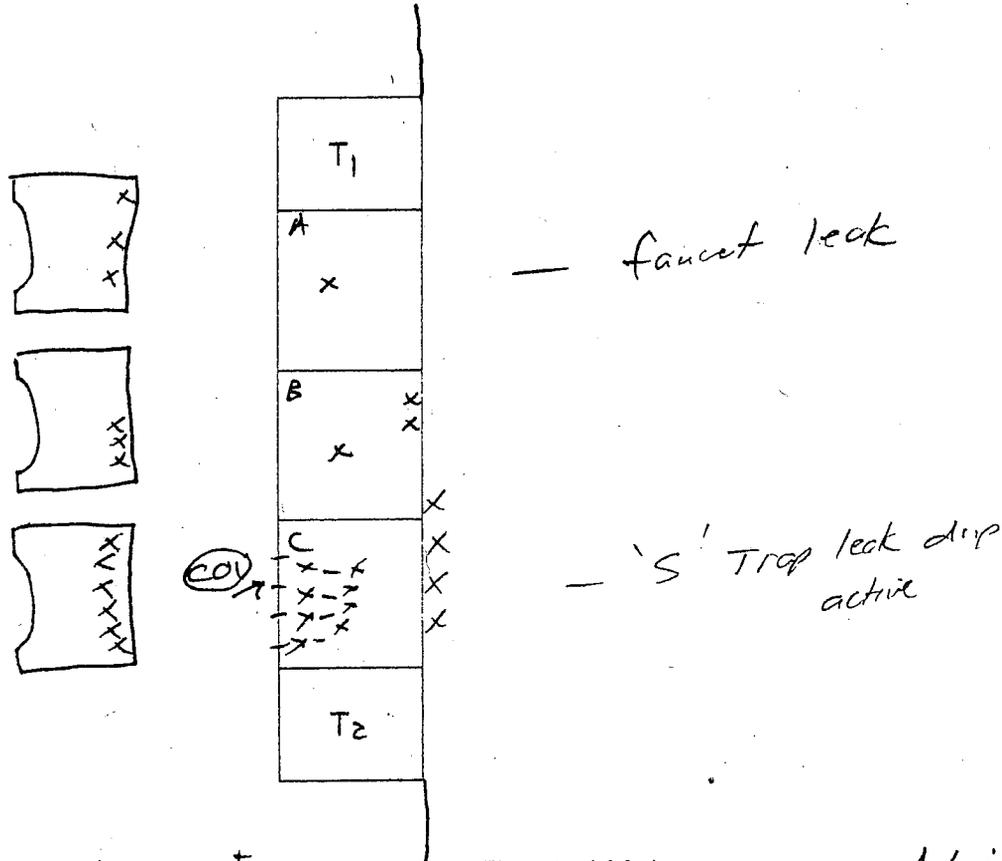
Level 1/2

Visible Staining: yes - A B C+
 Physical Damage: y - (A B C+) covers

Elevated Moisture: yes - Active Leak @ 'S' trap

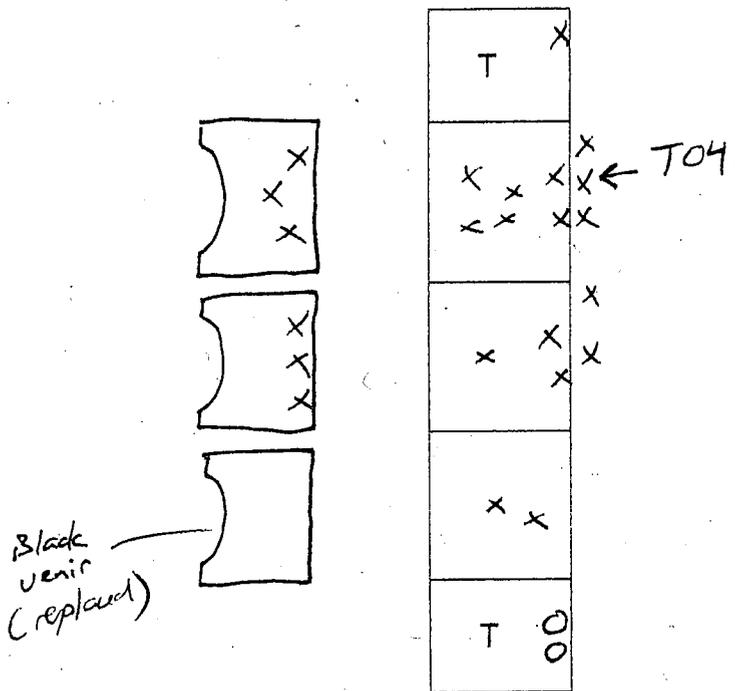
Level 1/2

Visible Staining: Y ABC + Slatrock Elevated Moisture: NO
under A + B

Physical Damage: Y Cabinet Cover A, Wall under cab A

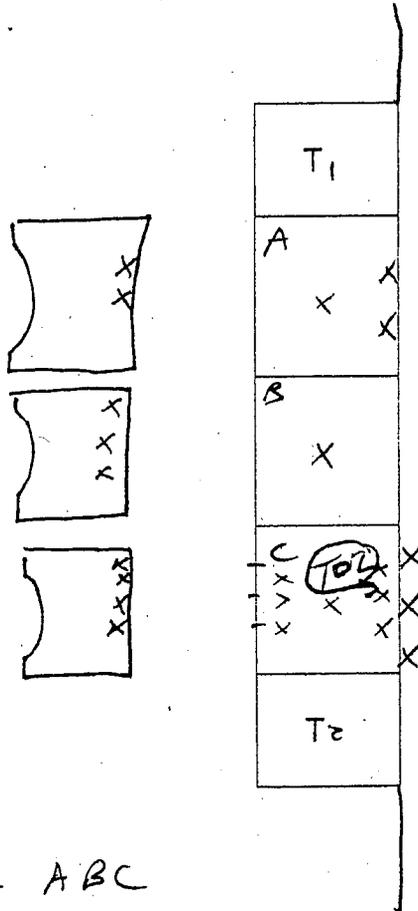
Level 2

Visible Staining: Y - ABC

Elevated Moisture: ND

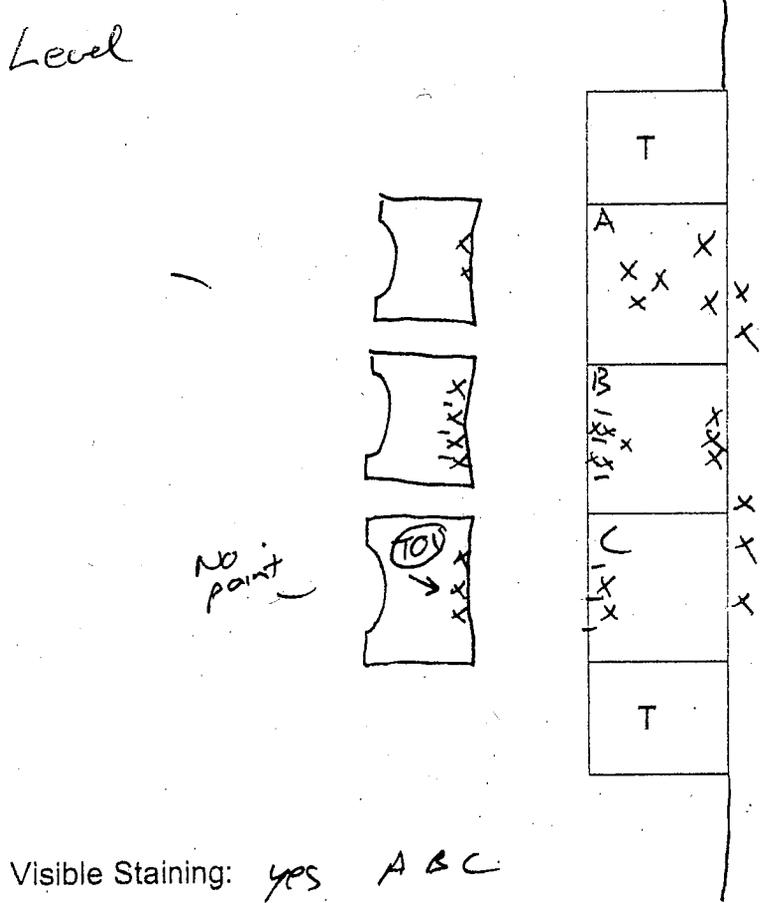
Restroom ID / Location: MRR 8

A - Valve leaks
 B - R - Valve leaks

Visible Staining: yes ABC

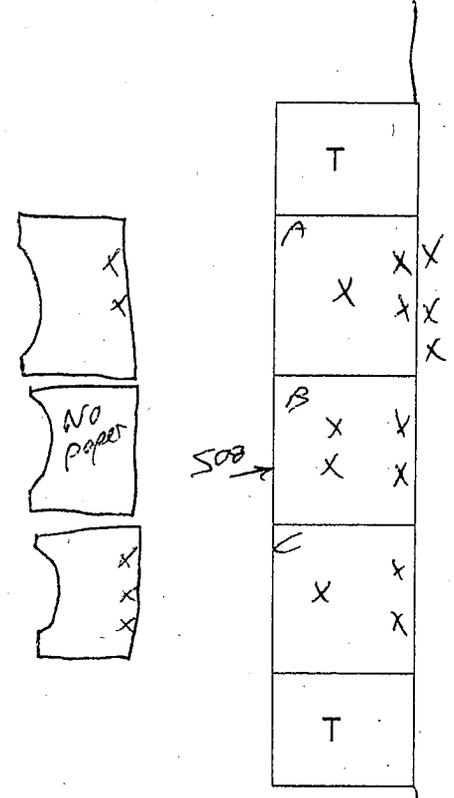
Level 3

— Caulking failure @ faucet needs re-set

Visible Staining: yes

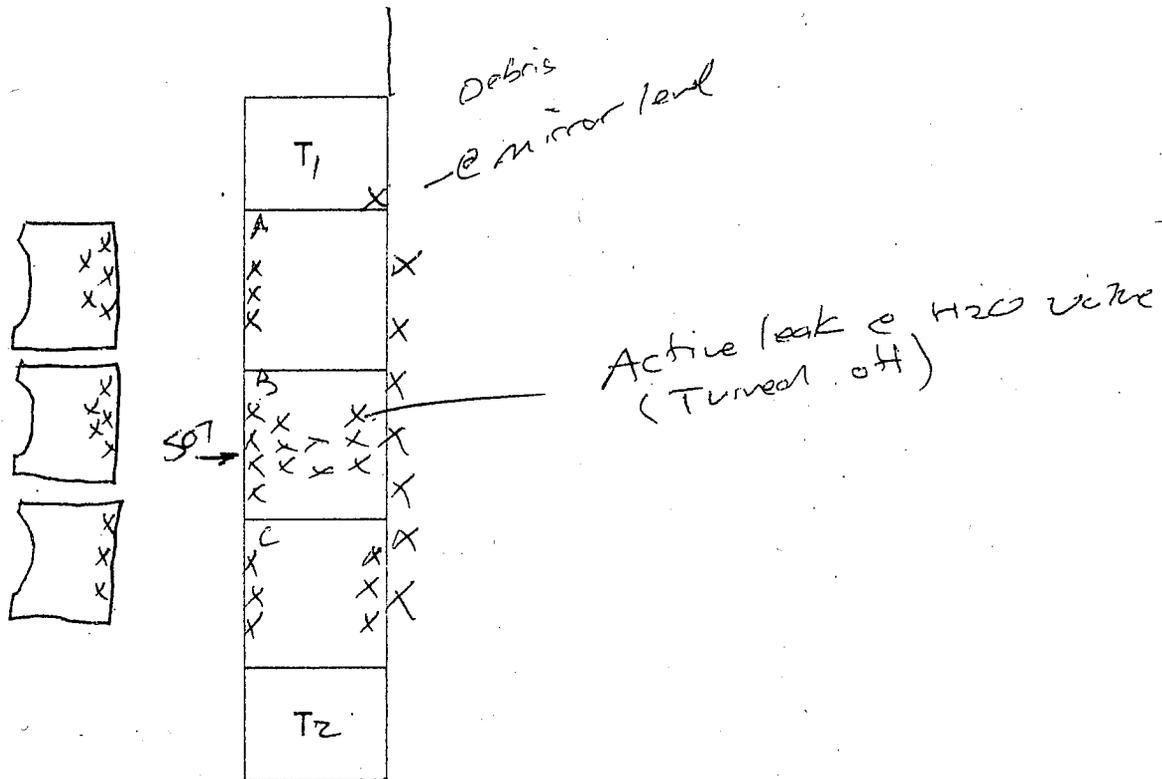
Level 1/2

Visible Staining: T1 A B C, Caress ABC

Elevated Moisture: yes @ B
 (Leak corrected - turned off valves)
