BioMax Environmental

April 10th, 2009

**Microbial Assessment of Rest Room Areas
Department of General Services Board of Equalization Building
450 N. Street
Sacramento, California**

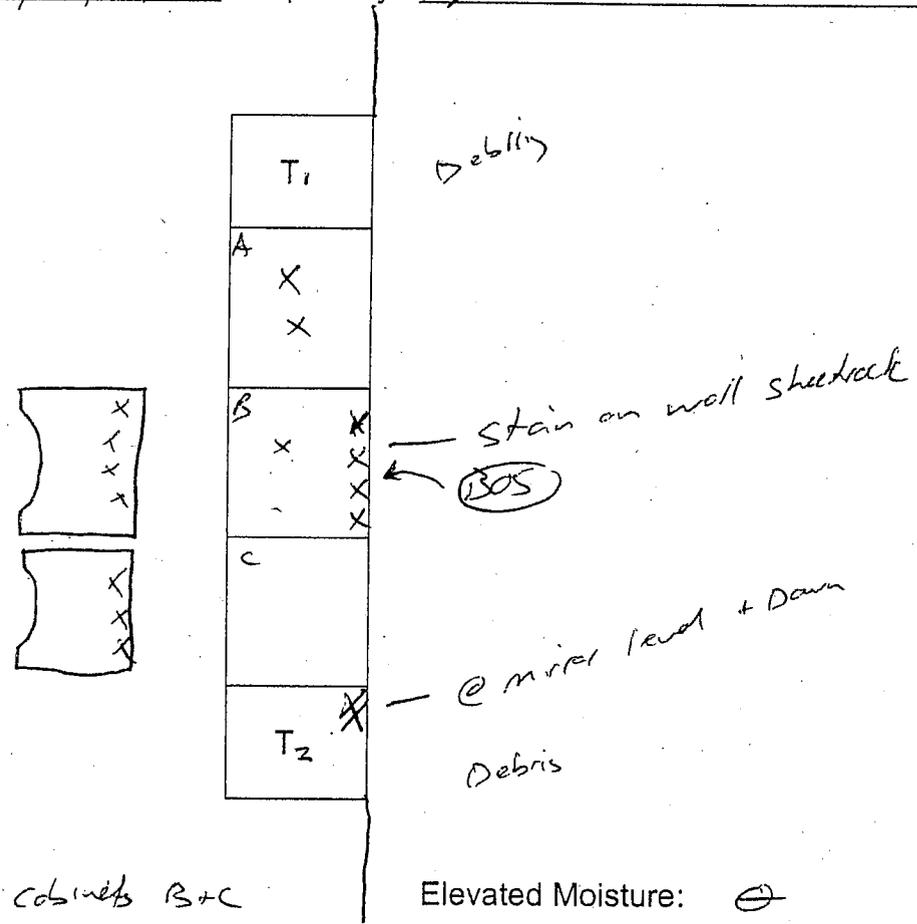
Level 3

Visible Staining: yes - cabinets B+C

Elevated Moisture: ⊖

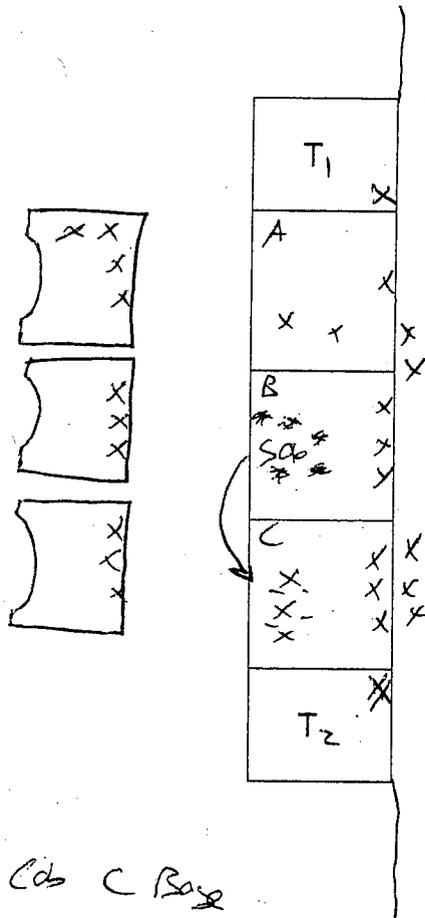
Level 2

^{Bis}
 puddles on sink w/
 poor caulk @ sink

* Active leak

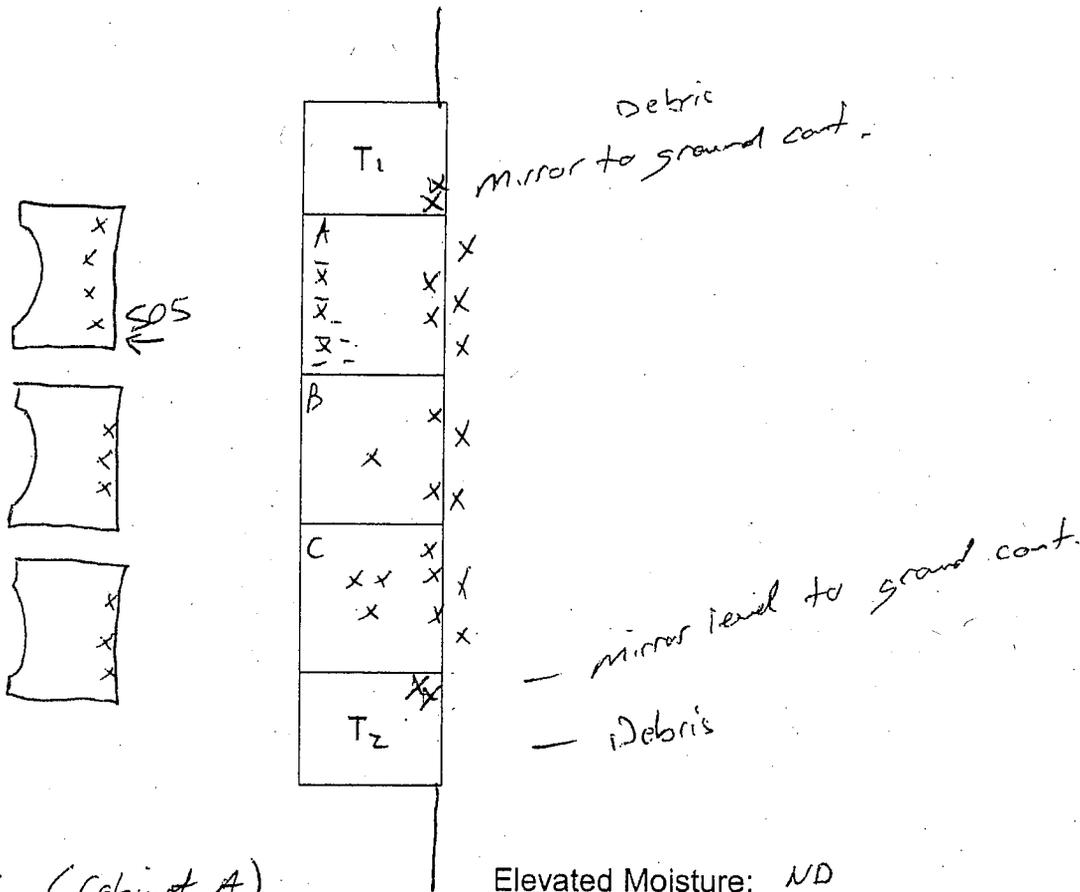
Level 2

Visible Staining: y (Cabinet A)

Elevated Moisture: ND

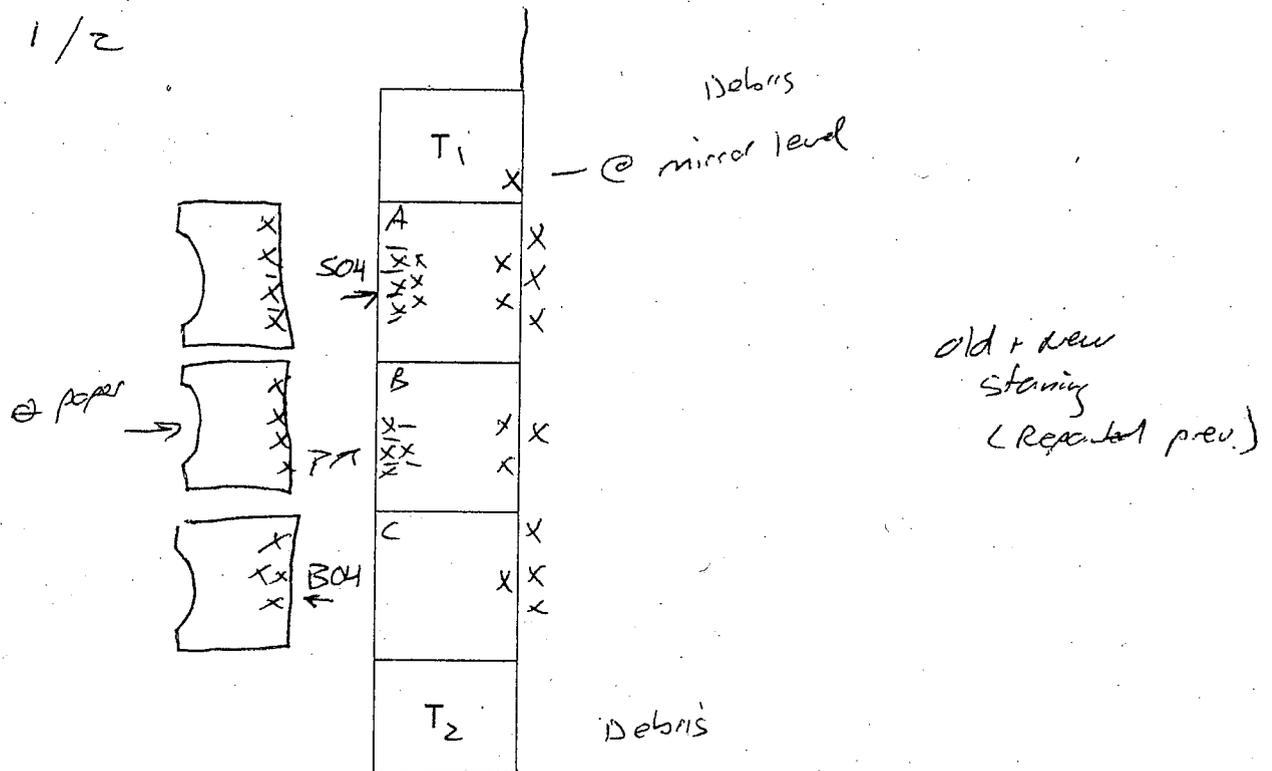
Level 1/2

Visible Staining: yes ABC covers ABC Elevated Moisture: ND

Physical Damage: yes ABC (11)

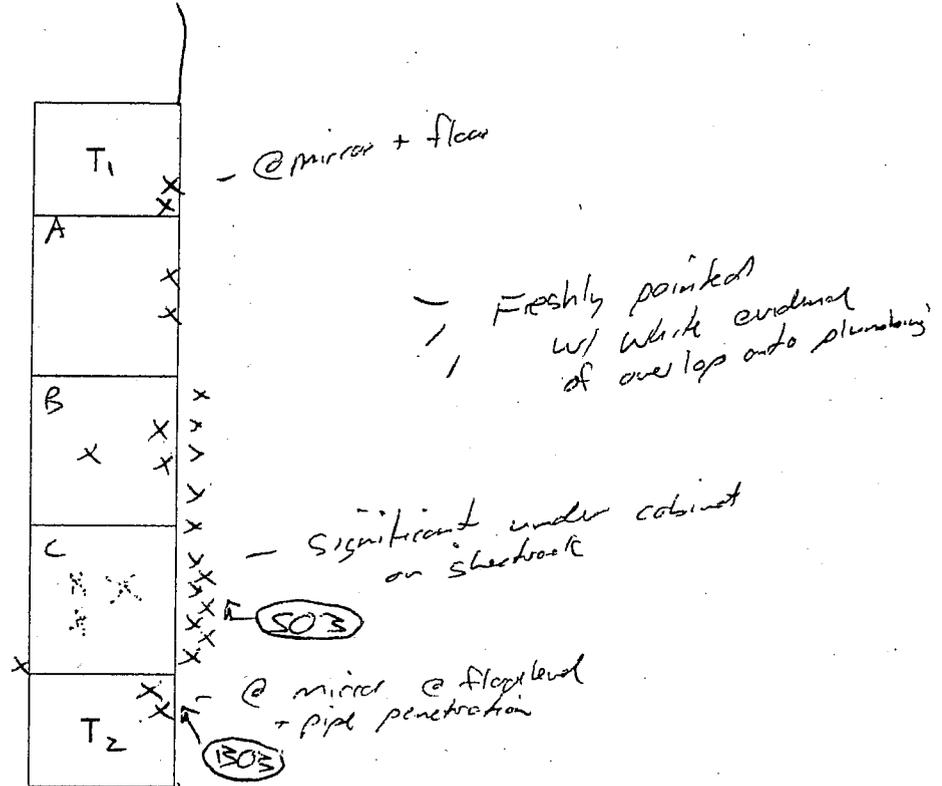
Level 1/2

Cover w/ o paper = replacement covers

Visible Staining: yes, sheetrock under cab

Elevated Moisture: ND

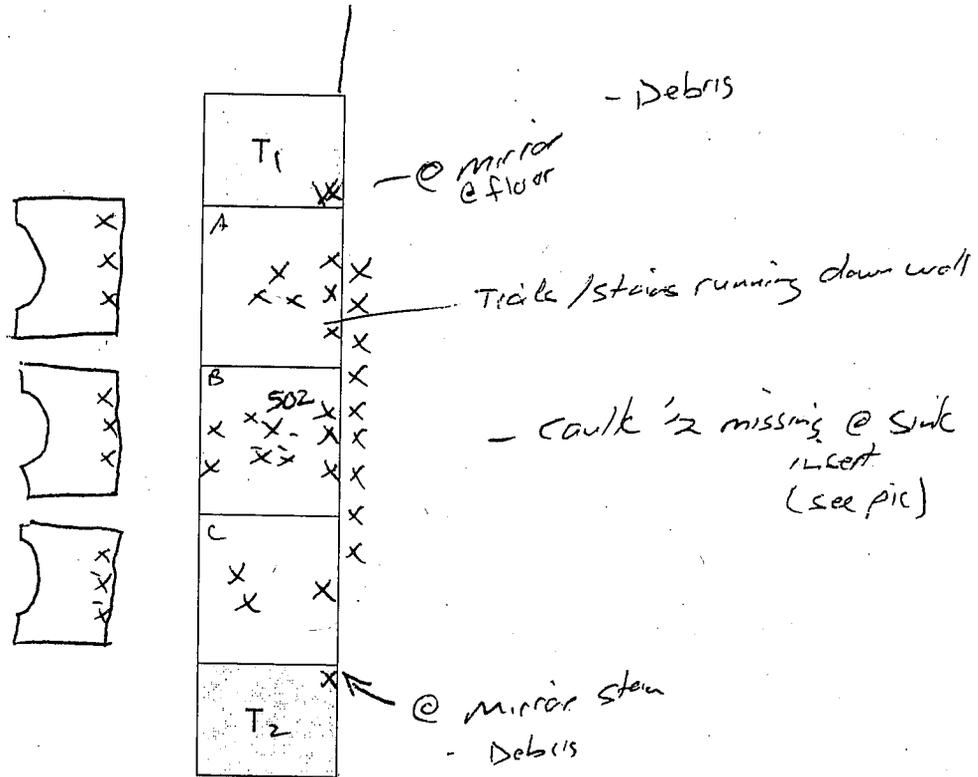
Level 1/2

Visible Staining: yes (A, B, COVA, COVB, C, COUC)

Elevated Moisture: ND

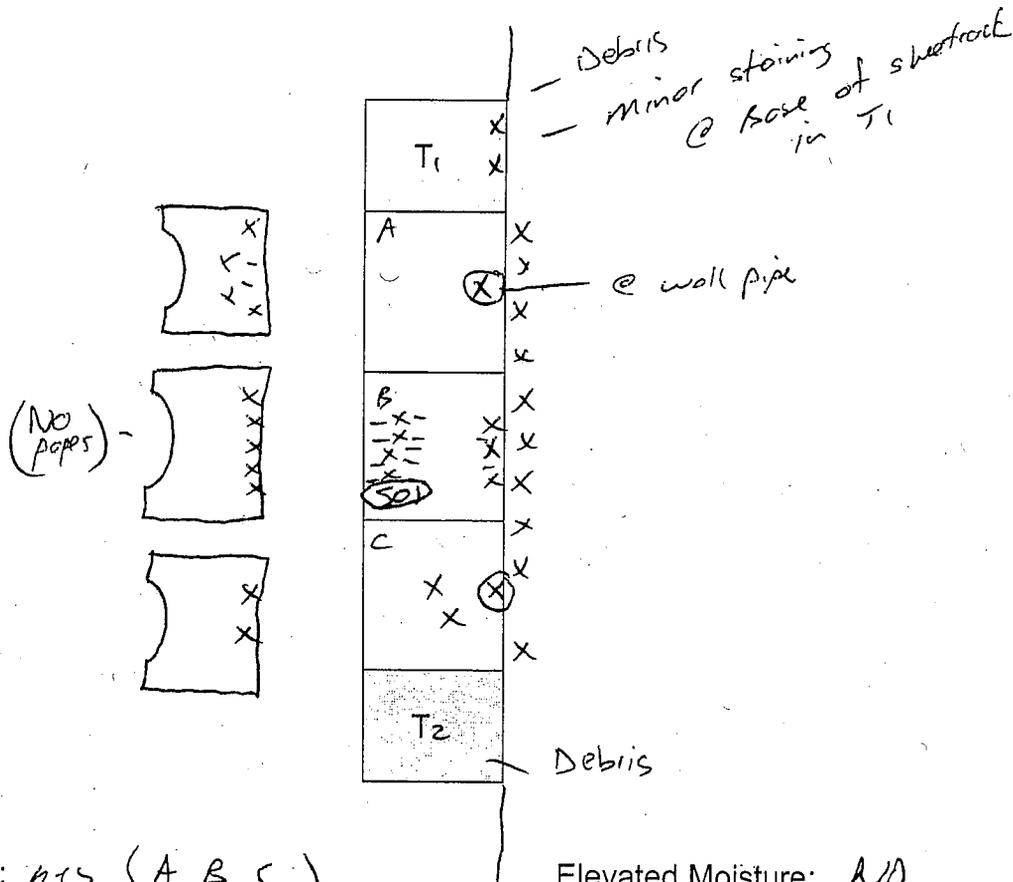
Level 1

Visible Staining: yes (A B C)

Elevated Moisture: ND

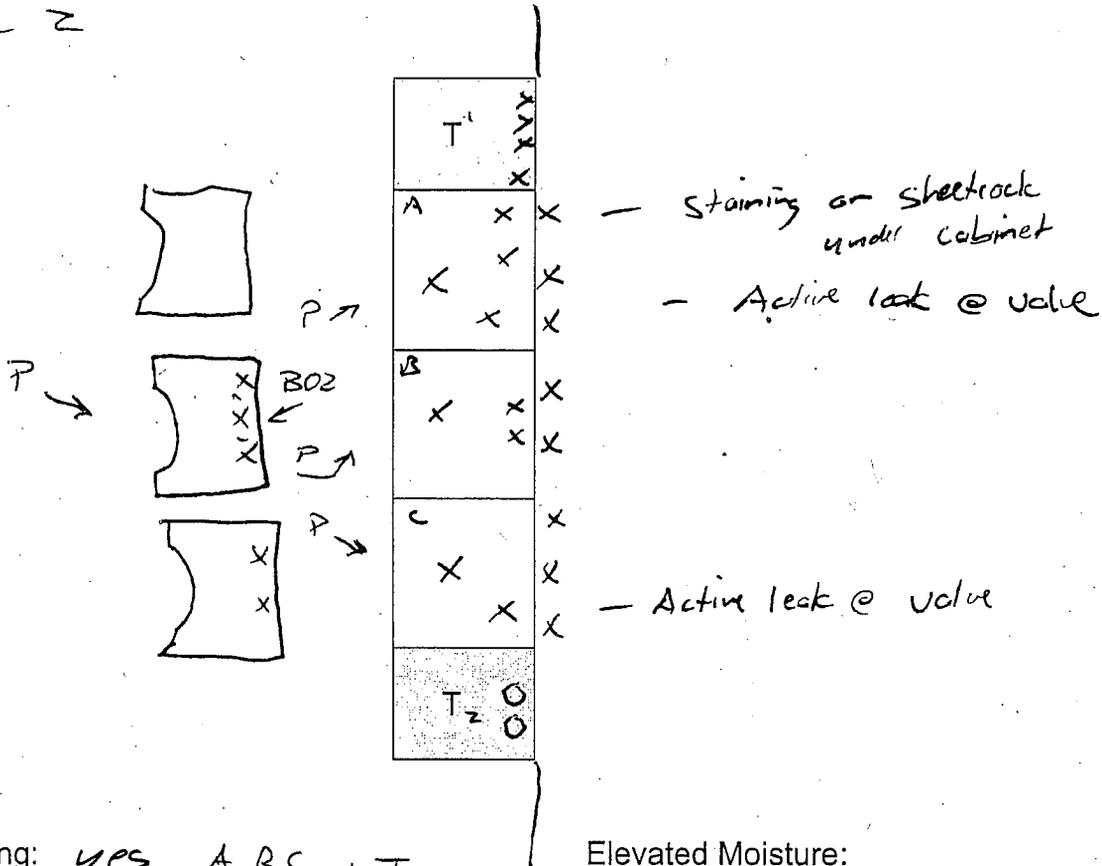
Level 2

Visible Staining: yes A B C + T₁

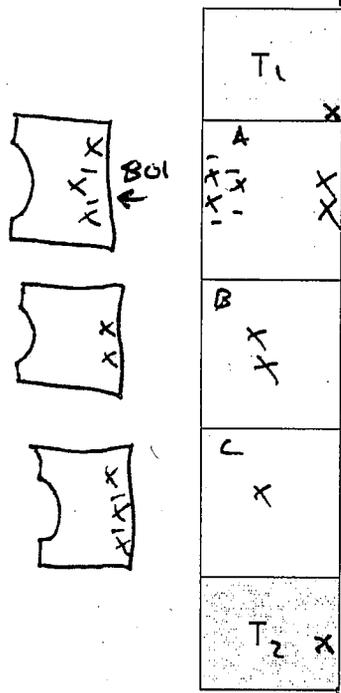
Level Z-3

X Staining
 - Physical Damage

- @ mirror level

- @ floor level
