McGinnis Chen Associates Inc
ARCHITECTS | ENGINEERS

31 January 2012

Re: BOE Building 450 N Street (MCA Project No.: 12008.00)
Subj: January 11, 2012 Glass Breakage Report

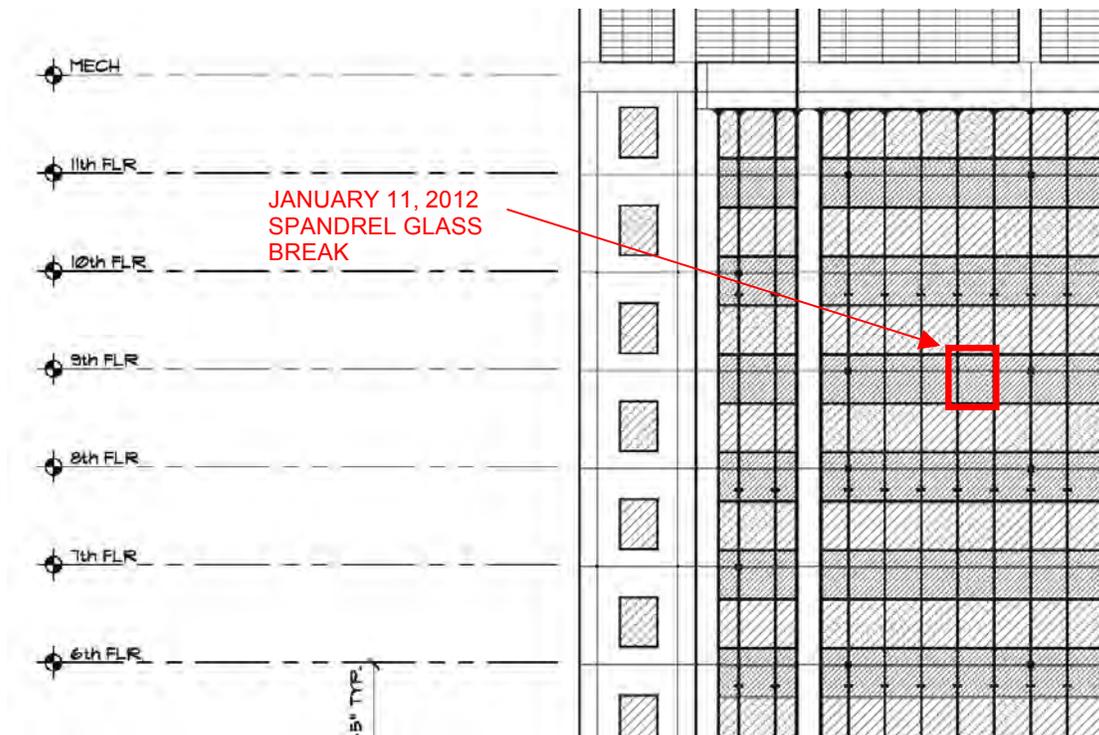
Figure 1 – Partial East Elevation

The spandrel glass at the east elevation, 9th floor level, 5th lite from the south end of the corner (Figure 1) was reported to have broken and fallen to the ground at approximately 10:30 am (PST) on January 11, 2012. Climate conditions as reported at a private weather station at 24th and K at 10:35 am (PST) were 50°F, Dew Point of 32°F, 50% RH, skies clear and wind calm. The low temperature overnight was 32°F.

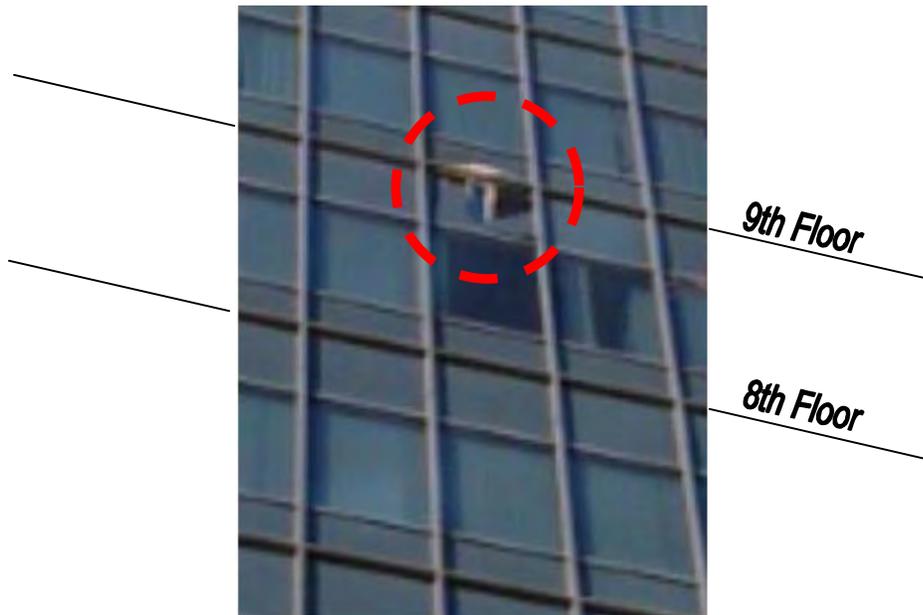
Significant portions of the glass below the floor level originally fell to the ground (Photo 1).

Photo 1 – View of broken spandrel glass shortly after it occurred.

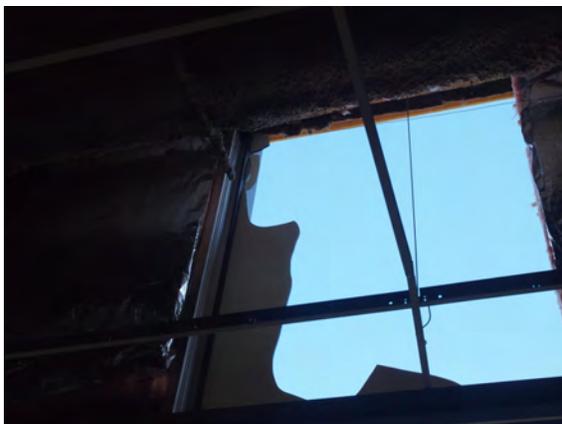
Upon MCA's arrival more glass below the floor line had fallen (Photos 2 and 3) and portions above the floor line had also fallen (Photos 4 and 5).

Photo 2 – View from interior of additional glass that had fallen below the floor level.

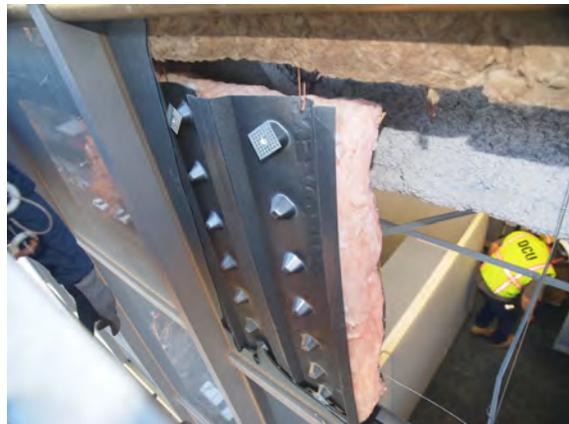
Photo 3 – View from exterior of additional glass that had fallen below the floor level.

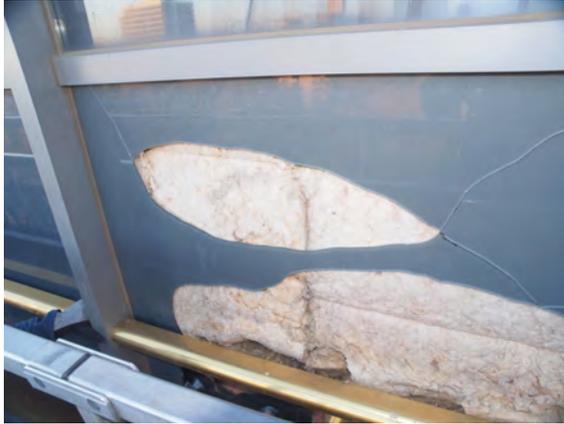
Photo 4 – View from exterior of additional glass that had fallen from above the floor line. Long arching cracks are observed in the glass.

- No staining was observed on the exterior glass surfaces indicating long-term glass breakage.
- Both long cracks with large glass pieces and localized concentrated small breakage patterns were observed in the glass (Photos 4, 6 and 7). The localized concentrated small breakage is in the areas of more constrained edges (corner and at the horizontal bar at the floor line).

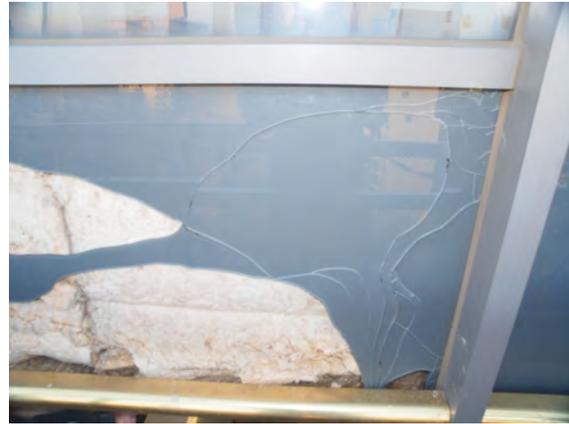
Photo 5 – View from exterior of additional glass that had fallen from above the floor line.

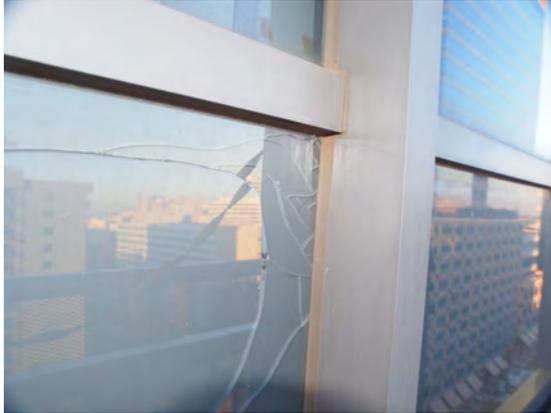
Photo 6 – View of upper right corner of the broken glass with concentrated small breaks.

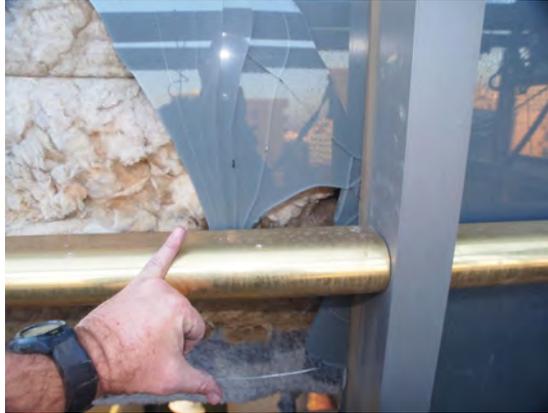
Photo 7 – View of the right side of the broken glass at the floor line with concentrated small breaks that terminate to a focal point (Photo 9).

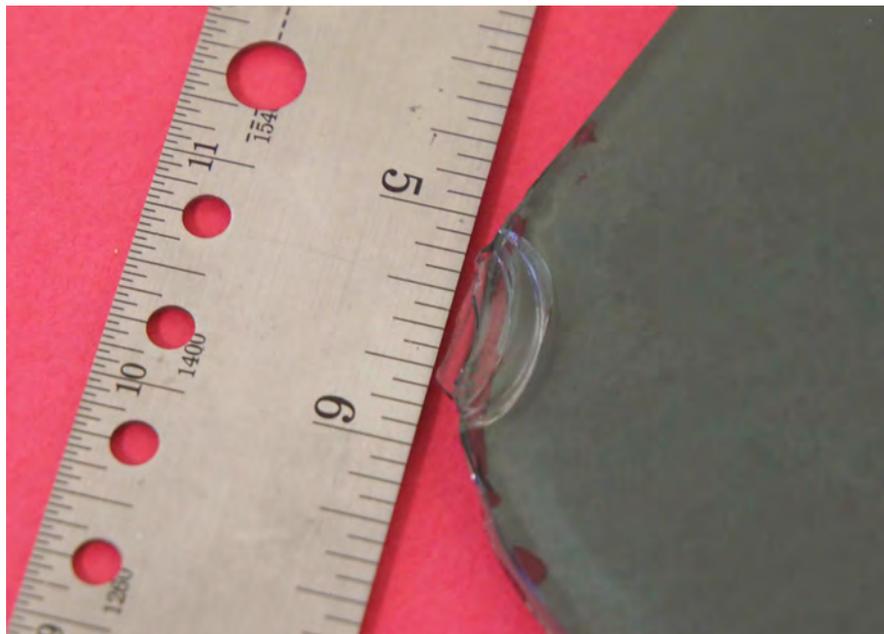
MCA was provided with a small piece of the spandrel glass for further testing. One corner of the specimen contains a circular pattern (Photo 8). The original location of this sample prior to the break is unknown.

Photo 8 – View of circular pattern at the corner of a piece of the spandrel glass.

On January 13, the sample piece provided was taken to MCA's San Francisco office to perform a strength analysis and further review of the sample piece circular pattern at the corner (Photo 8). The compressive strength was determined to be 7,500 psi using a GASP device. This result conforms to the glass type and is consistent with previous tests performed (reference attached 27 March letter.pdf).

Photos and the preliminary report were forwarded to Mr. Tom Schwartz (SGH) for further discussion and course of action to determine the cause/source of the break. The circular pattern at the corner of the glass sample was further reviewed and determined to be most likely a result of impact damage from falling. The focal point of the glass breakage pattern in Photos 7 and 9 was of interest and would be further reviewed along with edge conditions of the remaining glass during replacement of the broken glass on January 16th.

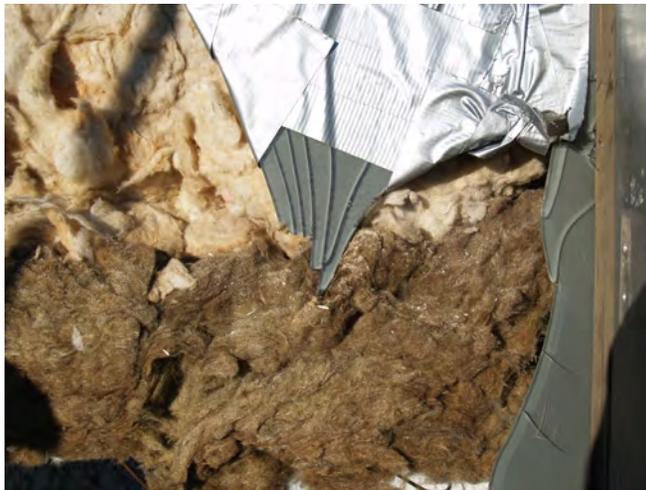
On January 16, Architectural Glass and Aluminum (AGA) removed the remaining glass pieces and installed a replacement spandrel glass (glass was taken from replacement spares kept in the building's mechanical penthouse). MCA was on site during the removal phase to investigate edge conditions not previously checked due to the glass remaining in place. The glass edges were verified not to be in contact with any metal framing pieces. The setting blocks were observed to be properly positioned. The back side of the brass bar was reviewed and no wear or burnish marks were observed indicating that something had been wedged between the brass bar and window. The glass break pattern that terminated to a focal point was photographed in place (Photo 9) and removed for further review and testing.

Photo 9 – January 16 view of focal point of glass break with the horizontal brass bar removed.

As stated in Mr. Schwartz's report, a definitive cause of the failure cannot be determined, but that with the information known a nickel-sulfide (NiS) fracture is the most likely cause.

The possibility of a future spontaneous fracture, though very limited, cannot be 100% ruled out. Consideration of applying a safety film (attached data sheet SH-4 CLARXL.pdf) to keep possible future glass breaks from falling or replacement with glass not considered to contain this element are the only options for greater assurance against falling glass. MCA did contact a contractor regarding applying a safety film and was given a budget of \$100,000 per elevation (\$400,000 for the building) to perform the work. MCA recommends additional contractors be contacted to firm up this budget, but believes the number provided to be, on order of magnitude, correct.
