**California State Board of Equalization**  
450 N Street, Sacramento, California

**Mold Remediation – 17<sup>th</sup> Floor  
Closure Report Addendum**

*Project No. 2372.02-572*

**Addendum Date:** October 31, 2012

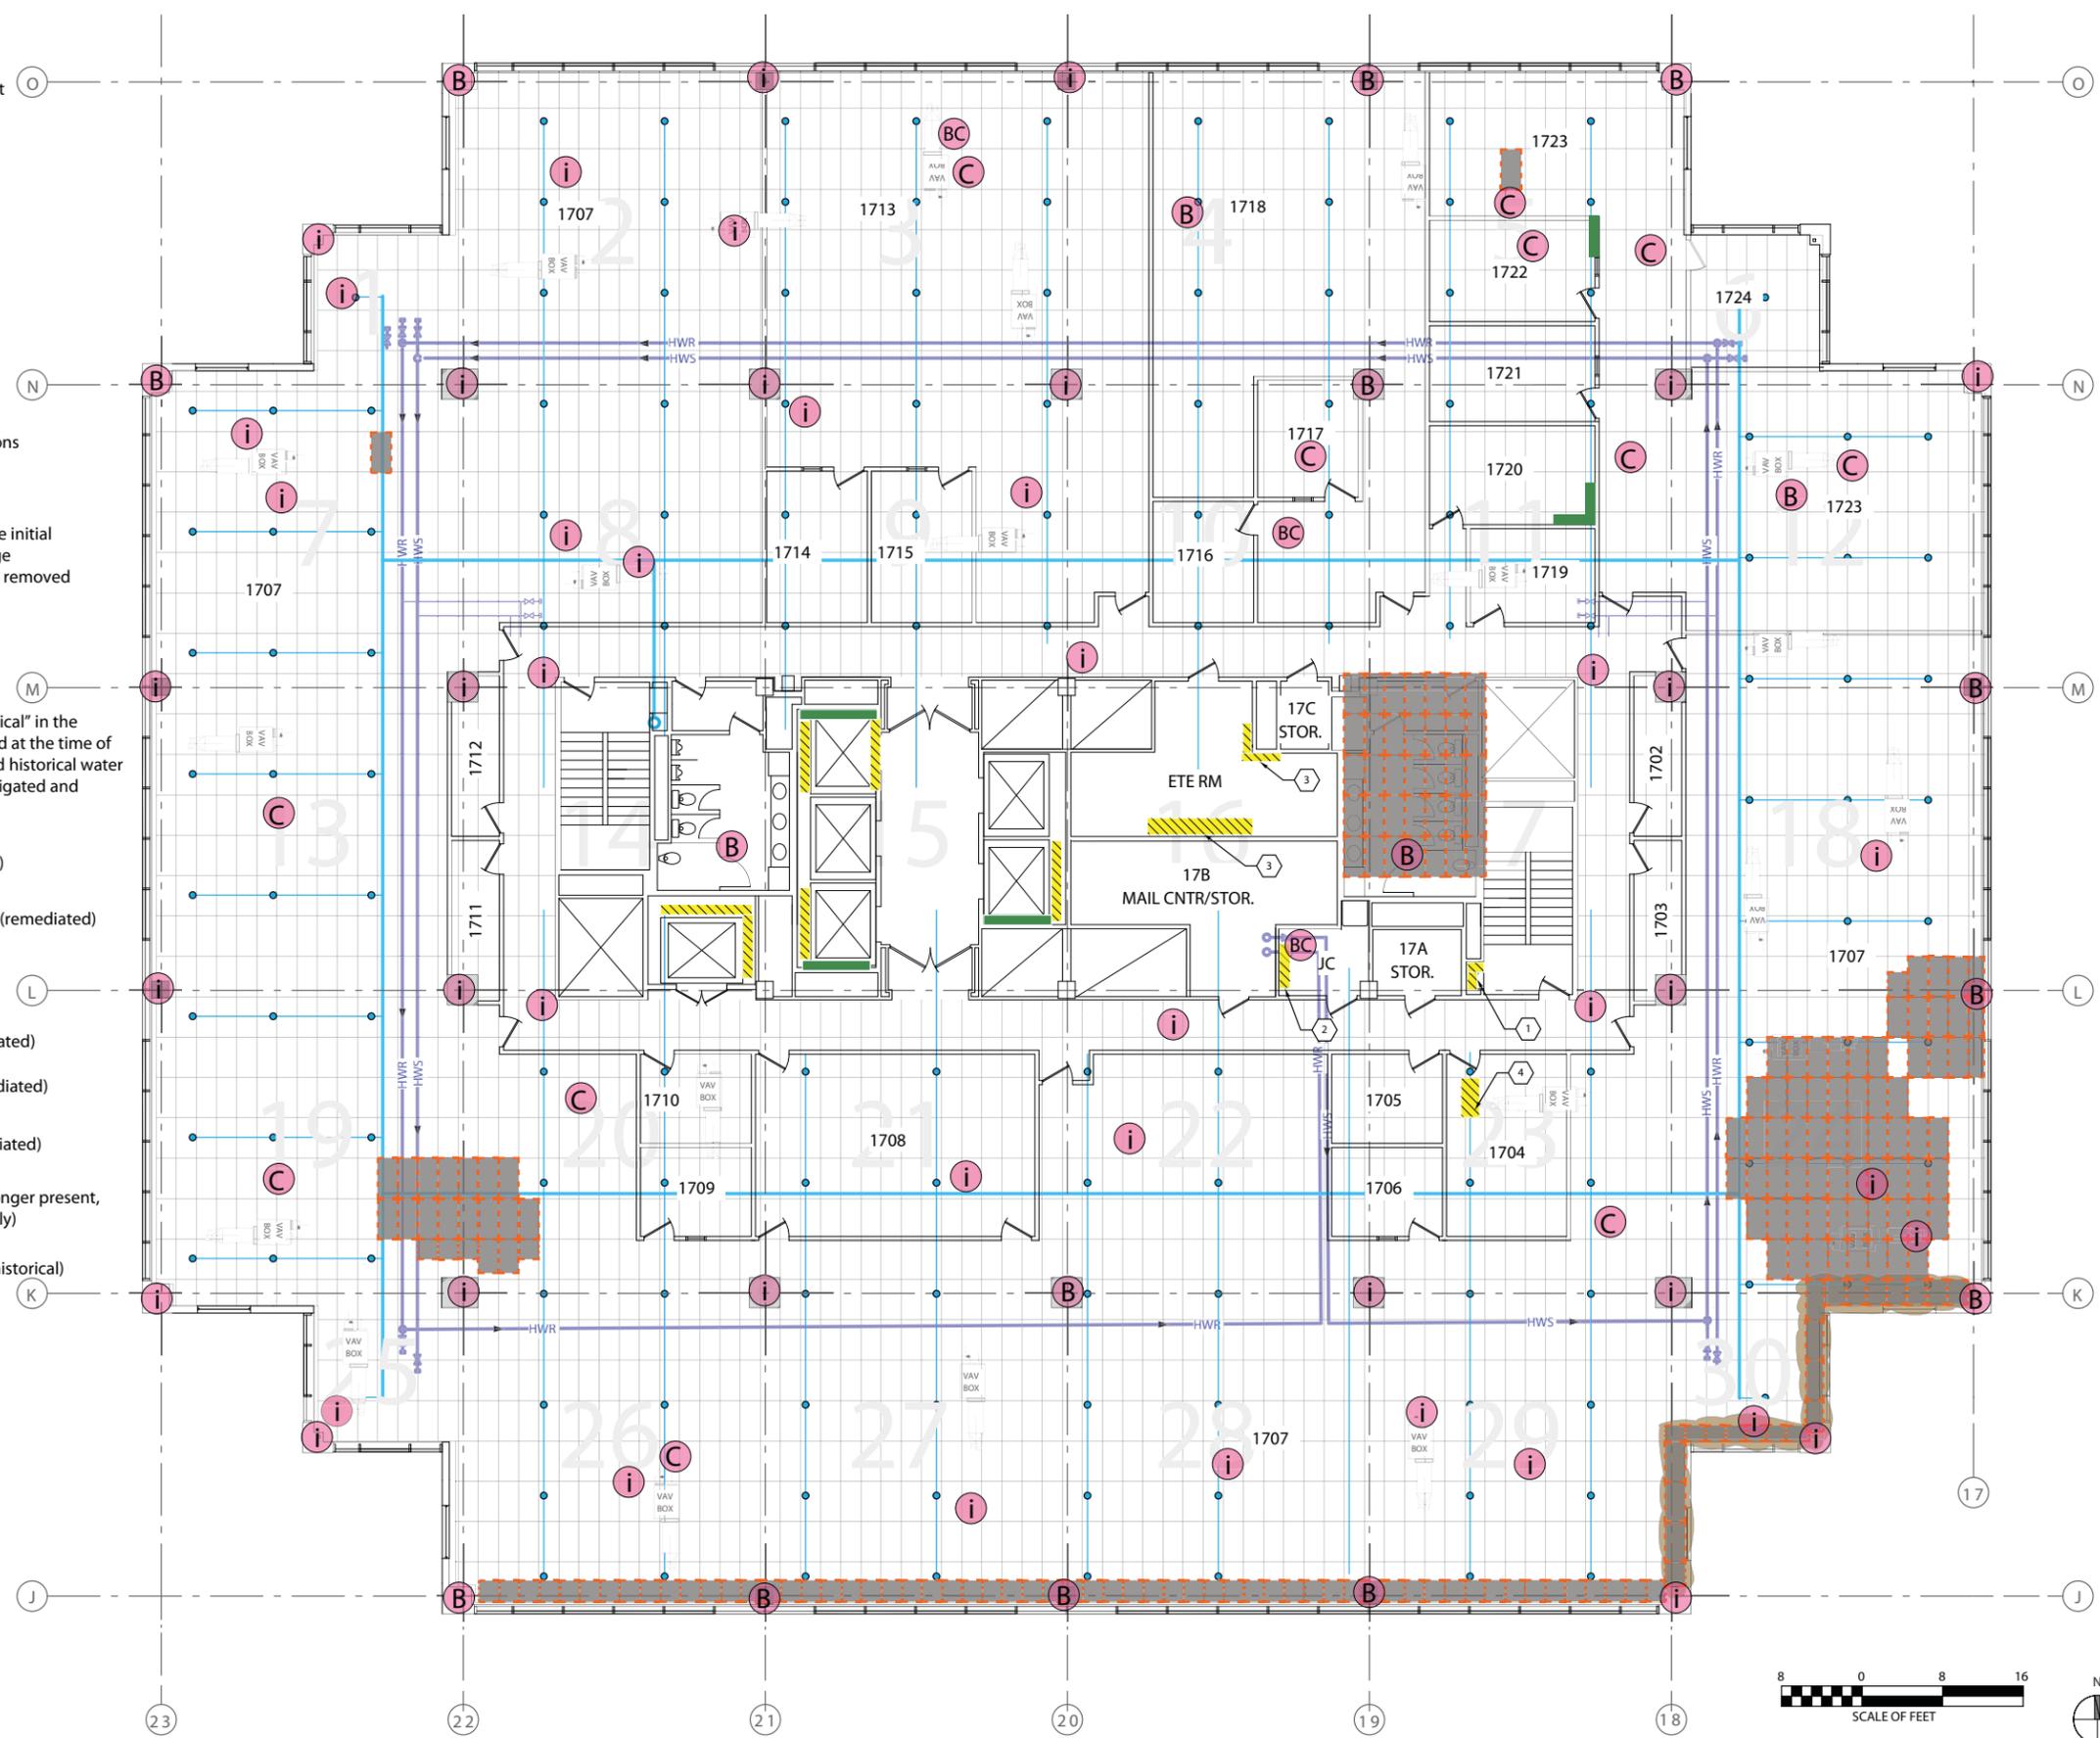
October 2012                      Figure 2 (Containment and Sample Locations) was revised and is attached.

- ① Water stain on North and West walls
- ② Water stain on wall and floor
- ③ Water stain on wall and floor
- ④ Stained ceiling
