California State Board of Equalization
450 N Street, Sacramento, California

**Mold Remediation – 5th Floor
Closure Report Addendum**

Project No. 2372.02-572

Closure Report Date: March 29, 2011

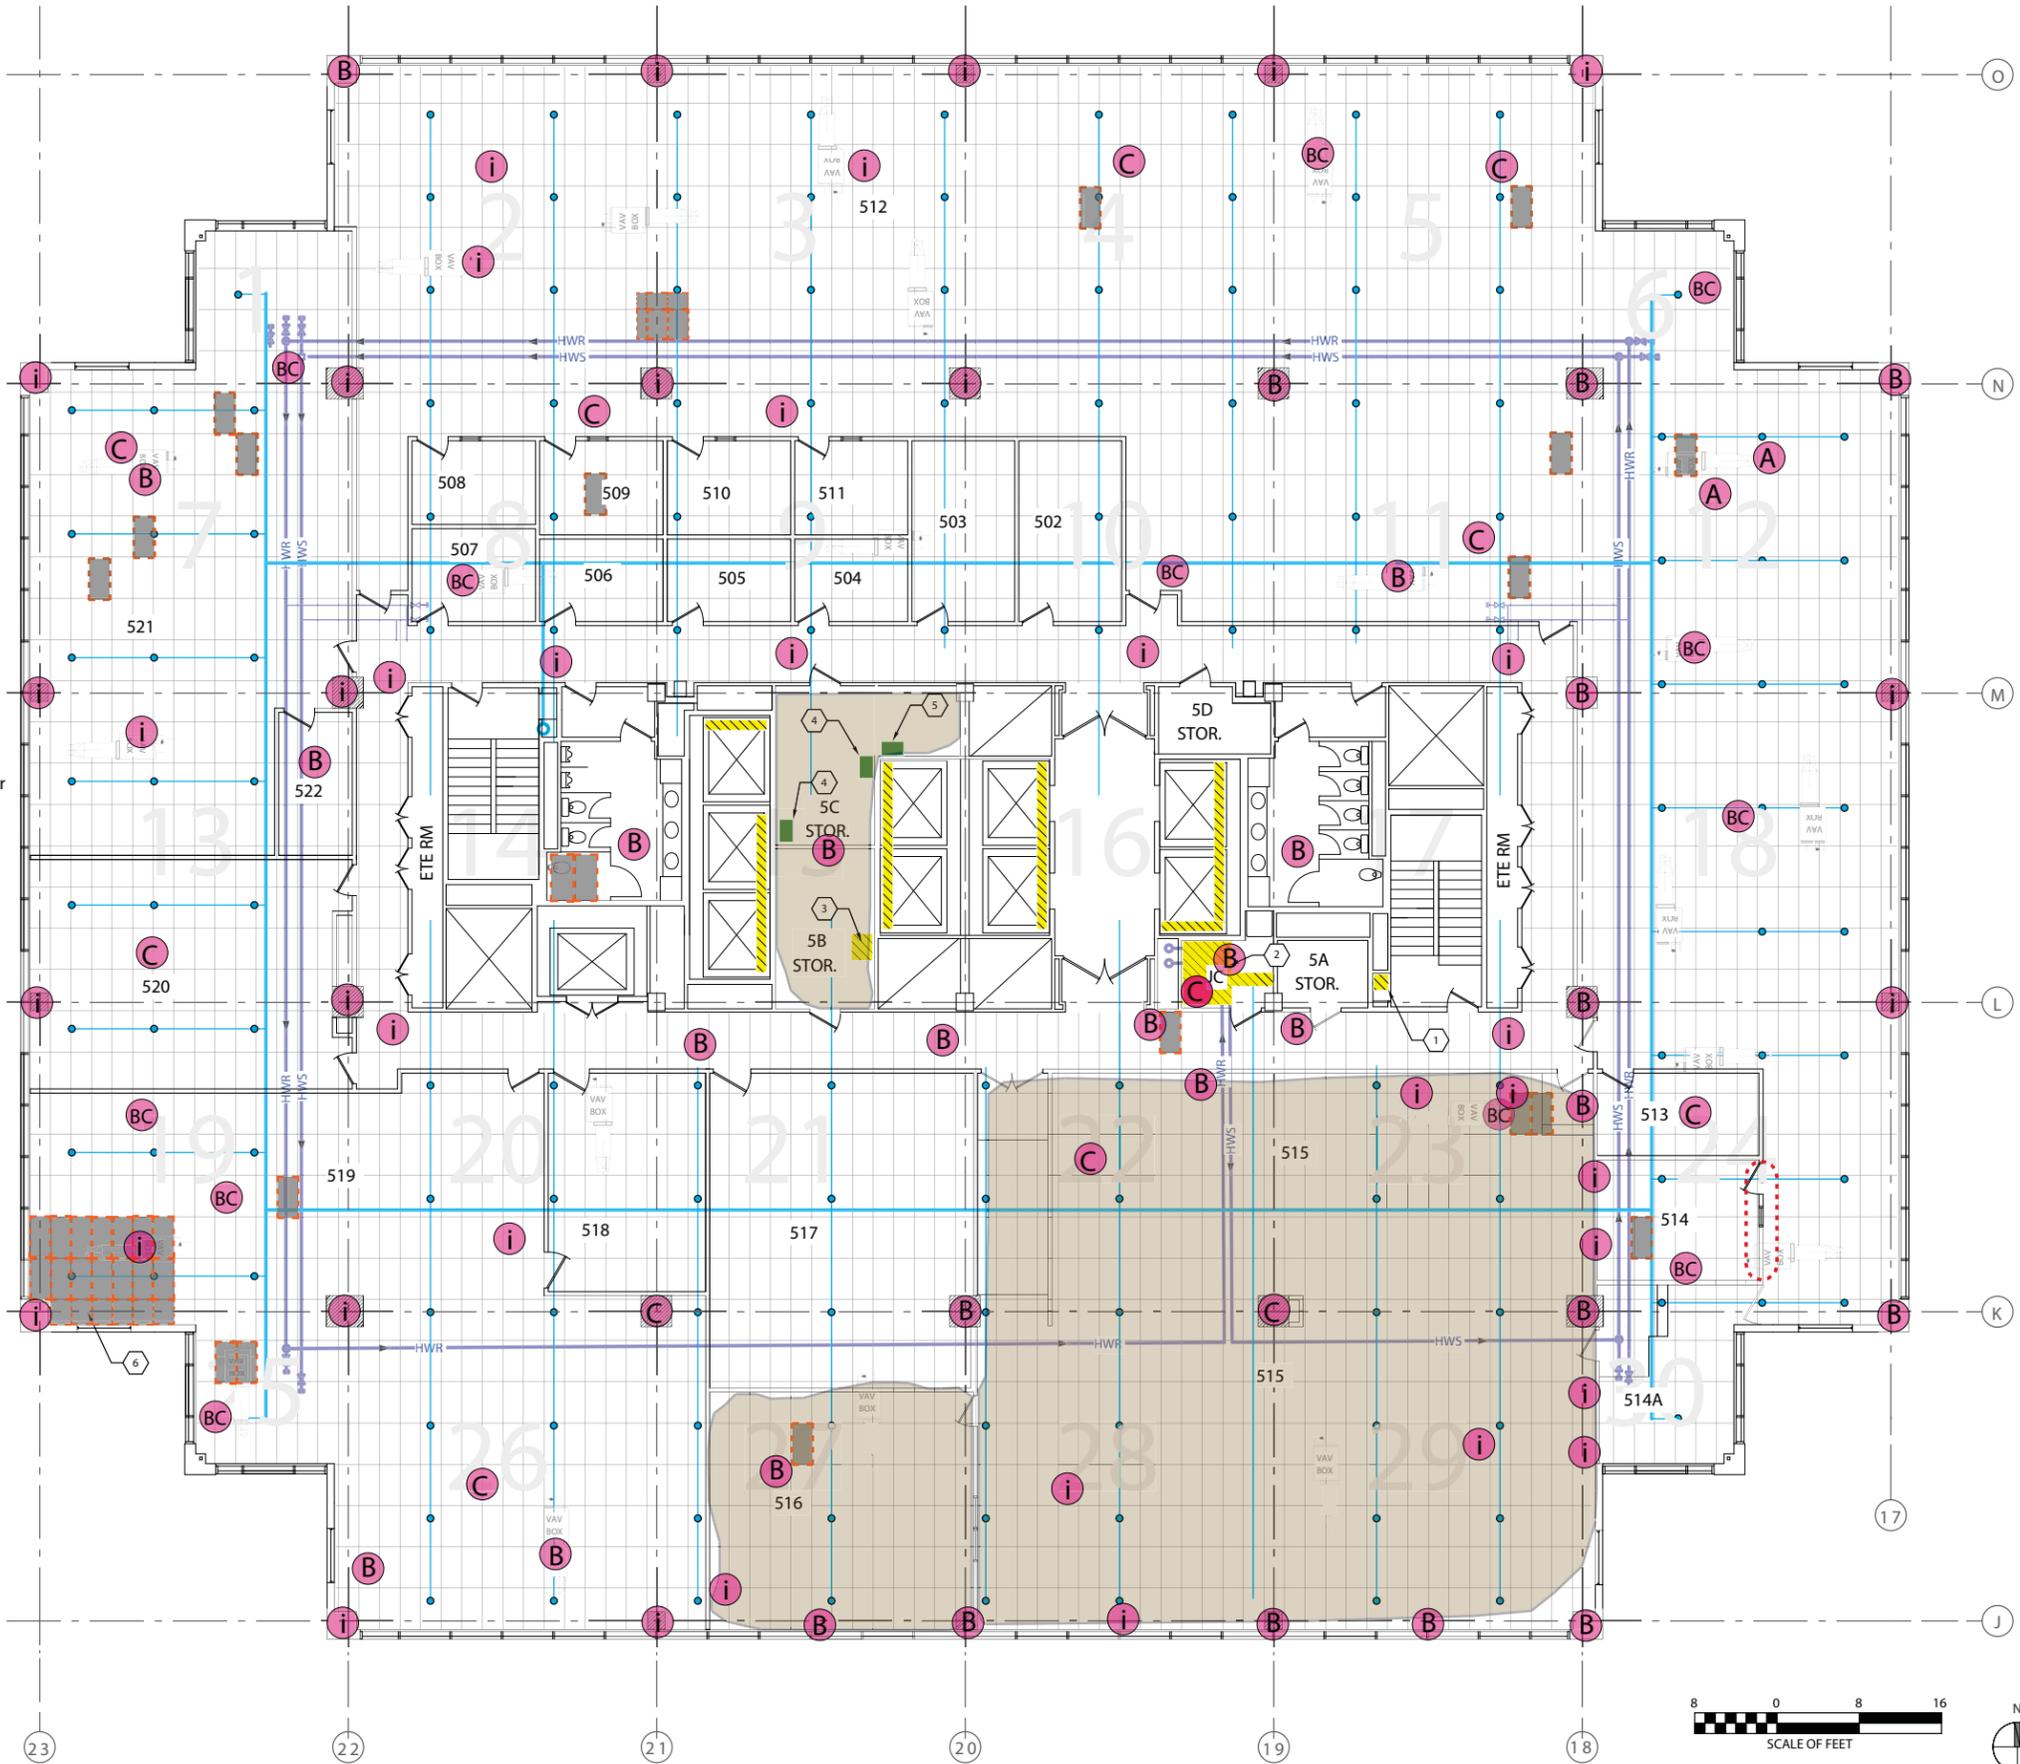
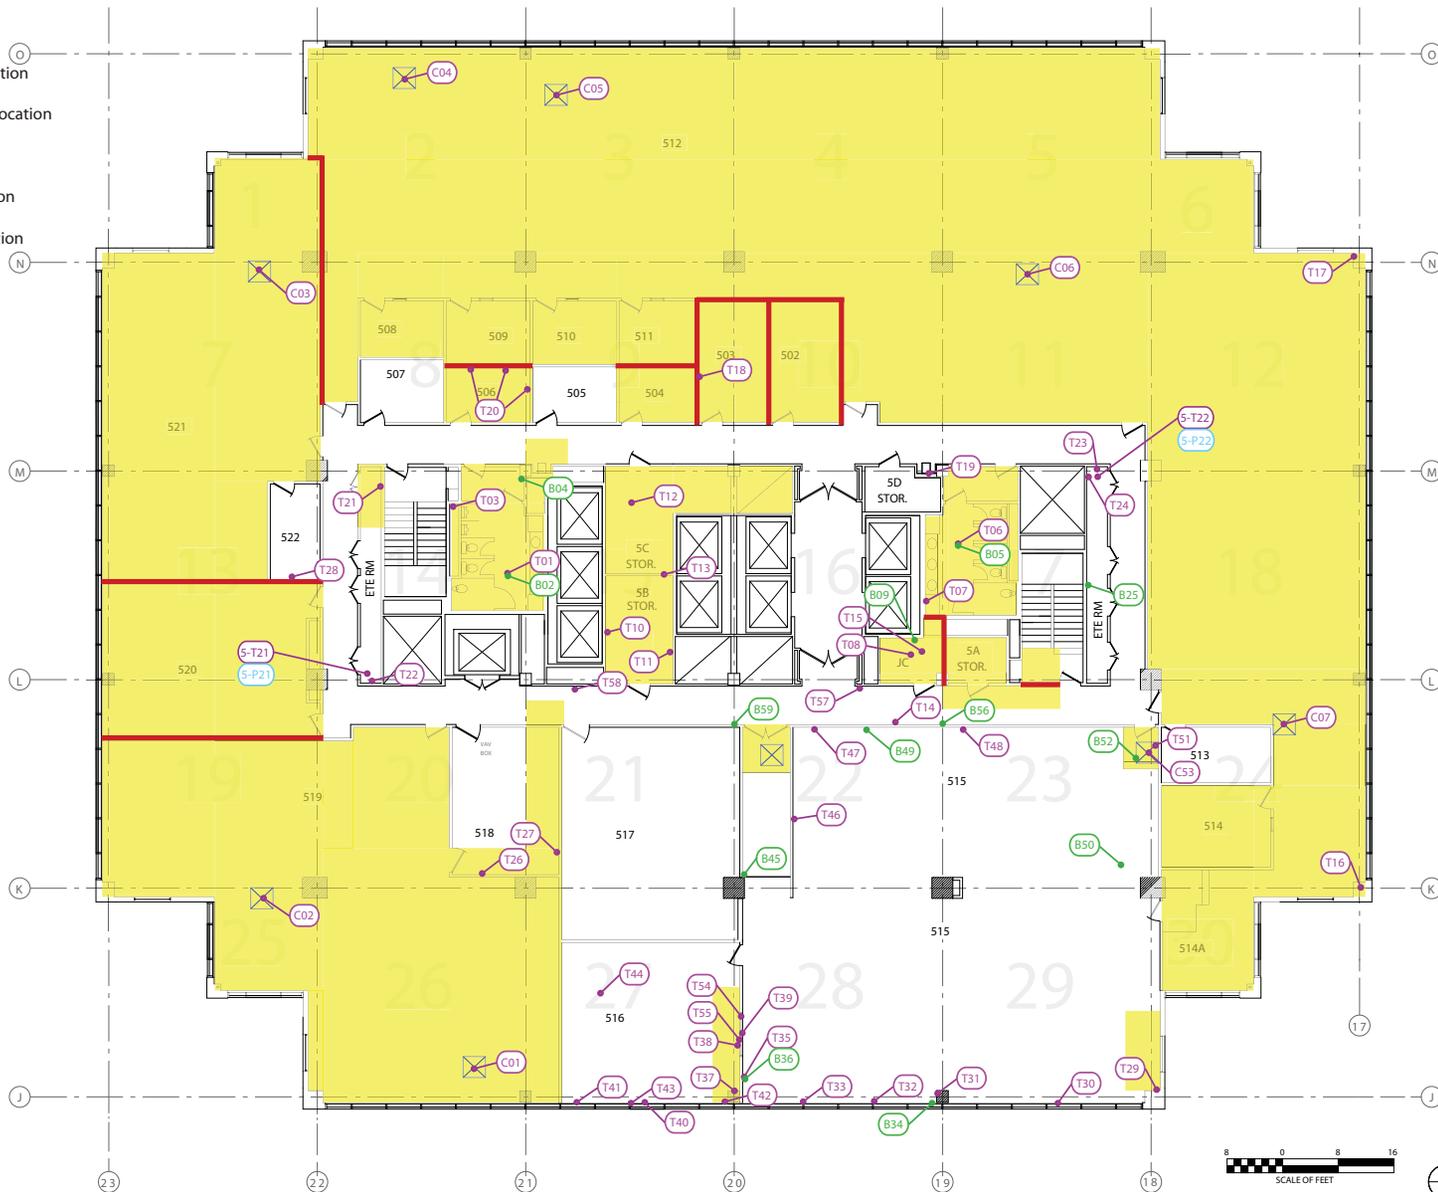
October 2012 Figure 2 (Containment and Sample Location) was revised and is attached.

- ① Water stain on wall and fireproofing
- ② Water stain on ceiling and wall
- ③ Water stain on wall and ceiling with paint delaminate
- ④ Visible mold growth above ceiling
- ⑤ Visible mold growth at lower wall
- ⑥ Ceiling tile collapse due to VAV leak
