**RE: California State Board of Equalization
Closure Report Addenda**

California State Board of Equalization
450 N Street, Sacramento, California

**Mold Remediation – 8th Floor
Closure Report Addendum**

Project No. 2372.02-572

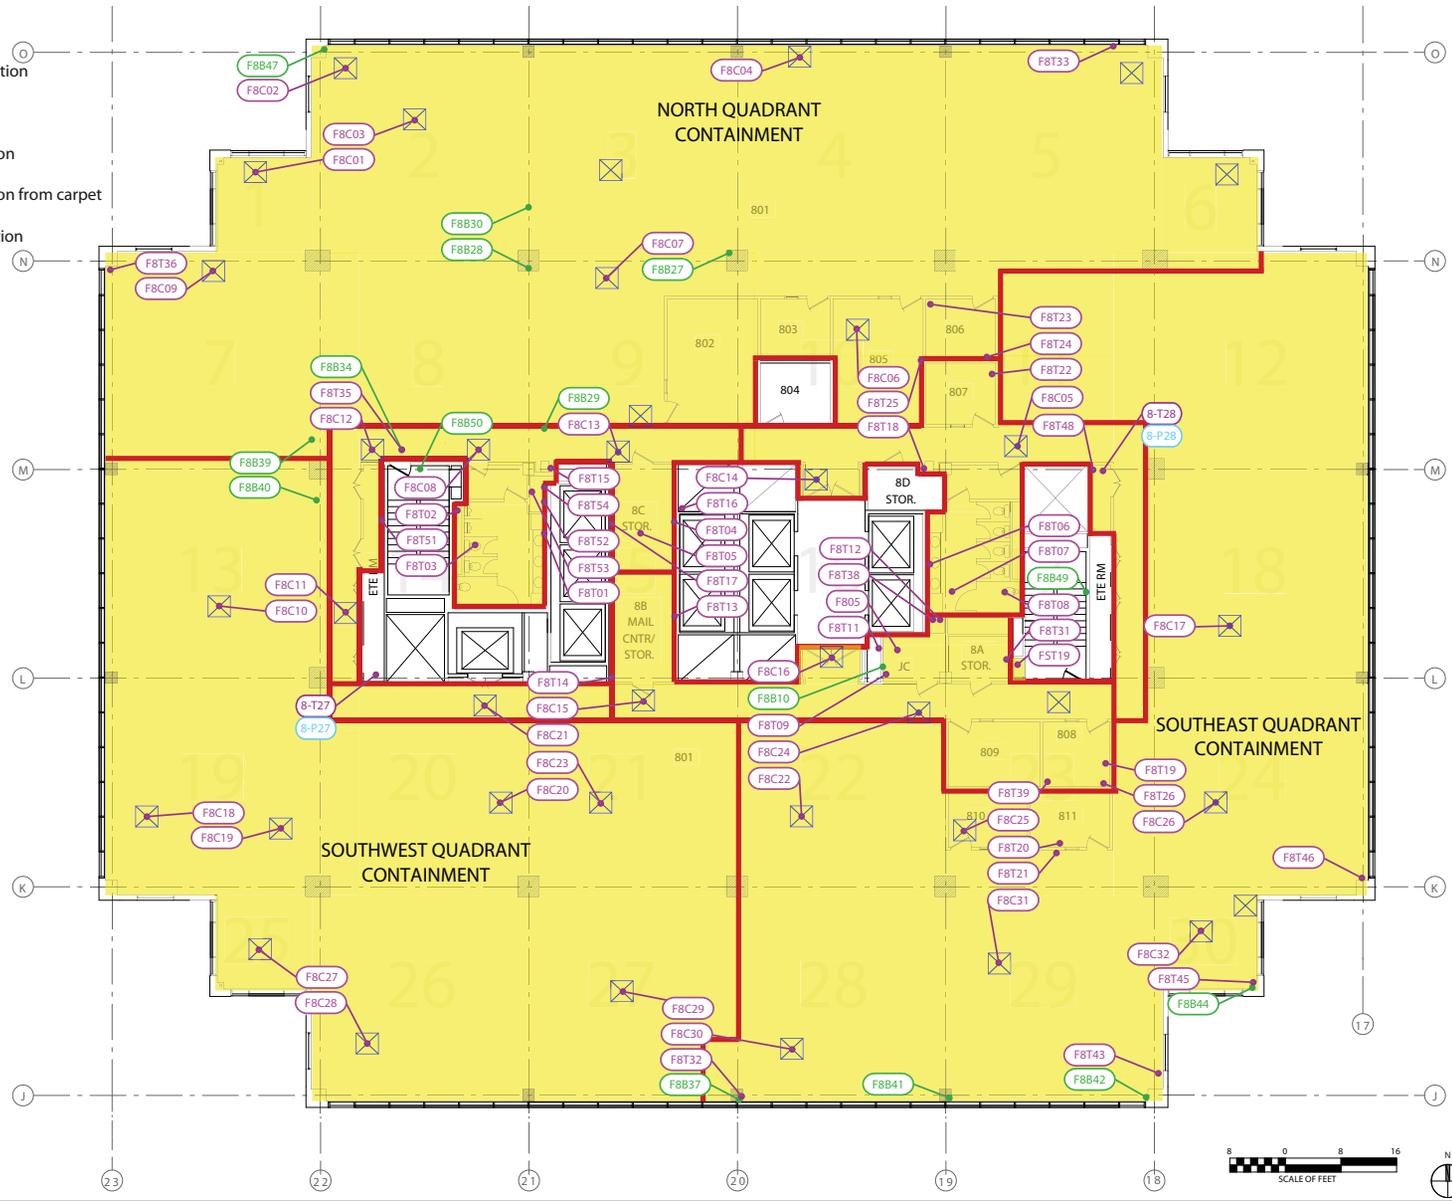
8th Floor
 Figure 2

Subsequent to the completion of the closure report, a need for additional investigation and/or remediation activities was identified. Identified areas were subjected to sampling. Using a combination of surface tape lift and/or bulk samples, LCD tested stains on walls and other building materials to determine if the stains were indicative of mold growth. The sample locations are depicted in a revised Figure 2 attached to this addendum.

Containment and Sample Locations (Oct 2012)
 Board of Equalization Building, Mold Remediation
 450 N Street, Sacramento, California
