BioMax Environmental

May 7th, 2009

Microbial Assessment of Janitor "Hopper" Room Areas
Department of General Services Board of Equalization Building
450 N. Street
Sacramento, California

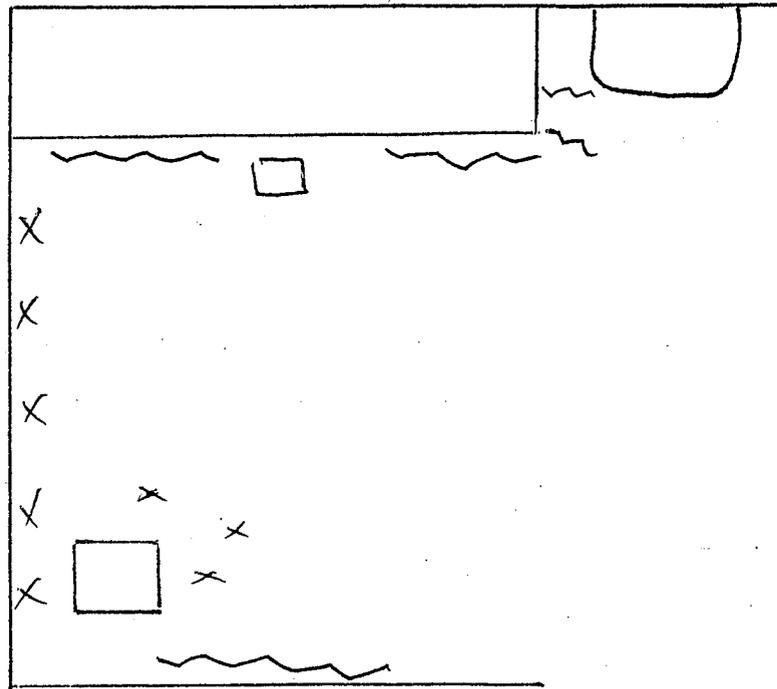
Significant staining on side wall
 ↗

Visible Staining/Damage:

Additional Comments: *Previously sampled area by BioMax*

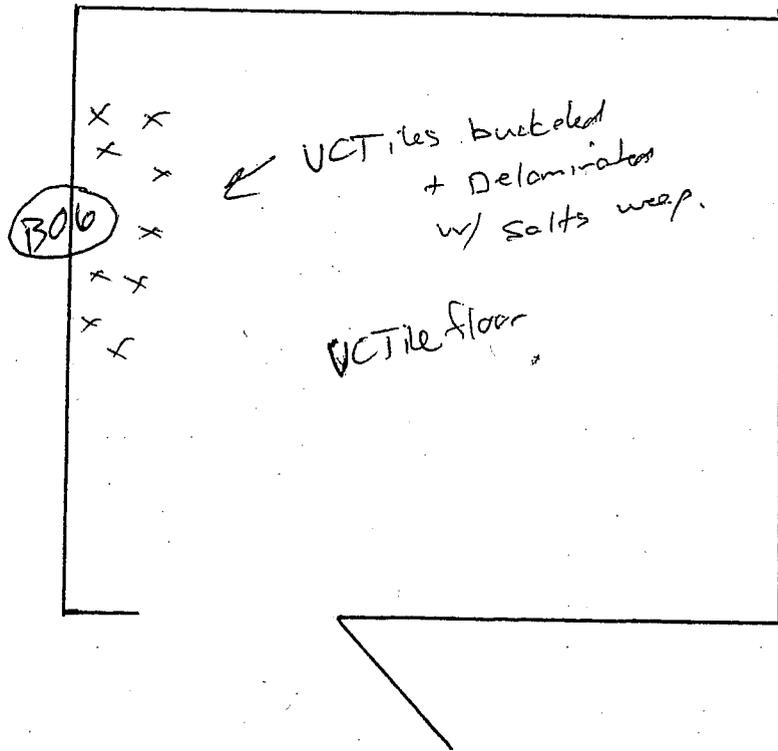
First Floor Fire Control Room
Adjacent to Hopper Rm

1 st Floor Fire Control Room (FCR) area	Significant staining on flooring materials	Significant cracking of vinyl flooring materials VCT "buckled" and delam.	Stachybotrys confirmed on West side wall sheetrock located beneath baseboard	ND	Evidence of historical moisture impacts present.	Recommend mitigation of damaged wall and flooring materials under containment control barriers. Also recommend removal and mitigation of VCT flooring under containment barrier controls.	Level 1

BOG - Bulk Beneath Baseboard on wall
paper sheetrock

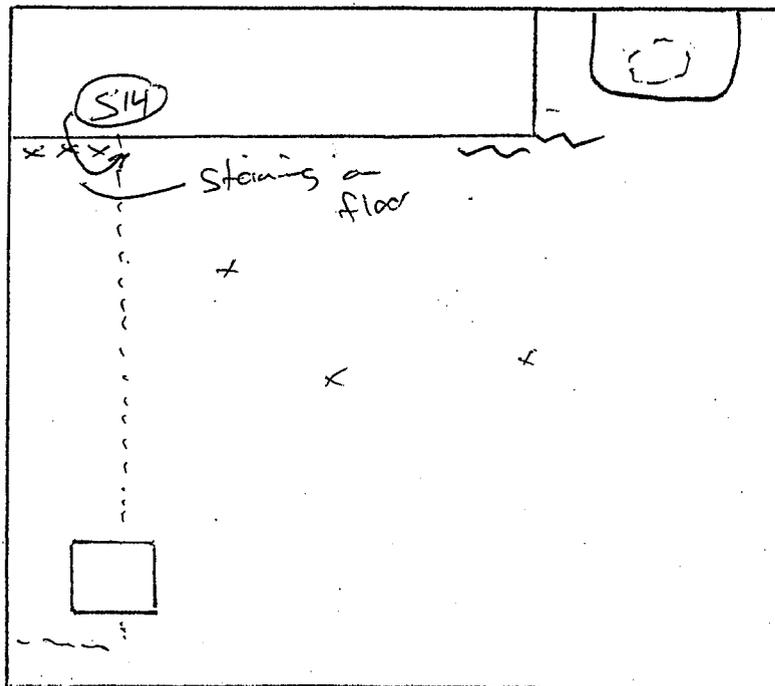
Janitor Room ID / Location: Floor 2

2 nd Floor Janitor Room	Rust-like staining present on sink foot support at floor level. General staining (significant) present on vinyl flooring	Minimal cracking of vinyl flooring in sink area	Sampling of vinyl floor to side of metal cabinet indicated "unremarkable" mold-like findings	ND	Staining on vinyl flooring and to side of shelving structures.	Recommend janitorial cleaning of floor staining and replacement and/or sealing of gaps and cracks present within flooring materials. Perform regular inspection and maintenance following recommended activities above.	NA
1 st Floor Janitor Room	Significant staining on flooring materials	Significant cracking of vinyl flooring materials	Confirmed mold growth present above ceiling on sheetrock materials	ND	Previous BioMax assessment performed with area specific procedure developed	Recommend mitigation of damaged ceiling materials under containment control barriers. Also recommend removal and mitigation of vinyl flooring under containment barrier controls. Perform regular inspection and maintenance following recommended activities above.	Level 1

Visible Staining/Damage: Minor staining a floor
sig a floor to side of metal cabinet

Sample ID Number	Sample Type (Bulk/Surf./Air)	Location/Description
S14	Surf	Staining on vinyl floor to side of metal cabinet

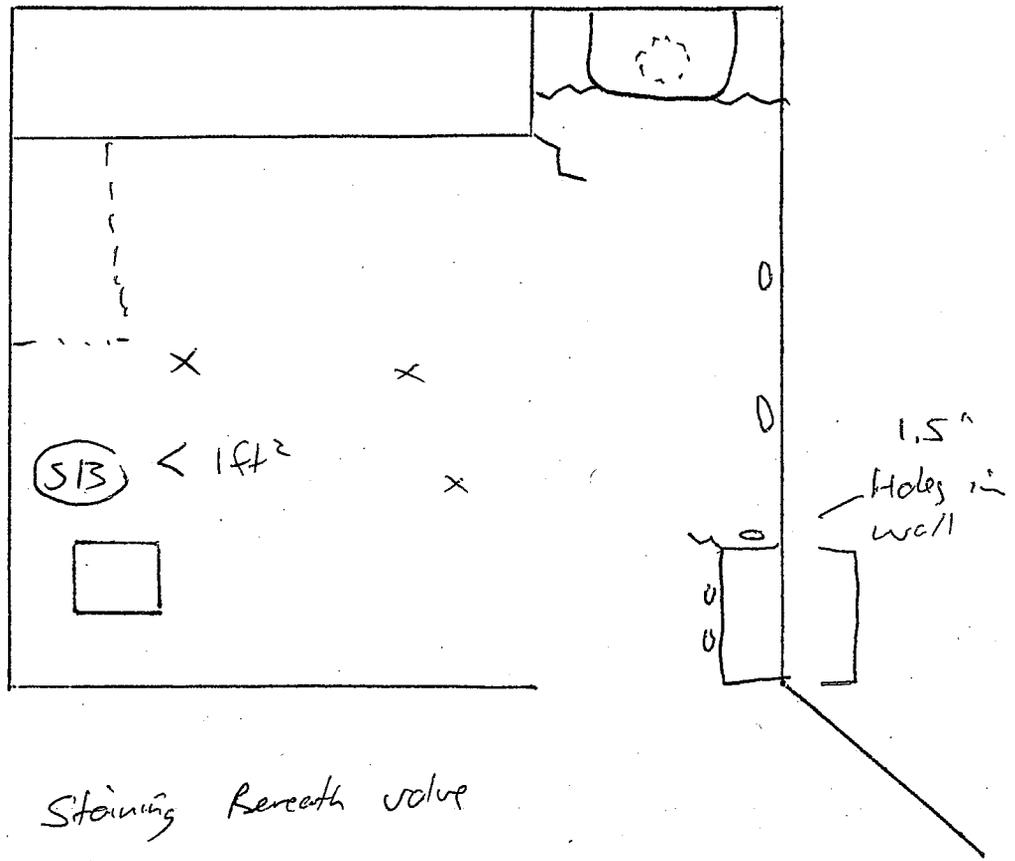
Janitor Room ID / Location: Floor 3

Visible Staining/Damage: Staining beneath valve

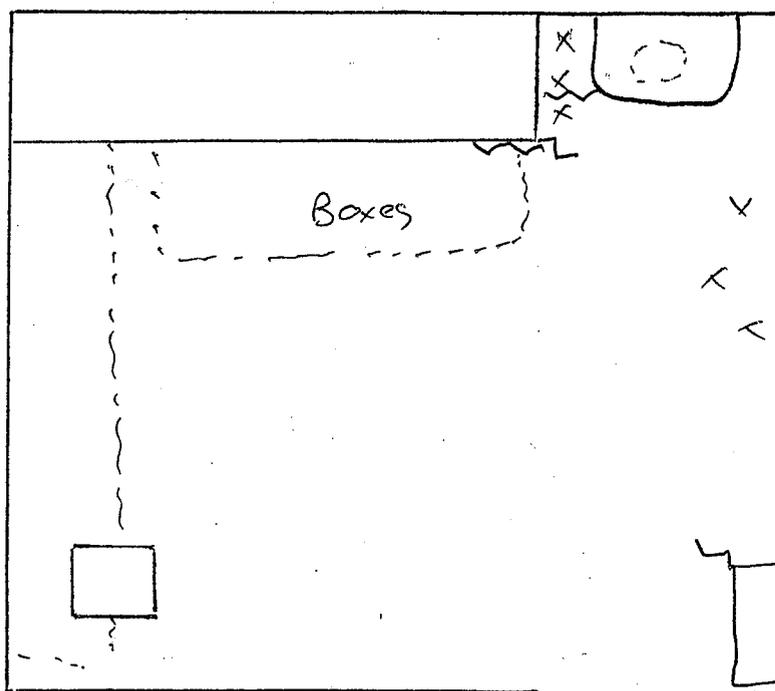
Janitor Room ID / Location: Floor 4

Visible Staining/Damage: *Minimal staining on linoleum floor*

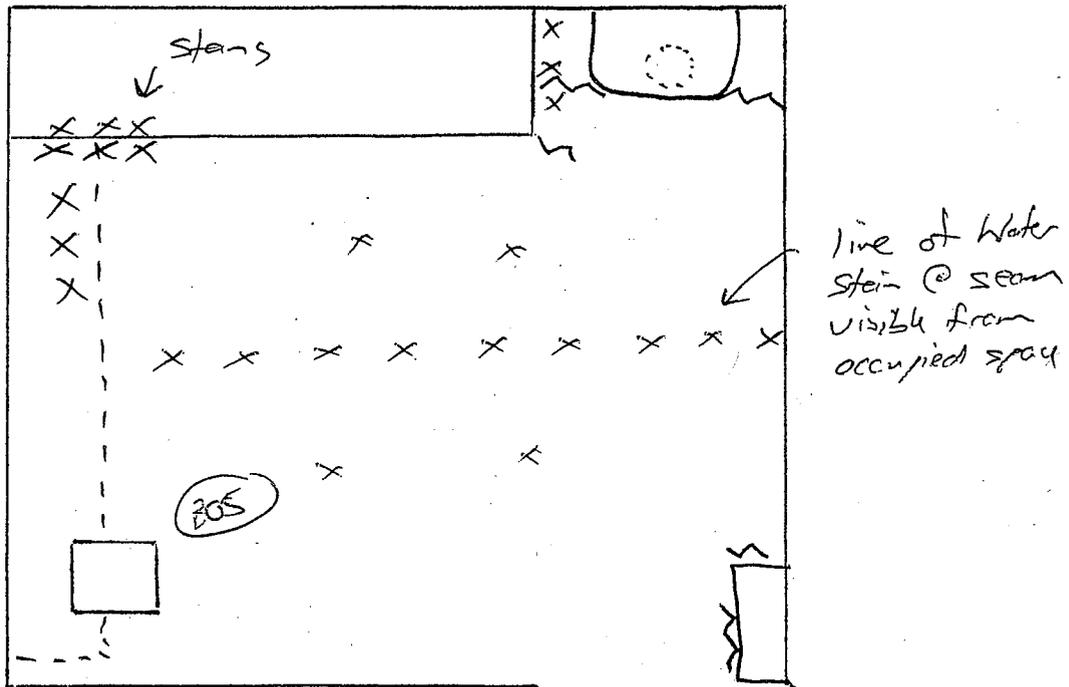
5 th Floor Janitor Room	General staining present on vinyl flooring. Significant staining present on exposed sheetrock tape joint surfaces in ceiling as viewed from working space	Damage present within ceiling space materials. Cracking of vinyl flooring	Sample of water stain material from sheetrock paper in ceiling maintenance areas indicated presence of Stachybotrys.	ND	Area above ceiling NOT indicated in LCD report. However, BioMax investigated area above ceiling due to significant work space evidence.	Recommend mitigation of damaged ceiling materials under containment control barriers. Also recommend removal and mitigation of vinyl flooring under containment barrier controls. Perform regular inspection and maintenance following recommended activities above.	Level 1 / 2
4 th Floor Janitor	Rust-like staining present	Minimal cracking of	No sampling was warranted	ND	Minimal staining on vinyl flooring.	Recommend janitorial cleaning of floor staining	NA

* This area was not noted in LCD report of VMG6 but evident significant H2O staining (> 15 linear feet)

Visible Staining/Damage: Significant staining on ceiling sheetrock + side wall in occupied space area.

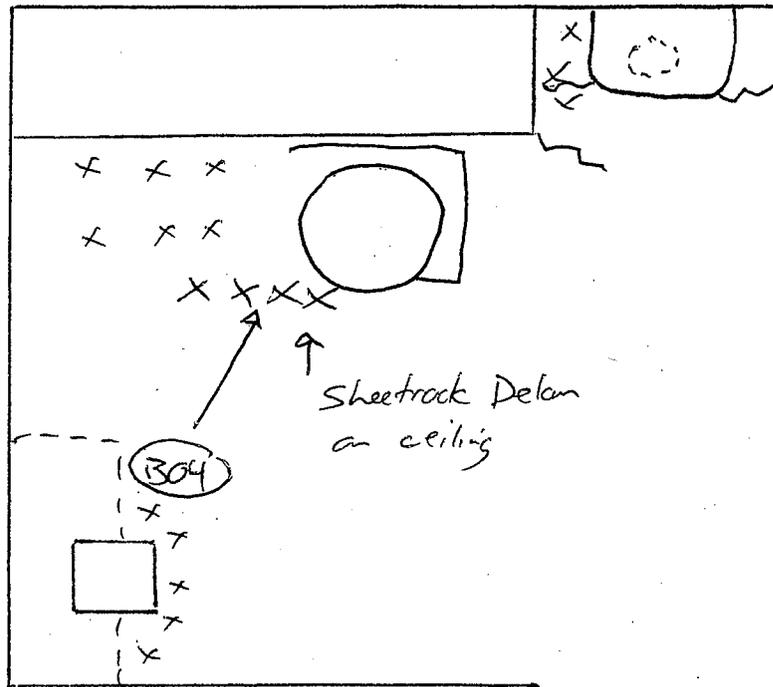
Janitor Room ID / Location: Floor 6

Visible Staining/Damage: Staining significant on floor

Additional Comments: H₂O tank present

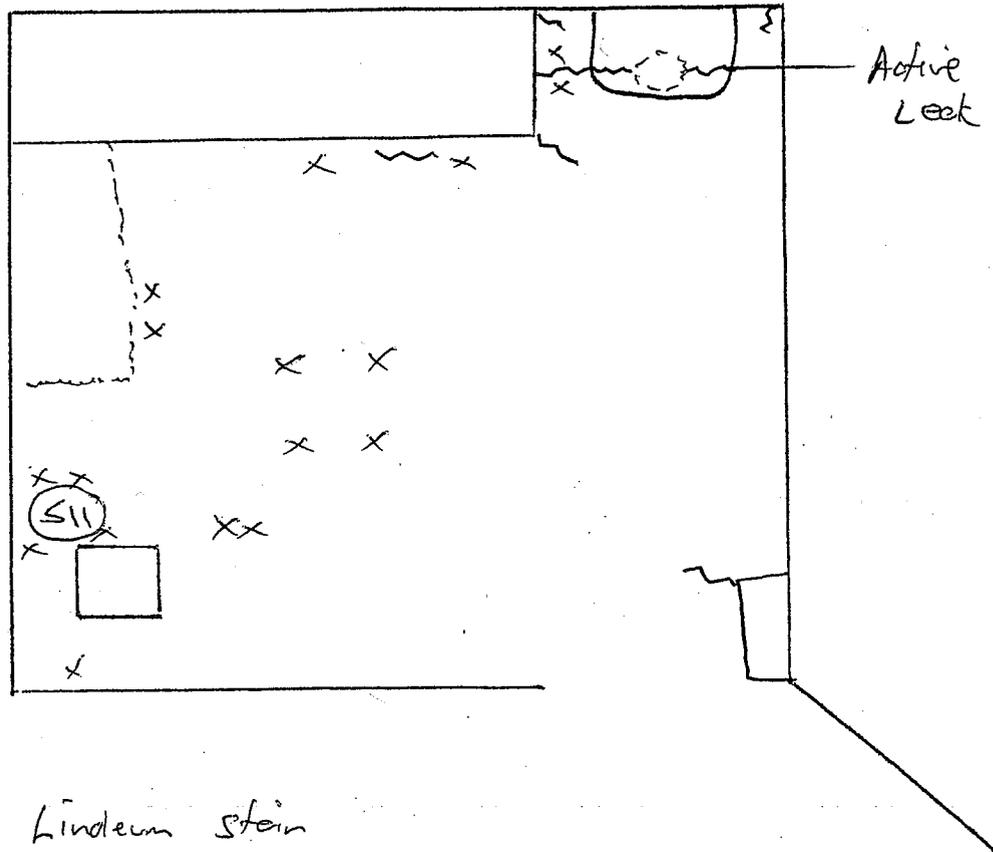
Janitor Room ID / Location: 8th Floor

Visible Staining/Damage: Lindeum stain

Additional Comments: Active leak in sink. Prev Damage in ceiling space.

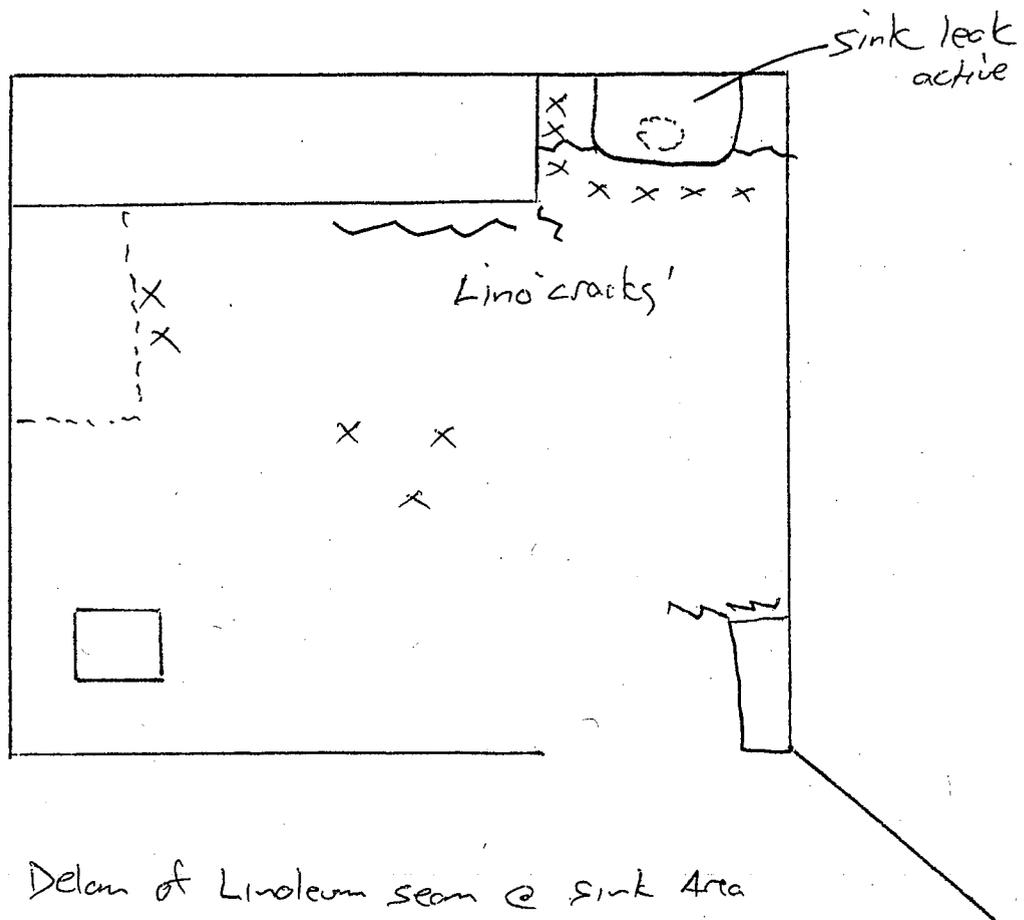
Janitor Room ID / Location: 9th Floor

9 th Floor Janitor Room	General staining present on vinyl flooring. Staining on	Significant cracking on vinyl flooring.	No sampling performed	ND	Significant cracking and staining on vinyl flooring with evidence of historical moisture	Recommend removal and mitigation of vinyl flooring under containment barrier controls.	Level 3

Visible Staining/Damage: Delam of Linoleum seen @ sink Area

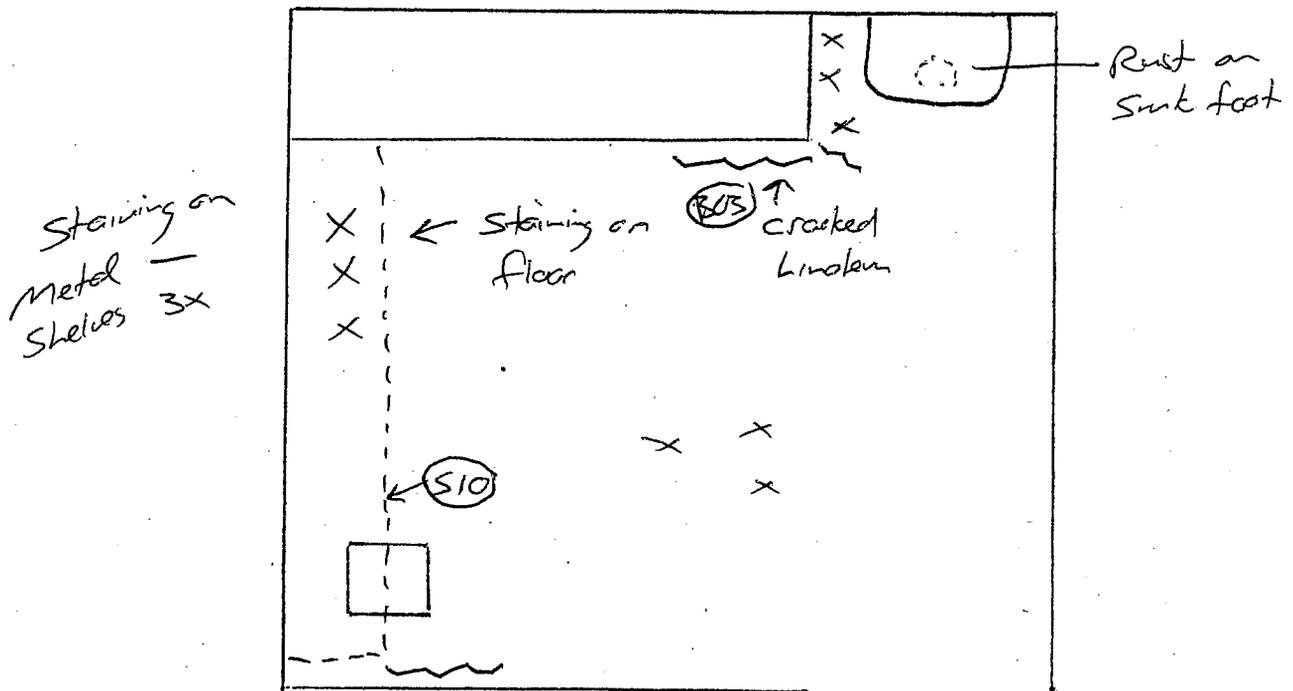
Janitor Room ID / Location: 10th Floor

Visible Staining/Damage: Staining on flooring (significant)

Additional Comments: cracks @ vinyl where wrap up wall

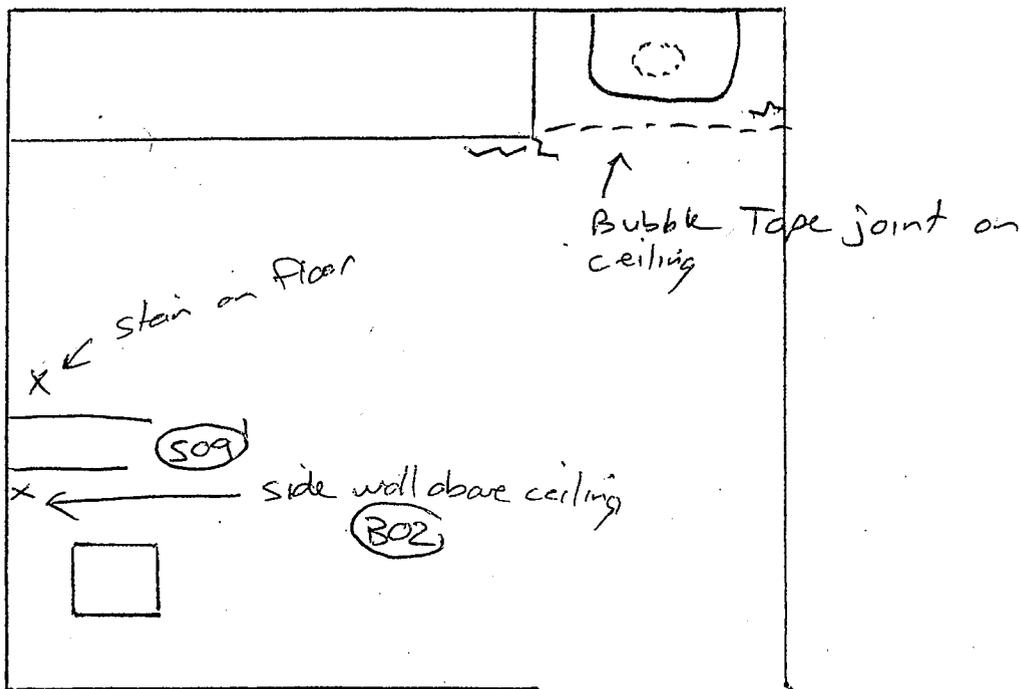
Janitor Room ID / Location: Floor 11 South

11 th Floor Janitor Room	General staining present on vinyl flooring. Staining on sheetrock surface above ceiling in maintenance space.	Minor cracking on flooring. Bubbling of tape joint on ceiling above sink.	Sampling confirmed Pen/Asp present on stained ceiling material	ND	Bubbled tape joint on ceiling above sink.	Recommend mitigation of ceiling materials under containment control barriers. Also recommend removal and mitigation of vinyl flooring under containment barrier controls. Perform regular inspection and maintenance following recommended activities above.	Level 2/3
10 th Floor Janitor Room	General staining present on vinyl flooring. Staining on sink foot support.	Significant cracking on vinyl flooring.	Clad and Chaetomium present on vinyl floor at cracked area.	ND	Significant cracking and staining on vinyl flooring with evidence of historical moisture releases.	Recommend removal and mitigation of vinyl flooring under containment barrier controls.	Level 3

Visible Staining/Damage: Floor Linoleum, cracked flooring @ seam

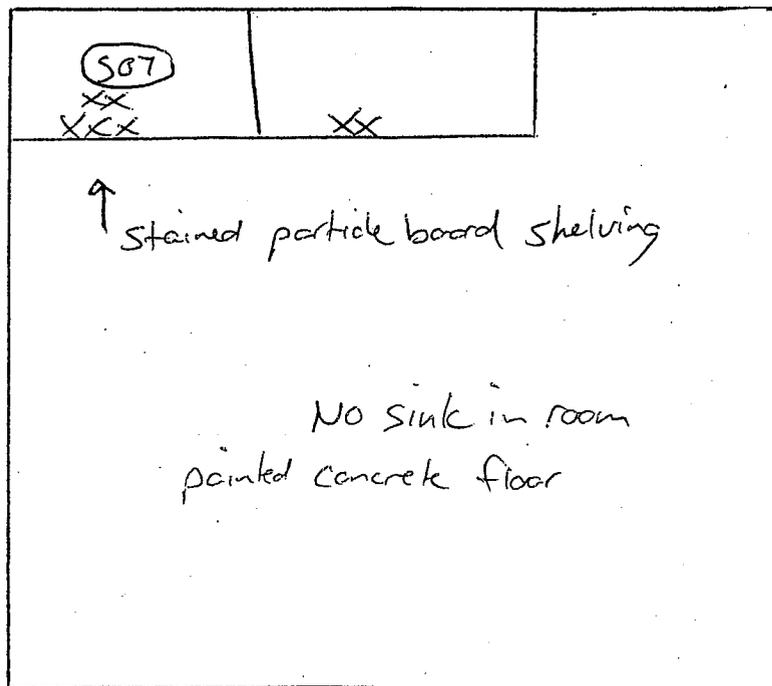
w/in men's Restroom Area

Visible Staining/Damage: *on particle board shelf*

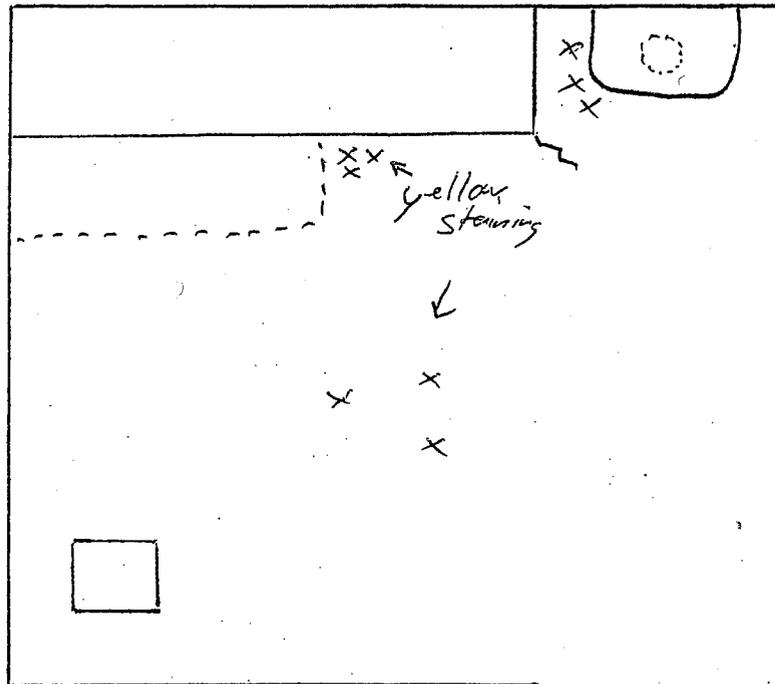
Janitor Room ID / Location: Floor 14

Faucet Drip @ sink

Visible Staining/Damage: Floors yellow staining

Additional Comments: Faucet Leak into Sink

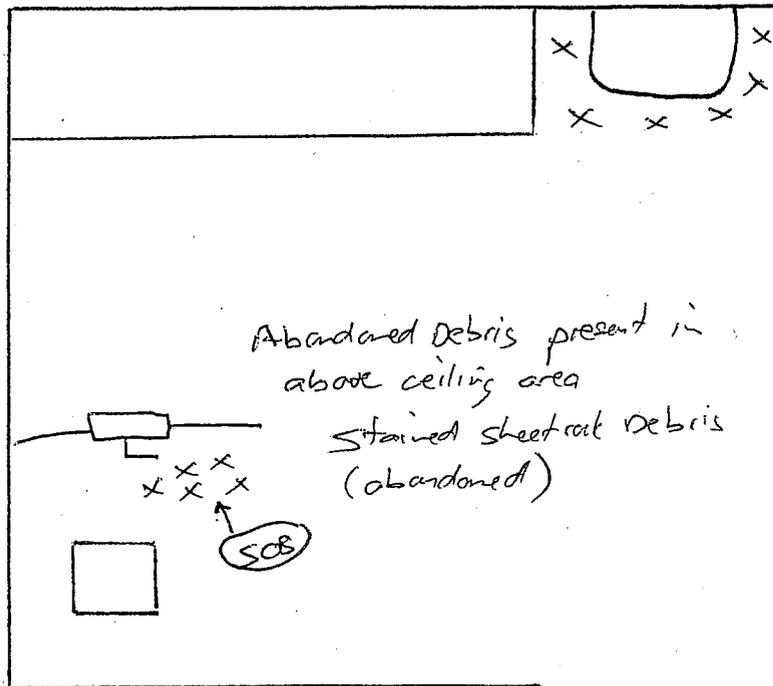
Level 1

Visible Staining/Damage: on Floor, Ceiling Area debris, sheetrock w/ Black staining

Additional Comments: Prev Hot H2O plumbing fix - sheetrock patch, Insulation not replaced, debris everywhere on floor surface

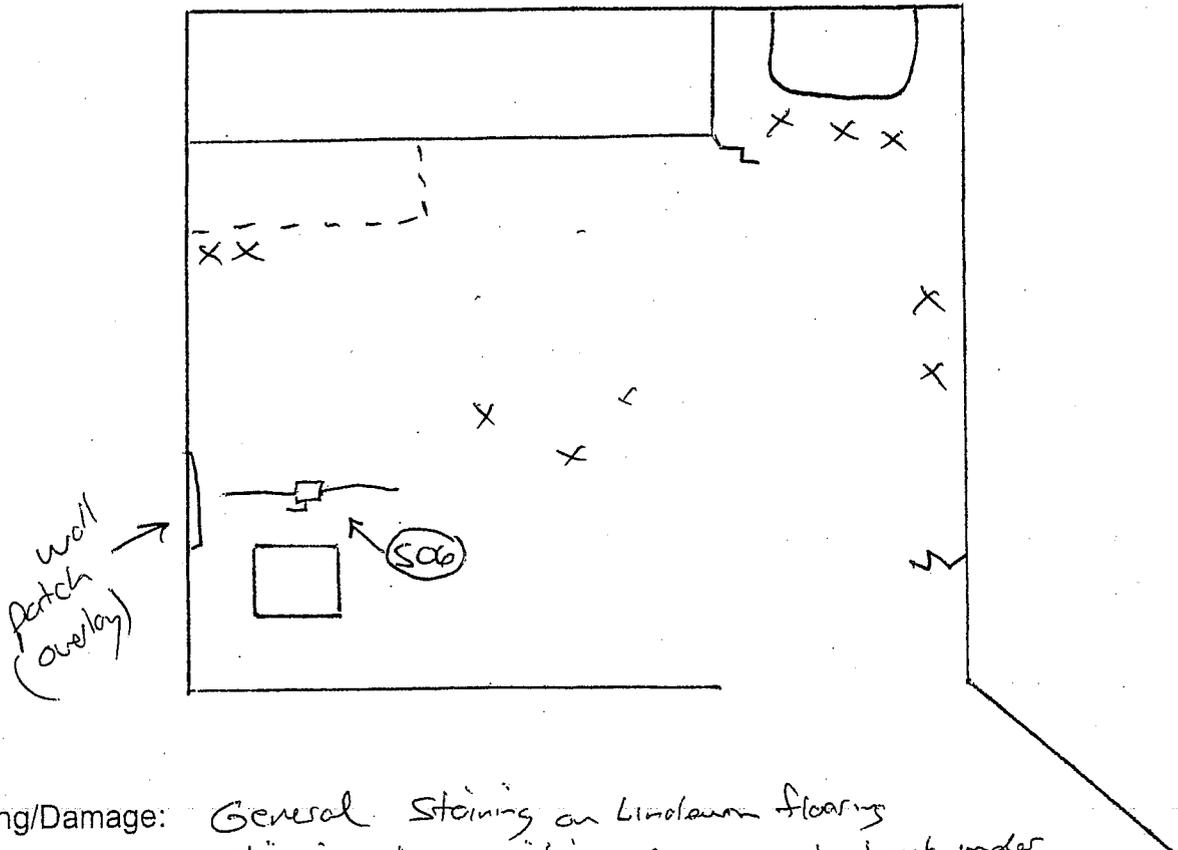
Level 1/2

Visible Staining/Damage: General staining on linoleum flooring
 Staining above ceiling space on sheetrock under pipe

Additional Comments: Mitigation recommended Level 1/2

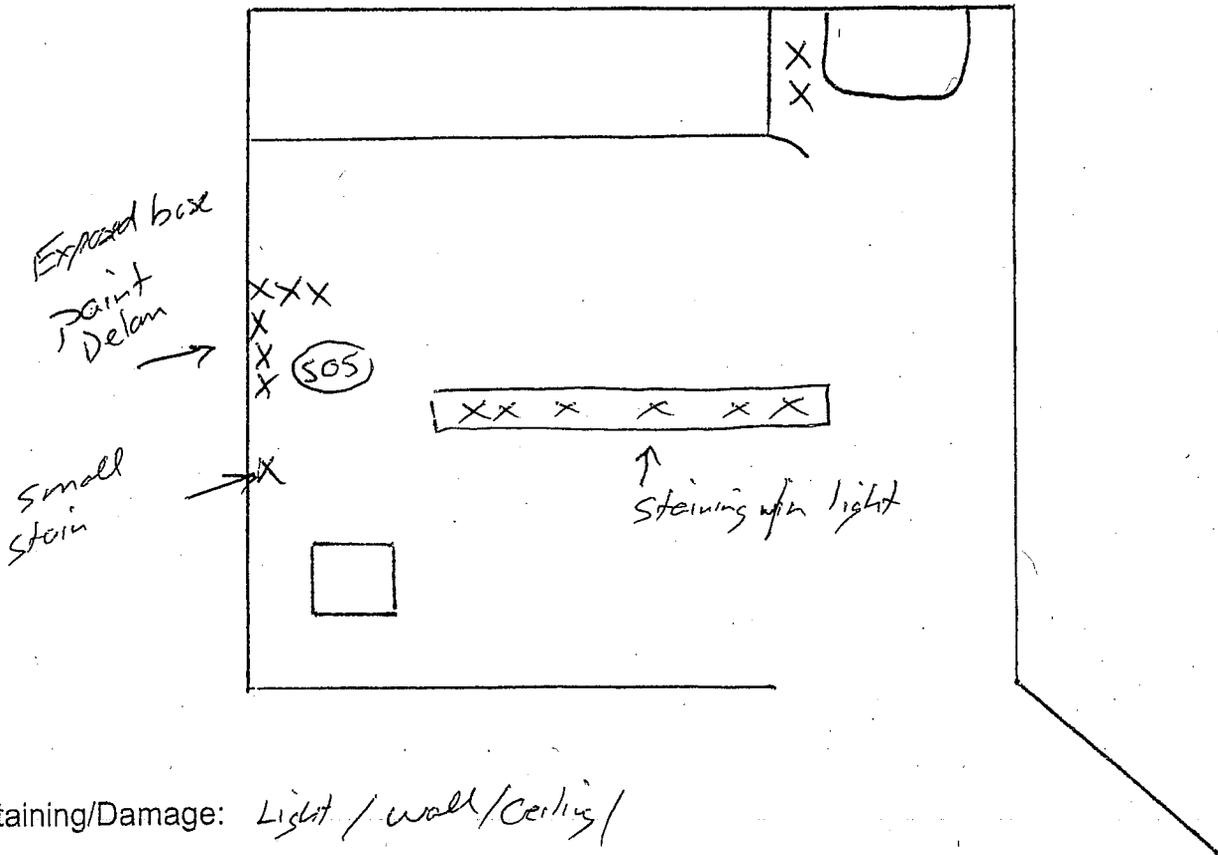
Level 2/3

Visible Staining/Damage: Light / wall / ceiling

Additional Comments: Mitigation Recommended

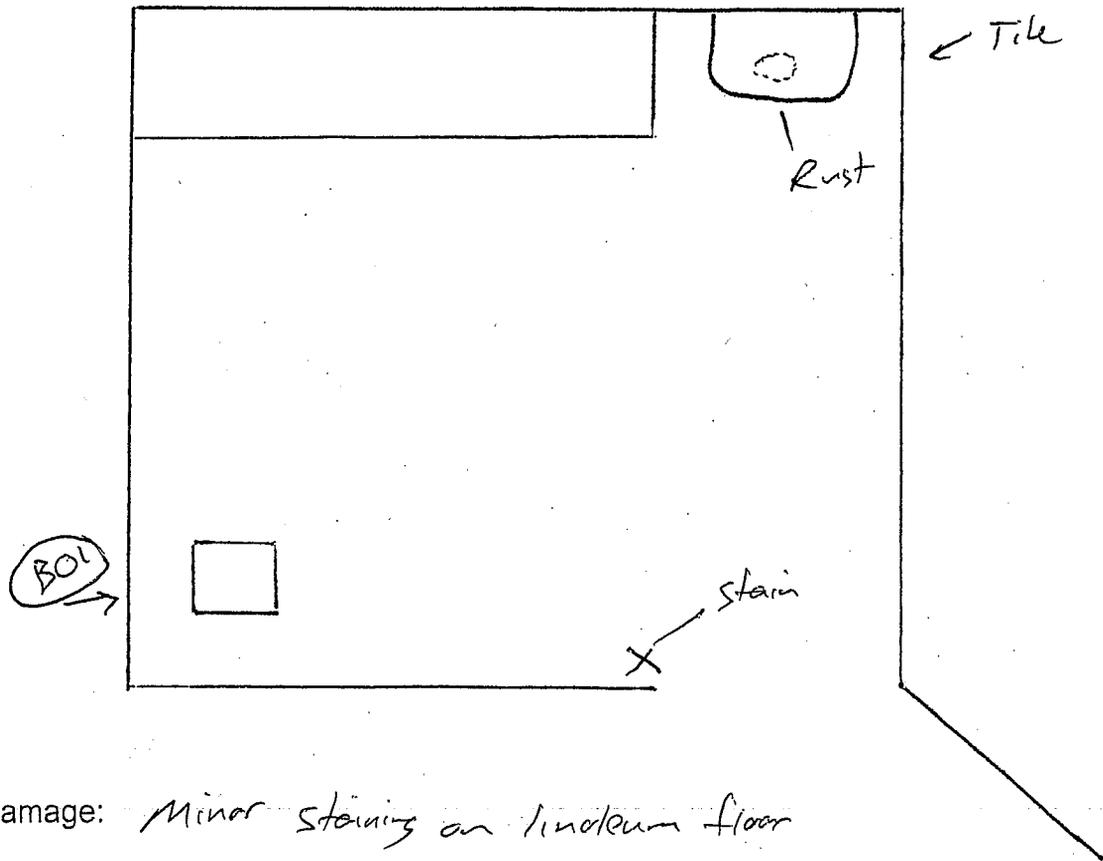
Janitor Room ID / Location: Floor 18

Visible Staining/Damage: Minor staining on linoleum floor

Additional Comments: Bulk Sample

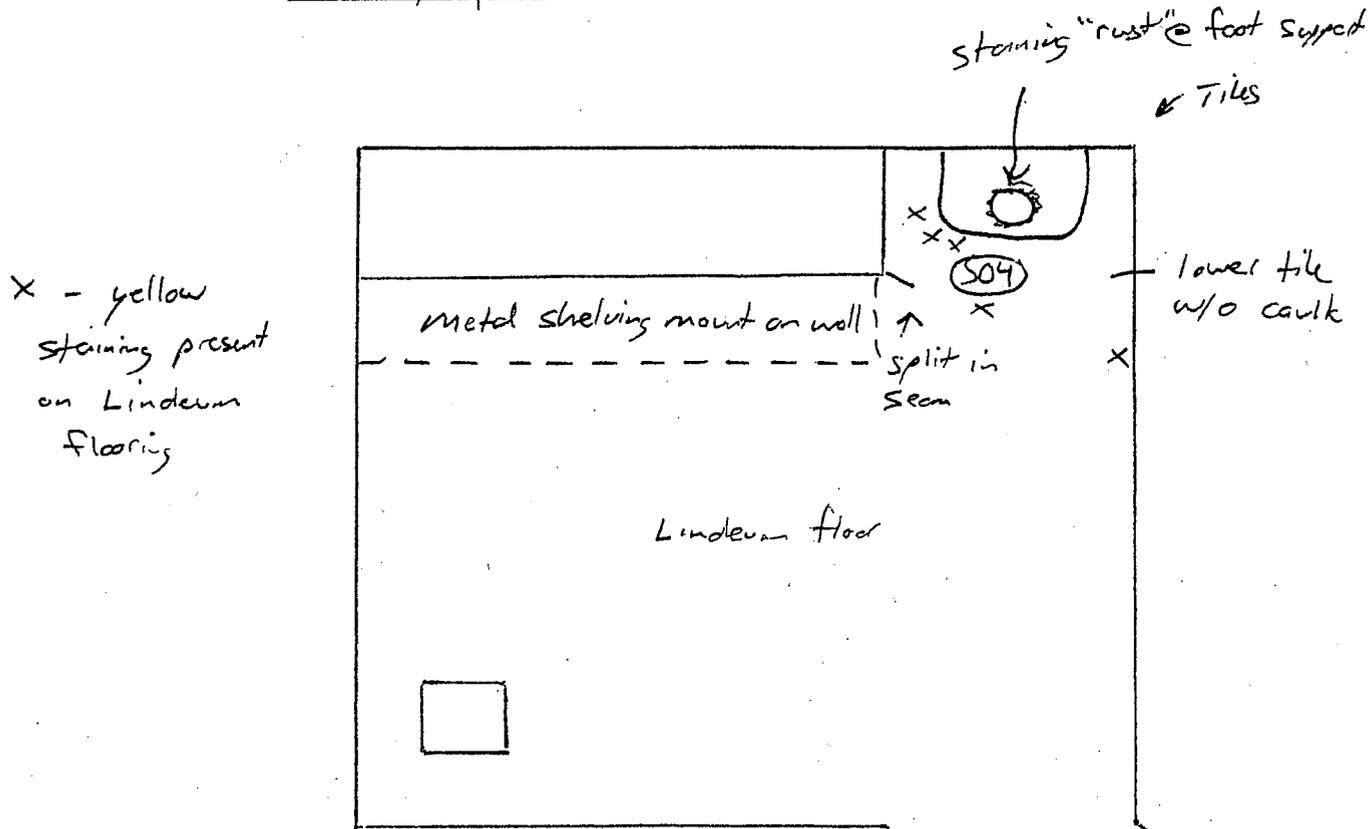
Janitor Room ID / Location: Z1 South Side

Visible Staining/Damage: @ sink floor < 4ft sq total (yellow)

Additional Comments: Leaking faucet

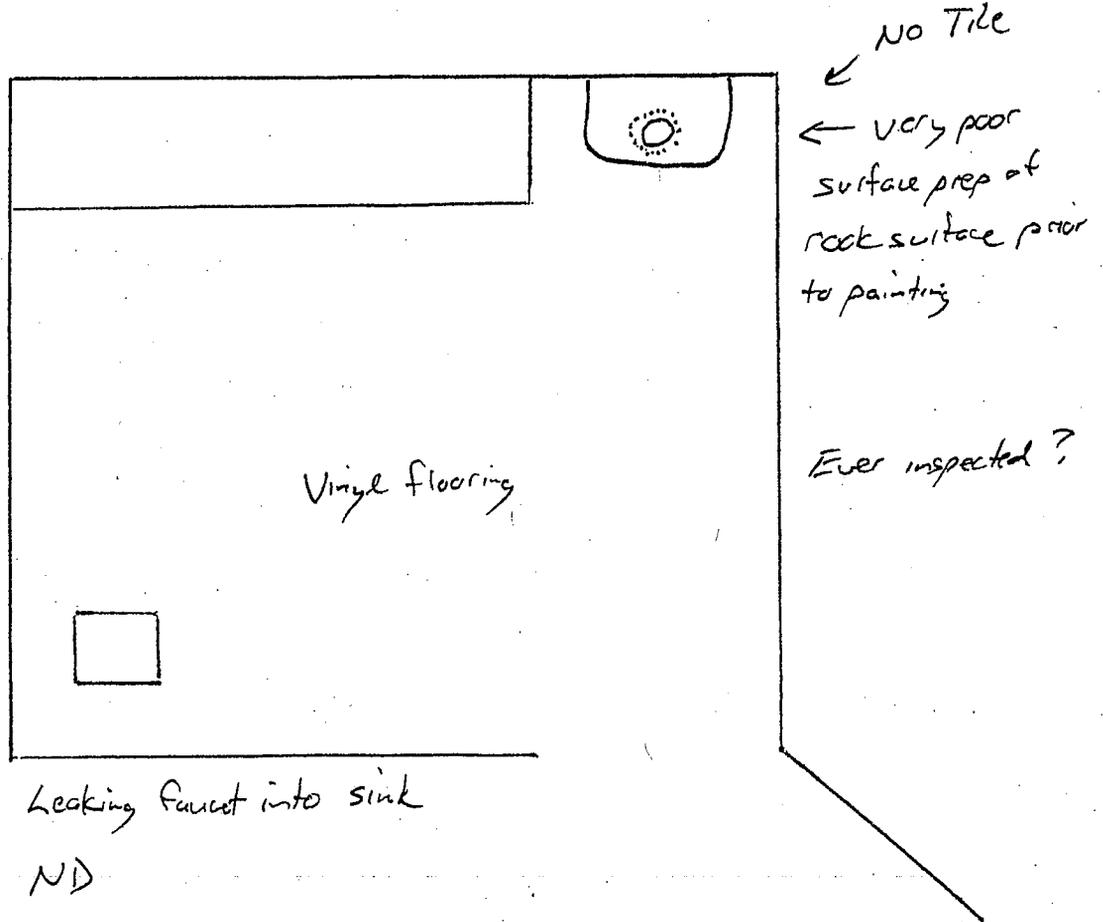
Janitor Room ID / Location: 22 South side

22 nd Floor Janitor Room	Rust-like staining present on sink foot support at floor level.	ND	No sampling was deemed necessary or performed	ND	Faucet observed leaking into sink. No tile backing around wet sink area. Poor surface prep of painted sheetrock. Floor vinyl installed as cut under sink foot support.	Recommend janitorial cleaning of rust staining on sink foot support. Installation of tile and/or appropriate sink backing material in accordance with applicable codes. Recommend replacement of vinyl flooring under sink foot to create better moisture barrier. Perform regular inspection and maintenance following recommended activities above.	NA
21 st Floor Janitor Room	Yellowing staining on flooring and adjacent to sink. Rust-like staining present on sink foot support at floor level.	Minimal cracking of vinyl flooring in sink area	Sampling indicated no mold growth within yellow staining.	ND	Caulk missing at lower tile to right of sink.	Recommend janitorial cleaning of floor staining and replacement and/or sealing of gaps and cracks present within flooring materials. Perform regular inspection and maintenance following recommended activities above.	NA

Visible Staining/Damage: ND

Additional Comments: Floor vinyl was installed after sink foot (5" circle) was finished. ∴ 5" circle cut in vinyl @ floor ∴ potential H₂O Damage area

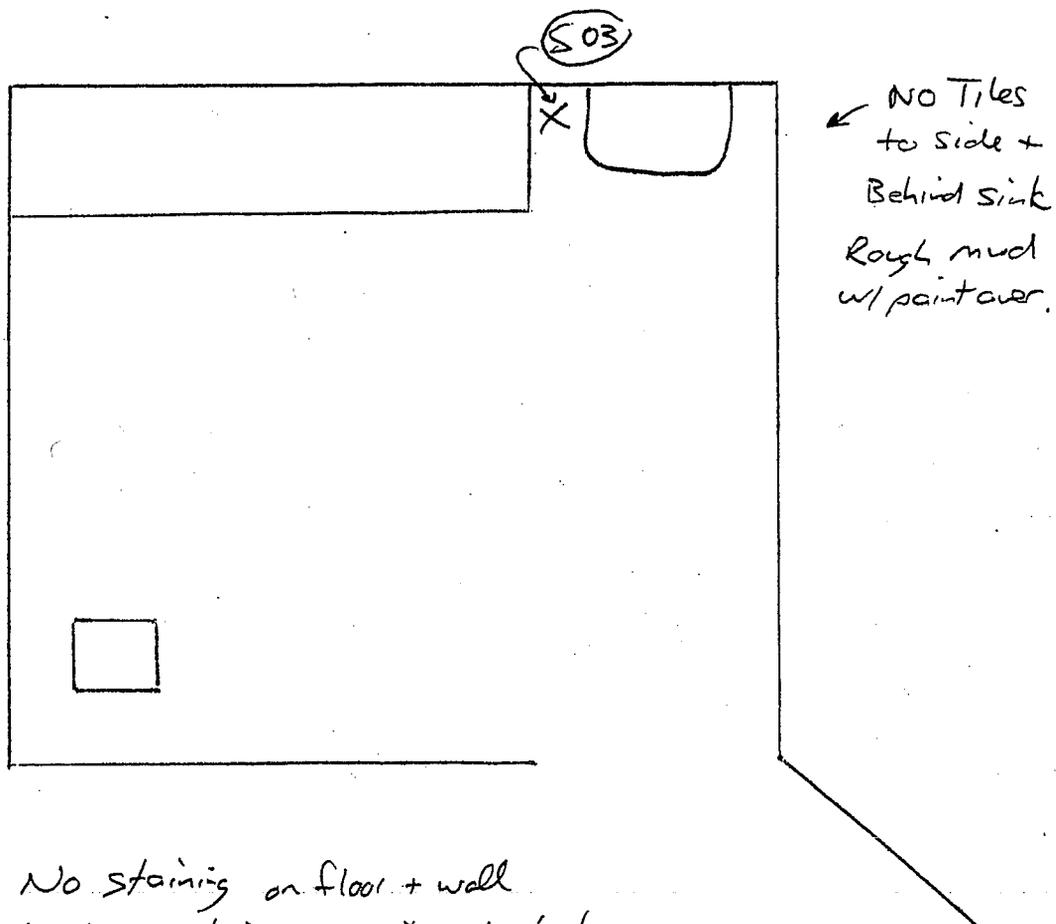
Janitor Room ID / Location: 23rd Floor South Side

Visible Staining/Damage: *No staining on floor + wall
 < 4" sq staining on ceiling sheetrock*

Additional Comments: *Poor mud job @ sink + NO Tile*

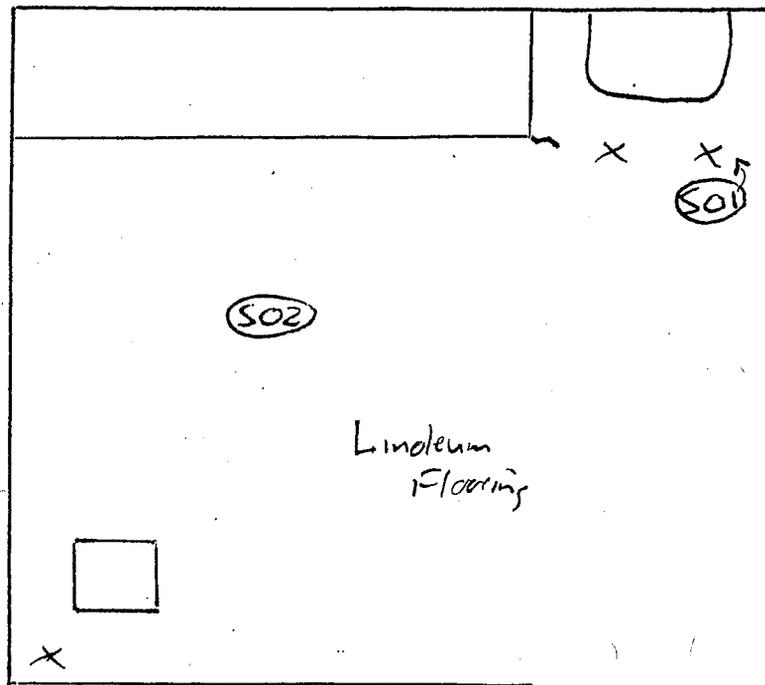
Janitor Room ID / Location: 24th Floor North Side

Janitor Room Location	Physical Staining	Material Damage	Visible Mold-like growth indicators	Moisture Content	Comments	Recommendations	Mitigation Priority Level * (1-3)
24 th Floor Janitor Room	Yellowing staining on flooring and adjacent to sink	Minimal cracking of vinyl flooring in sink area	Sampling indicated no mold growth within yellow staining	ND	Staining Present Minimal cracking in flooring present.	Recommend janitorial cleaning of floor staining and replacement and/or sealing of gaps and cracks present within flooring materials. Perform regular inspection and maintenance following recommended activities above.	NA
23 rd Floor Janitor Room	Staining on ceiling above sink.	ND	Sampling indicated no mold growth within stain.	ND	No tile backing around wet sink area. Ceiling staining present above sink.	Recommend janitorial cleaning of staining on ceiling. Installation of tile and/or appropriate sink backing material in accordance with applicable codes. Perform regular inspection and maintenance following recommended activities above.	NA

Visible Staining/Damage: Lindoleum Staining "yellow"

Additional Comments: Area previously rebuilt by BPM ~ 1 yr ago
