Attachment A: Digital Images

October 29th, 2008

BOE Building 5th and 6th Floor Storage Area Assessment
Sacramento, CA

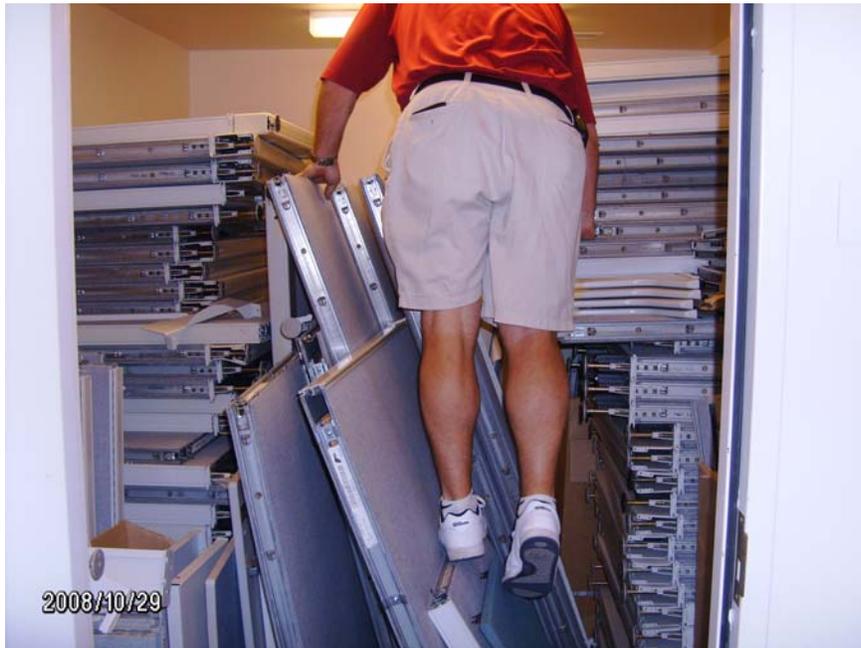
- 1) Condition of Storage Room 6C wherein extensive quantities of cubicle furniture was stored creating limited access for inspection and sampling during assessment.

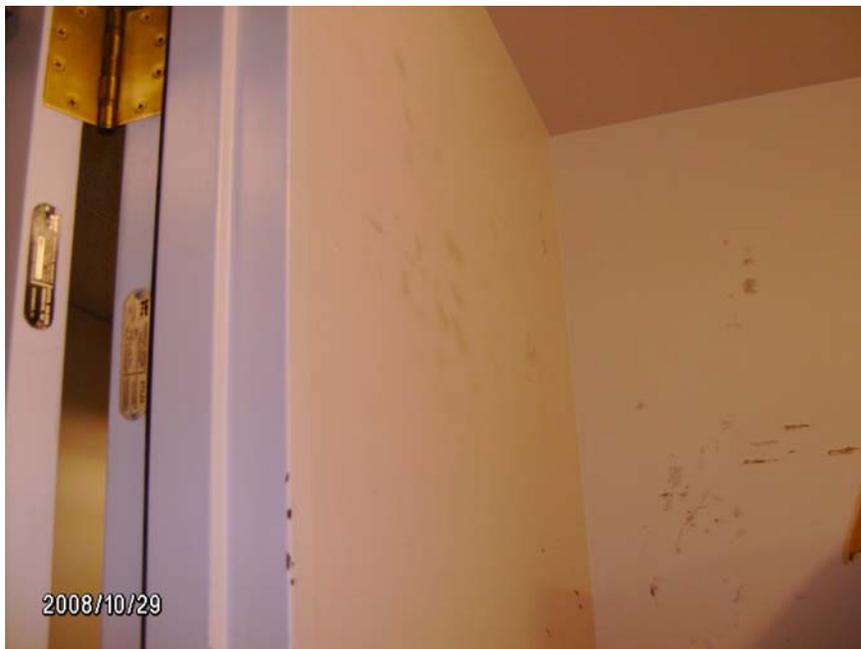
- 2) Image within Storage Room 6C of wall surface indicating suspect “smudges” which were sampled as part of surface assessment on 10/29/08.

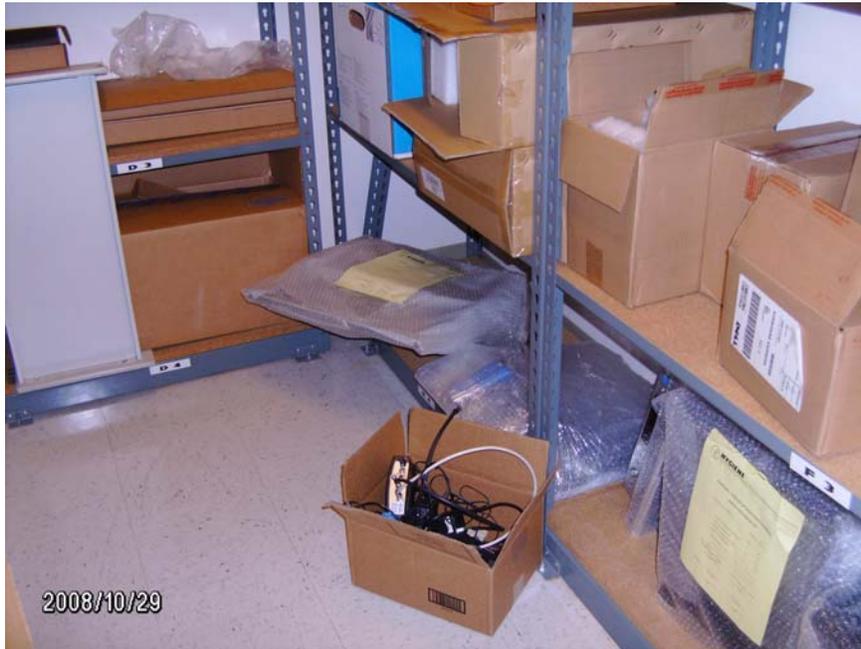
- 3) Image within Storage Room 5C wherein wall-bolted metal framed shelving had covered localized suspect mold-like growth at lower shelf area.

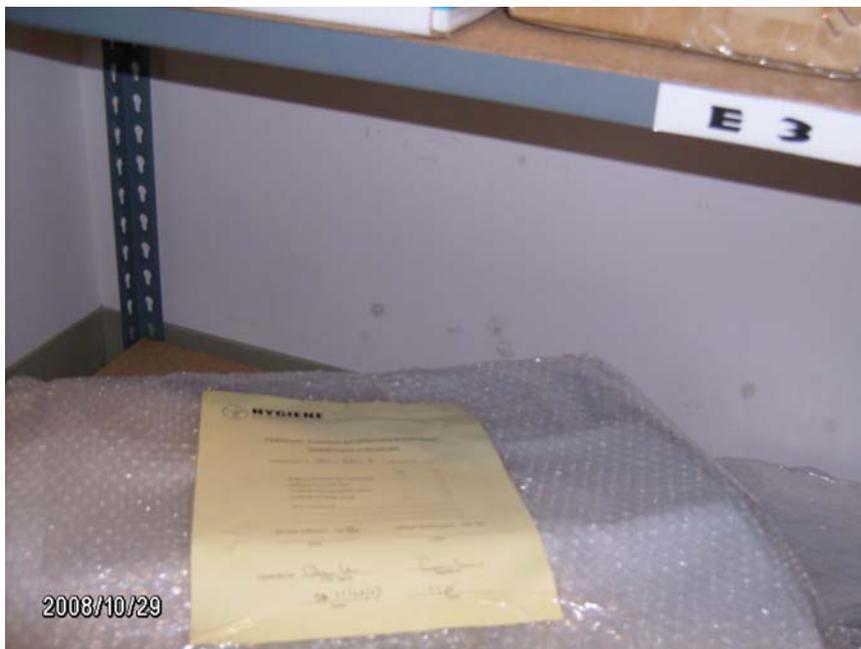
- 4) Close-up image of stained wall surface following removal of office equipment from lower shelf at time of assessment.

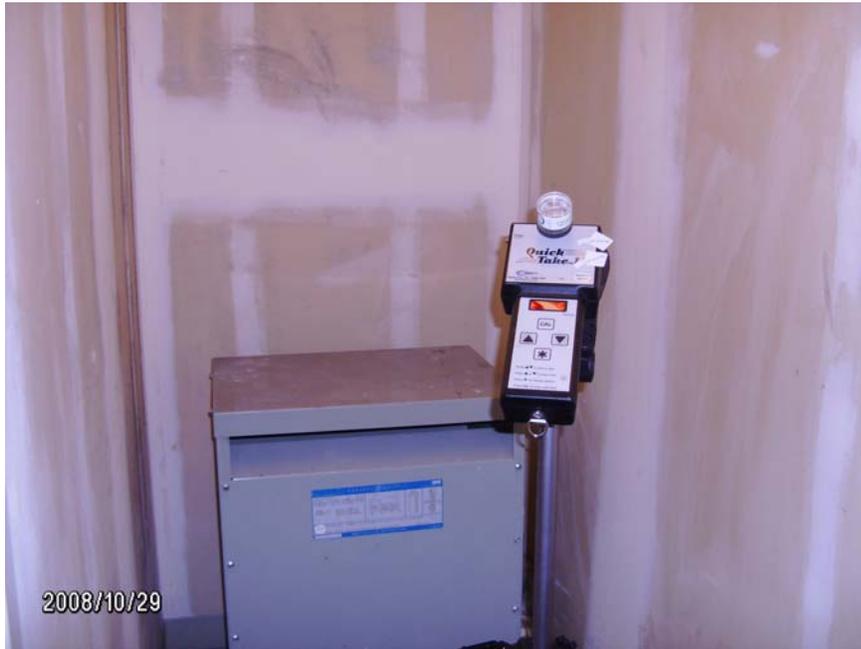
- 5) Image of air sampling and wall debris present within Electrical and Telephone Equipment Room located at northeastern access doorway of 5th floor.

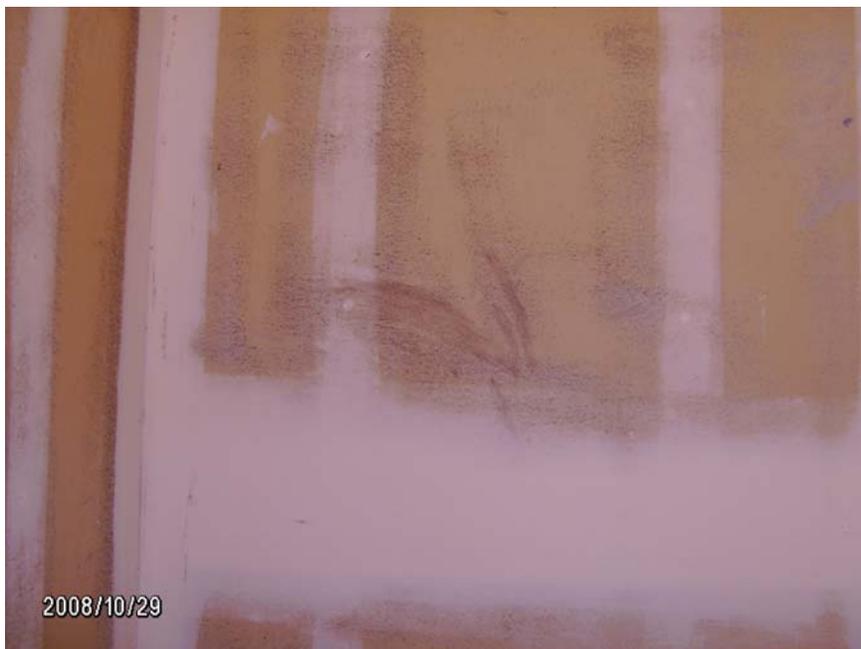
- 6) Close-up image of black “fuzzy” material present on southern wall within 5th Floor Electrical and Telephone Equipment Room.

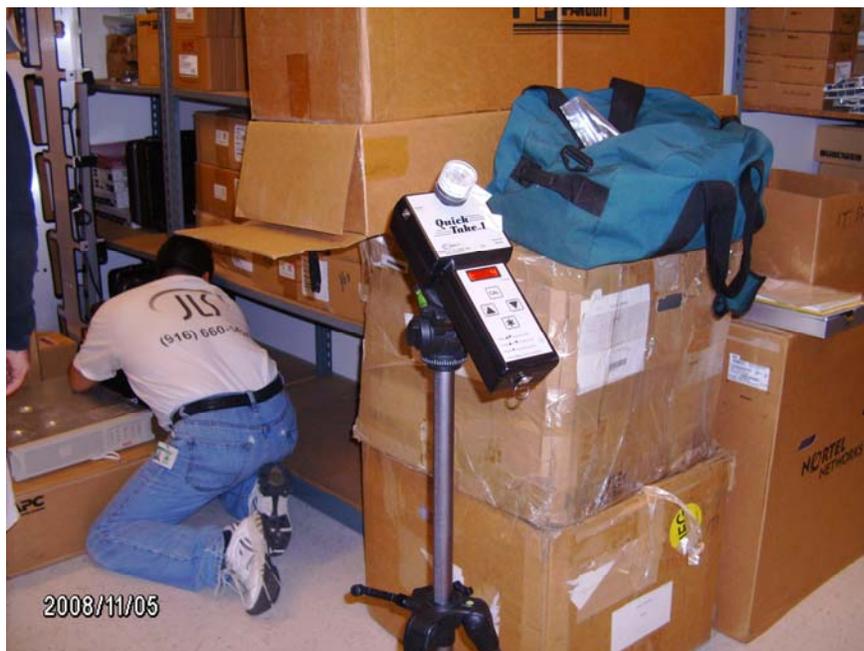
7) Image of air sampling and storage materials present within storage room 5B at time of follow-up airborne and surface assessment performed on 11/05/08.

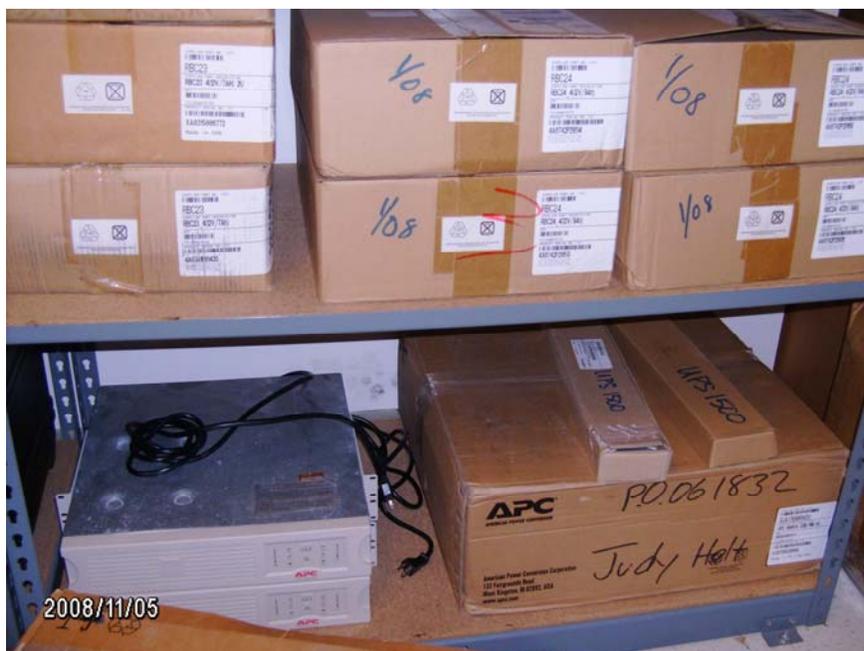
8) Image of stored material covering stained wallboard material within storage Room 5B at time of assessment.

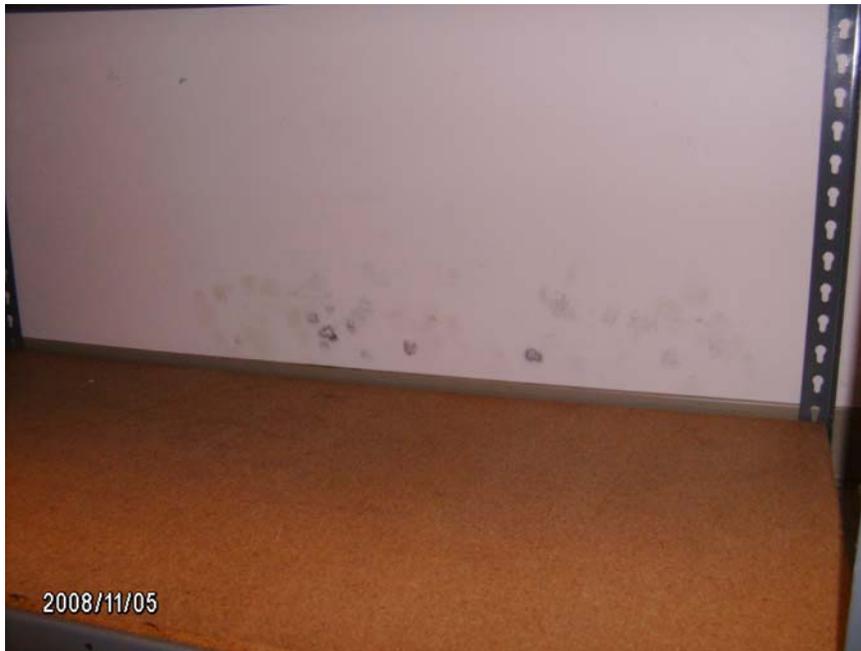
9) Close image of stained material on wallboard surface within storage Room 5B at time of assessment.

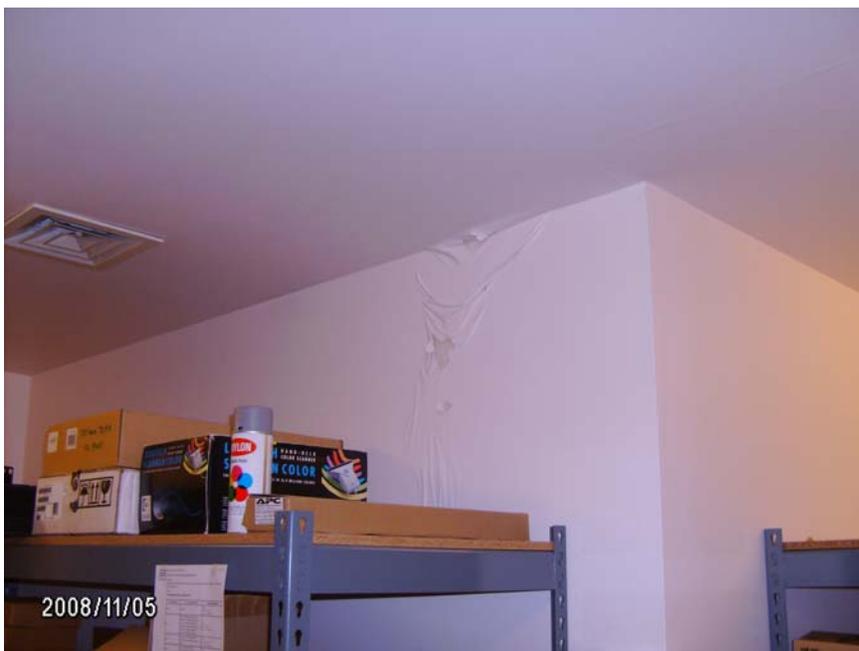
10) Image of “sluffed” paint material present on wall-to-ceiling interface within Storage Room 5B at area above and adjacent to visible wall staining.
