Re: 450 N Street – Board of Equalization, MCA Job No.: 05155.00 RP  
Subj: January 4, 2008 Storm Water Intrusion Observations

The following letter report is a preliminary summary of the water intrusion leak sources based on site observations during the extreme weather event that occurred on Friday, January 4, 2008, and follow-up limited investigations on Monday, January 7<sup>th</sup> and Wednesday, January 9<sup>th</sup>.

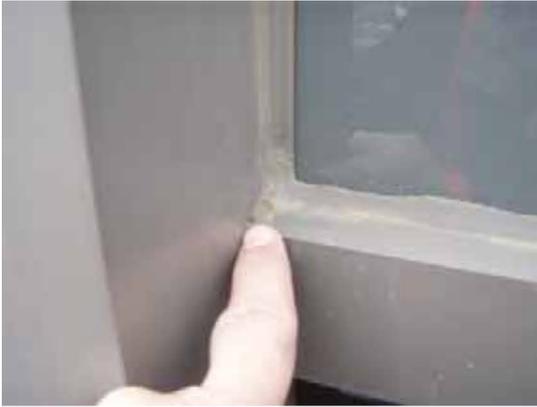
The exterior investigation by MCA on January 9th of the south wall between grid lines 20 and 21 from floor 22 to floor 7 did not result in observations of any significant curtain wall perimeter or expansion joint cover sealant problems (missing sealant, failed sealant). A small quantity of pin-holes (Photos 1 and 2) in the exterior sealant were observed; however, these did not correlate to interior leaks observed during the January 4<sup>th</sup> storm. MCA recommends that the horizontal beauty caps be removed at the leak locations to further investigate the leak sources.

Photo 1: Pin-hole encountered at south elevation.

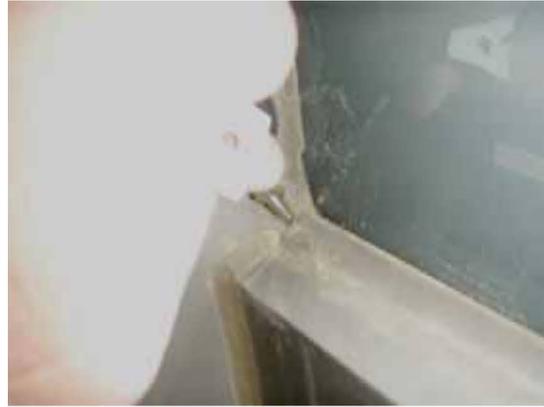
Photo 2: Pin-hole encountered at south elevation.

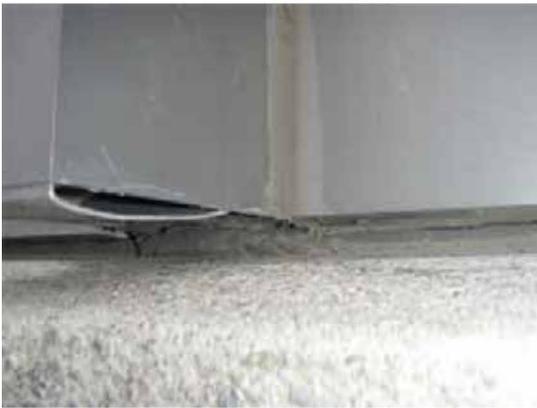
The more significant sealant problems were encountered at the joint between the curtain wall/pre-cast at the 14<sup>th</sup> floor (vision sill), 11<sup>th</sup> Floor (vision head). Adhesion and cohesion failures were observed (Photos 3 and 4).

Photo 3: Cohesion failure at sealant joint between 14<sup>th</sup> floor vision sill/precast panel.

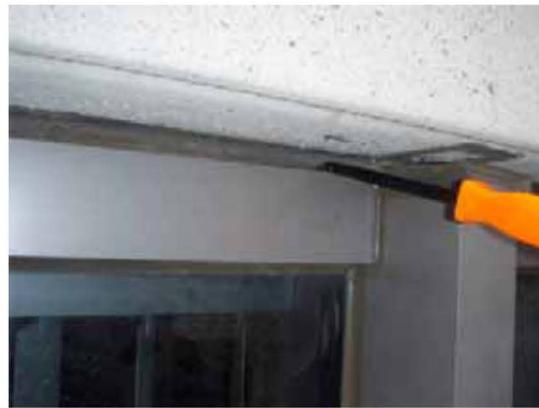
Photo 4: Adhesion failure at sealant joint between 11<sup>th</sup> floor vision head/precast panel.

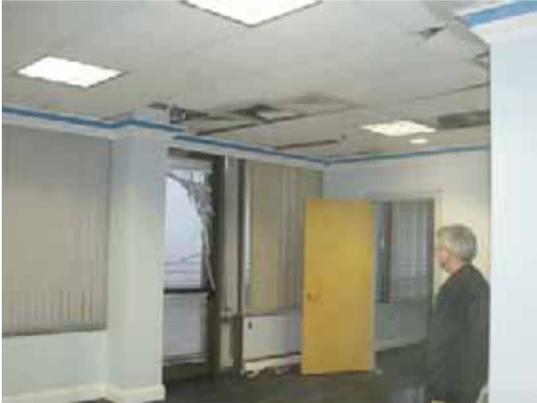
The most significant water entry was due to the northern most door of the East balcony blowing open (Photos 5, 6 and 7). This door is also in the worst possible location for this storm direction as the water on the balcony deck was being blown to the north end of the balcony (where the door is). This resulted in a large amount of water at the office where door is located and then the water dispersed to the adjacent southerly offices. The water also was found to leak down the the wall (where the balcony transitions to the building) and was observed at the 18<sup>th</sup> floor ceiling tile.

Photo 5: East Balcony, north end door had blown open earlier.

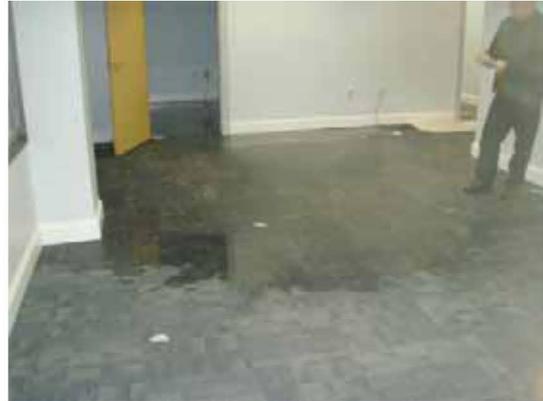
Photo 6: East Balcony, north end office, water accumulated on floor at door (looking south)

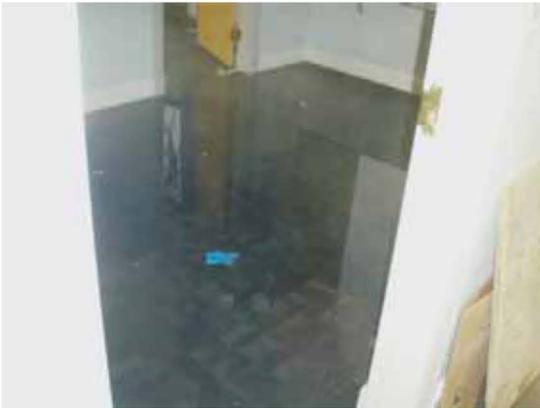
Photo 7: Water accumulated at office south of door that had blown open.

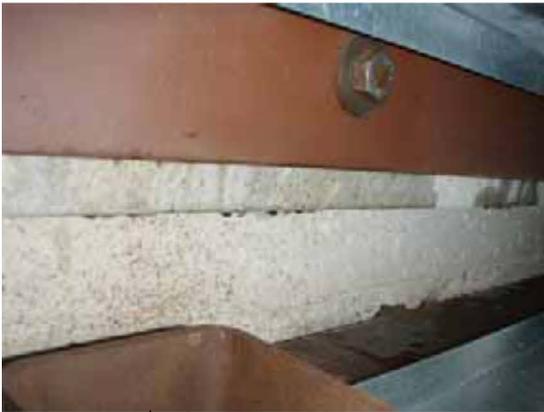
Water was observed to be dripping down the bottom of the structural angle that rests on the pre-cast concrete panel supporting the curtain wall above (Photos 8 and 9). Closer investigation revealed that water appeared to be bypassing the sealant at the curtain wall to pre-cast concrete panel joint. It was found to be more significant where the vertical mullions terminated at the pre-cast concrete panels. MCA reviewed the sealant joint assembly at each of the balconies and notes that the joint dimension is most narrow at the South Balcony and that the elastomeric coating on the pre-cast concrete terminates at the exterior face of the horizontal beauty cap (Photo 10) at some locations and may have prevented proper weeping.

Photo 8: 23<sup>rd</sup> floor south balcony, water dripping at bottom of the angle and precast.

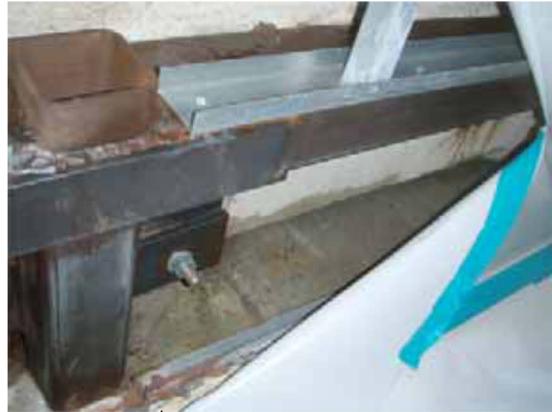
Photo 9: 23<sup>rd</sup> floor south balcony, water at the floor slab below the precast panel.

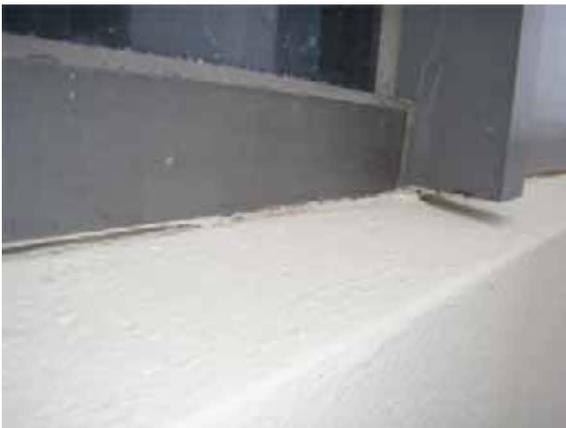
Photo 10: Elastomeric coating build-up at face of horizontal beauty cap.

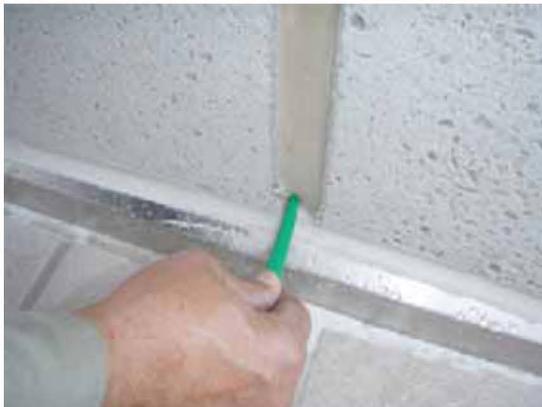
The January 9<sup>th</sup> review of the deck and pre-cast joint sealant revealed concrete pulling away in the west parapet pre-cast concrete panel joints adjacent to the sealant joint (Photos 11 and 12).

Photo 11: Concrete pulled away at base of the sealant joint.

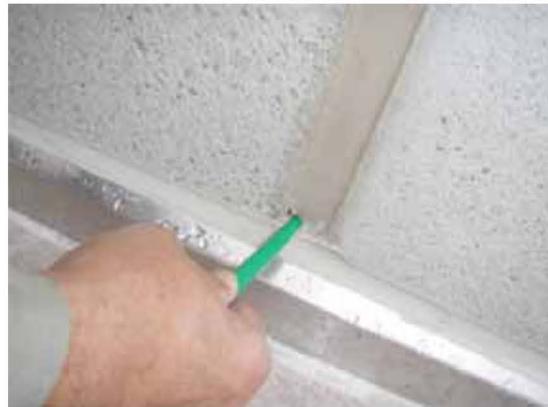
Photo 12: Concrete pulled away at base of the sealant joint.

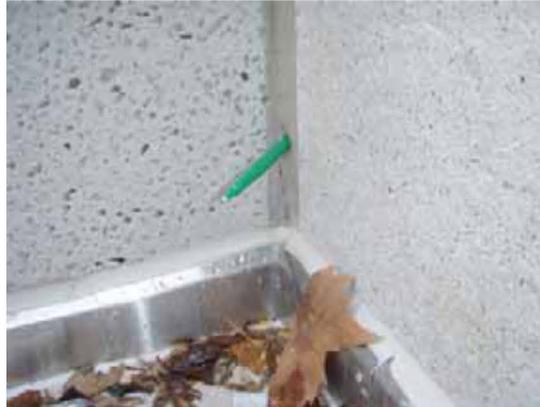
The January 9<sup>th</sup> review of the deck and pre-cast joints revealed cuts in the northeast corner vertical pre-cast panel joint (Photo 13).

Photo 13: North Balcony, northeast corner precast joint, sealant is cut at the base.
