1. Civil

B. ADA Accessibility

Civil site visits took place February 9th & 10th, 2009, to observe site characteristics that pertain to Americans with Disabilities Act (ADA) accessibility compliance for the 450 N Street building from the public sidewalk to the building entrances.

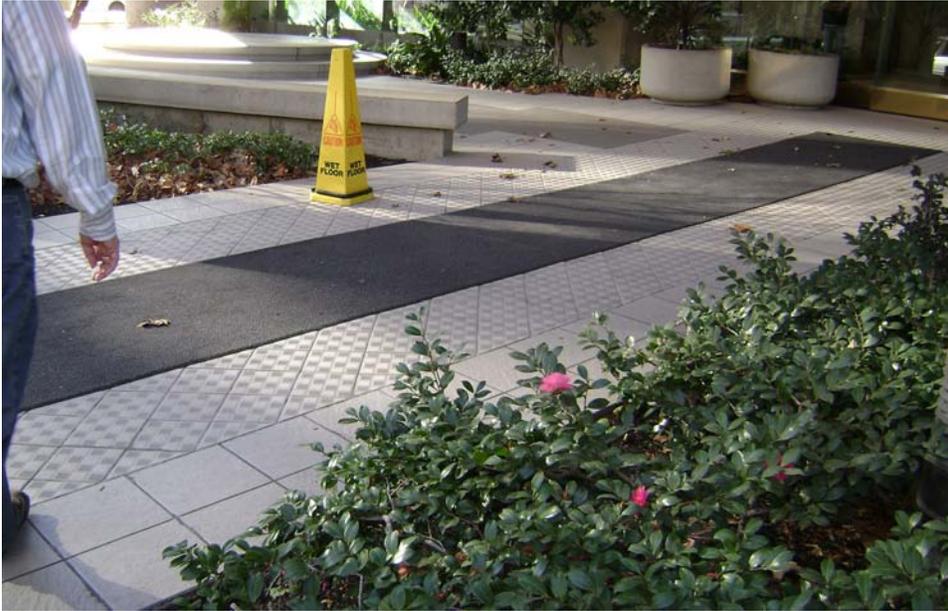
CONDITION NO. 1

Photo of main entrance at northeast corner of building off “N” Street.

The longitudinal slope up to the landing is 7% and exceeds the 5% maximum slope and therefore would require handrails per CBC 1133B.7.3, 1133B.5.1. Remedial concrete repair could be done to eliminate that need. The landing slope at the threshold is 3%. These slopes are not in compliance with CBC section 1133B.5.1 through B.5.8 as they exceed the maximum slope criteria for longitudinal, cross slope and landing slope. In addition, the walkway mat shall be secured in place per CBC section 1124B.1.

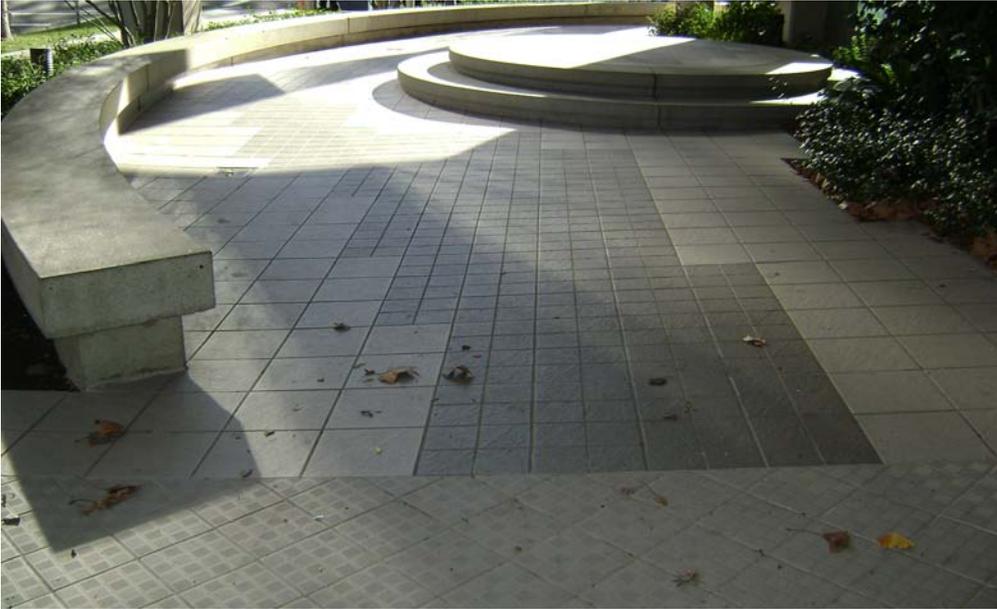
CONDITION NO. 2

This photo indicates the cross slope at the drain in front of the rounded concrete bench.

The walkway in front of the rounded concrete bench has 8% to 3% variable cross slope to a drain just in front of the bench. These cross slopes are not in compliance with CBC section 1133B.5.3.1 and will require reconstruction at a maximum cross slope of 2%.

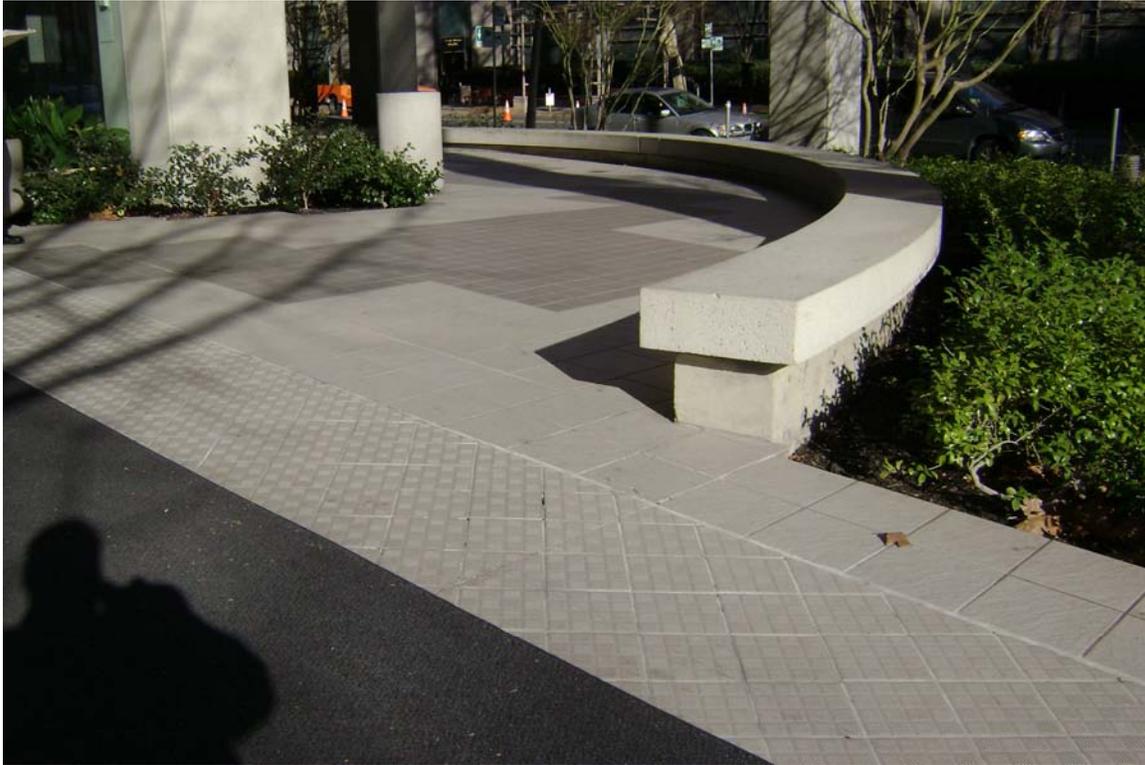
CONDITION NO. 3

This photo shows the entrance off 5th Street.

This sidewalk slopes up to the northeast entrance off 5th Street and is sloped at 7% and exceeds the 5% maximum slope and therefore would require handrails per CBC 1133B.7.3, 1133B.5.1. Remedial concrete repair could be done to eliminate that need. The landing at the threshold that indicates a 3% longitudinal slope, cross slope at concrete bench varies from 8.2% to 2.8%. This condition is not in compliance with CBC section 1133B.5.1 through B.5.8 and the area will need to be reconstructed as also noted in previous condition 2.

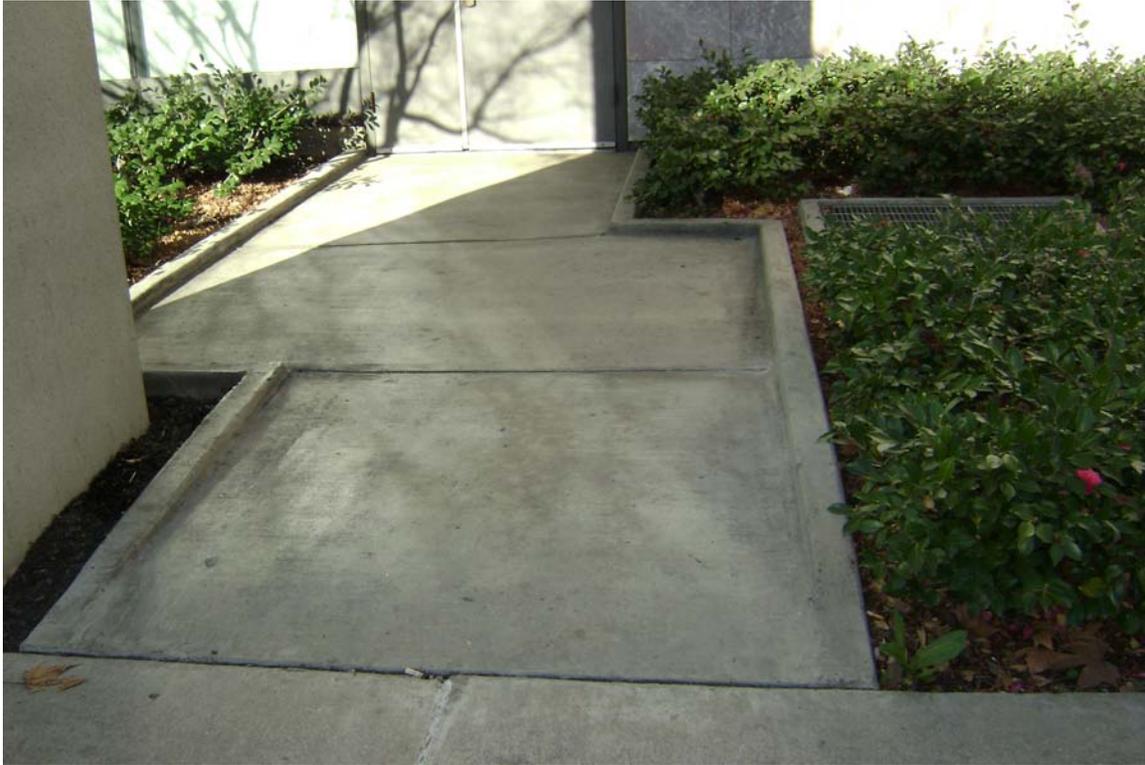
CONDITION NO. 4

This photo is the pedestrian access to the Fire Control Room and stairwell (northeast).

This entrance is a straight gradient from the back of the public sidewalk to the door threshold and at 5.93%. Since this slope is less than 6% but exceeds the 5% maximum slope, the condition would require handrails per CBC 1133B.7.3, 1133B.5.1. The walkway requires a slip resistant surface to be in compliance with CBC section 1133B.7.1 for walkways with less than 6 percent slope. The walkway meets criteria with the addition of a slip resistant surface and handrails.

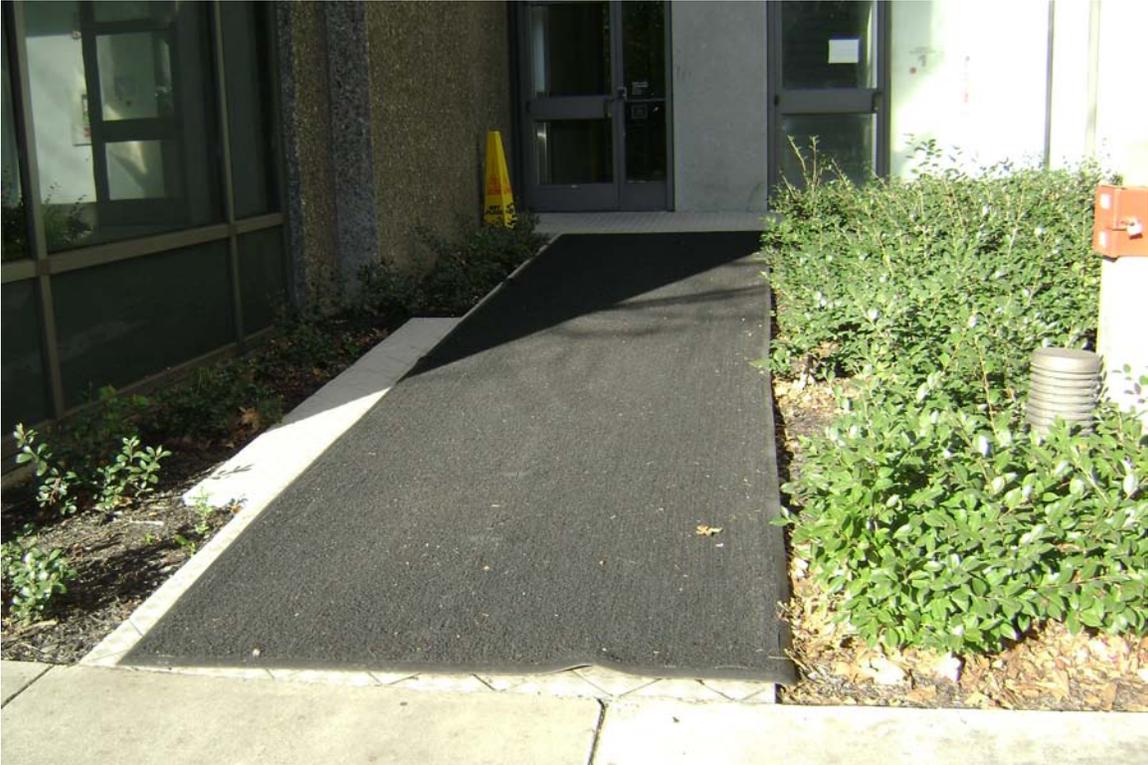
CONDITION NO. 5

Employee cardlock entrance, mid-block off 5th street.

The ramp has a longitudinal slope of 7% which exceeds the 5% maximum slope and therefore would require handrails per CBC 1133B.7.3, 1133B.5.1. The landing slope at the threshold is 4.7%. Although the cross slope is under 2%, the existing access will need to be replaced so as to comply with CBC section 1133B.5.1 through B.5.8. In addition the non-slip surface mat needs to be secured in place.

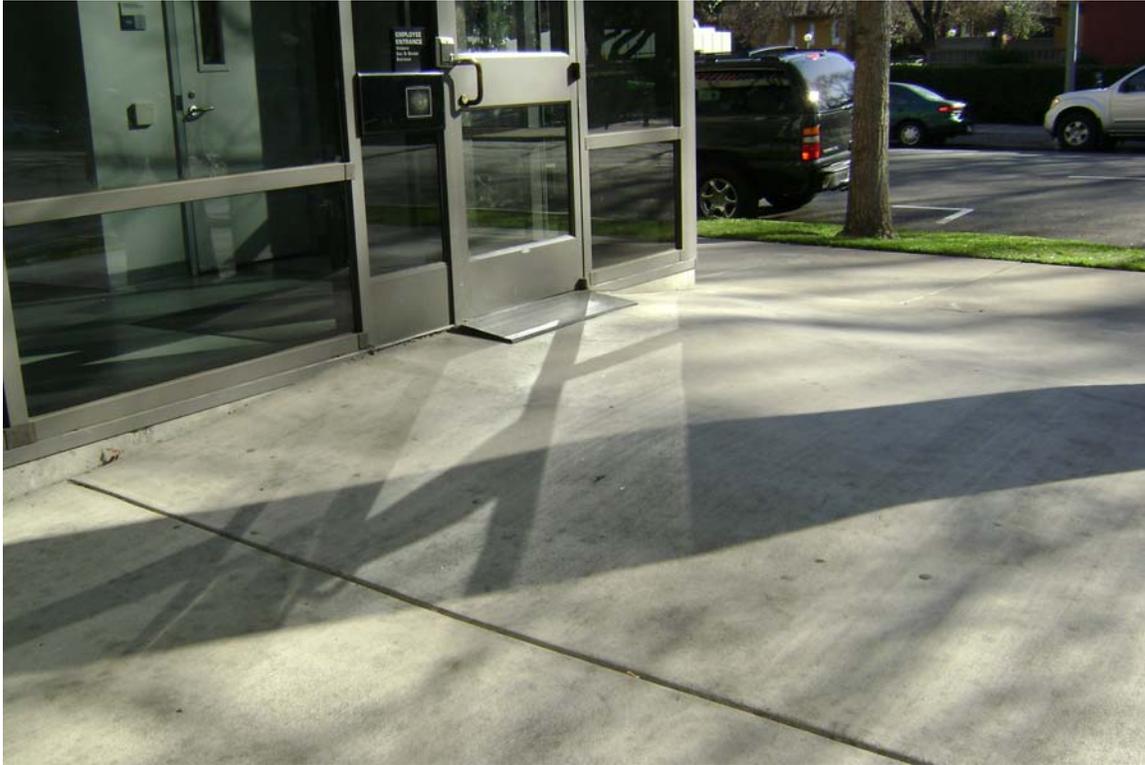
CONDITION NO. 6

This is the southeastern employee cardlock entrance off “O” Street.

The concrete landing at the threshold and the public sidewalk approaching it has very radical slopes, 13.8% easterly to the public sidewalk, 7.3% southerly to the sidewalk. This condition is not in compliance with CBC section 1133B.2.4.2 and needs attention.

Also, Figure 11B-26A-Level Maneuvering Clearance at Doors denotes the minimum landing requirements at a door threshold. The landing requirements are likely to dictate the remaining remedial work to be constructed in this area. If the remedial work requires 5% slope on the ramp, handrails will be required also per CBC 1133B.7.3, 1133B.5.1.

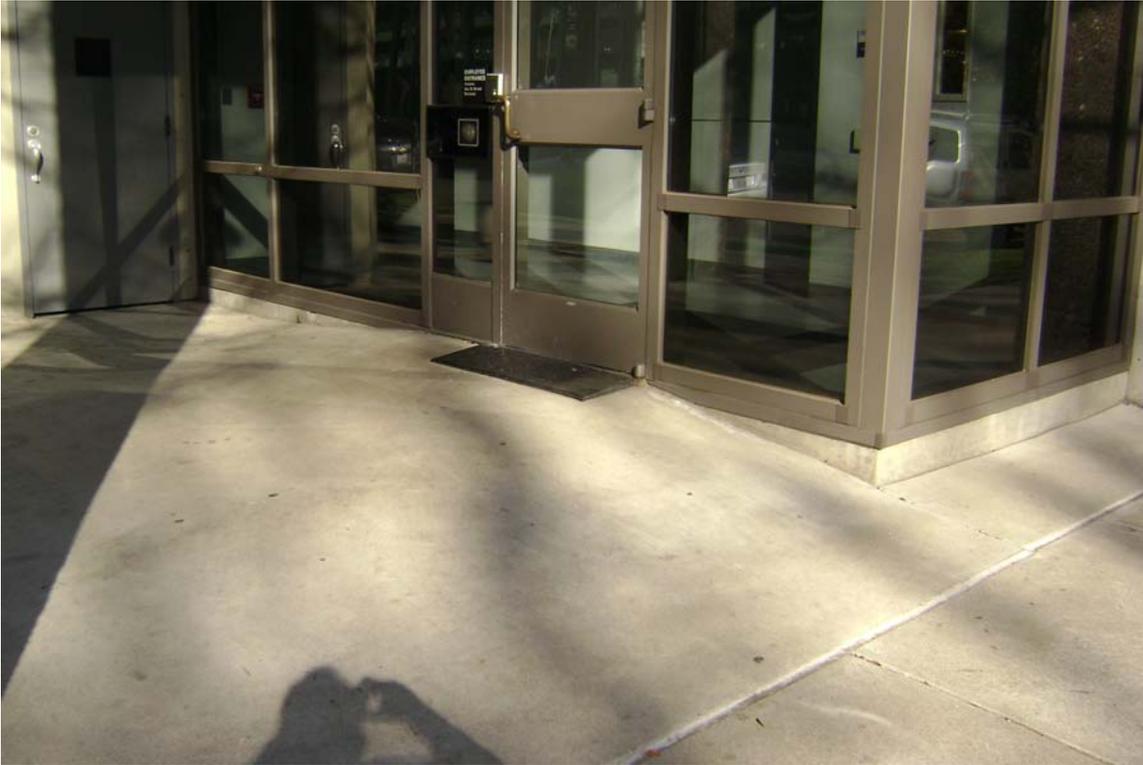
ADDITIONAL PHOTO AT CONDITION NO. 6A

The public sidewalk as it slopes to the east includes a variable cross slope from 1.5% just to the north, to a 4.5% cross slope at this entrance. Approximately 45 feet of the public sidewalk will need to be reconstructed to be in compliance with CBC Section 1133B.7.1.3, Surface Cross Slopes.

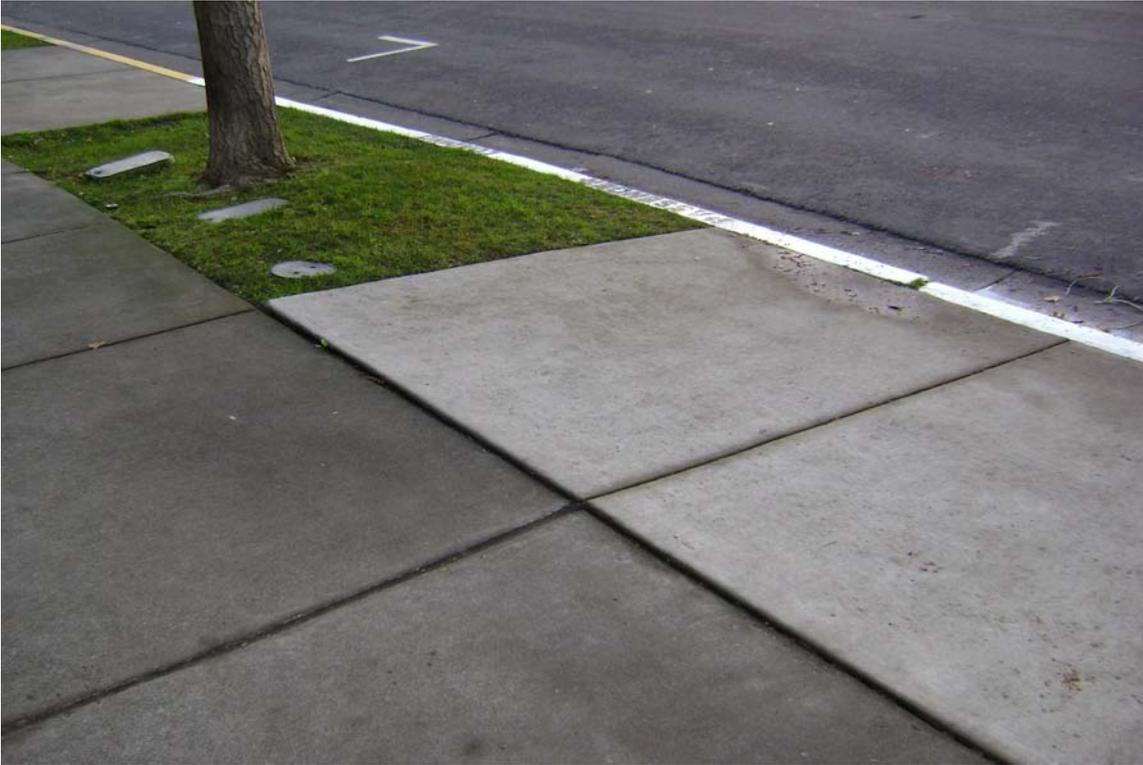
CONDITION NO. 7

Photo of passenger drop off at children's day care center off 4th Street.

The concrete slab has lifted an inch plus, creating an undesirable tripping hazard. Two of these conditions exist along 4th Street. These conditions are not in compliance with CBC section 1133B.7.4, Changes in Level, and will require removal and reconstruction.

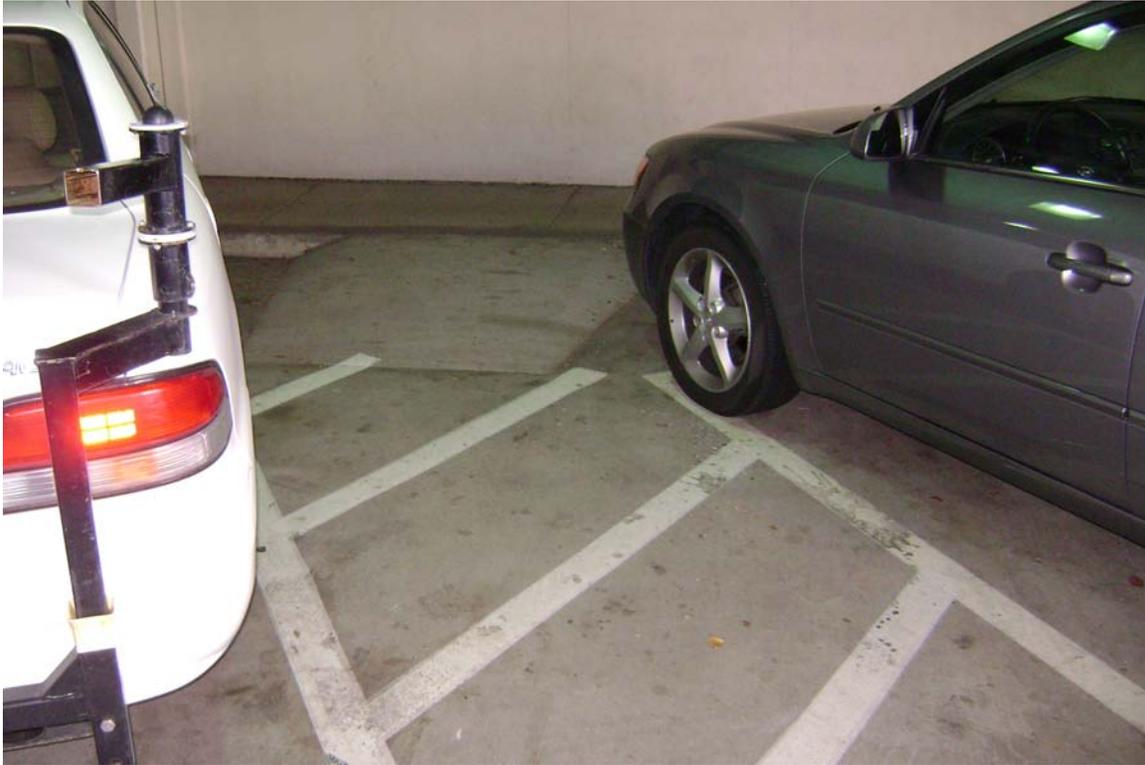
CONDITION NO. 8

Accessible parking in garage lower level. Entrance off “O” Street.

Slopes on ramps exceed maximum allowed 6 inches in rise, 6 feet in run, 8.3% maximum. Not in compliance with CBC section 1133B.5.3.

The southerly three of the four ramps are not in compliance with CBC section 1133B.5.3.

Accessible van stall parking striping is also not in compliance. Accessible stall diagonal striping shall have a “NO PARKING” legend painted at the outside edge per CBC figure 11B-18C diagonal parking stalls.

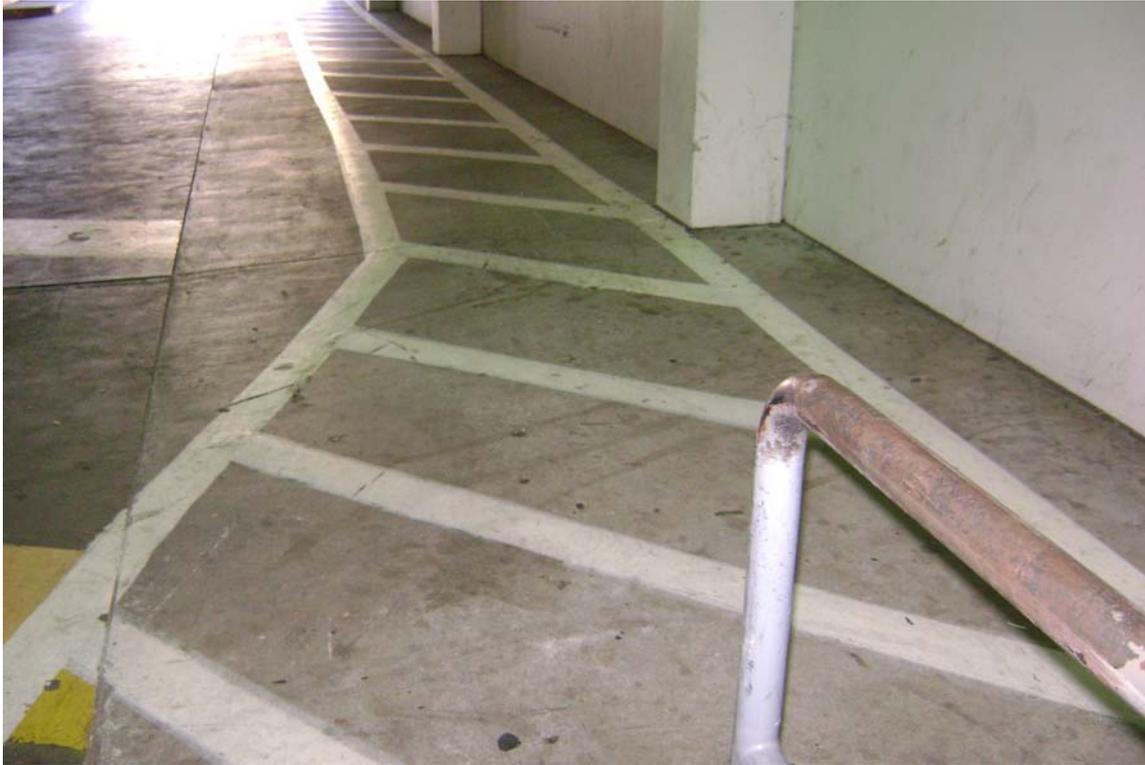
CONDITION NO. 9

ADA Path from accessible parking stalls to 4th Street public sidewalk.

The hatched ADA access path has an existing cross slope that varies from 5.6% to 5.9%. Code requires a maximum of 2% cross slope.

This is not compliant with CBC section 1133B.7.1.3, Travel Path Surface Cross Slopes.

CBC Section 1133B.8.5, Detectable Warning at Hazardous Vehicular Areas, requires a separation of pedestrians and vehicles which is not present.

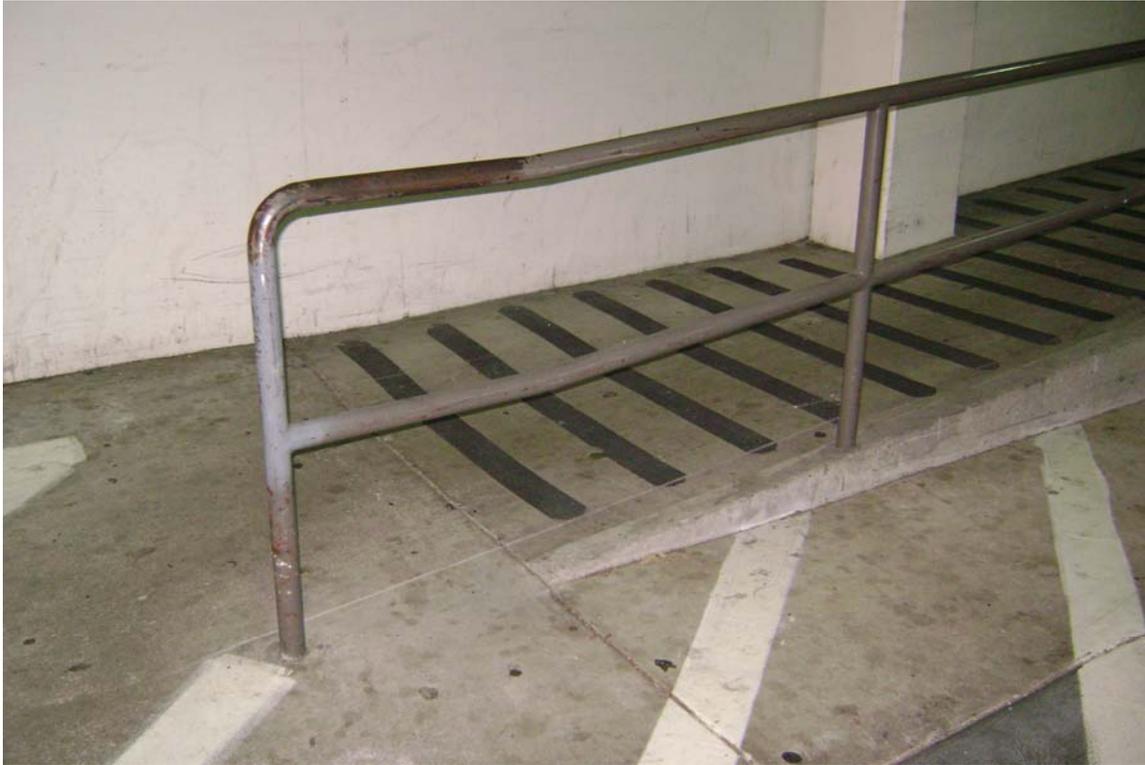
CONDITION NO. 10

Accessible ramp at street level parking garage north employee entrance.

Ramp is at 8% slope up to entrance door landing. The landing cross slope exceeds the 2% maximum. The landing at this doorway will have to be reconfigured to be in compliance with Figure 11B-26A. This remedial landing repair work will then also require adjustments to the existing ramp. This new ramp must have a rise not in excess of 30-inches and a run not in excess of 30 feet without intervening landings.

The ramp also has a cross slope of 5.9% from bottom of landing.

Final conditions must be in compliance with CBC section 1133B.5.1 through B.5.8.

CBC Section 1133B.8.5, Detectable Warning at Hazardous Vehicular Areas, requires a separation of pedestrians and vehicles which is not present.
