**Microbial Assessment and Mitigation Procedures -  
First Floor Janitor's "Hopper" Room  
Department of General Services Board of Equalization Building  
450 N. Street  
Sacramento, California**

**Attachment A: Digital Images**  
September 19<sup>th</sup>, 2008  
BOE Building 1<sup>st</sup> Floor Janitor's Plenum Area  
Sacramento, CA

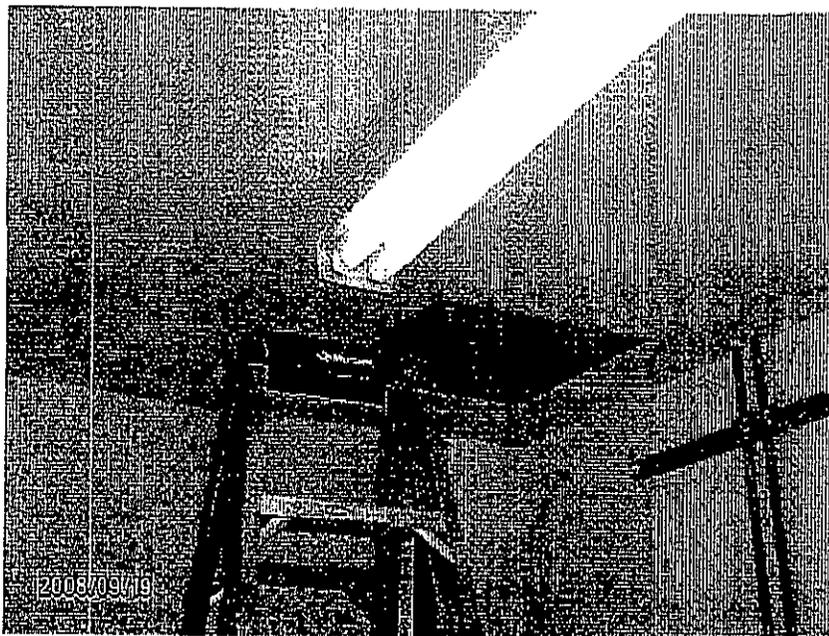
5) Image of inspector access panel on ceiling within janitor's room.
