- 1) Image of security area kiosk containment entry at time of clearance assessment of BOE Building (Subject Building) located at 450 N. Street, Sacramento, California.

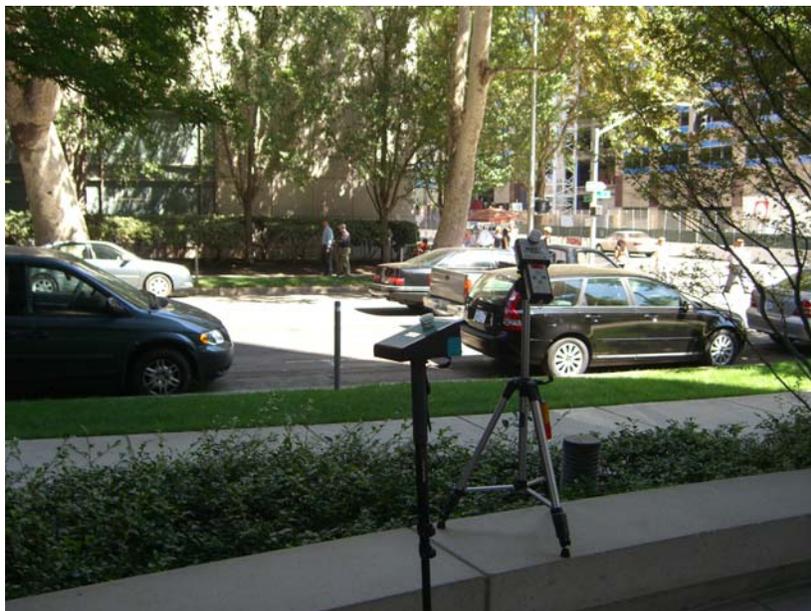
- 2) Image of ambient air sampling location prior to the performance of interior containment assessment activities.

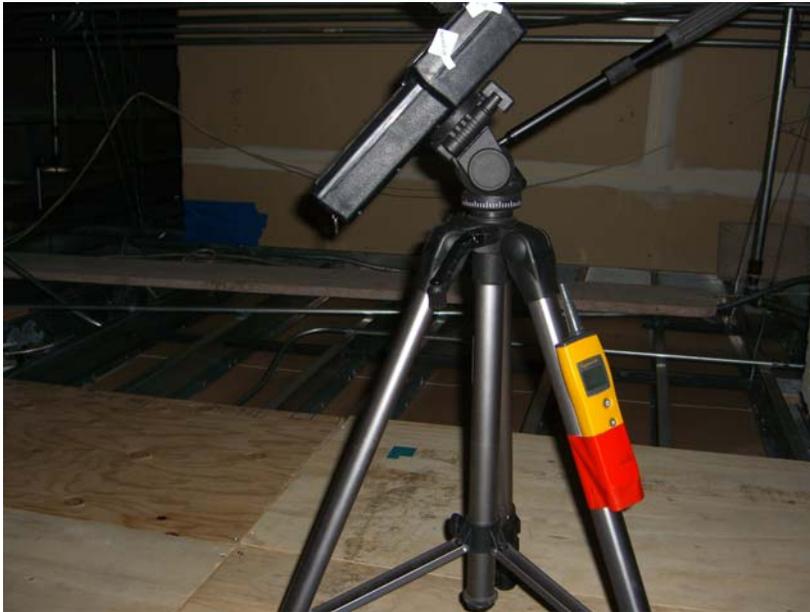
3) Image of air sampling activity performed at center area of Security Kiosk plenum area at time of assessment.

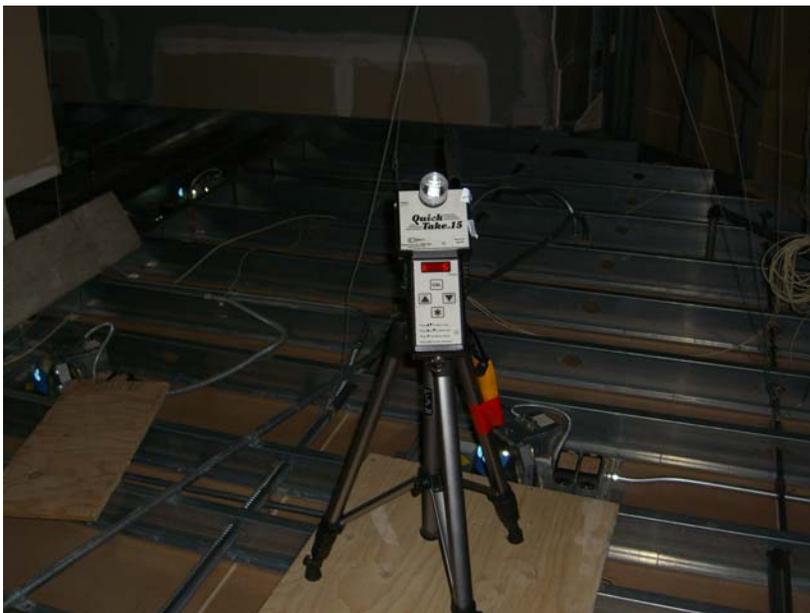
4) Image of air sampling activity performed at eastern side of Security Kiosk plenum area at time of assessment.

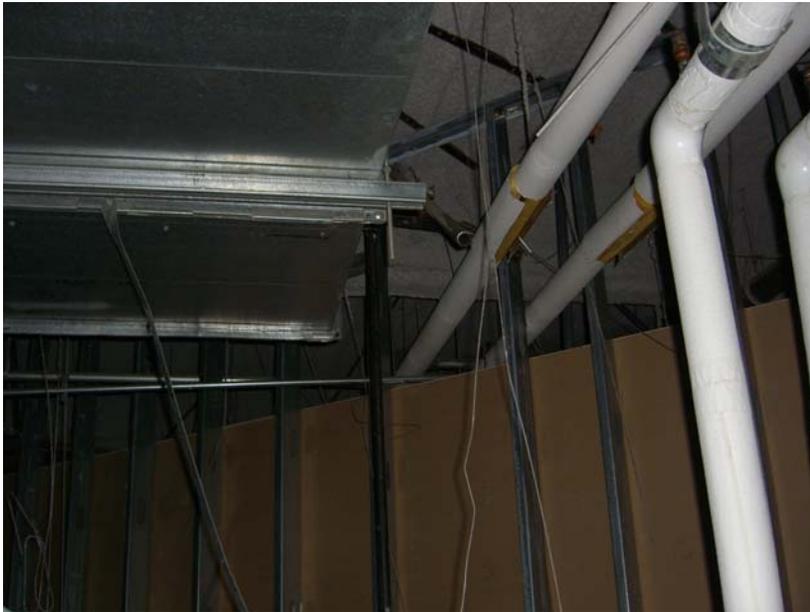
5) Image of ceiling structures and physical systems as viewed from Security Kiosk plenum area at time of assessment.

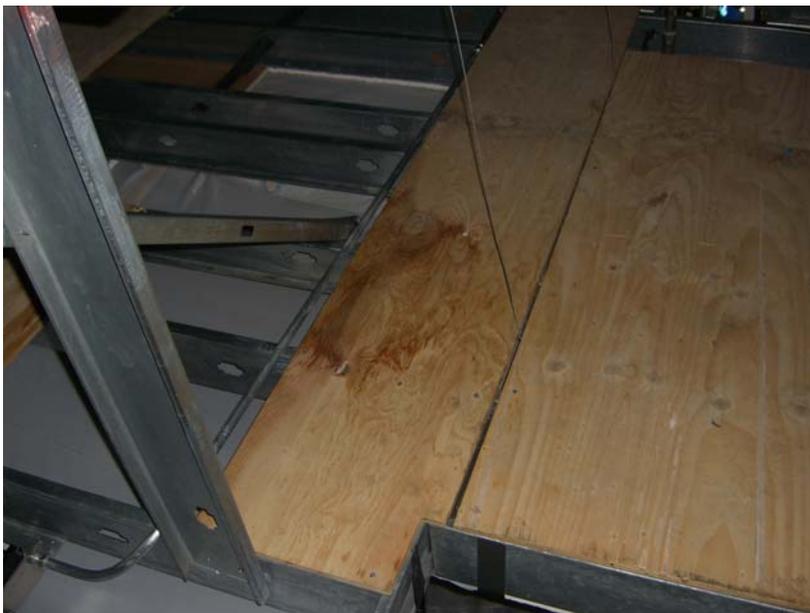
6) Image of plywood walk-on flooring present within Security Kiosk plenum area at time of assessment.

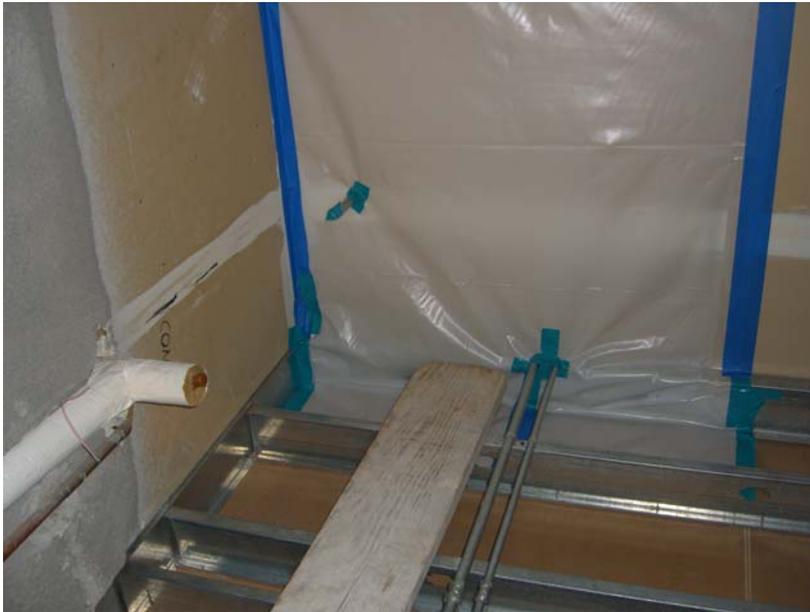
- 7) Close-up image of critical barrier isolating damaged materials (from Security Kiosk plenum area) located at southeastern most portion of plenum at time of assessment.

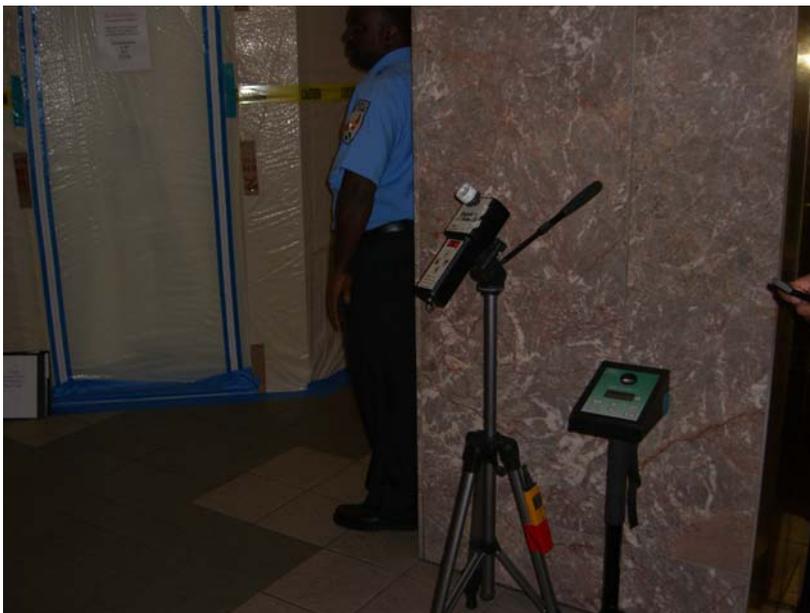
- 8) Image of air sampling performed within occupied elevator lobby area located adjacent to Security Kiosk area at the time of assessment.
