**California State Board of Equalization**  
450 N Street, Sacramento, California

**Mold Remediation – 20th Floor**  
**August 9, 2010 – September 30, 2010**  
**Closure Report**  
*Project No. 2372.02-572*

**Report Date:**  
November 30, 2010

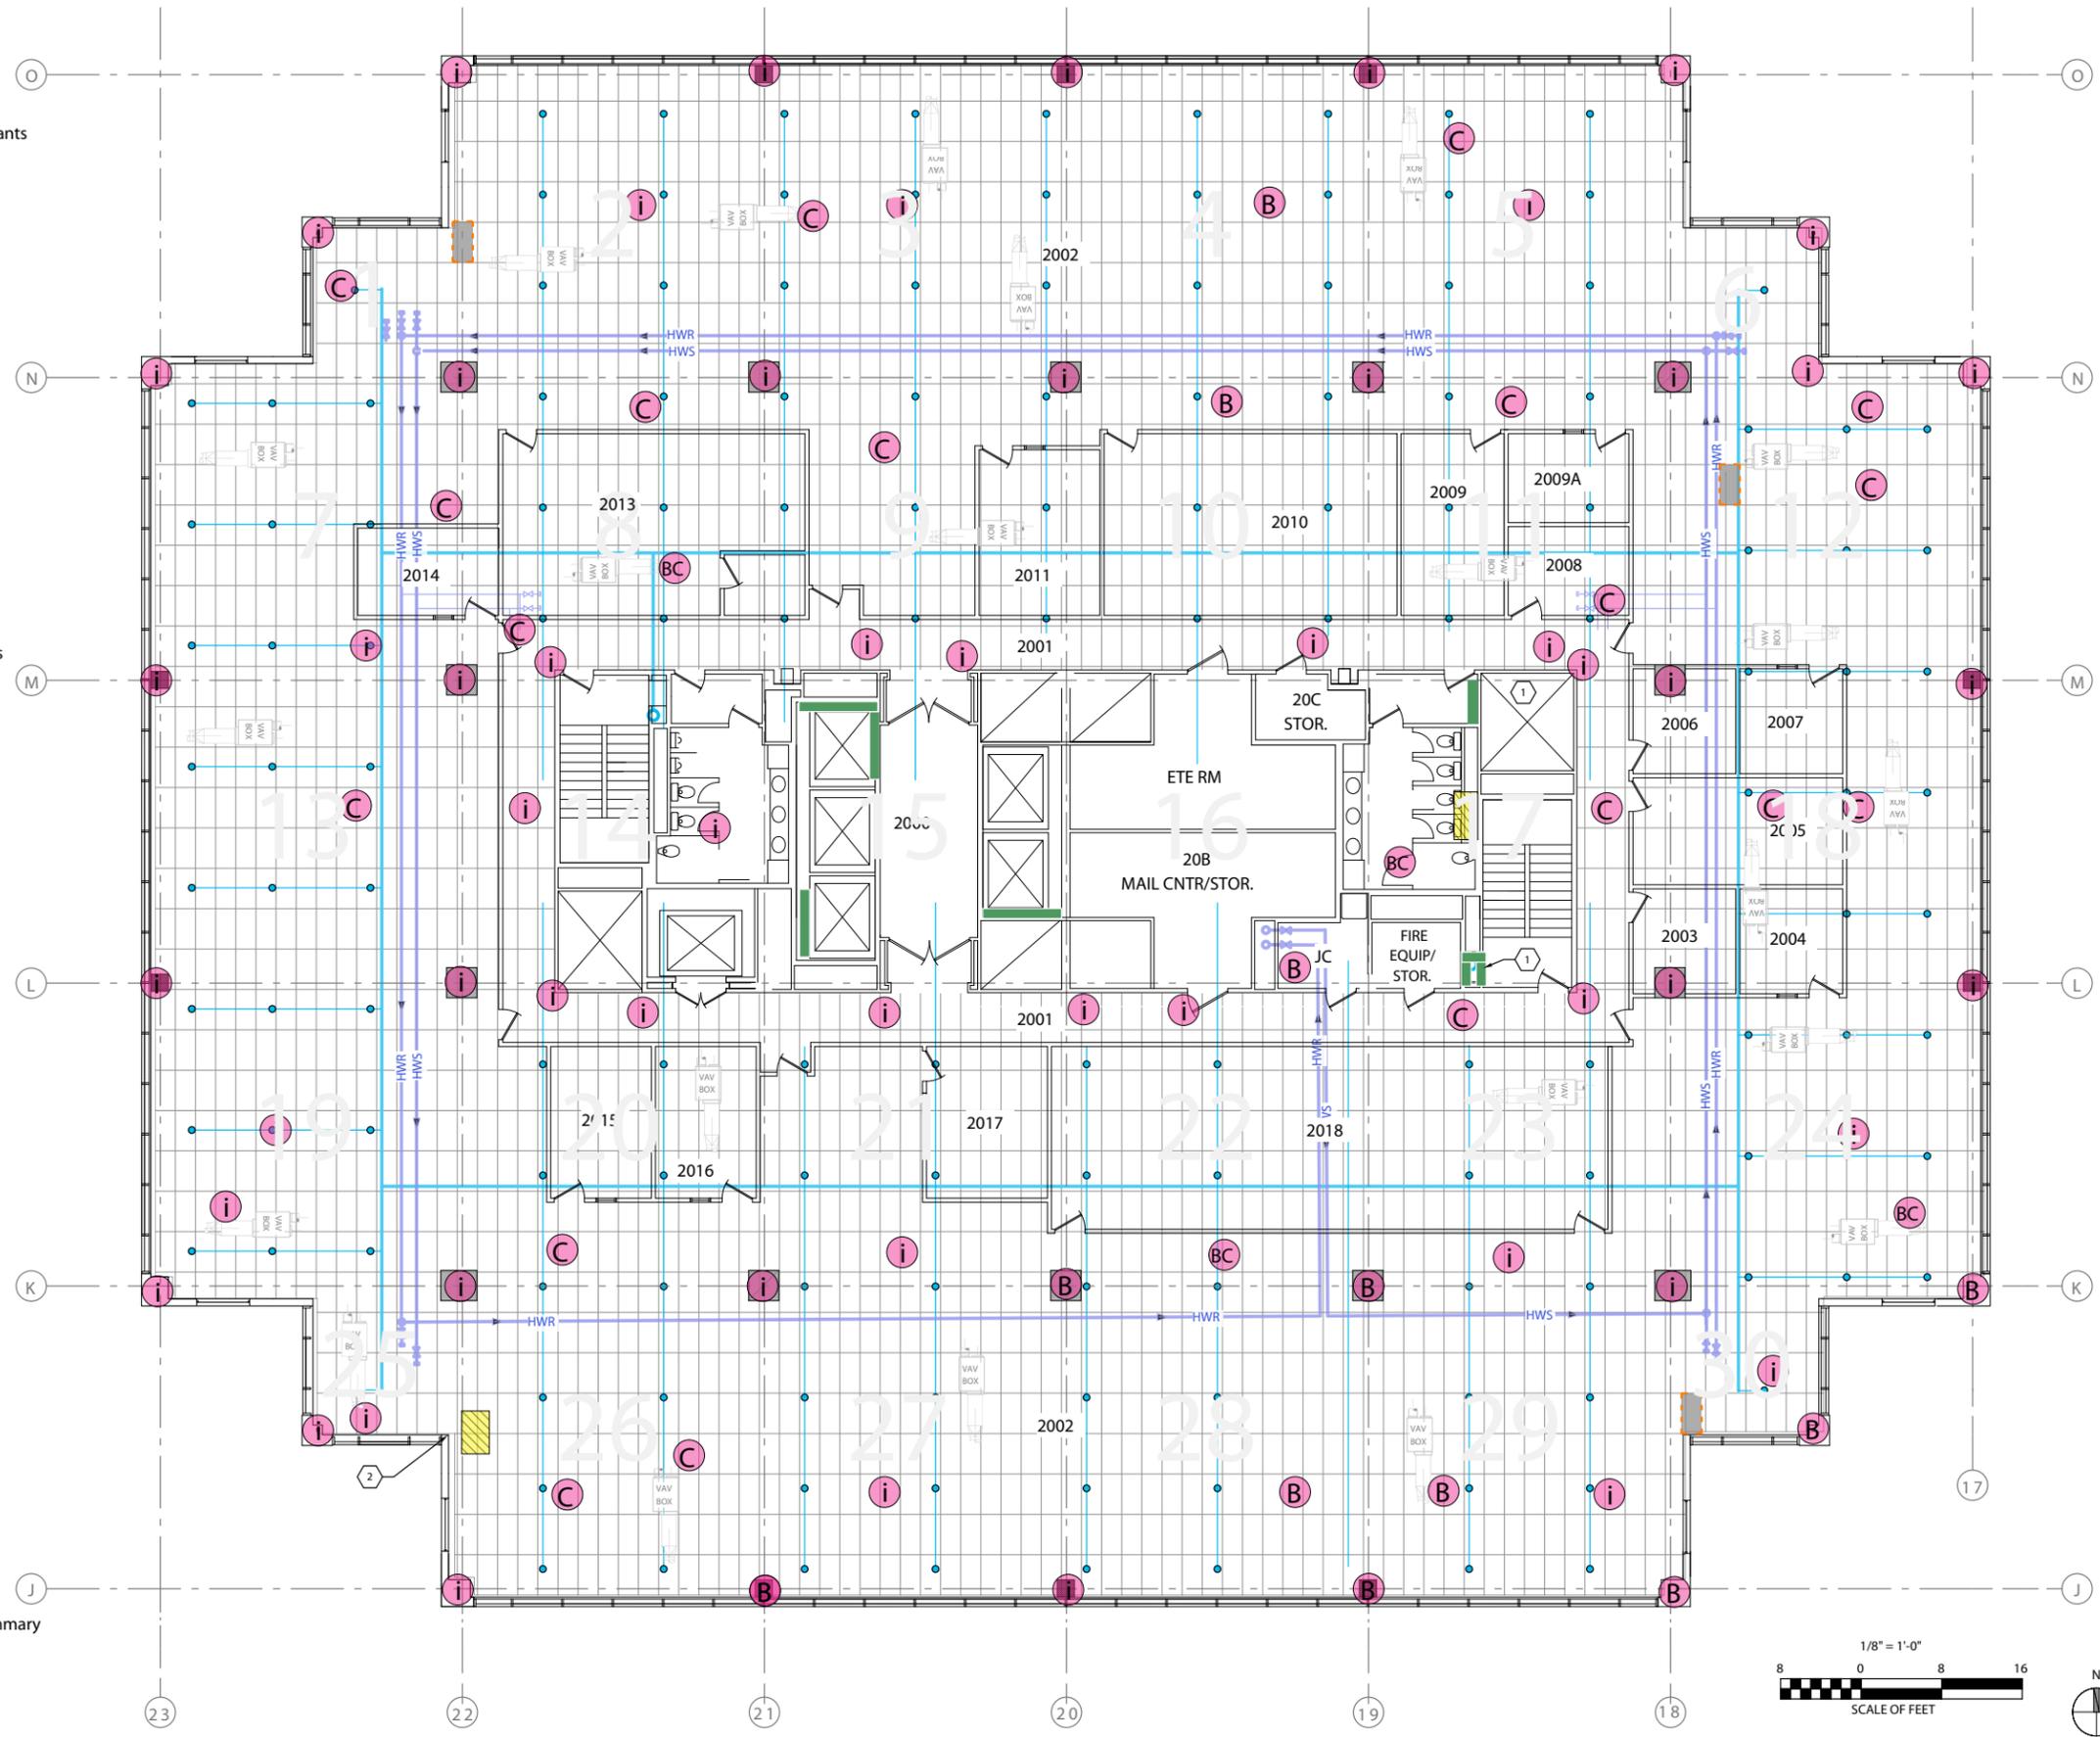
**Figure 1 Water Damage Assessment Revised**

- ① 10 sq. ft. visible mold growth
- ② Floor stain from over-watered plants without drip pans

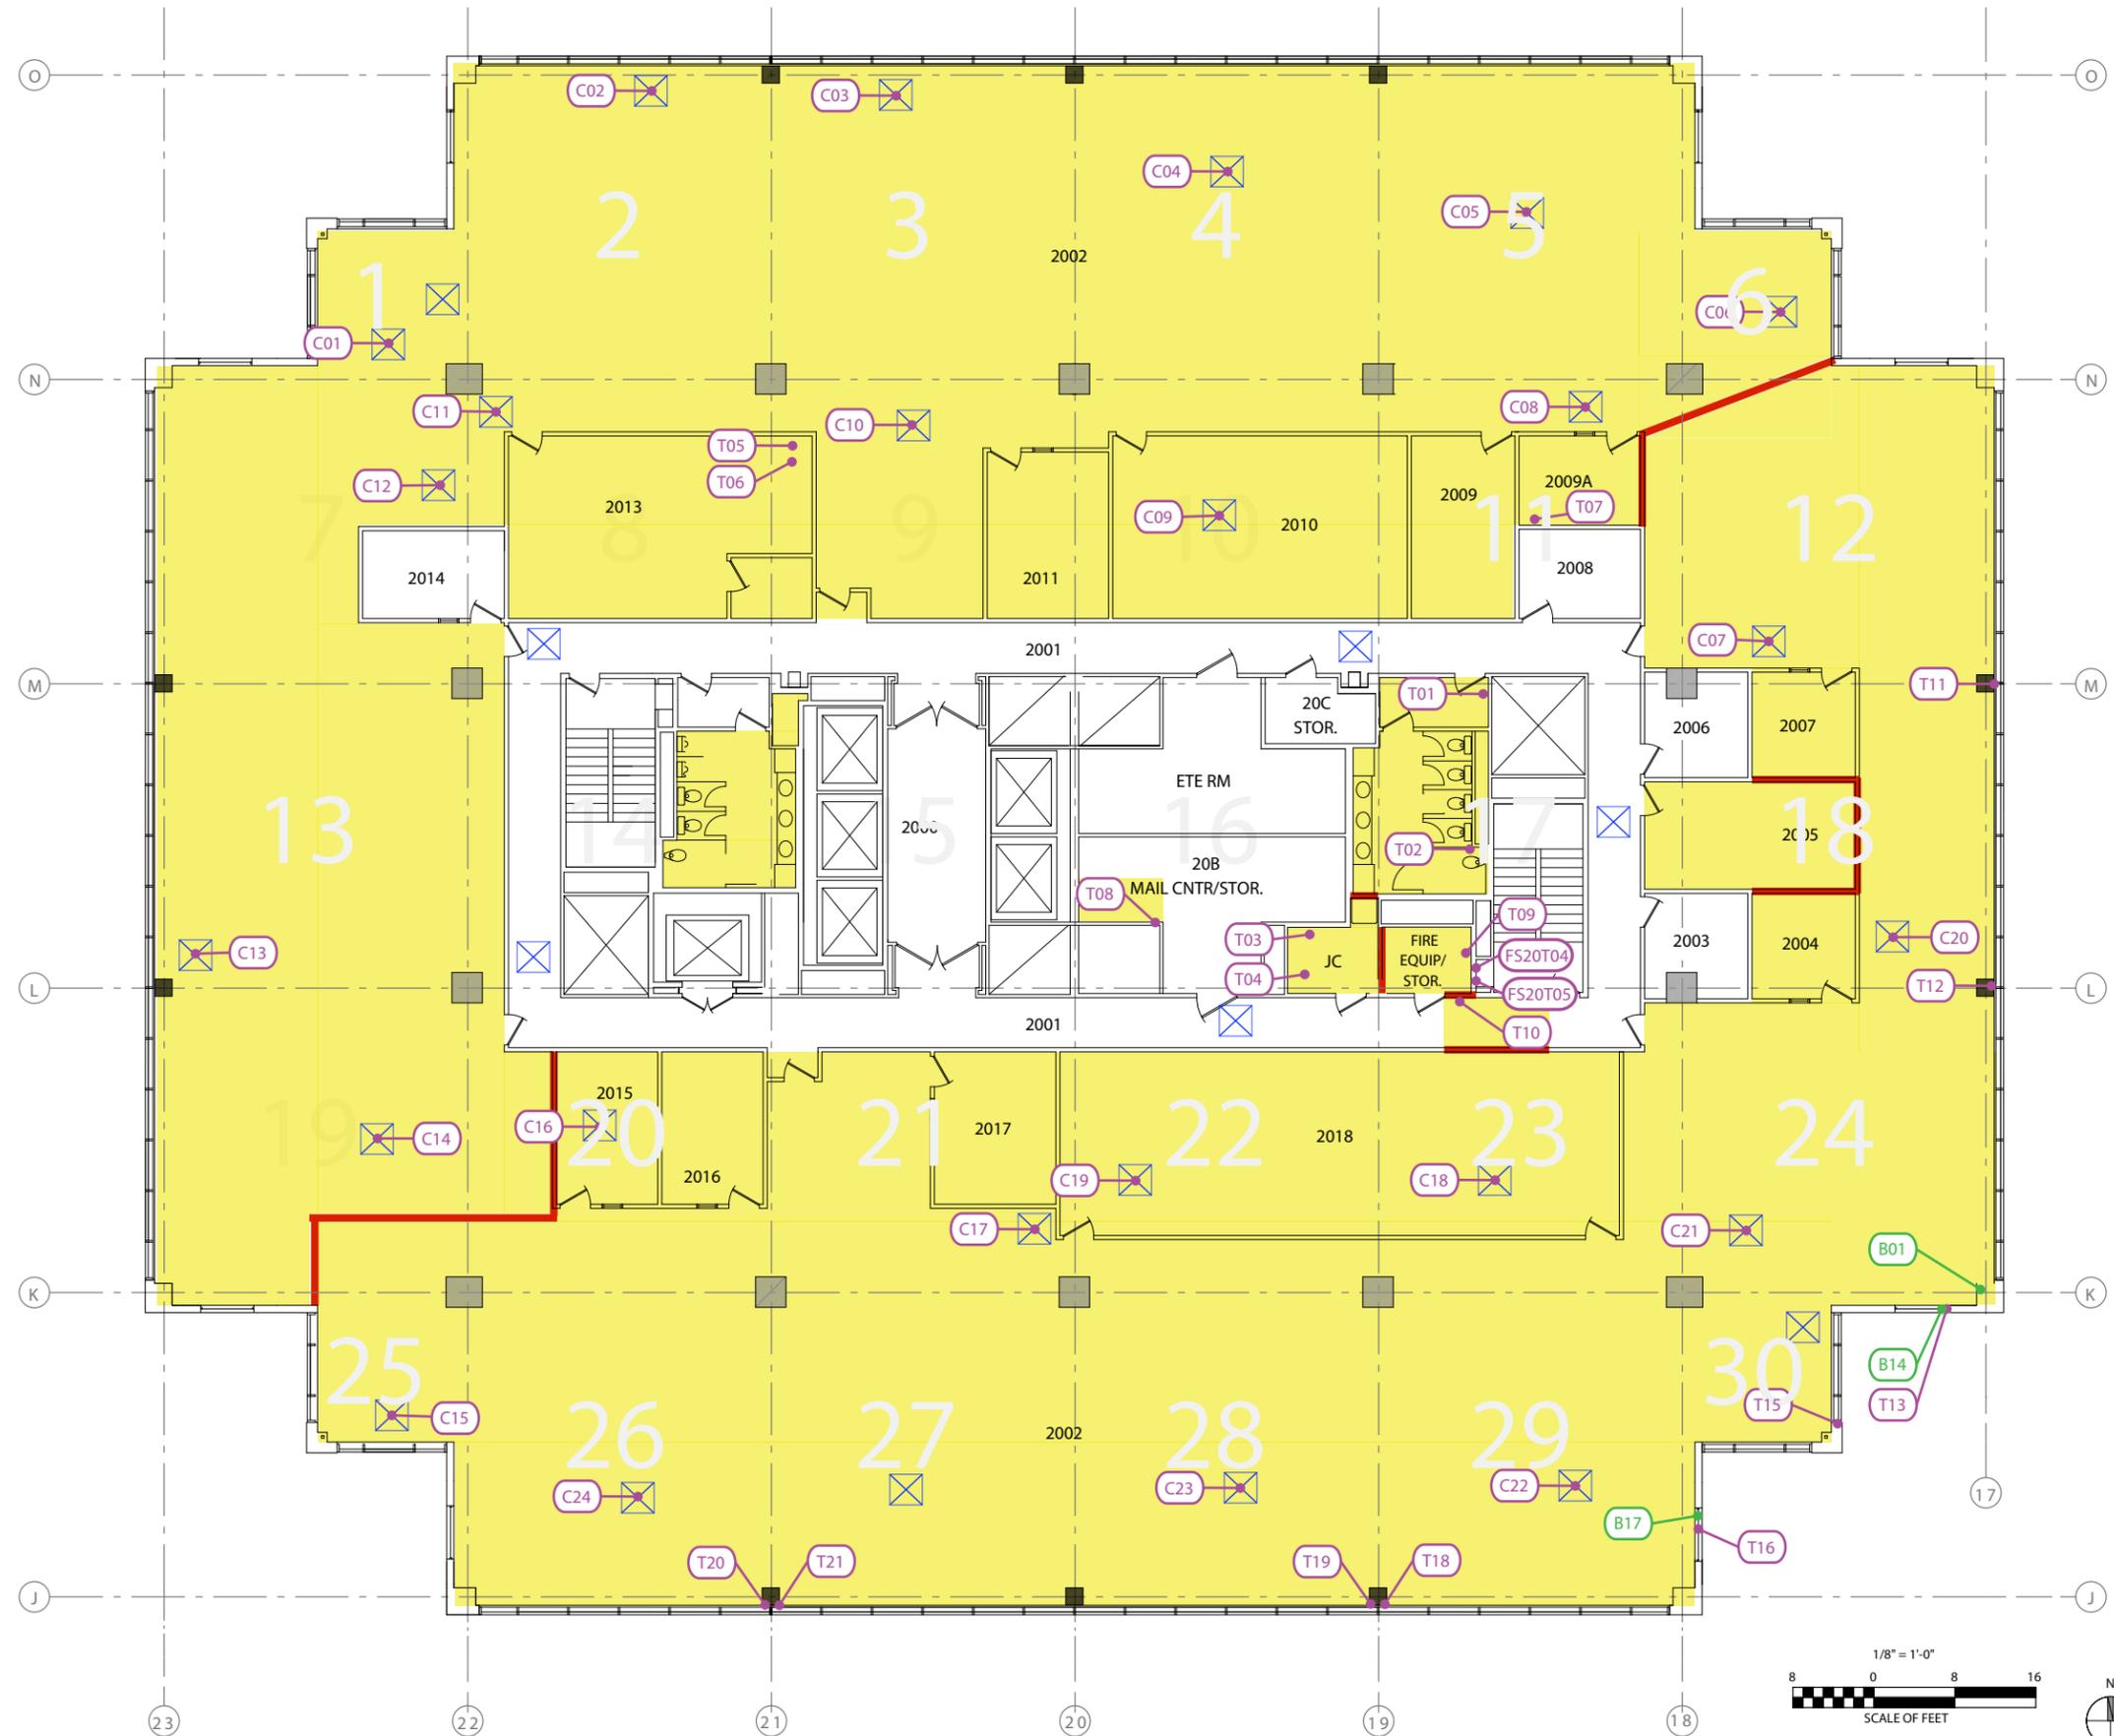
Figure 2

Areas and materials that were identified to contain mold growth were subsequently placed under containment and subjected to an appropriate mitigative or remedial action. These actions were taken to eliminate or minimize potential exposures to VMG by personnel that may later access the subject area. The containment locations are shown in Figure 2.
