Re: 450 N Street – Board of Equalization, MCA Job No.: 05155.00 RP
Subj: January 4, 2008 Storm Water Intrusion Observations

The following letter report is a preliminary summary of the water intrusion leak sources based on site observations during the extreme weather event that occurred on Friday, January 4, 2008, and follow-up limited investigations on Monday, January 7th and Wednesday, January 9th.

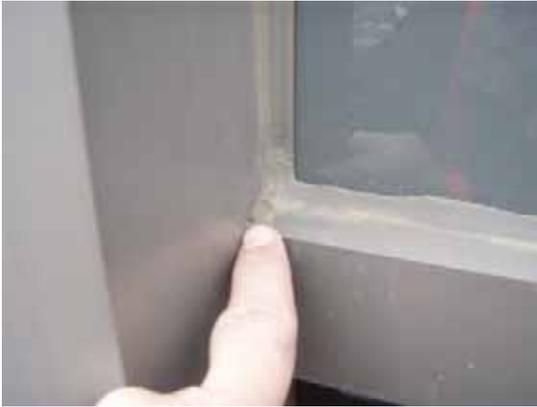
The exterior investigation by MCA on January 9th of the south wall between grid lines 20 and 21 from floor 22 to floor 7 did not result in observations of any significant curtain wall perimeter or expansion joint cover sealant problems (missing sealant, failed sealant). A small quantity of pin-holes (Photos 1 and 2) in the exterior sealant were observed; however, these did not correlate to interior leaks observed during the January 4th storm. MCA recommends that the horizontal beauty caps be removed at the leak locations to further investigate the leak sources.

Photo 1: Pin-hole encountered at south elevation.

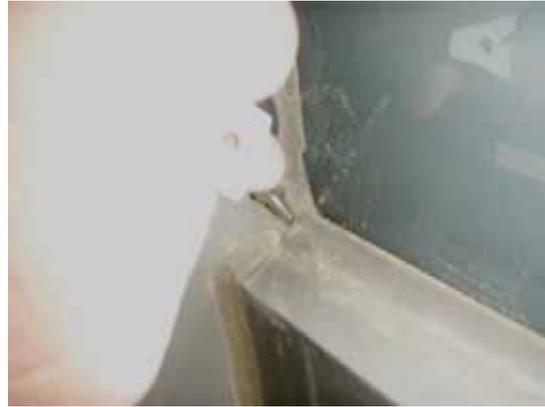
Photo 2: Pin-hole encountered at south elevation.

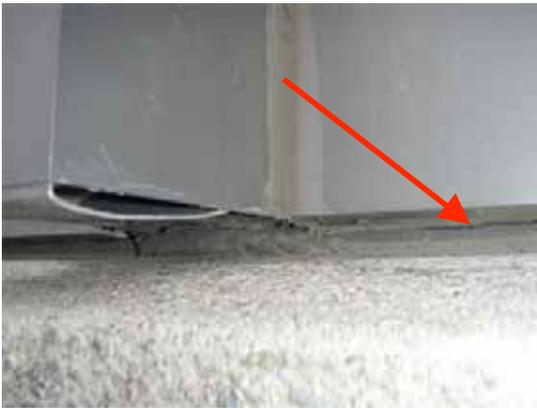
The more significant sealant problems were encountered at the joint between the curtain wall/pre-cast at the 14th floor (vision sill), 11th Floor (vision head). Adhesion and cohesion failures were observed (Photos 3 and 4).

Photo 3: Cohesion failure at sealant joint between 14th floor vision sill/precast panel.

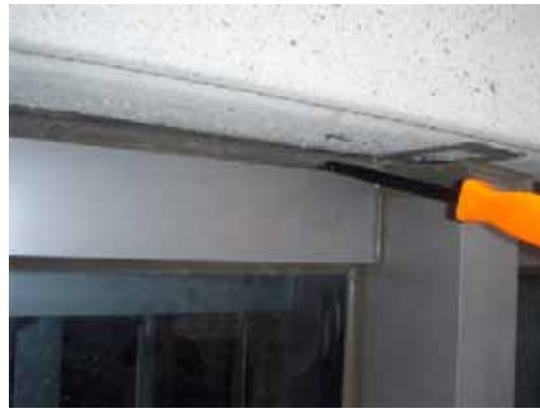
Photo 4: Adhesion failure at sealant joint between 11th floor vision head/precast panel.

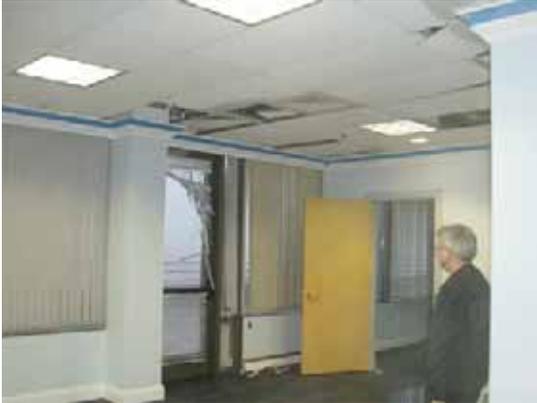
The most significant water entry was due to the northern most door of the East balcony blowing open (Photos 5, 6 and 7). This door is also in the worst possible location for this storm direction as the water on the balcony deck was being blown to the north end of the balcony (where the door is). This resulted in a large amount of water at the office where door is located and then the water dispersed to the adjacent southerly offices. The water also was found to leak down the the wall (where the balcony transitions to the building) and was observed at the 18th floor ceiling tile.

Photo 5: East Balcony, north end door had blown open earlier.

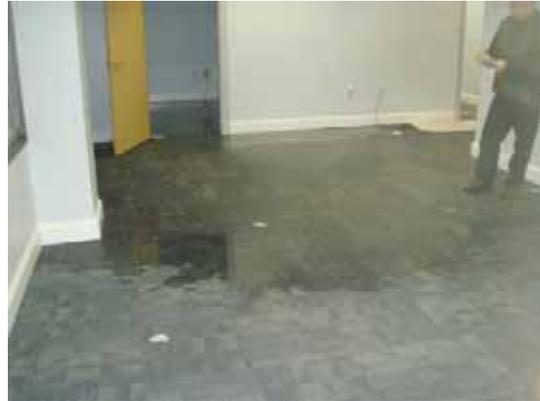
Photo 6: East Balcony, north end office, water accumulated on floor at door (looking south)

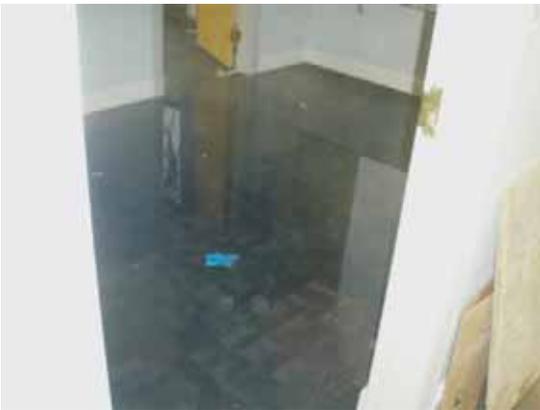
Photo 7: Water accumulated at office south of door that had blown open.

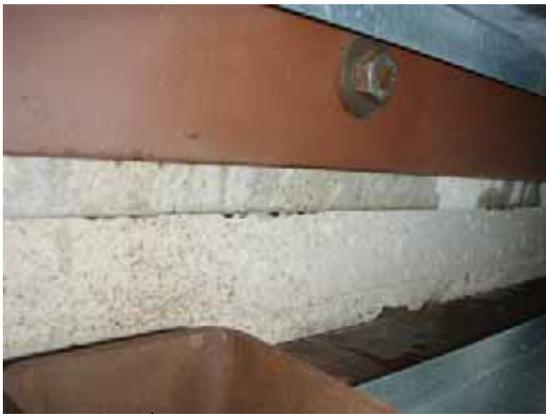
Water was observed to be dripping down the bottom of the structural angle that rests on the pre-cast concrete panel supporting the curtain wall above (Photos 8 and 9). Closer investigation revealed that water appeared to be bypassing the sealant at the curtain wall to pre-cast concrete panel joint. It was found to be more significant where the vertical mullions terminated at the pre-cast concrete panels. MCA reviewed the sealant joint assembly at each of the balconies and notes that the joint dimension is most narrow at the South Balcony and that the elastomeric coating on the pre-cast concrete terminates at the exterior face of the horizontal beauty cap (Photo 10) at some locations and may have prevented proper weeping.

Photo 8: 23rd floor south balcony, water dripping at bottom of the angle and precast.

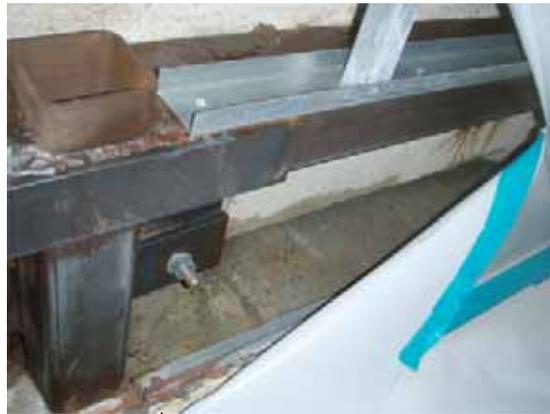
Photo 9: 23rd floor south balcony, water at the floor slab below the precast panel.

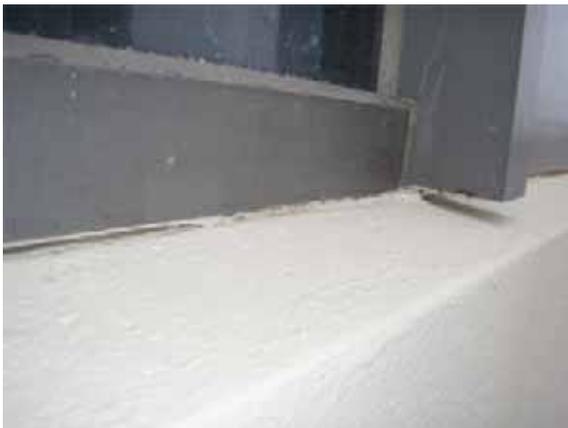
Photo 10: Elastomeric coating build-up at face of horizontal beauty cap.

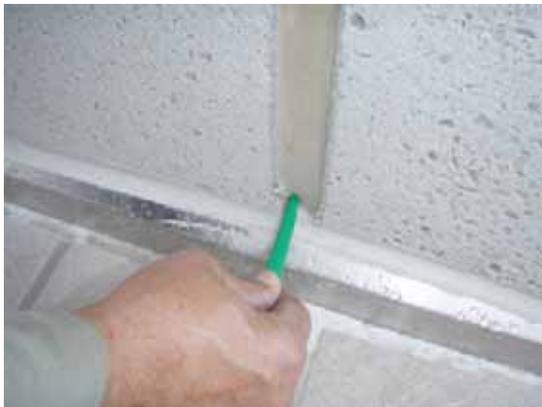
The January 9th review of the deck and pre-cast joint sealant revealed concrete pulling away in the west parapet pre-cast concrete panel joints adjacent to the sealant joint (Photos 11 and 12).

Photo 11: Concrete pulled away at base of the sealant joint.

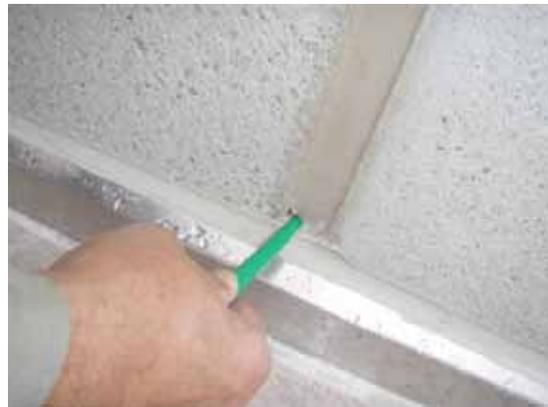
Photo 12: Concrete pulled away at base of the sealant joint.

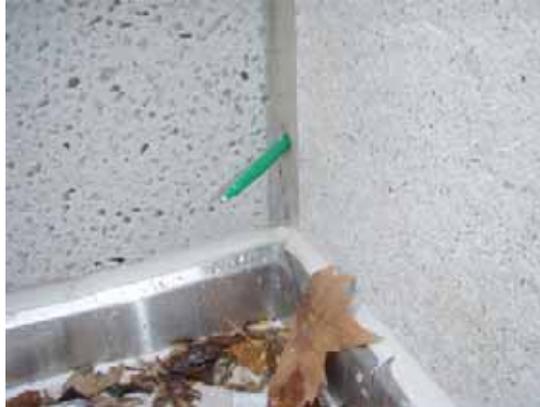
The January 9th review of the deck and pre-cast joints revealed cuts in the northeast corner vertical pre-cast panel joint (Photo 13).

Photo 13: North Balcony, northeast corner precast joint, sealant is cut at the base.
