Board of Equalization Building
450 N Street, Sacramento, CA 95814
Forensic Analysis – Glass Breakage
Prepared for DGS

Interactive Resources Project No. 2011-099-01
IDGS Contract No. 3158936 (BPM #028)

June 25, 2012

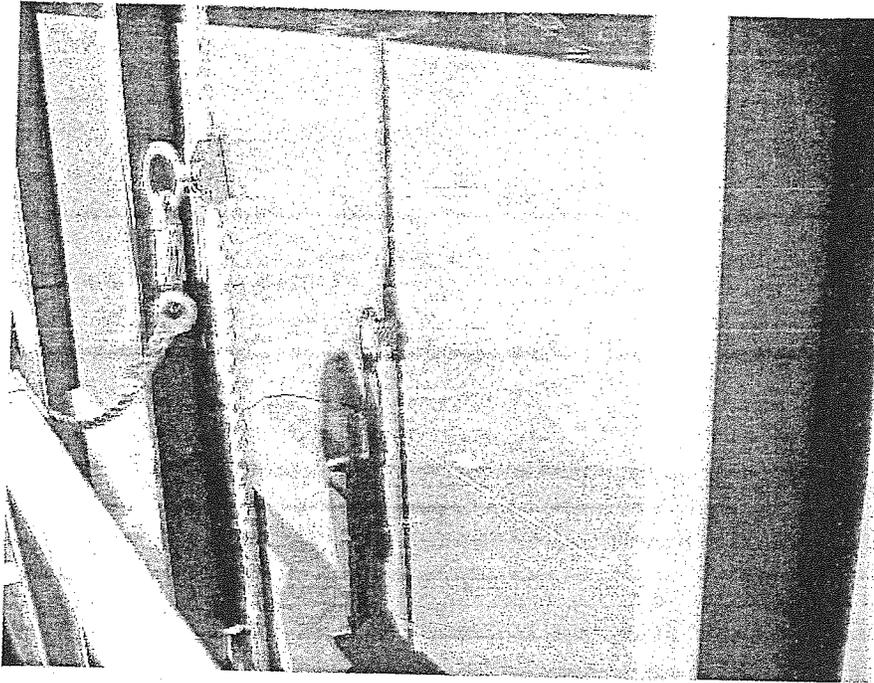
Photo 1: Cracked spandrel glass near gold bull-nose attachment

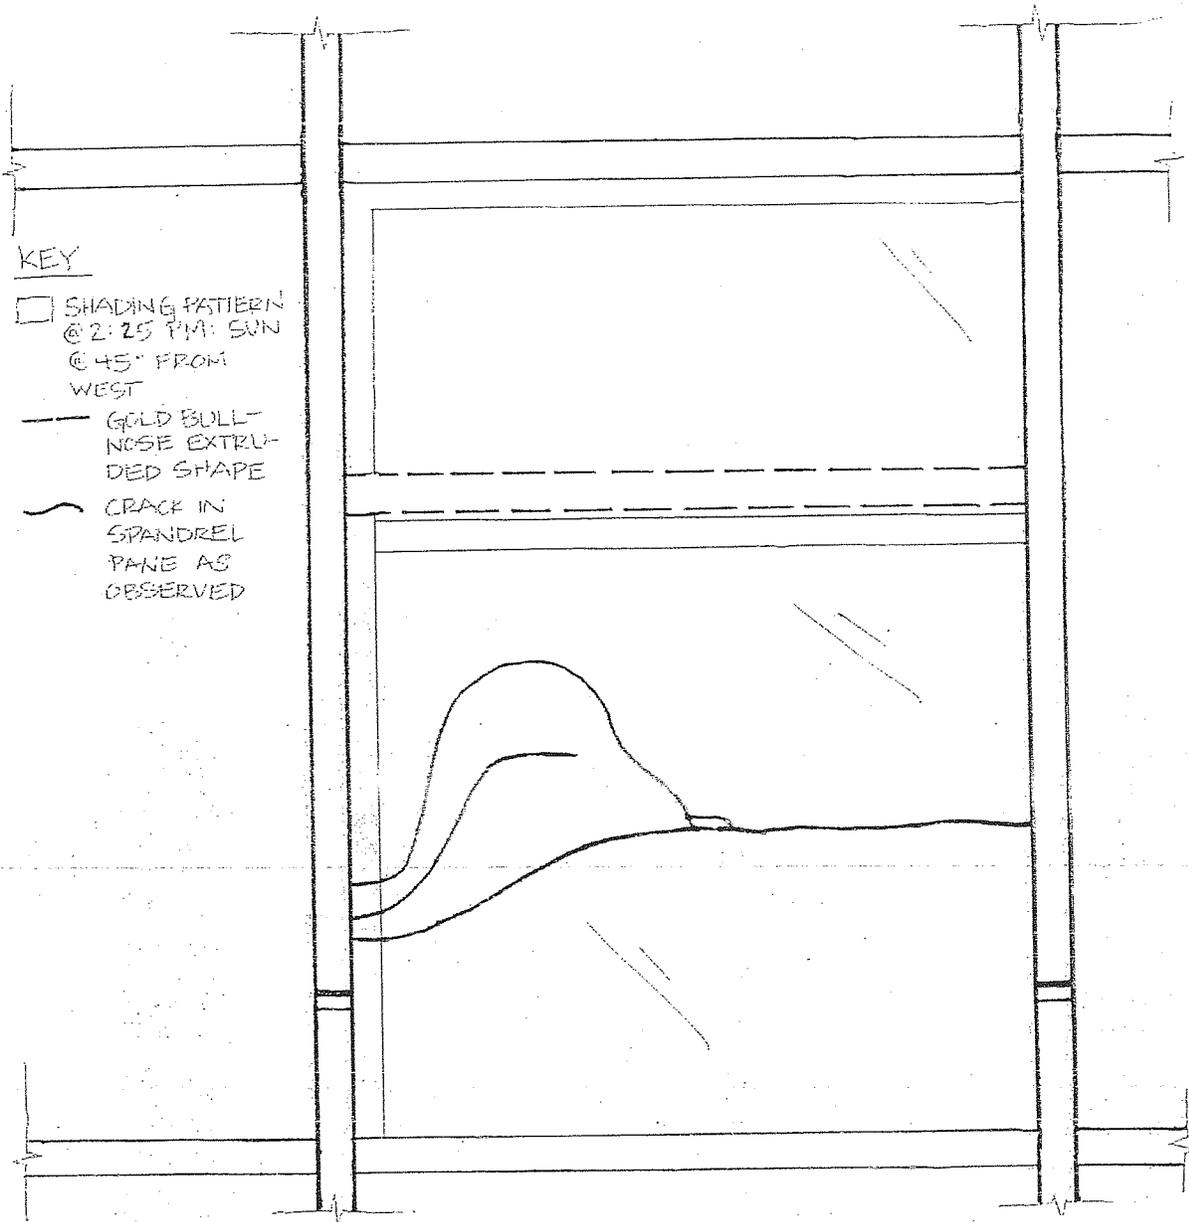
Figure 2: Elevation of Observed Cracking Pattern

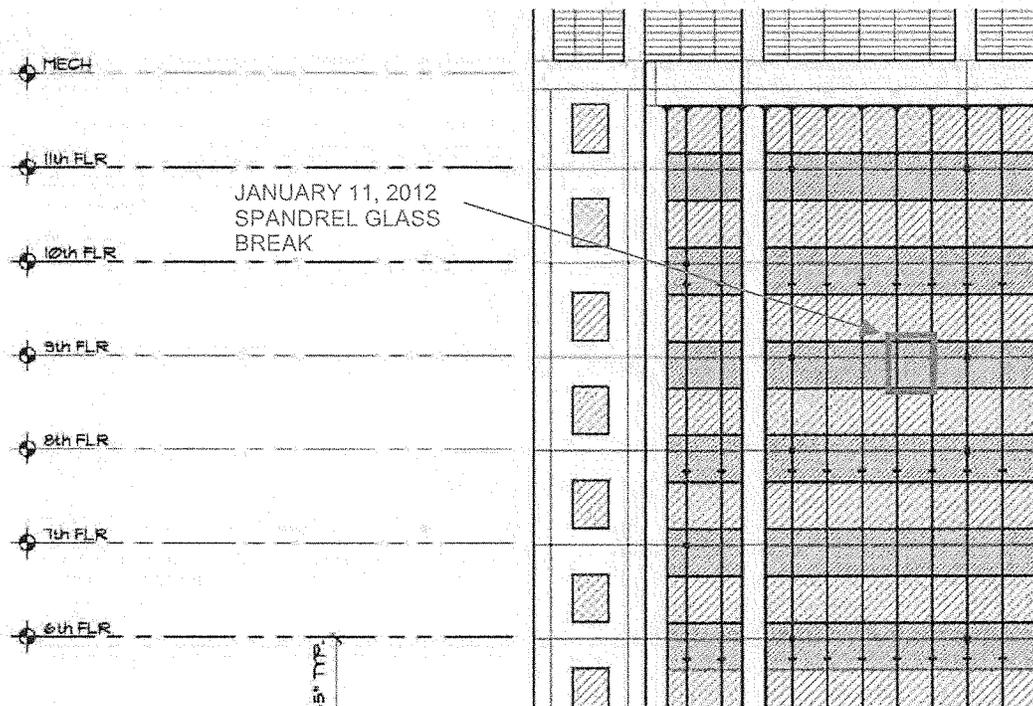
Figure 1 - Partial East Elevation

The spandrel glass at the east elevation, 9th floor level, 5th lite from the south end of the corner (Figure 1) was reported to have broken and fallen to the ground at approximately 10:30 am (PST) on January 11, 2012. Climate conditions as reported at a private weather station at 24th and K at 10:35 am (PST) were 50°F, Dew Point of 32°F, 50% RH, skies clear and wind calm. The low temperature overnight was 32°F.

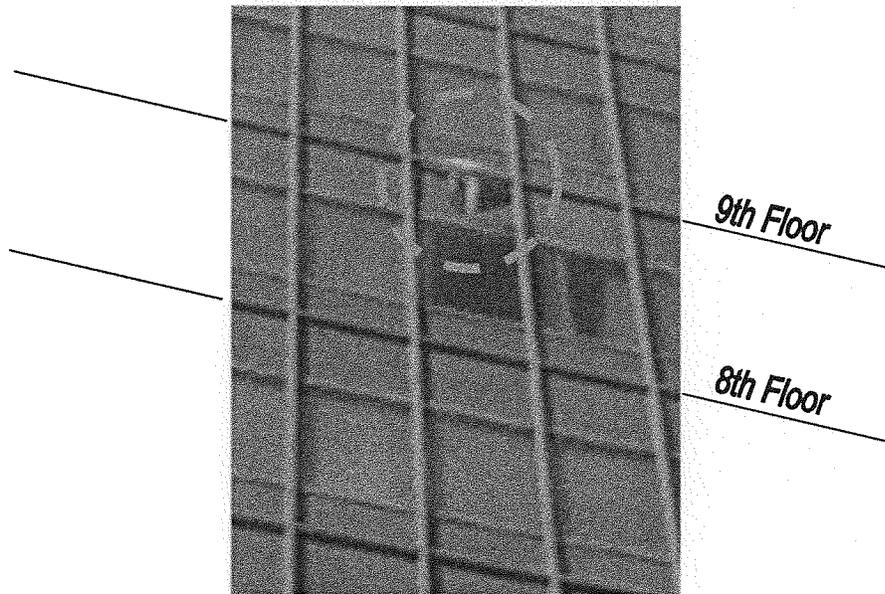
Significant portions of the glass below the floor level originally fell to the ground (Photo 1).

Photo 1 – View of broken spandrel glass shortly after it occurred.

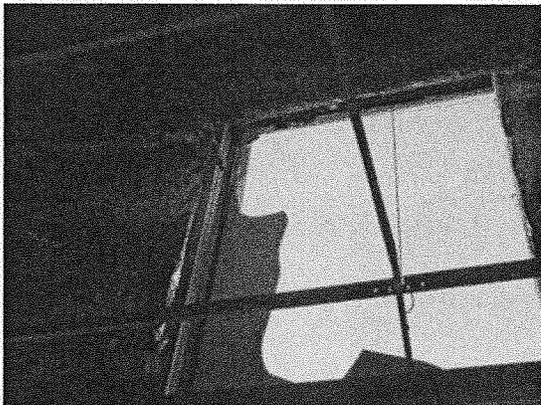
Photo 2 – View from interior of additional glass that had fallen below the floor level.

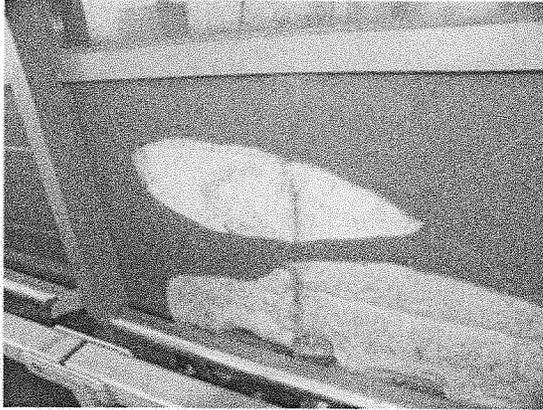
Photo 4 – View from exterior of additional glass that had fallen from above the floor line. Long arching cracks are observed in the glass.

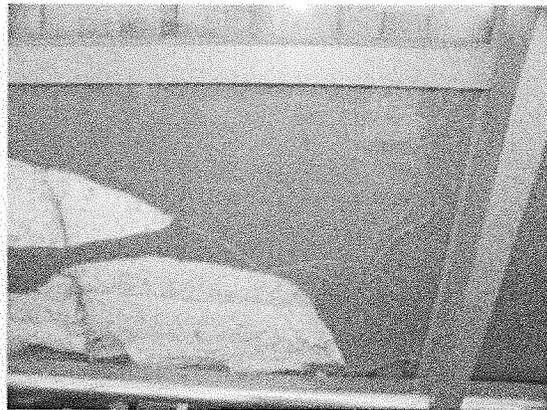
Photo 5 – View from exterior of additional glass that had fallen from above the floor line.

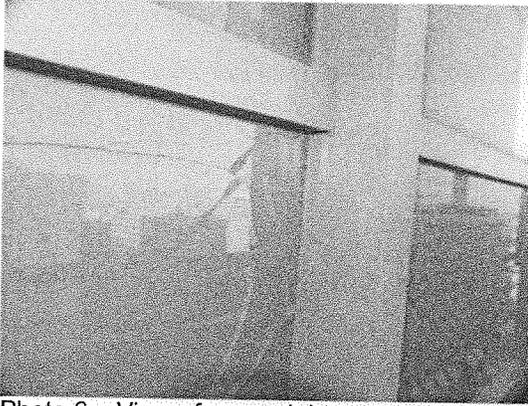
Photo 6 – View of upper right corner of the broken glass with concentrated small breaks.

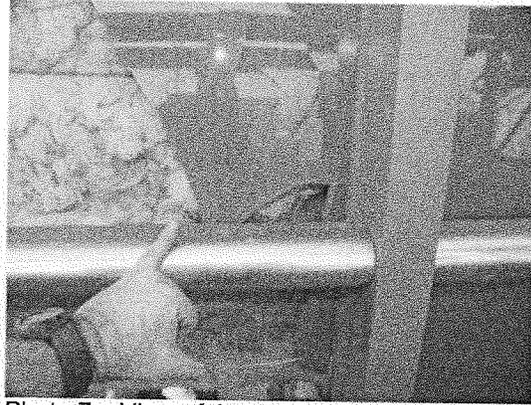
Photo 7 – View of the right side of the broken glass at the floor line with concentrated small breaks that terminate to a focal point (Photo 9).

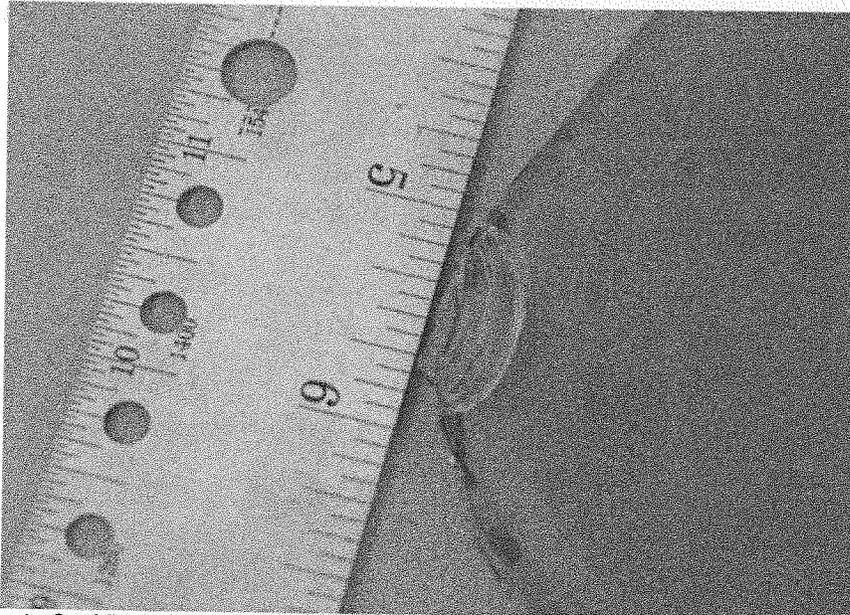
MCA was provided with a small piece of the spandrel glass for further testing. One corner of the specimen contains a circular pattern (Photo 8). The original location of this sample prior to the break is unknown.

Photo 8 – View of circular pattern at the corner of a piece of the spandrel glass.

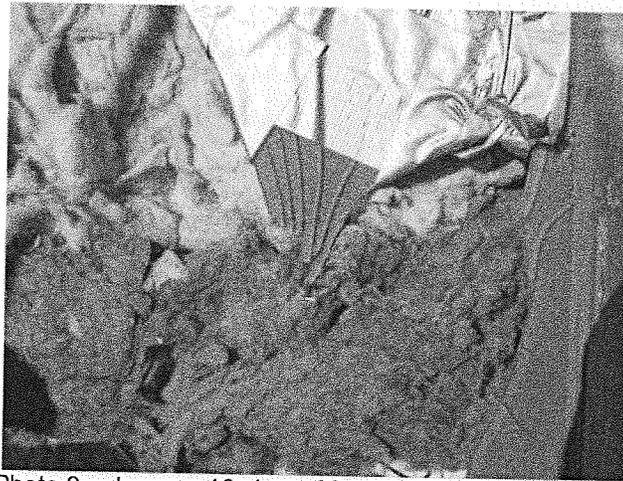
Photo 9 – January 16 view of focal point of glass break with the horizontal brass bar removed.

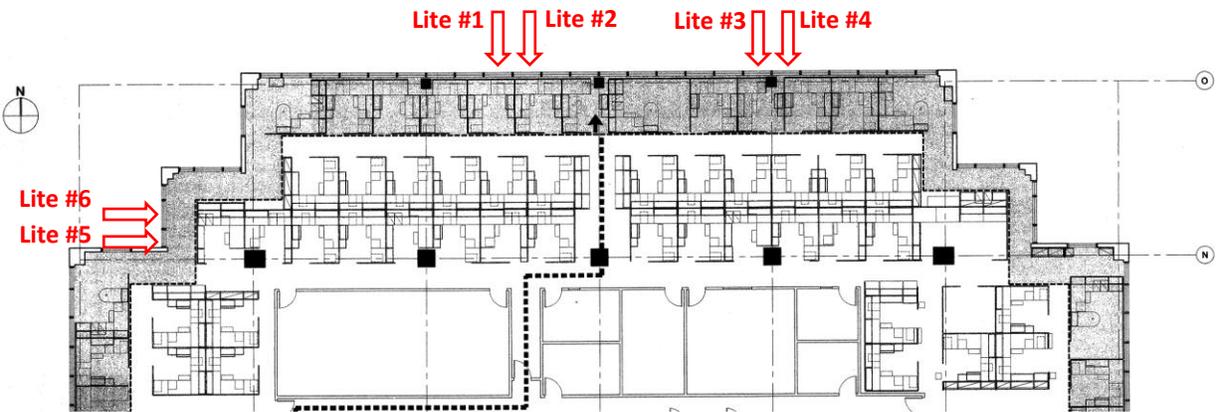
Figure 1. Partial plan of 18th floor indicating locations of reportedly cracked lites.

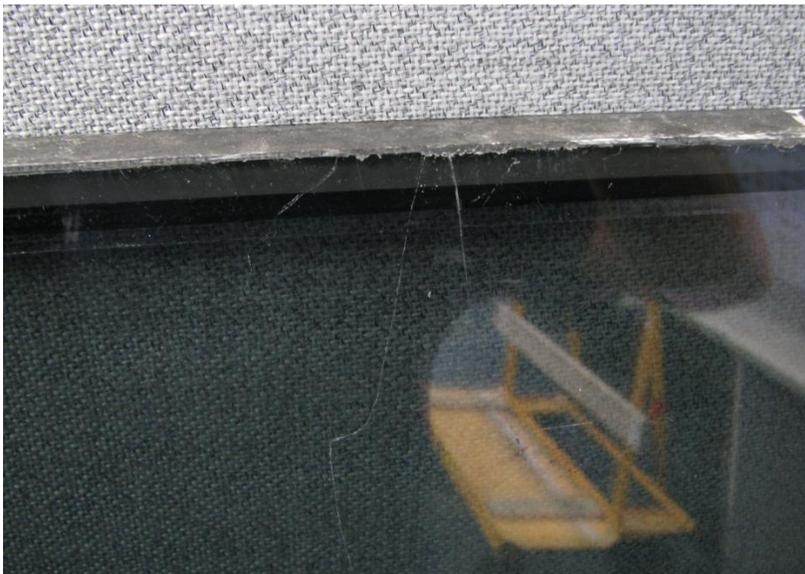
Figure 4. Scratches and edge damage on left edge of Lite #1 (same location as Figure 3). Photo taken after lite was removed from window opening.

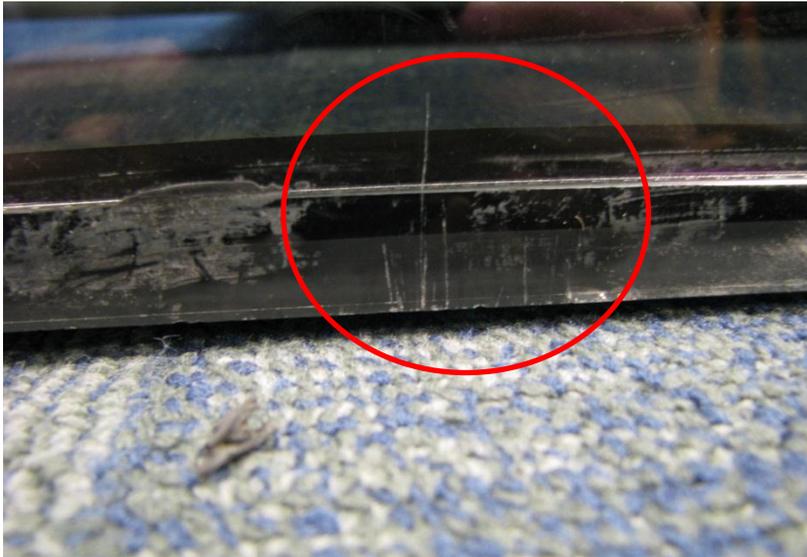
Figure 5. Scratches at right edge of Lite #1. Photo taken after lite was removed from opening.

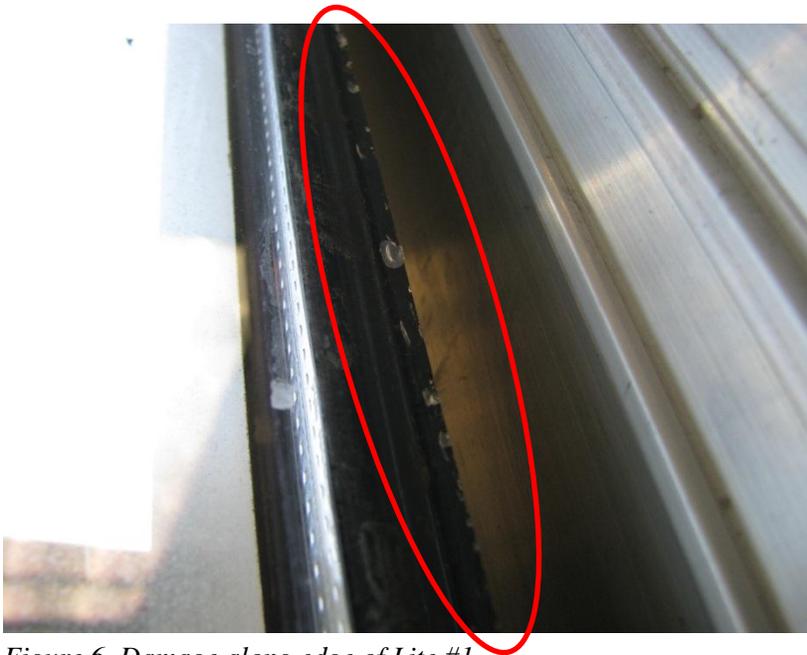
Figure 6. Damage along edge of Lite #1.

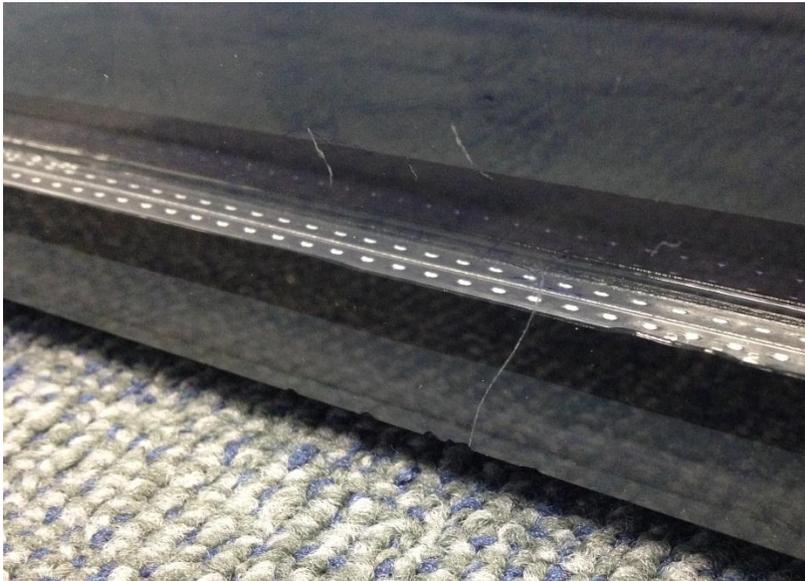
Figure 9. Scratch and edge damage on Lite #2. Same location as shown Figure 8.

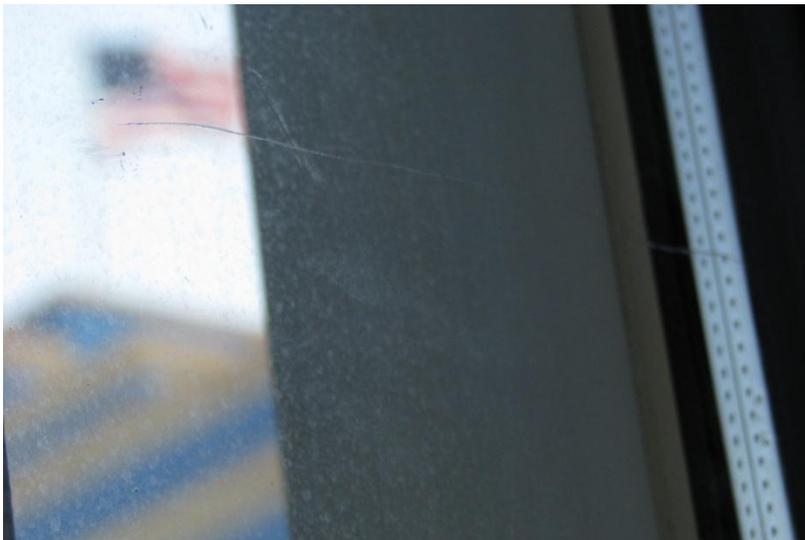
Figure 10. Scratch on Lite #3.

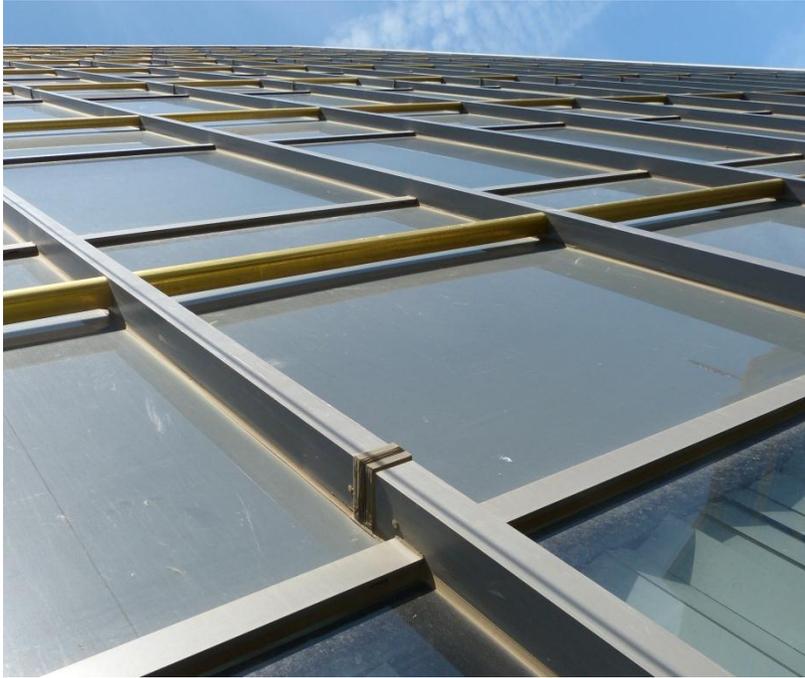
Figure 4. View looking up at curtain wall showing wet-seal around glass perimeter and pre-formed silicone boot over mullion splice, both from the 2006 repair project. Also visible is the brass bar suspended in front of each spandrel lite.

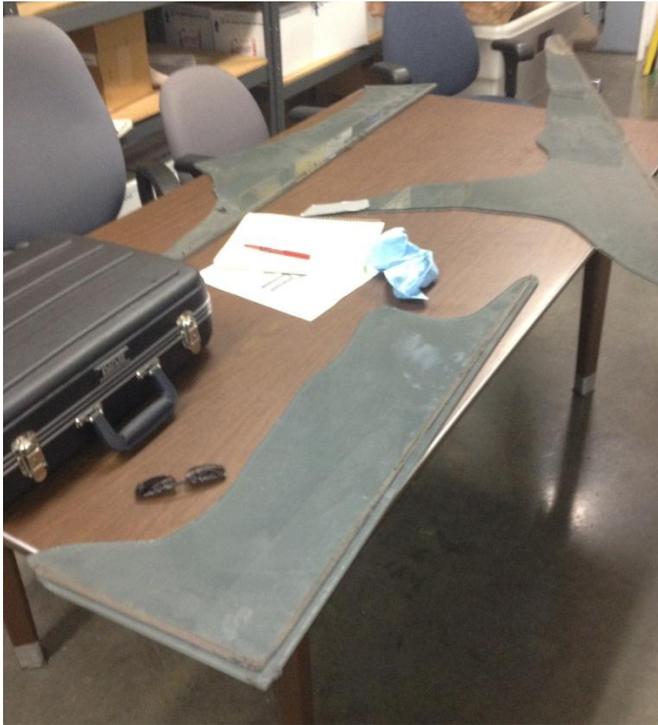
Figure 6. Three sections of the broken spandrel lite made available for our review.

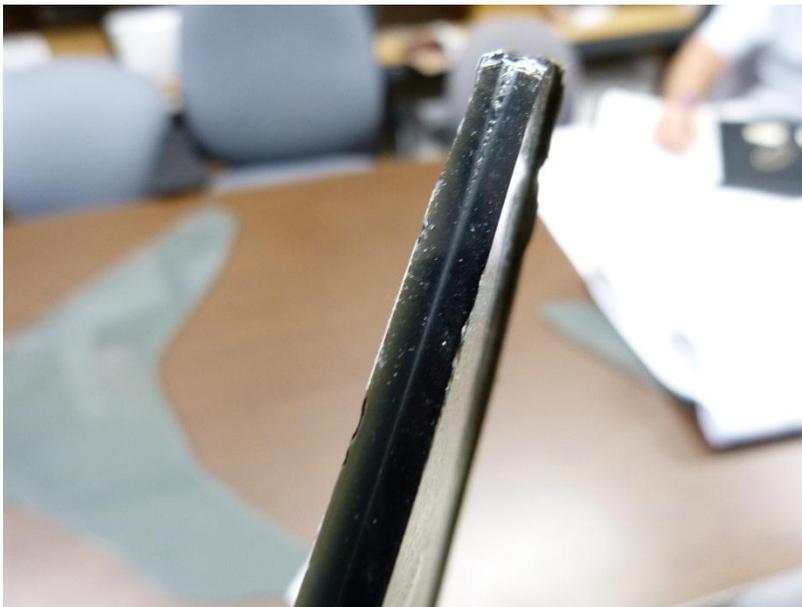
Figure 7. Line of roughness in center of glass thickness, typical of heat-strengthened glass.
