California State Board of Equalization
450 N Street, Sacramento, California

**Mold Remediation – Mechanical Floor
Closure Report Addendum**
Project No. 2372.02-572

Closure Report Date: February 17, 2012
Addendum Date: October 31, 2012

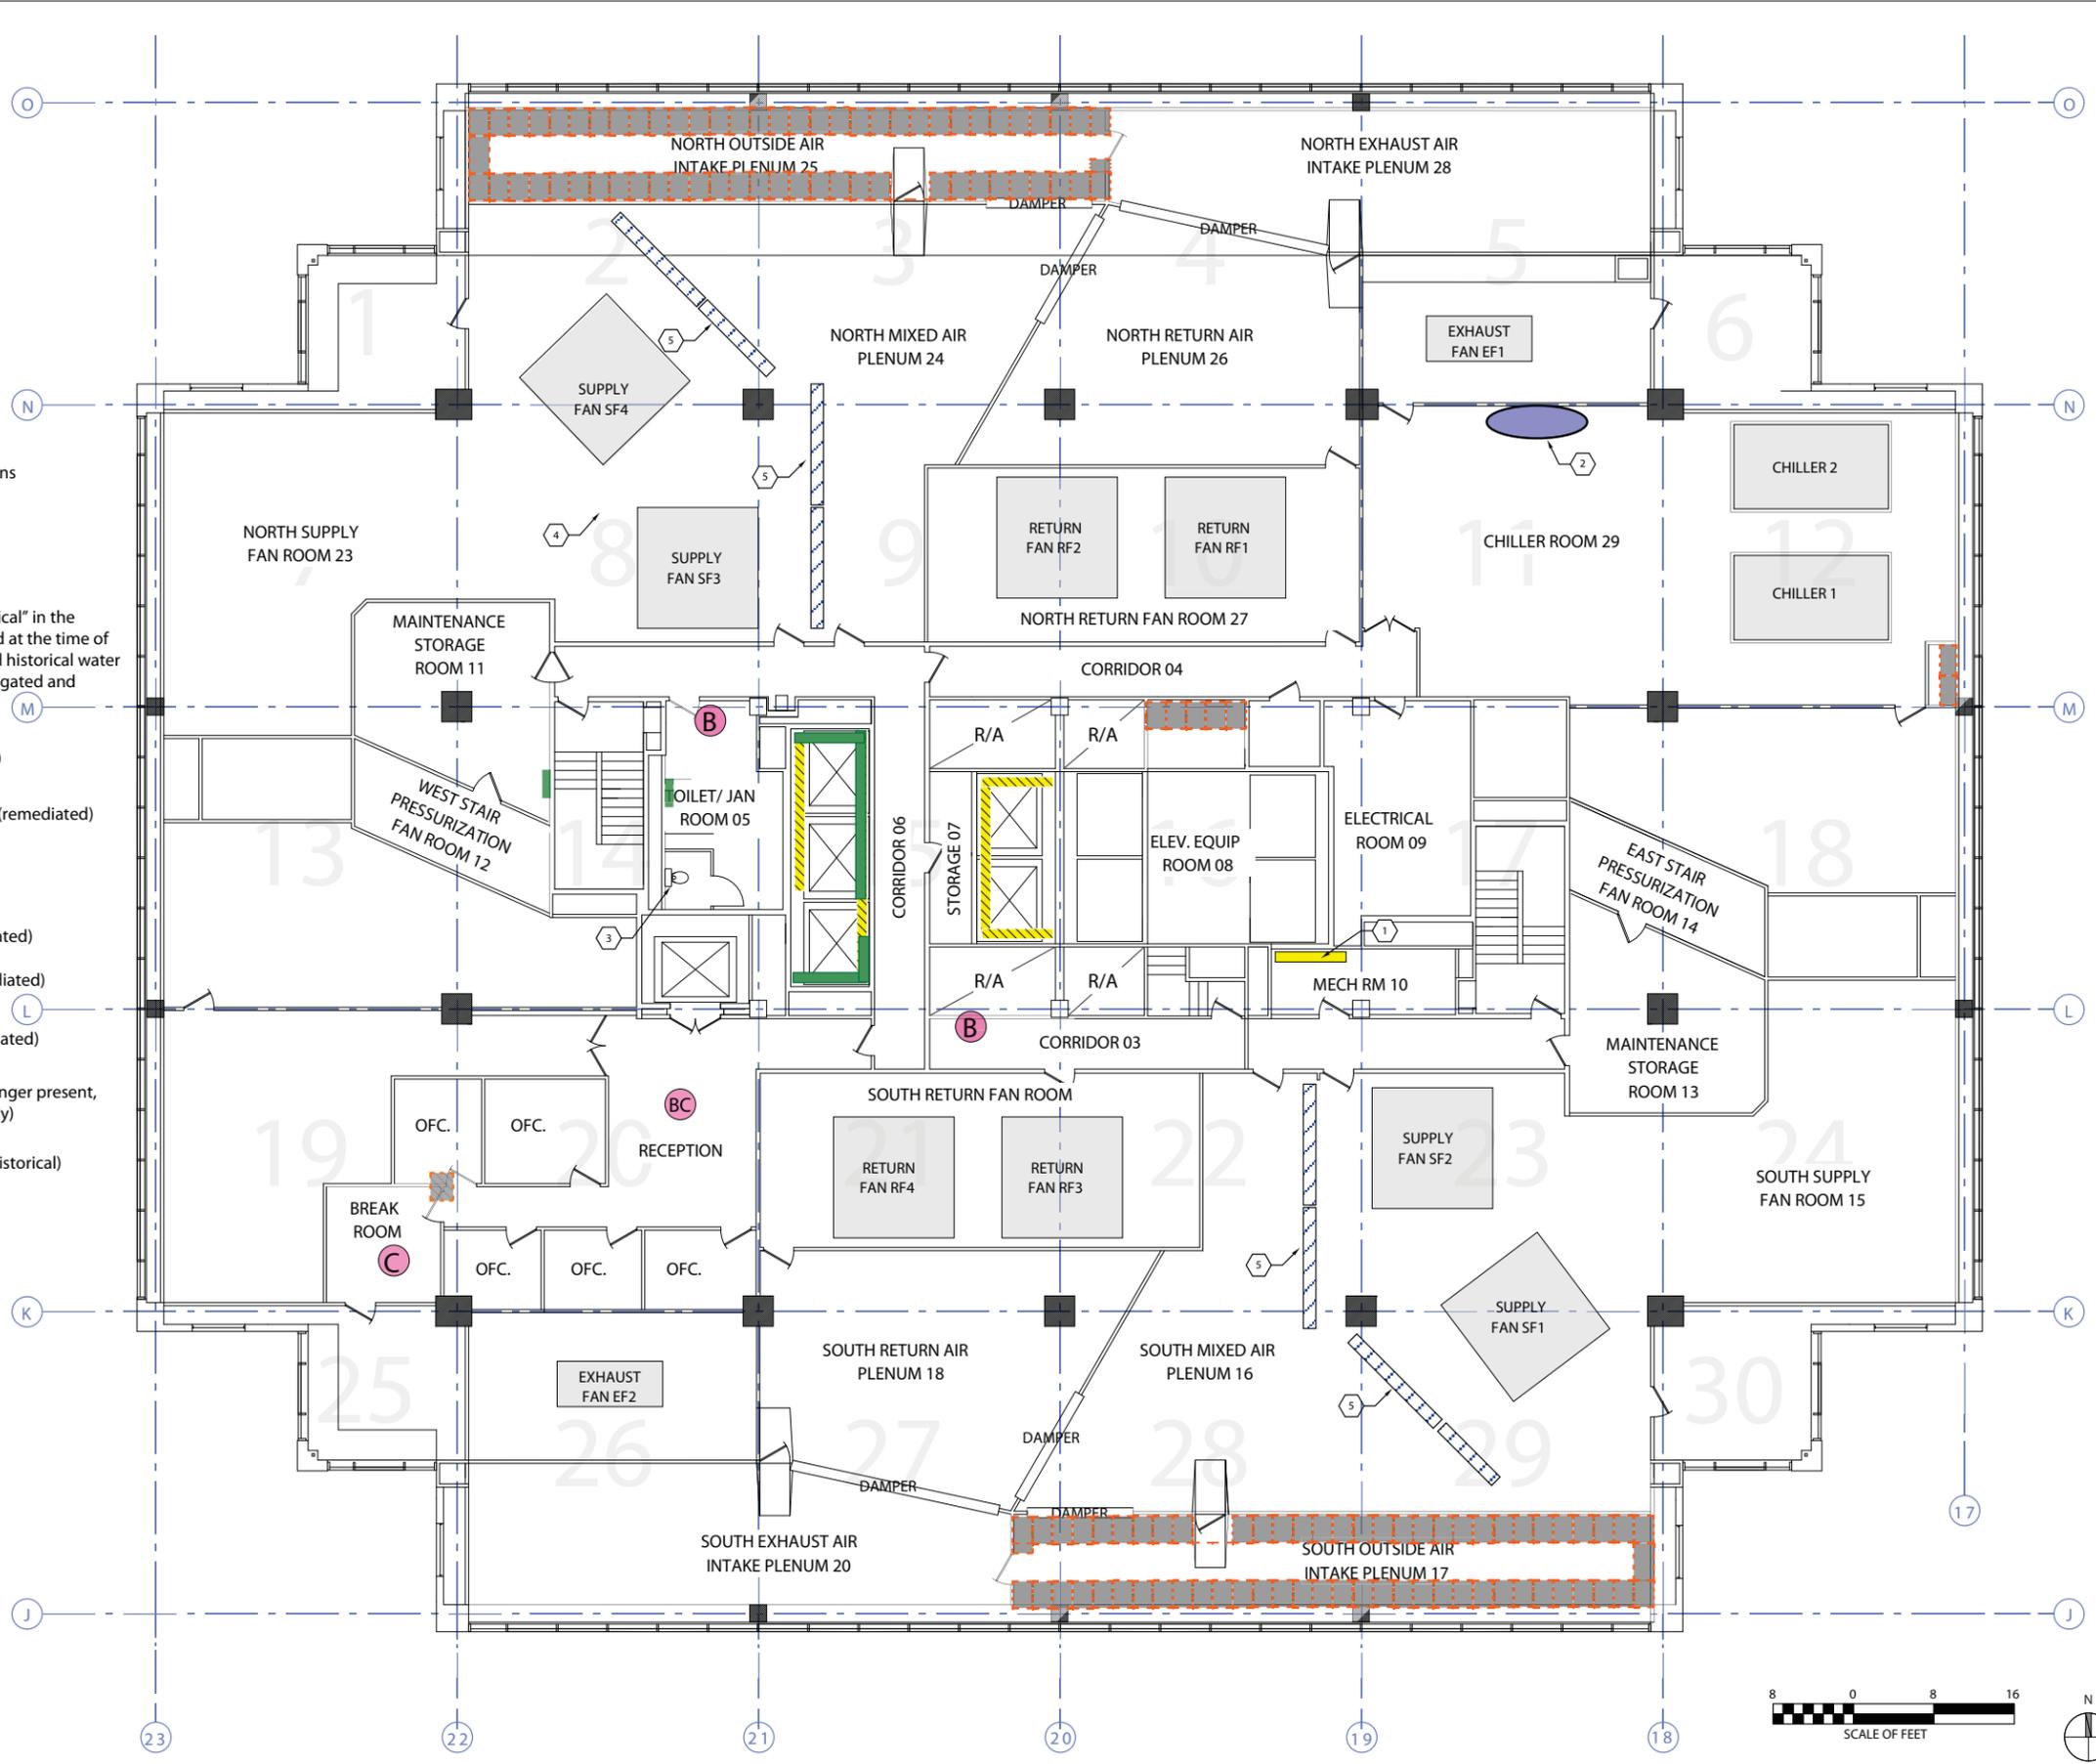
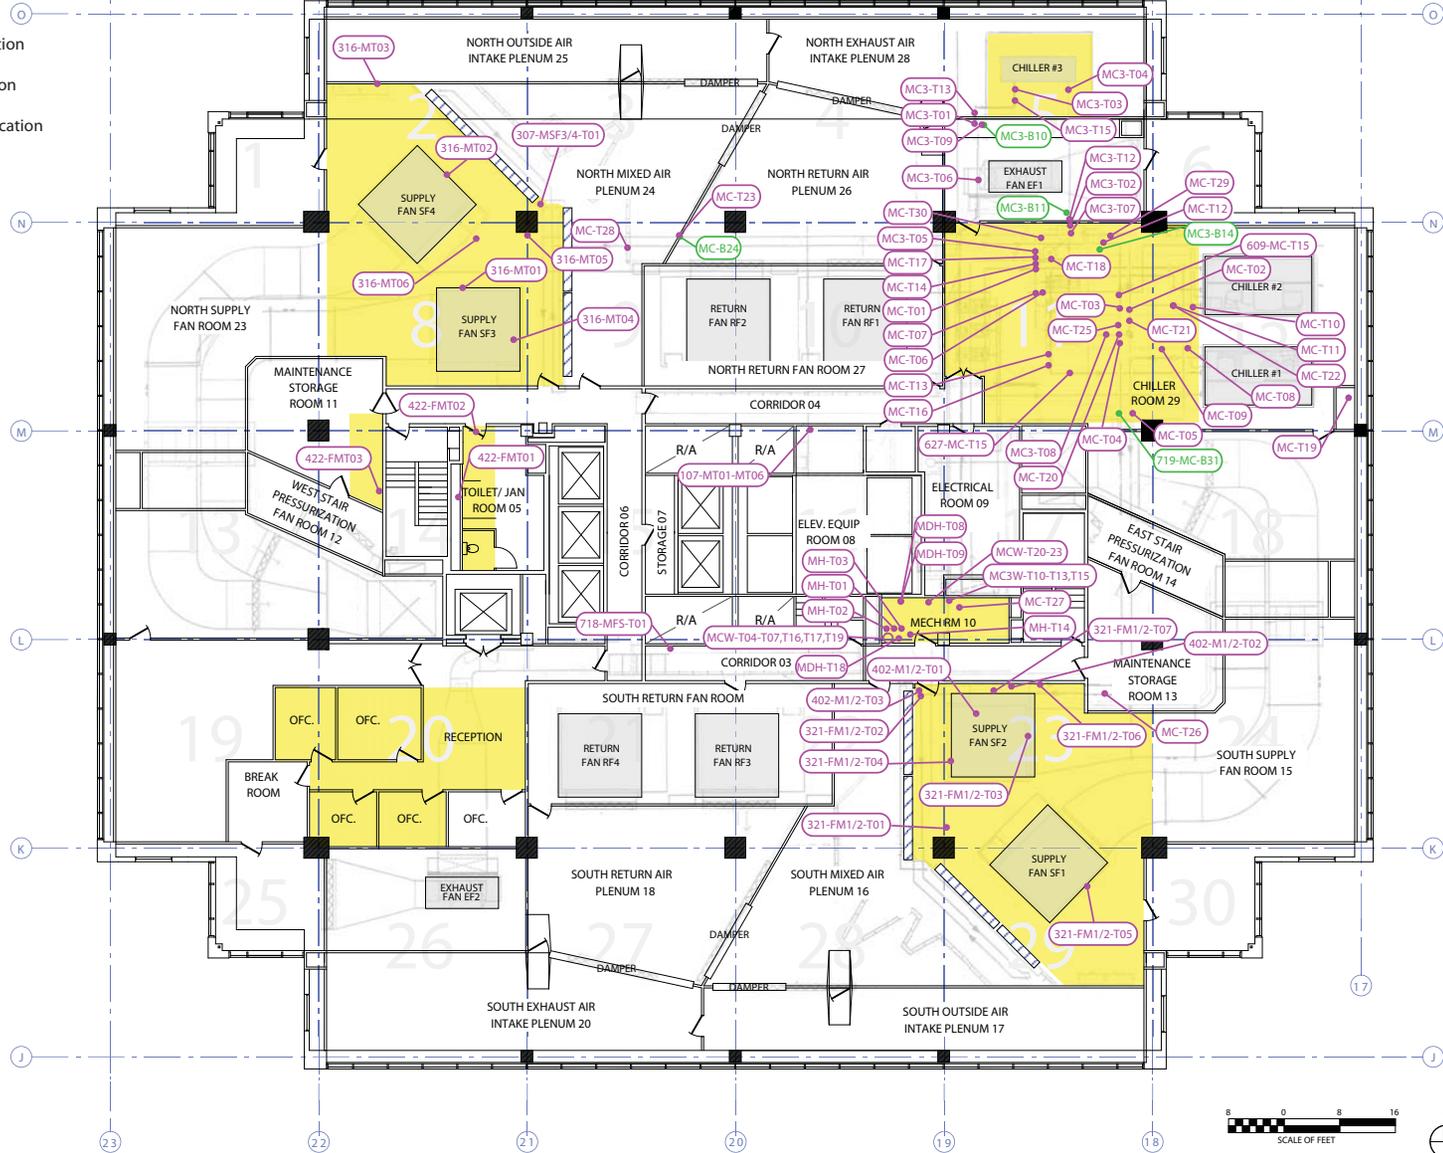
Figure 2

- ① L/19 Water stain on concrete floor
- ② N/18.5 failure of chiller tank chemical manifold (historical)
- ③ Floor tile damage from water behind toilet
- ④ Loose acoustic ceiling tile
- ⑤ Condensate pans rusting
