California State Board of Equalization
450 N Street, Sacramento, California

**Mold Remediation – 18th Floor
Closure Report Addendum**

Project No. 2372.02-572

Addendum Date: October 31, 2012

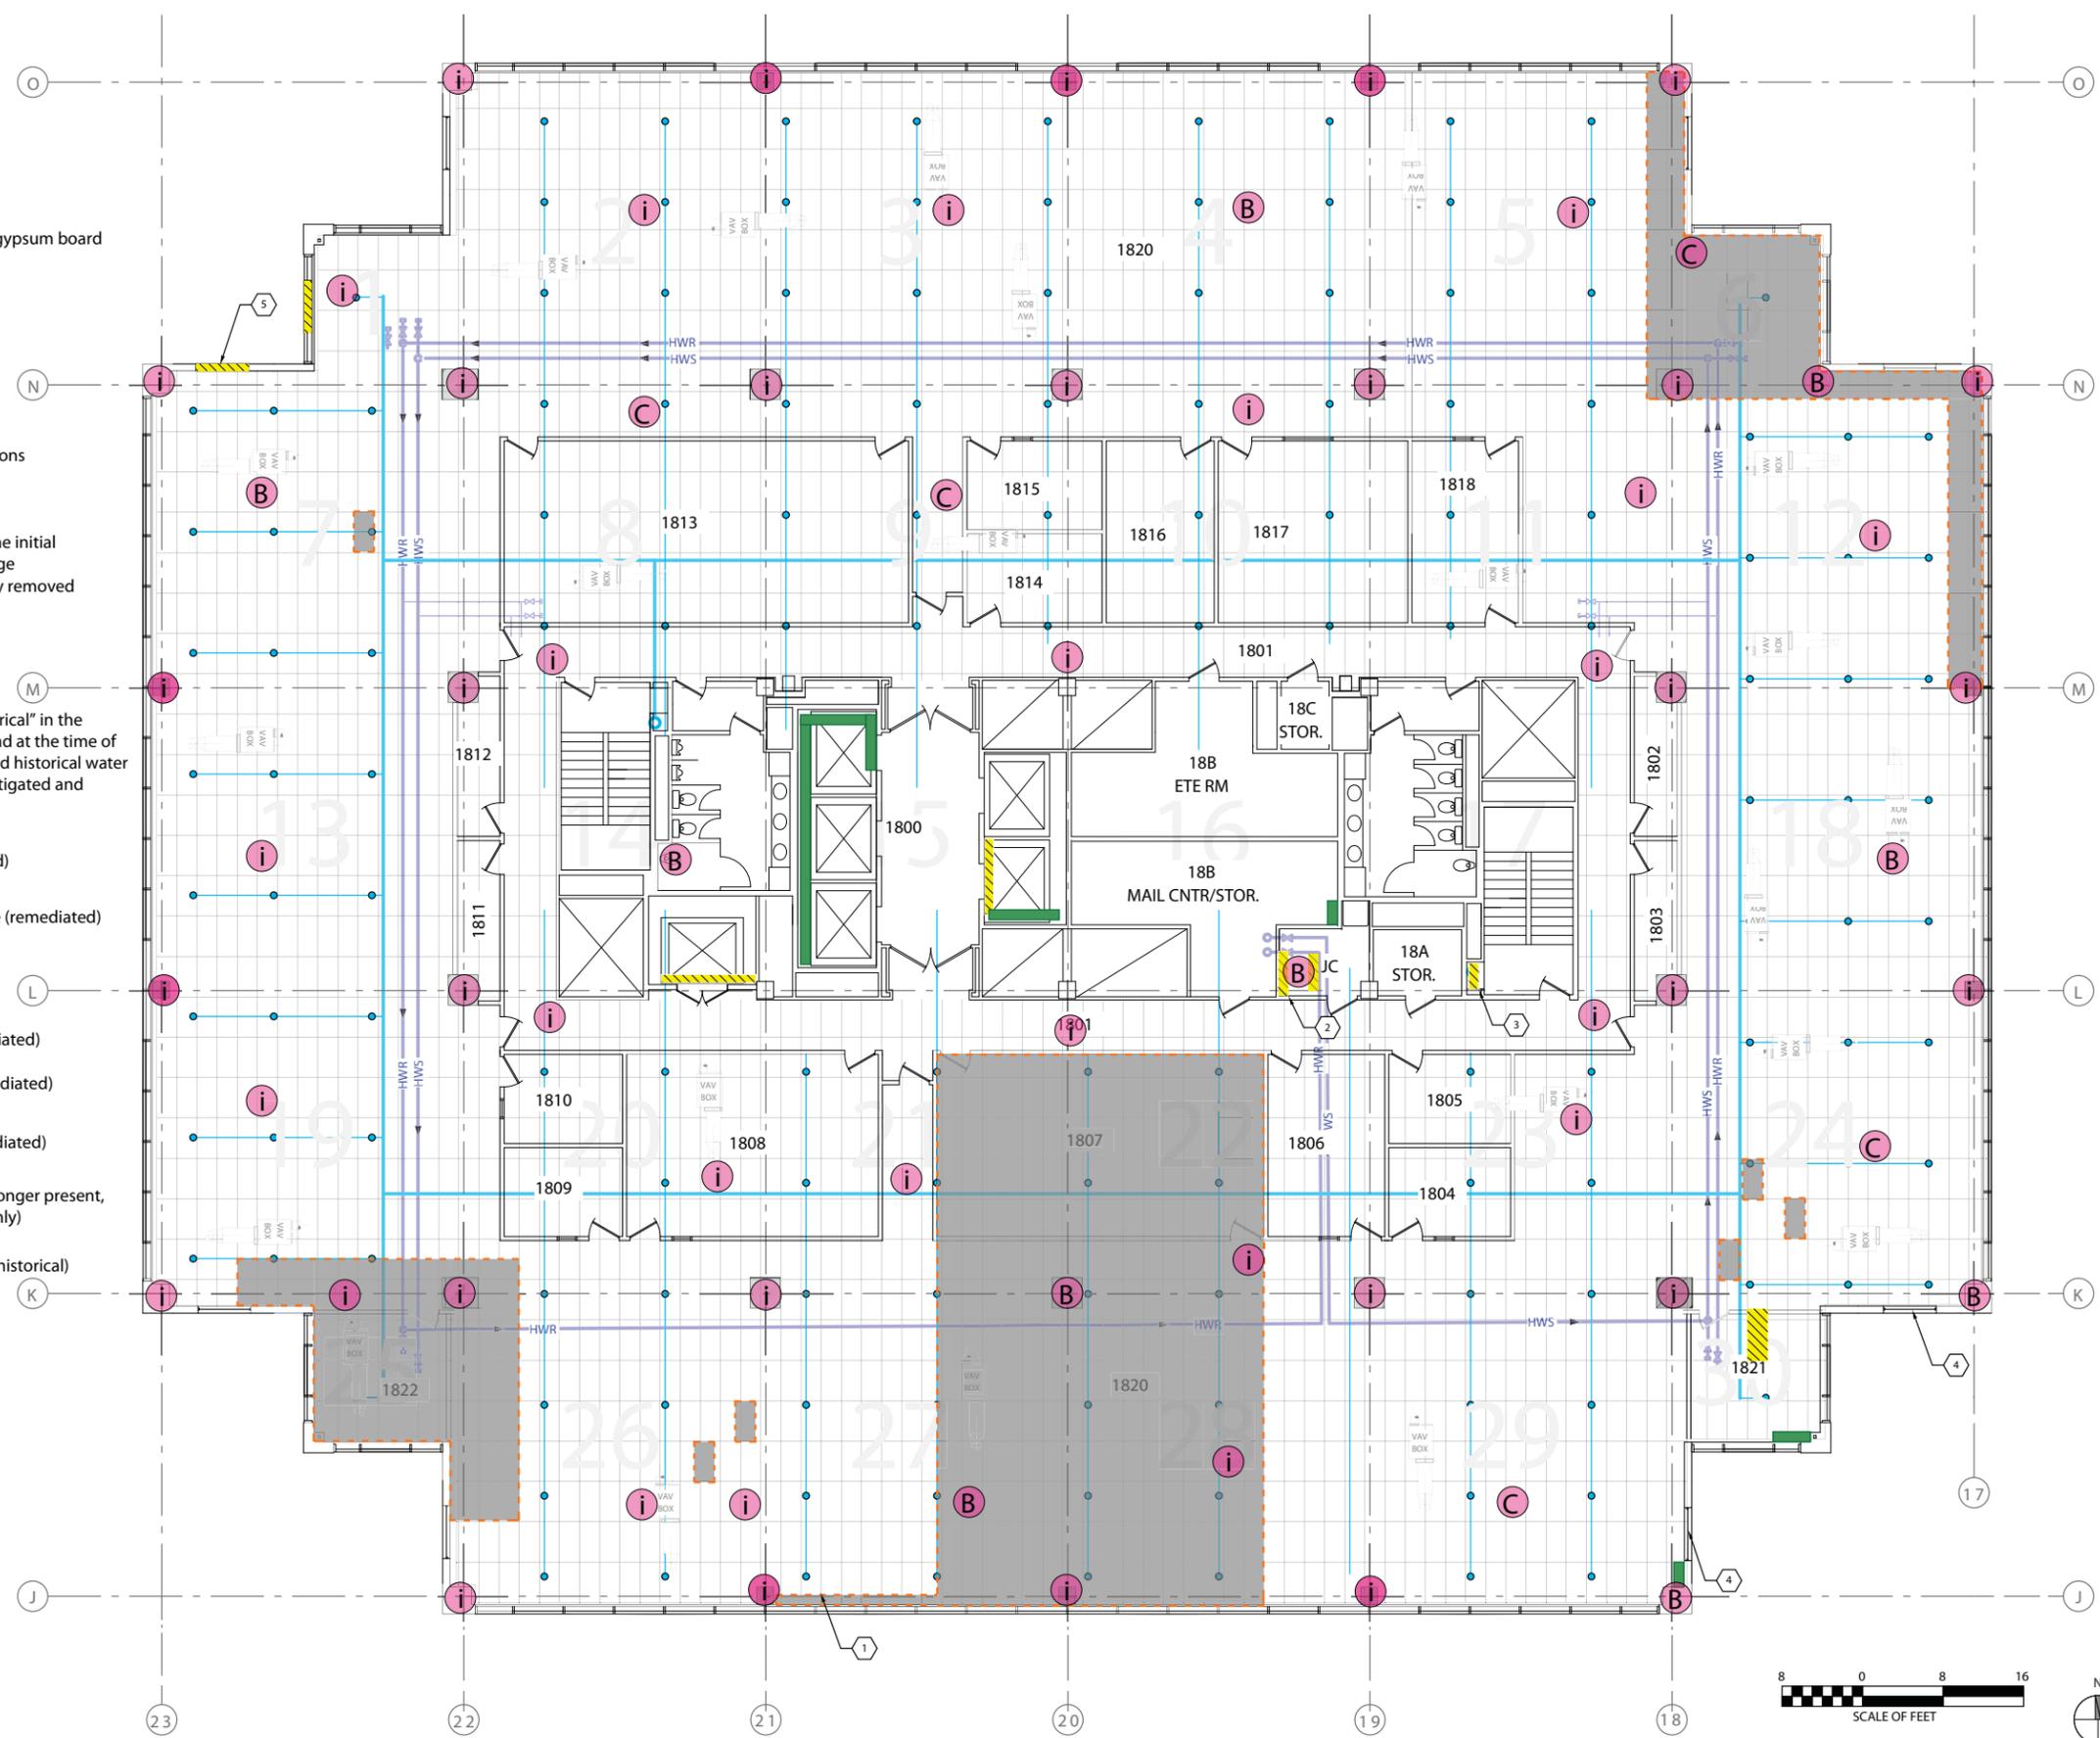
- ① Curtain wall leak (historic)
- ② Stain on pipe and wall
- ③ Water stain on wall
- ④ Visible mold growth on wall gypsum board
- ⑤ Stain on sill
