**California State Board of Equalization**  
450 N Street, Sacramento, California

**Mold Remediation – 6<sup>th</sup> Floor  
Closure Report Addendum**

*Project No. 2372.02-572*

**Addendum Date:** October 31, 2012

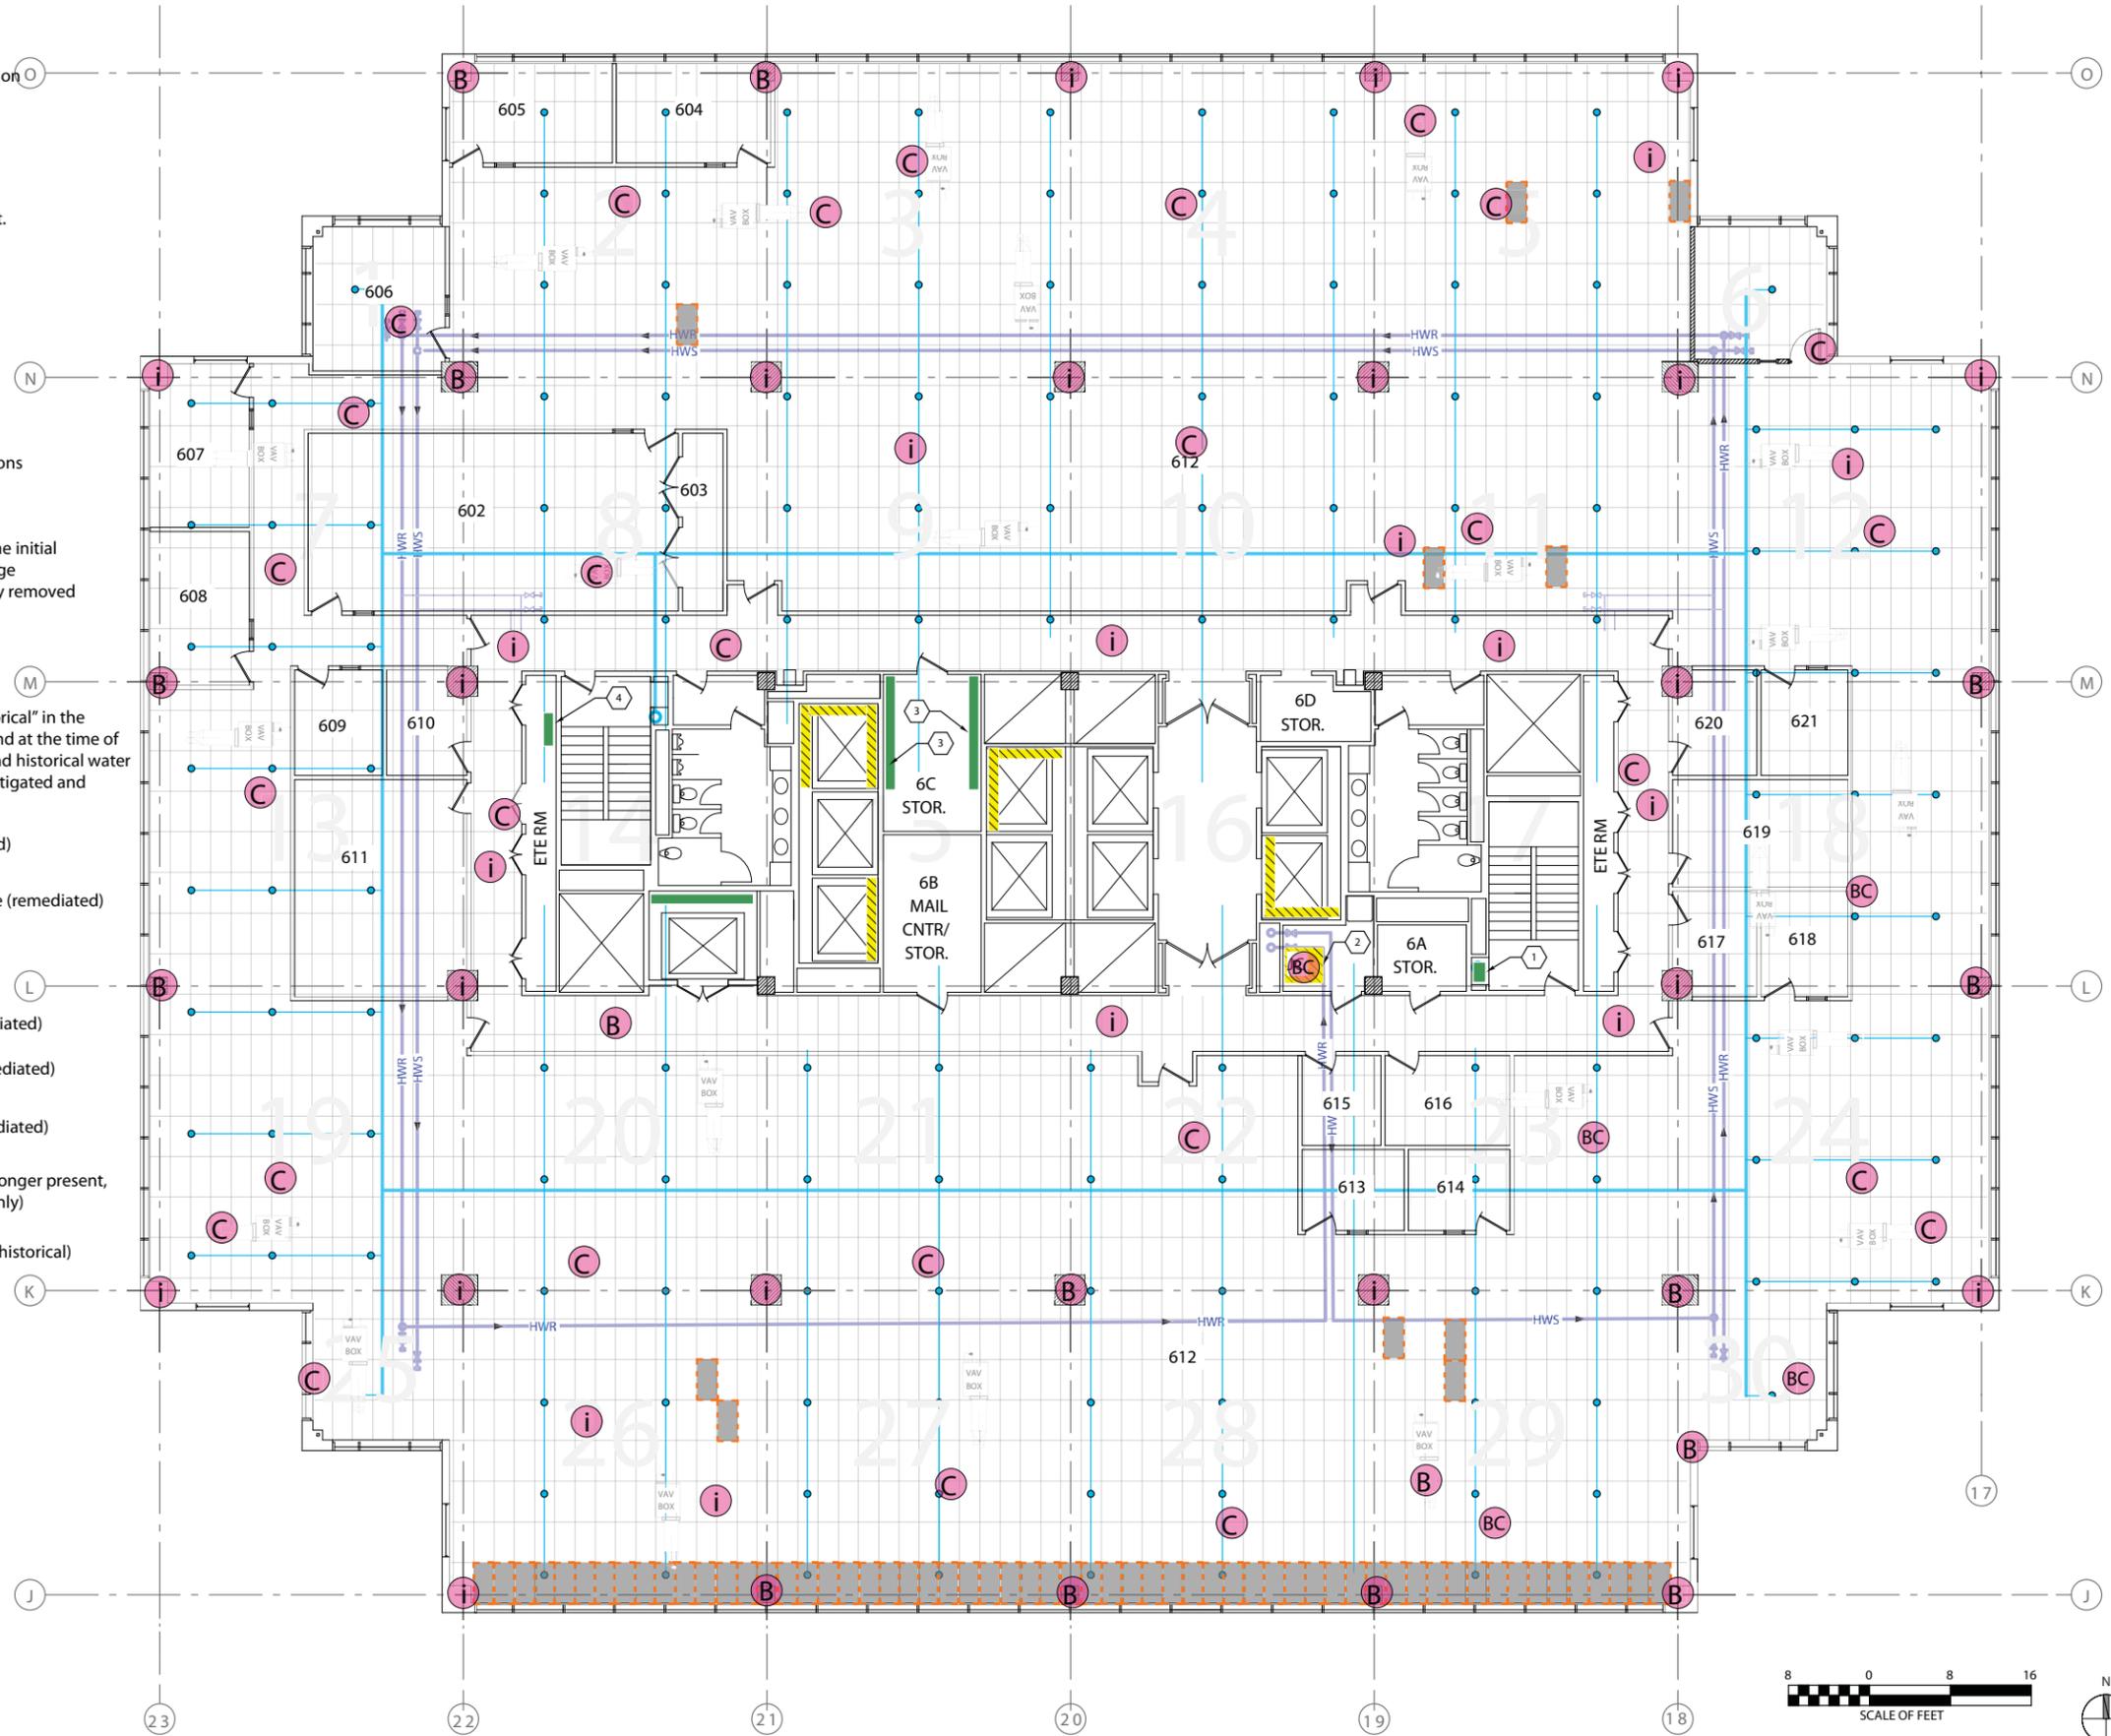
- 1 Visible mold growth 10 sq. ft. on South and West walls
- 2 Water stain on ceiling, extensive water damage
- 3 Visible mold growth 100 sq. ft. above ceiling
- 4 Visible mold growth 1 sq. ft.

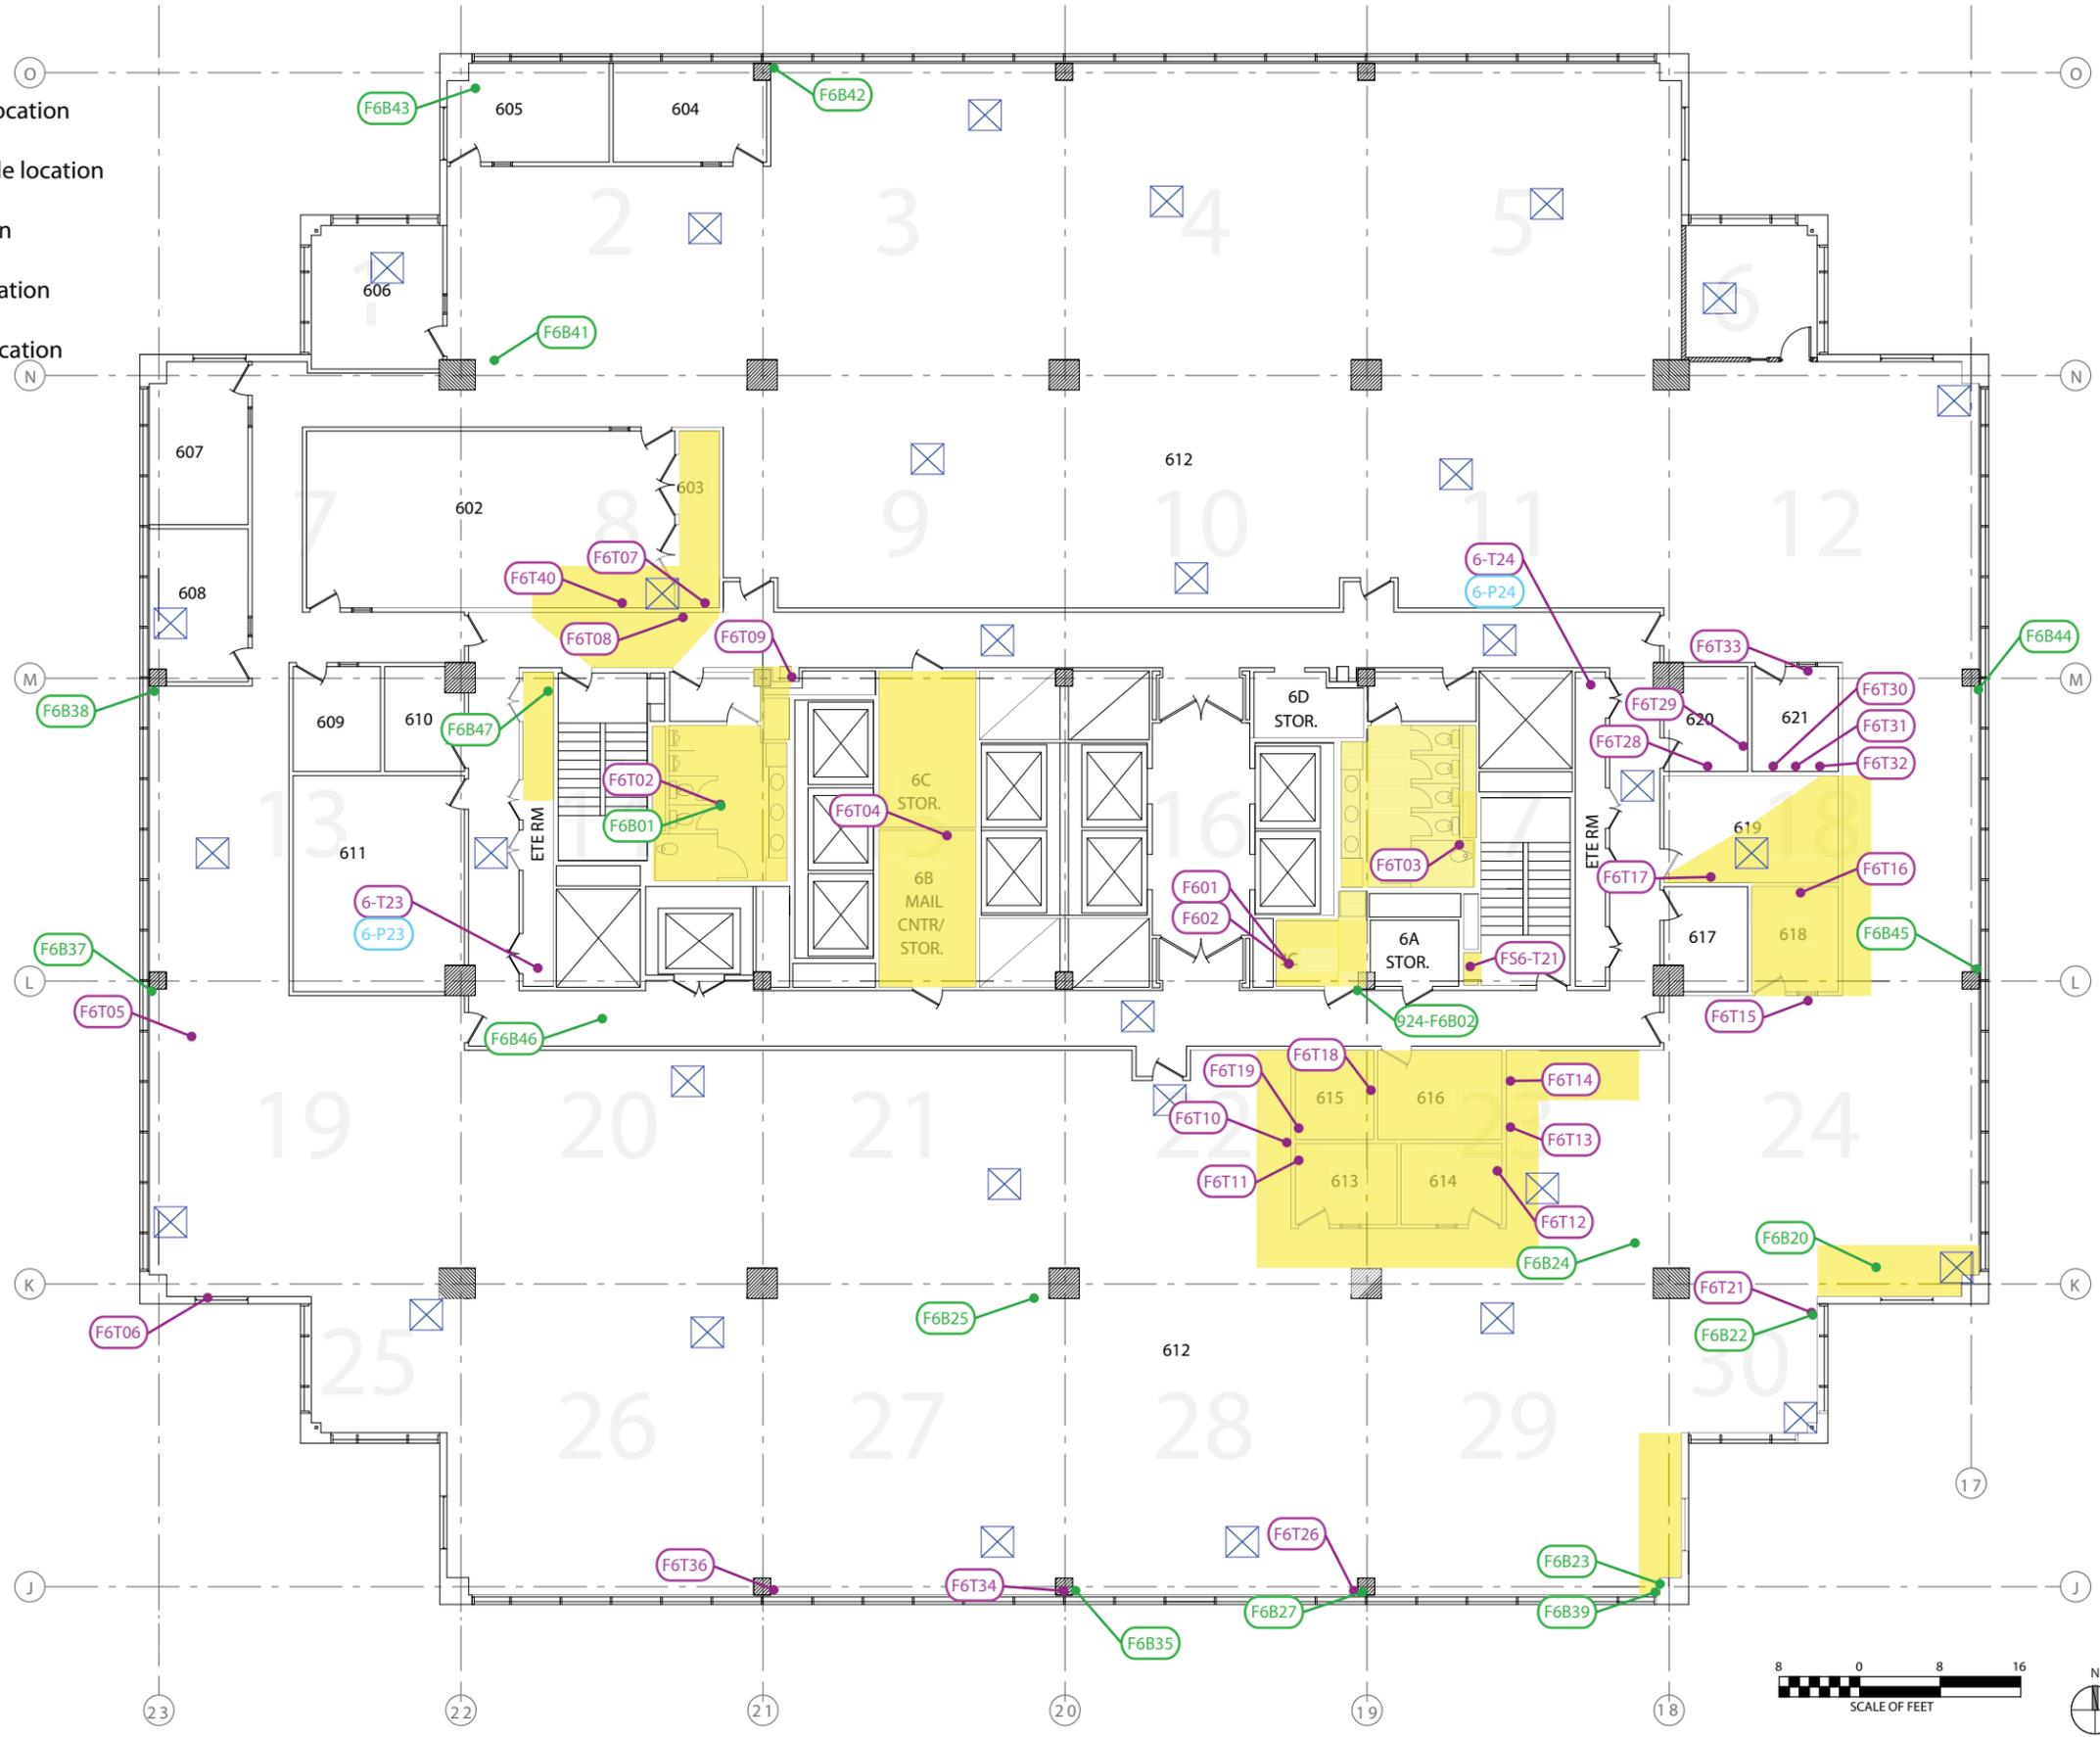
Subsequent to the completion of the closure report, a need for additional investigation and/or remediation activities was identified. Identified areas were subjected to sampling. Using a combination of surface tape lift and/or bulk samples, LCD tested stains on walls and other building materials to determine if the stains were indicative of mold growth. The sample locations are depicted in a revised Figure 2 attached to this addendum.
